ODI RESUME

Investigation: EA 06-003
 Prompted By: PE05-061
 Date Opened: 03/08/2006 Date Closed: 05/22/2007
 Principal Investigator: Michael Lee
 Subject: Front Air Bag Crash Sensor Failure

Manufacturer: DaimlerChrysler Corporation
 Products: 2005-2006 DaimlerChrysler Minivans (Dodge Caravan and Grand Caravan, and Chrysler Town and Country)
 Population: 960,569

Problem Description: Frame rail-mounted front air bag crash sensors can fail due to corrosion. The failure may cause the frontal air bags to deploy late or reduce the driver air bag inflation level in certain types of frontal crashes.

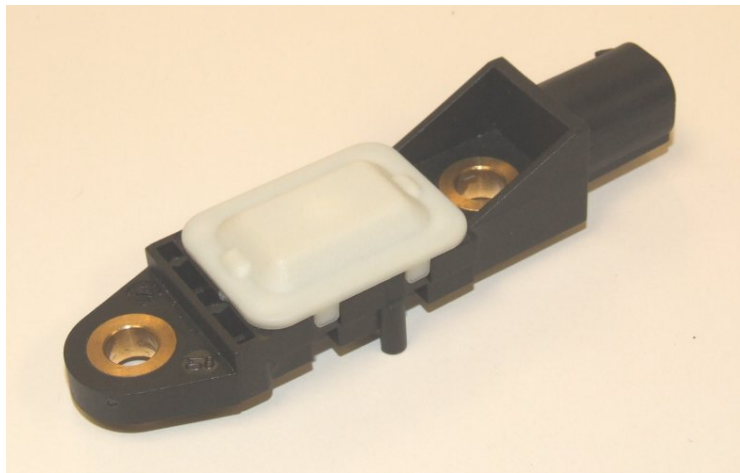
New Brass Bushing Front Crash Sensor

The alleged defect is the failure of the front crash sensors due to corrosion caused by the use of dissimilar metals—in this case, brass bushings secured with steel fasteners to a steel frame rail—exposed to road splash water (especially salt water) that accelerates the rate of corrosion. Metal corrosion eventually leads to cracking of the sensor's plastic housing starting near the bushings and propagating to the connector housing and molded plastic at the circuit board. Water enters through the cracks, reaches the sensor's internal components (connector pins and circuit board), corrodes them, and damages the sensor, causing it to malfunction. The failure manifests itself as increased electrical resistance.

DCC will replace the frame rail-mounted front air bag crash sensors (herein referred to as front crash sensors) in approximately 270,958 MY 2005 DaimlerChrysler Minivans.¹ These vehicles are equipped with front crash sensors with brass bushings and were built between April 24, 2003 and February 2, 2005. This action covers vehicles originally sold, or currently registered, in 27 states and the District of Columbia.²
