ODI RESUME

Investigation: EA06-010
Prompted By: PE06-009
Date Opened: 06/15/2006 Date Closed: 09/11/2007
Principal Investigator: Stephen McHenry
Subject: Fuel tank punctures

Manufacturer: DaimlerChrysler Corporation
Products: 2004-2006 Chrysler Pacifica
Population: 299,694

Engineering Analysis Closing Report

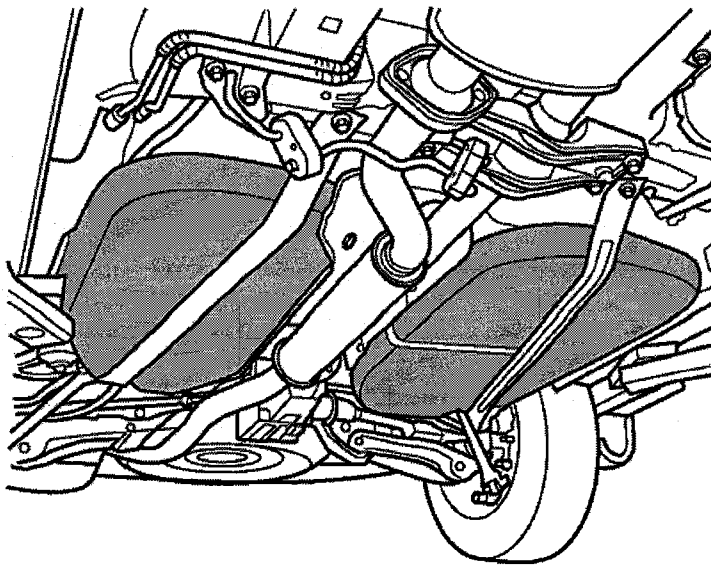
Figure 1: Diagram of underneath of Chrysler Pacifica showing plastic saddlebag style fuel tank (area in gray)

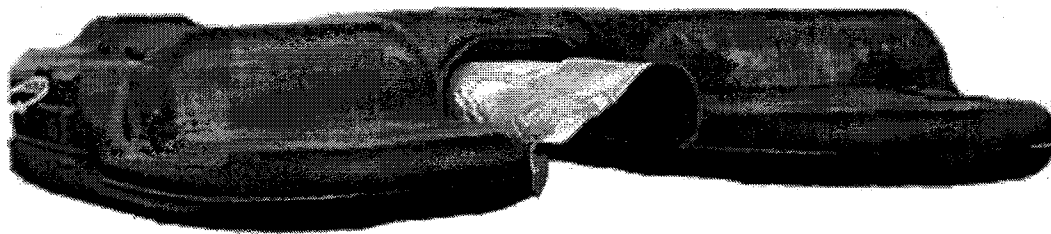
Figure 2: Photo of Pacifica HDPE fuel tank.

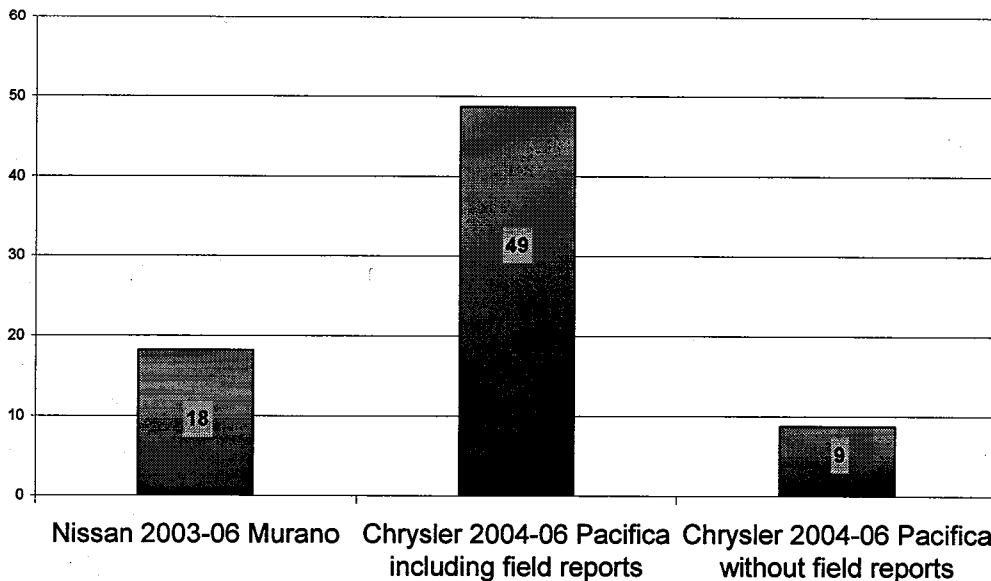
A similar analysis of the Pacifica response data yielded consumer complaints to Chrysler (15) and Chrysler field reports (120). The comparative complaint/field-report rate per 100,000 vehicles was significantly higher for the Pacifica vehicles than for any of the other peers that ODI studied during PE05-050. ODI also noted that the Murano and Pacifica were the only vehicles for which information was requested under PE05-050 that did not have shielding on the front region of the fuel tank. The apparently high rate for the Pacificas prompted the opening of PE06-009 into the MY 2004 through 2006 Chrysler Pacifica vehicles.

Chart 1: Comparative complaint rates Murano versus Pacifica including field reports from parts restriction, and with only complaints counted (same criteria as Murano)

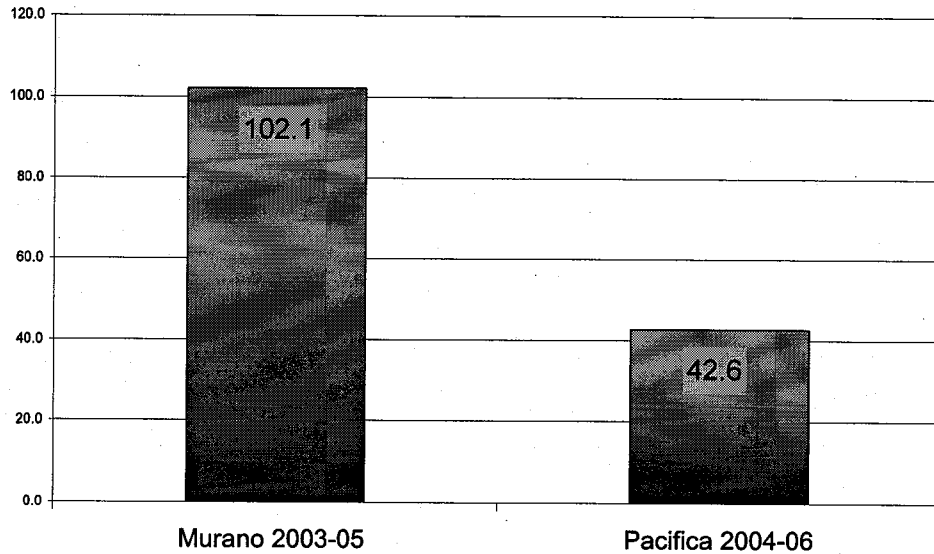
Chart 2 provides a comparison of the complaint rates adjusted for exposure years for the recalled Nissan Murano vehicles and the subject vehicles. The Murano rate is approximately 2.5 times higher than that of the subject vehicles.

Chart 2: Subject vehicle exposure adjusted complaint rate comparison with recalled Nissan Murano vehicles (complaint per million vehicle years).
