**Honda presentation
to
NHTSA Office of Defect Investigation
(00-01M Odyssey coil spring)**

April 20th 2006

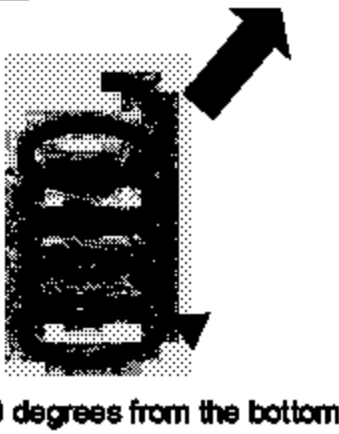
● Confirmation of the situation in which the spring was broken at 360 degrees from the bottom

Condition after fracture	Condition of tire	Broken location (▼)			
L side	Spring side face interfered with tire sidewall	Interference did not result in failure during 100km driving at 60km/h

<table border="1"> <tr> <td>Puncture may occur</td> </tr> <tr> <td>Tire failure may occur</td> </tr> <tr> <td>No puncture</td> </tr> <tr> <td>No contact with tire</td> </tr> </table>	Puncture may occur	Tire failure may occur	No puncture
Puncture may occur						
Tire failure may occur						
No puncture						
No contact with tire						
R side	Spring did not interfere with tire	No interference

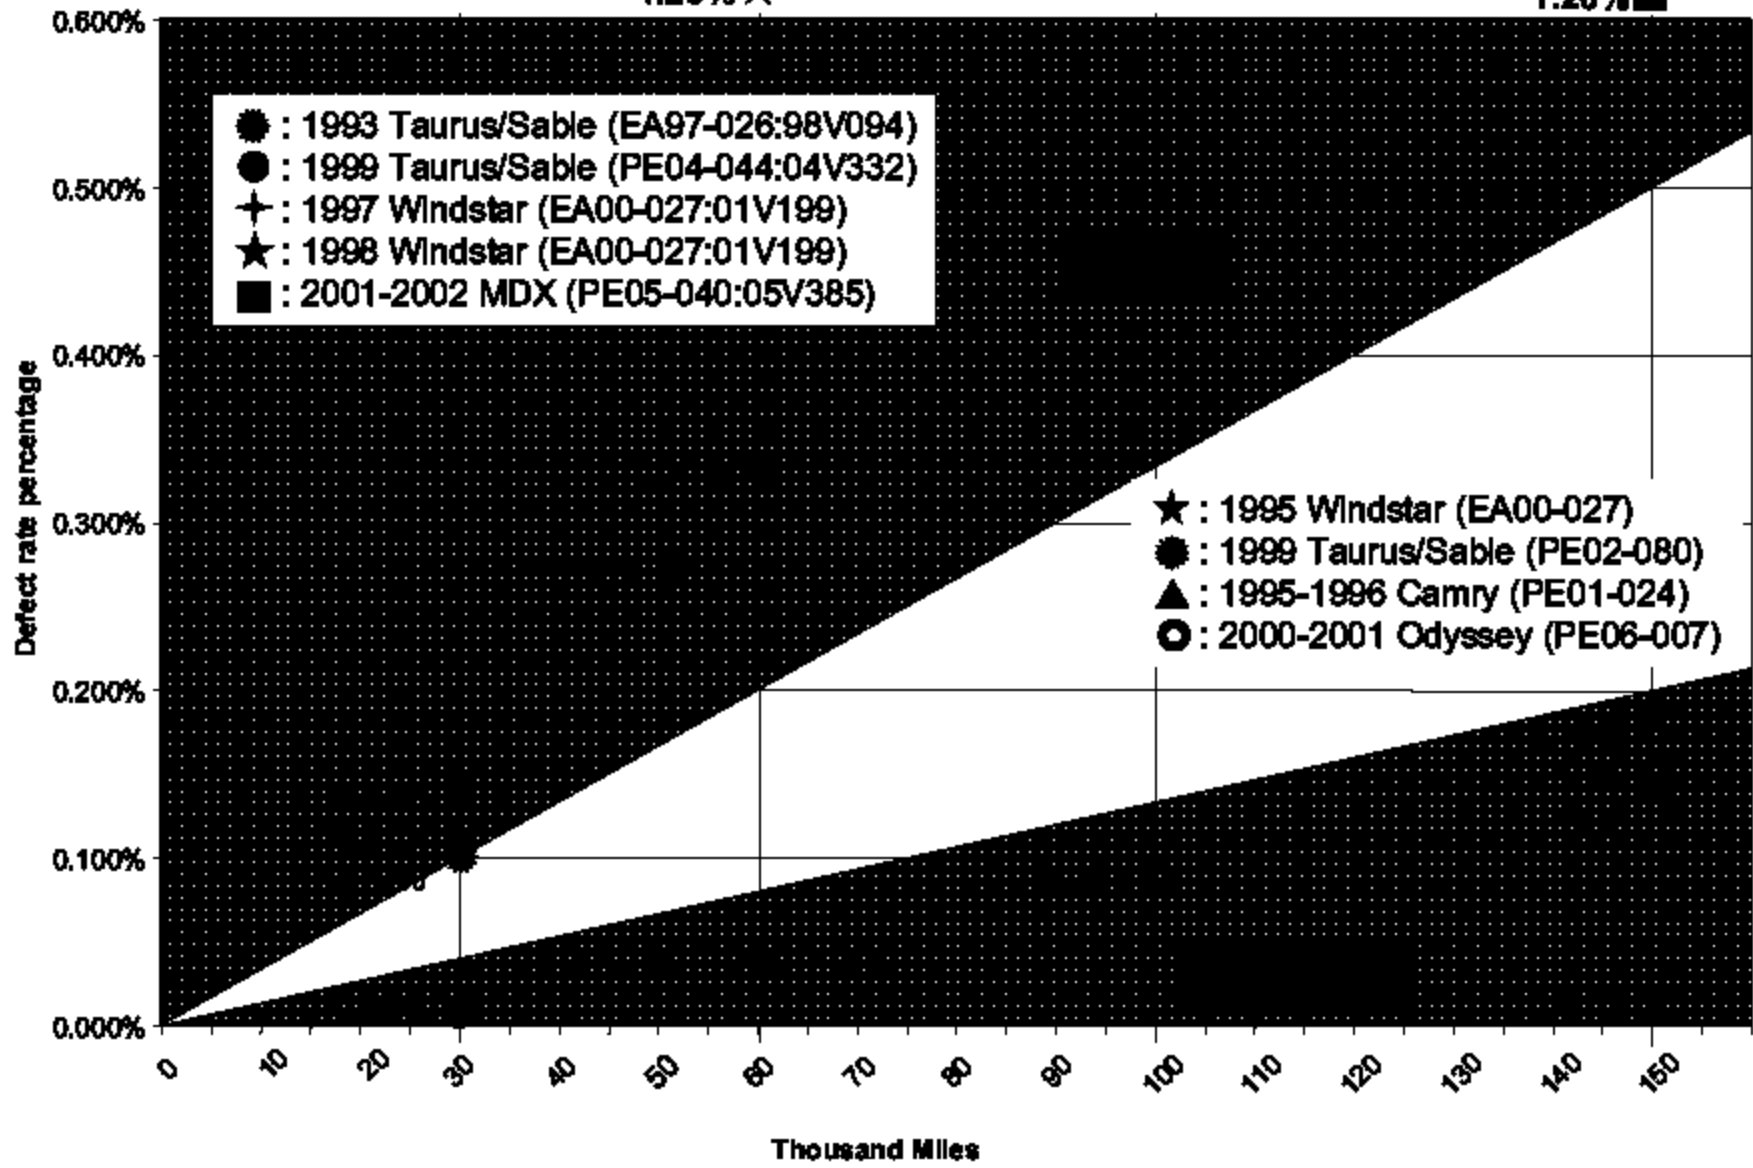
Front Coil Spring Fracture Rate (US salt region)

4.6% ★
 2.0% ●
 1.3% ✦
 1.20% ■
