PE06-048

MAZDA

APPENDIX 4

**SOUTHERN FARM BUREAU CASUALTY INSURANCE COMPANY  
MISSISSIPPI FARM BUREAU MUTUAL INSURANCE COMPANY  
MISSISSIPPI FARM BUREAU CASUALTY INSURANCE COMPANY  
P. O. BOX 780 . BATESVILLE, MISSISSIPPI 38606-0780 . (601) 561-0116**

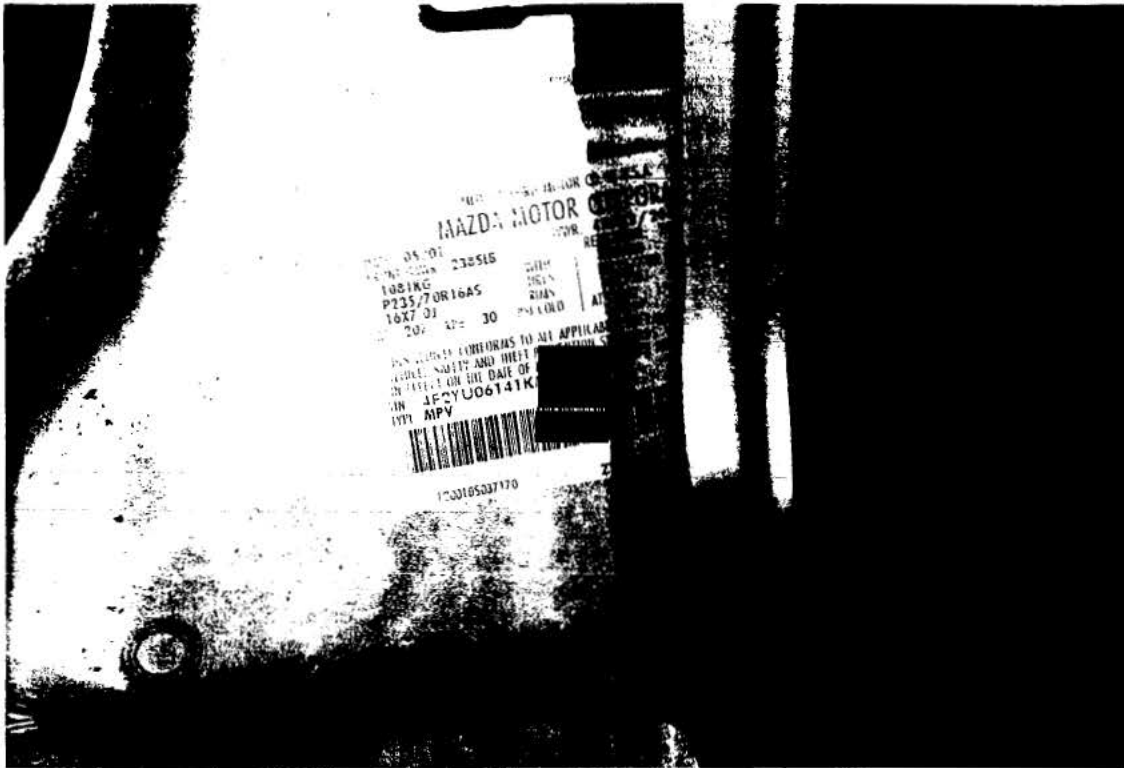
1. A view of the Vehicle Identification Number identifying the 2001 Mazda, Tribute.

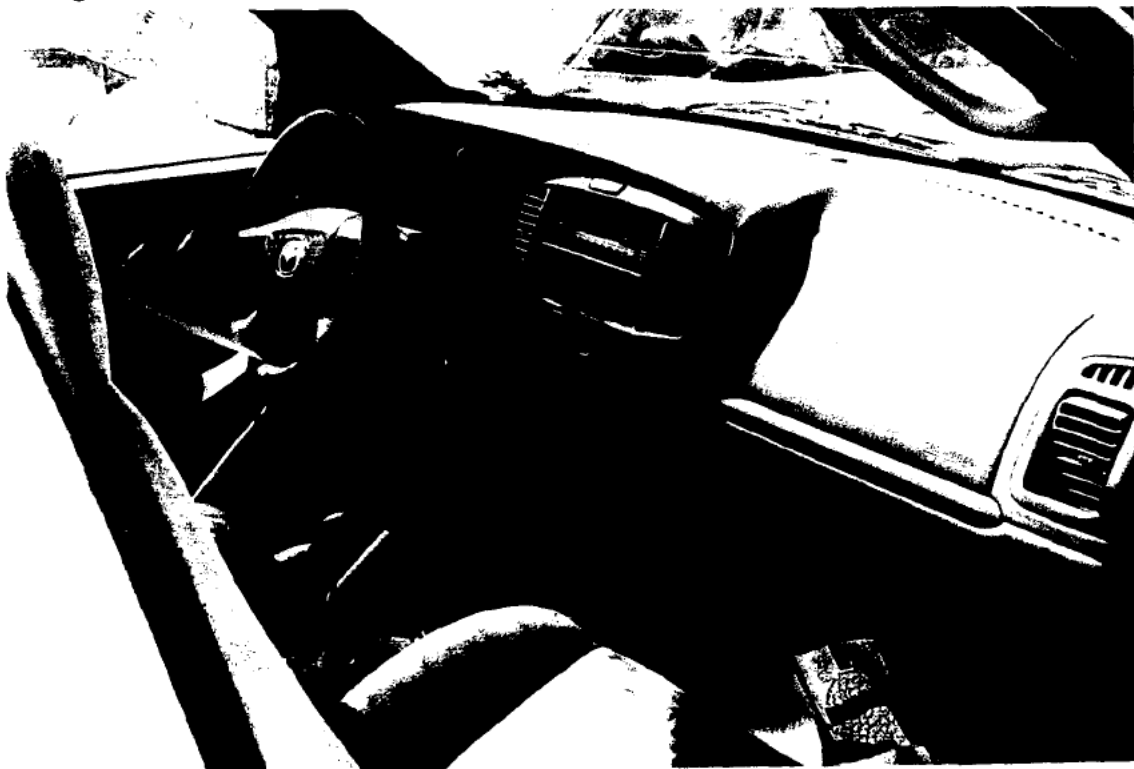
- 
8. A view of the front of the vehicle with the burn pattern present on the left or driver's side extending to the right or passenger's side.

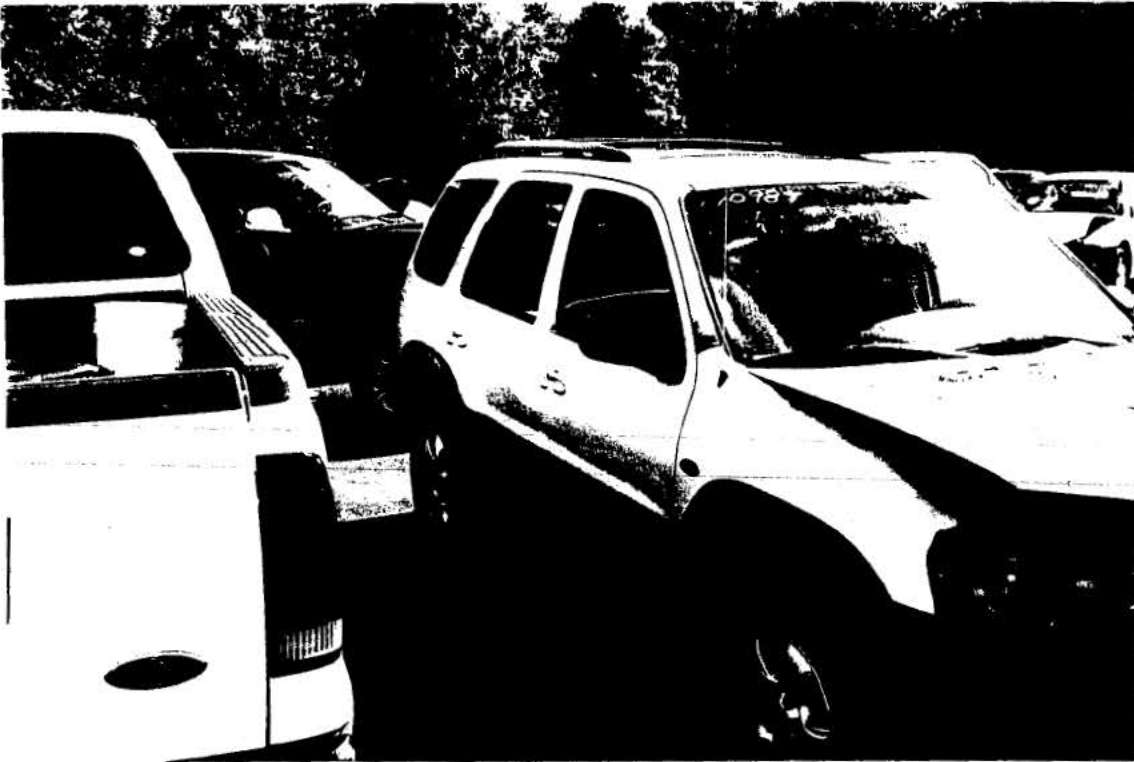
11. A view of the passenger's side of the vehicle from the front.

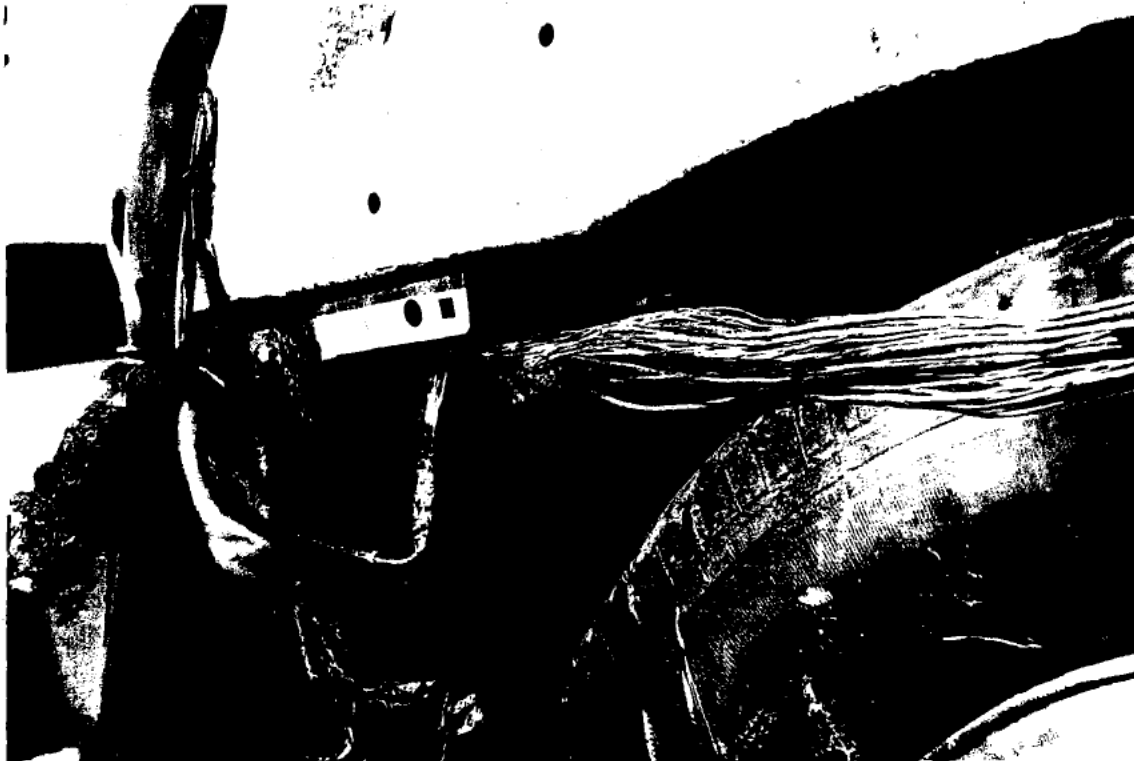
27. A view of the remains of the battery tray with the battery removed.
