Subject: FINAL REPORT: VRTC-DCD7106 "Investigation of
Instrument Panel Warpage That May Affect Passenger Airbag
Deployment"

Investigation of Instrument Panel Warpage That May Affect Passenger Airbag Deployment

FINAL REPORT
November 2007

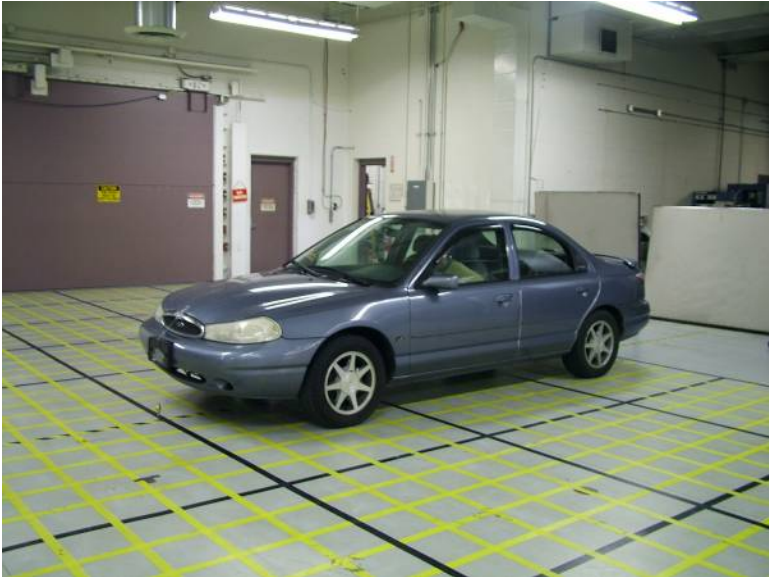
1999 Ford Contour non-complaint vehicle (good instrument panel) positioned on sight distance grid in preparation for testing.
Figure 2 – 1999 Ford Contour Forward Visibility Test

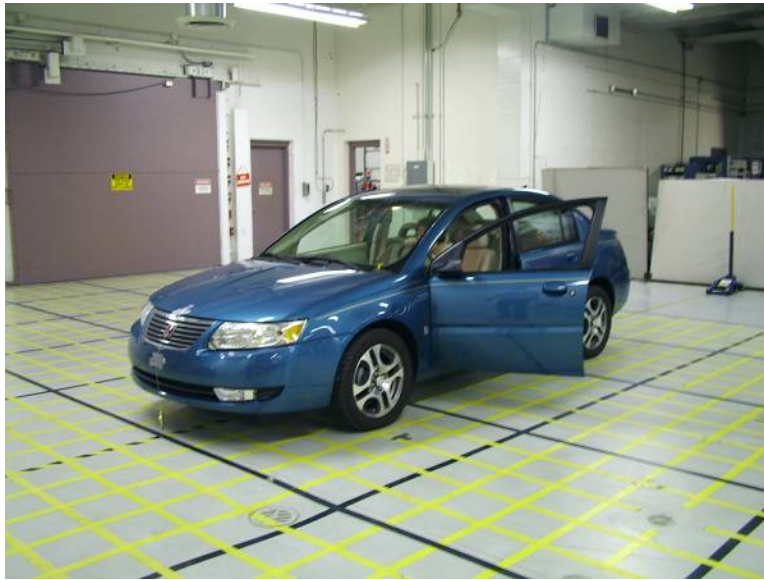
Figure 4 – 2005 Saturn Ion Visibility Test

2005 Saturn Ion peer vehicle positioned on sight distance grid in preparation for testing.

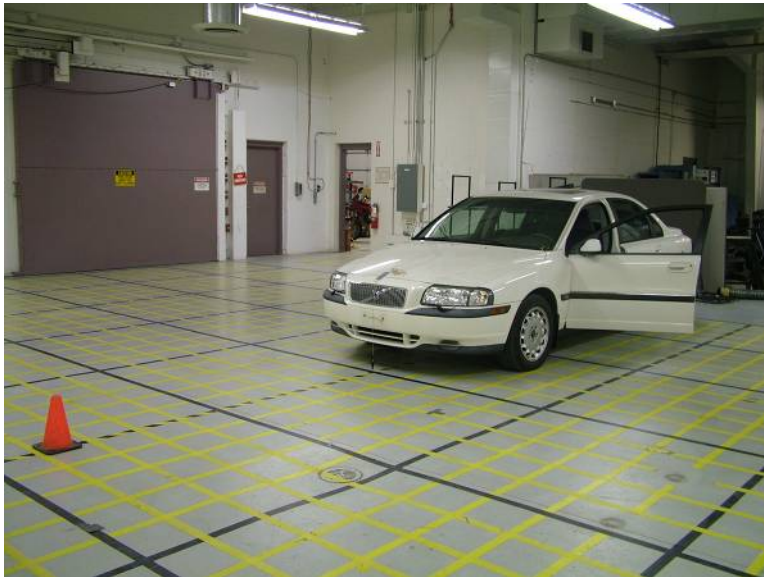
Figure 5 – 1999 Volvo S80 Visibility Test

1999 Volvo S80 peer vehicle positioned on sight distance grid in preparation for testing.

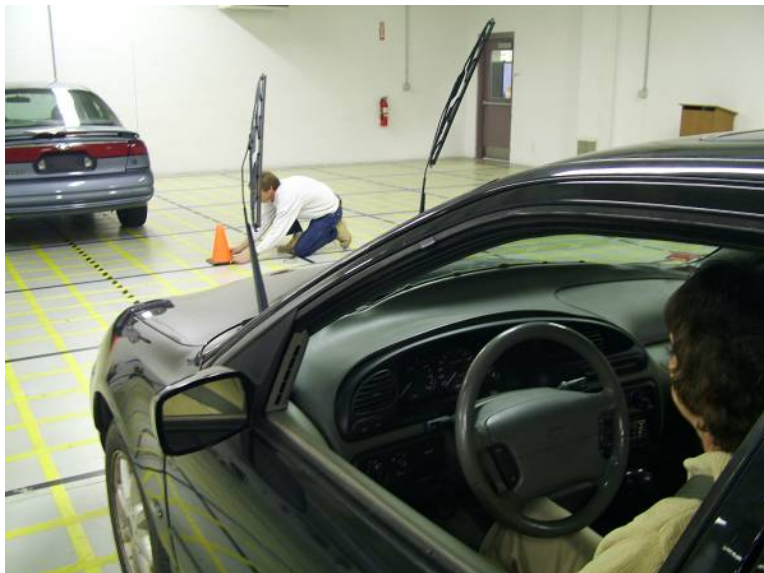
Figure 13 – Visibility Test - Adjusting Cone

Adjusting the 12-inch cone to measure forward field of view in the 2000 Contour complaint vehicle

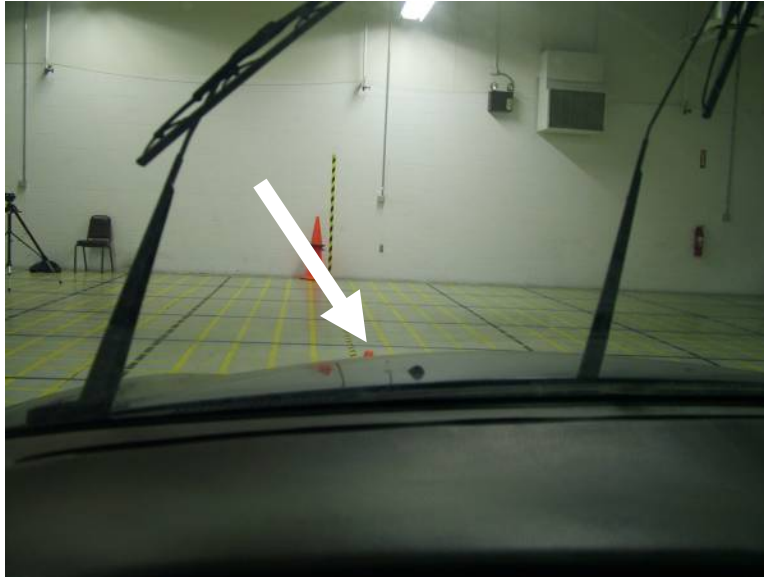
Figure 14 – Visibility Test - Cone Entering Field of View

Typical Measurement location. Arrow shows tip of cone just entering field of view.

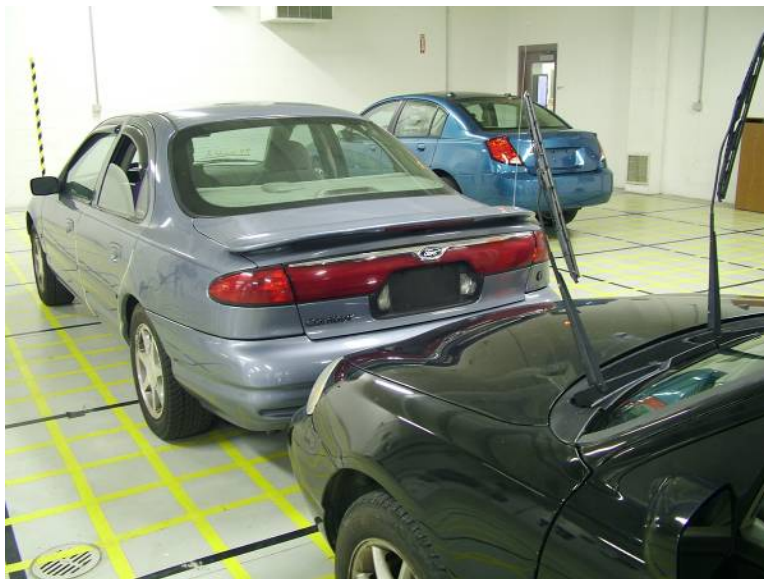
Figure 15 – Taillights Visible at 0 ft. by Complaint Vehicle

Minimum distance of visibility of taillights in 2000 Ford Contour was at point of contact of vehicles.

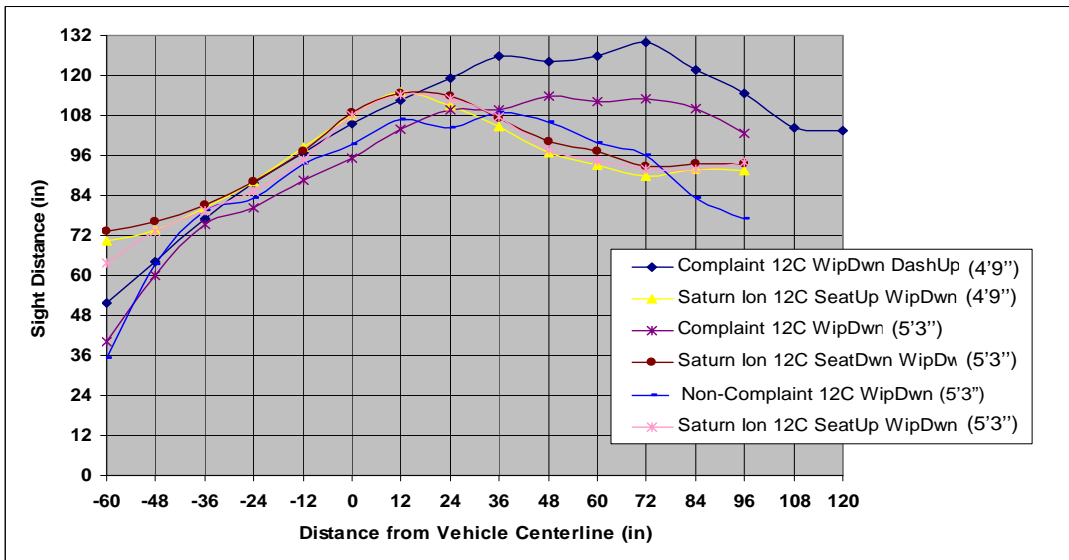
Figure 17 – Complaint, Non-Complaint and Saturn Vehicles with Wipers Down

Comparison of Complaint Vehicle, Non-Complaint Vehicle, and Saturn with windshield wipers in down position for the 4'9" and 5'3" test subjects.

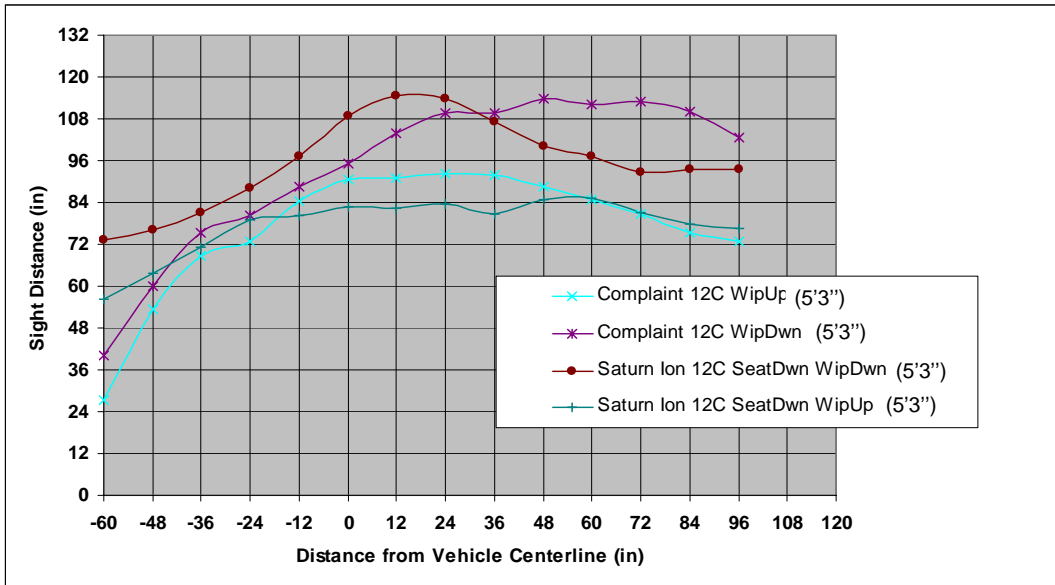
Figure 18 – Comparison of Complaint Vehicle and Saturn with Wipers Up and Down

Comparison of Complaint Vehicle and Saturn With Wipers Up and Wipers Down for the 5'3" Test Subjects

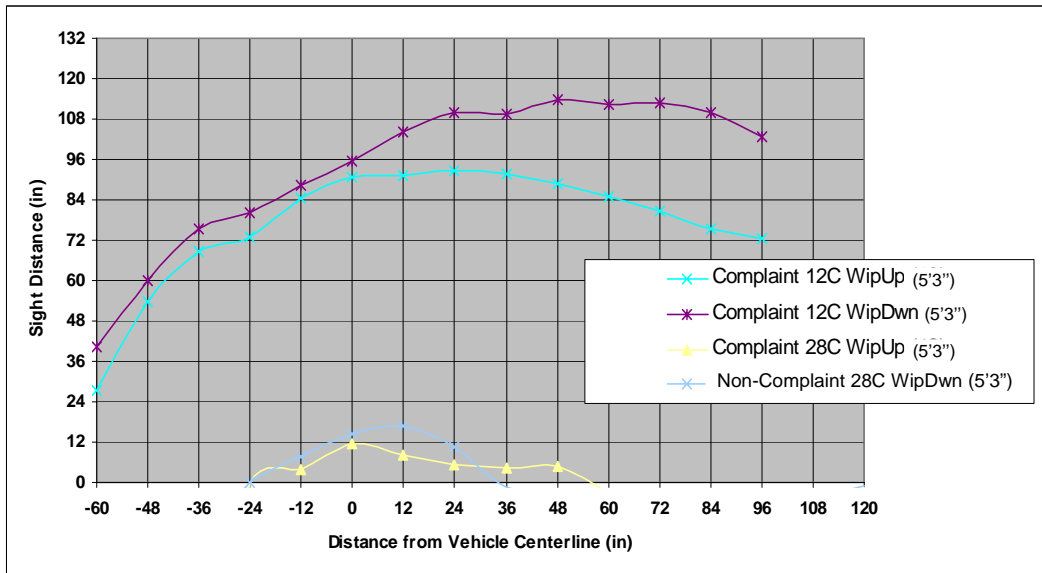
Figure 19 – Comparison of 12-inch Cone and 28-inch Cone

Comparison of Contour Complaint Vehicle and Non-Complaint Contour with 28 inch cone and 12 inch cone for the 5'3" test subject.

The maximum blind spot even in the complaint vehicle with a 28-inch cone was only 12 inches for a 5’3” test subject. Because the 5’3” test subject’s result with the 28-inch cone showed minimal loss of vision (see Figure 19), no further tests were run with this cone after the initial complaint and non-complaint vehicle tests. For the 12-inch cone, the 6’1” test subject’s forward visibility was on average 35 inches better than the 5’3” test subject (see Figure 21). Therefore, we can conclude that there would be almost no loss of forward visibility for the 6’1” test subject with the 28-inch cone.

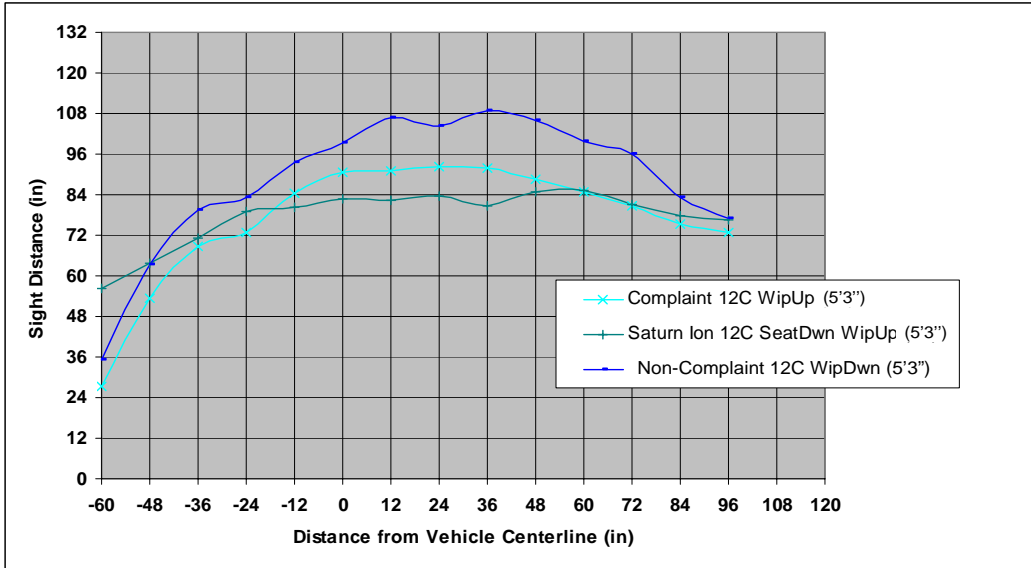
Figure 20 – Forward Sight Distance for Various Seat Configurations

Forward Sight Distance as a Function of Offset from Vehicle Centerline for a 5'3" test Subject Viewing a 12 inch Cone

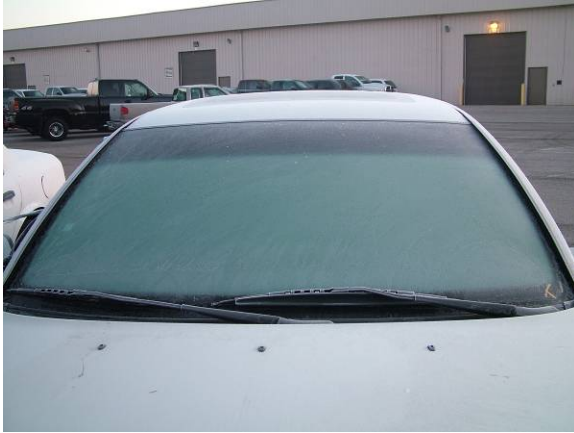
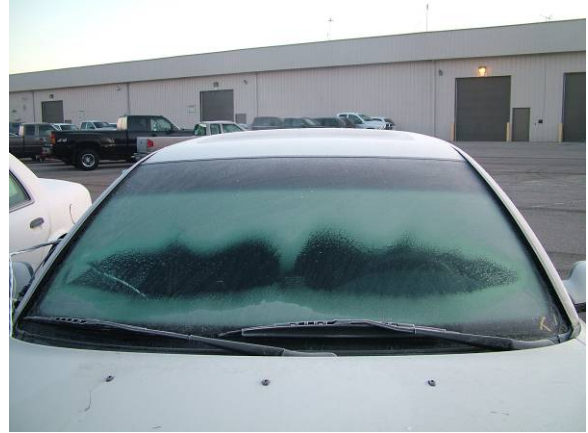
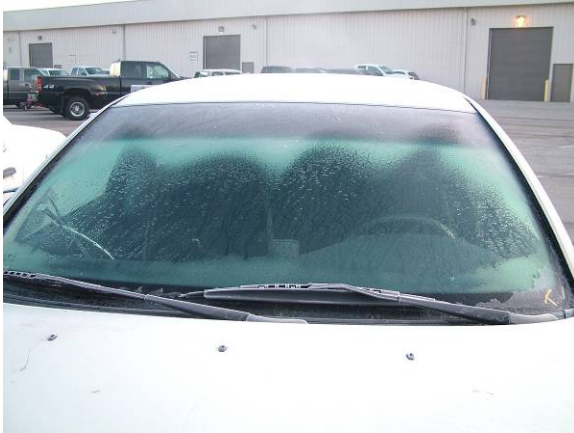
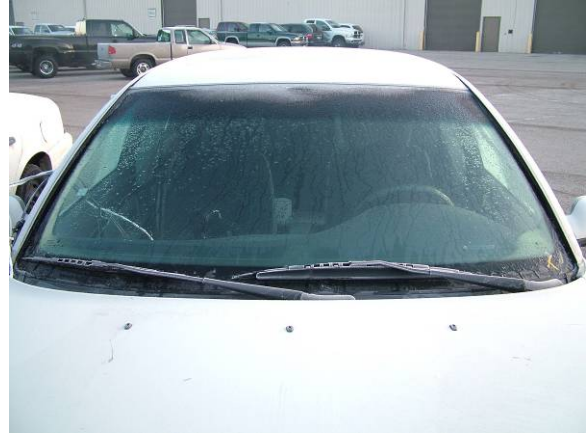
Figures 27-30. Volvo S80 Peer Vehicle Defroster Test Results

VEHICLE	TYPE	TIME	TIME TO DEFROST	REMARKS
2000 Contour	Complaint	7:56-8:11 am	15+ min	Clearance with ~15% frost remaining
1999 Volvo S80	Peer	7:56-8:11 am	11 min	Fast front and rear defrost. Good defrost rate.
2005 Saturn Ion	Peer	8:19-8:33 am	12 min	Slow defrost start; with good side defrost with ~10% frost remaining.

Tests of defrost rates of the subject vehicles showed similar windshield clearing rates for frost for the Ford Contours with instrument panel warpage, the 1999 Volvo S80, and the 2005 Saturn Ion.

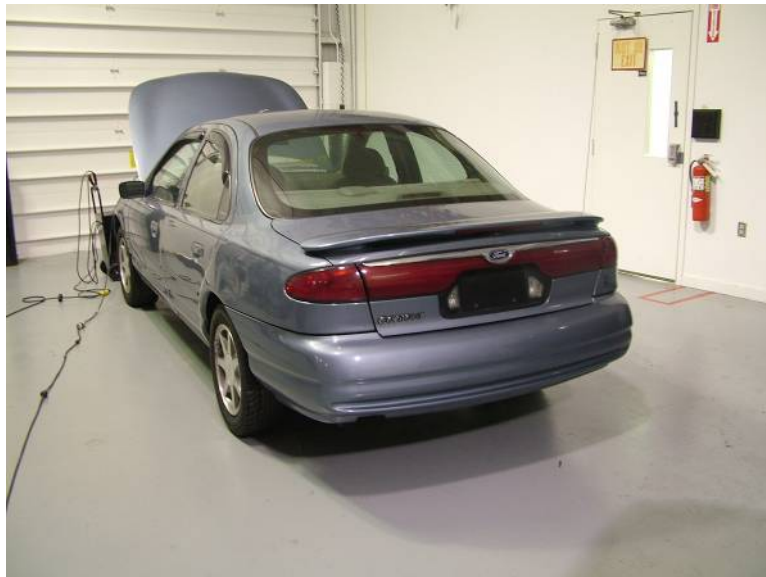
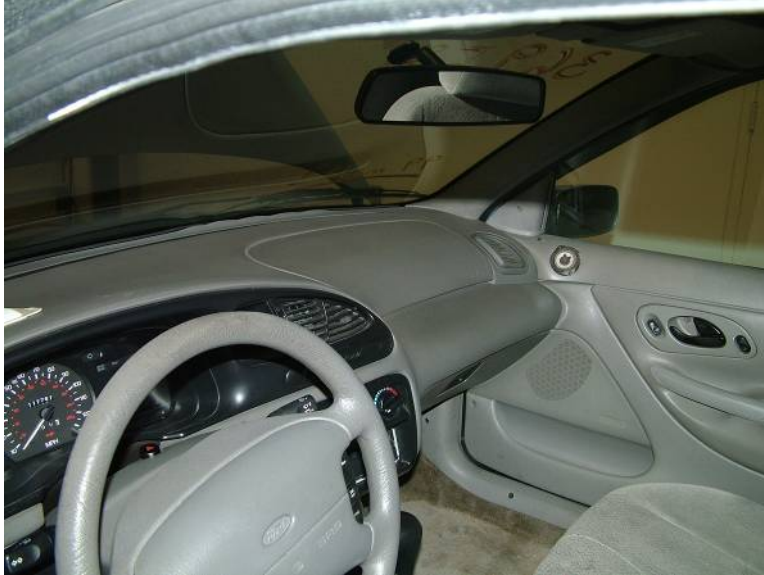
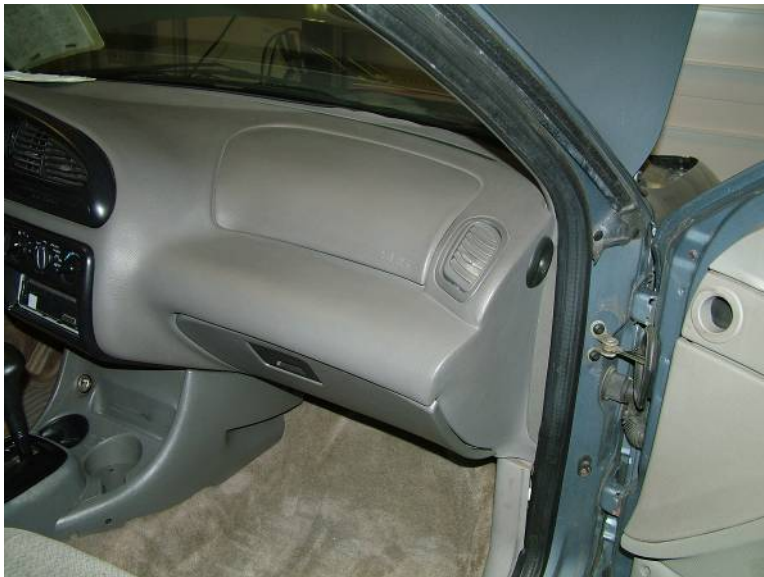
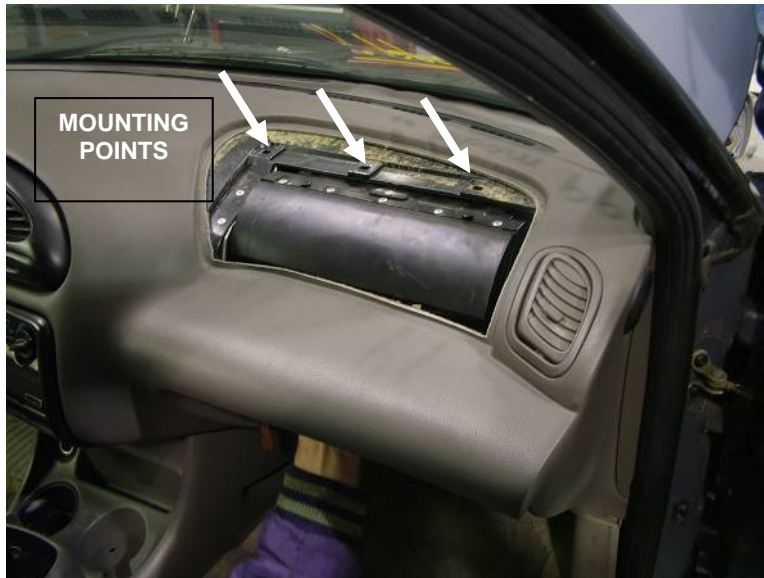
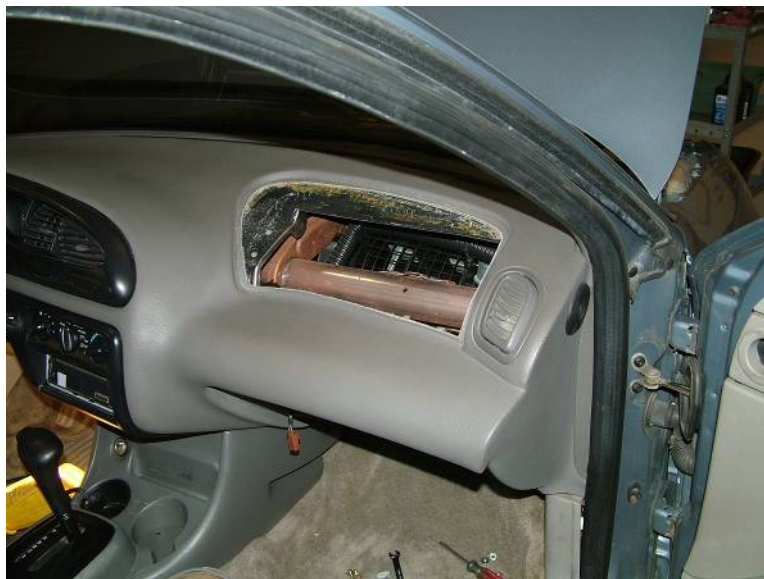
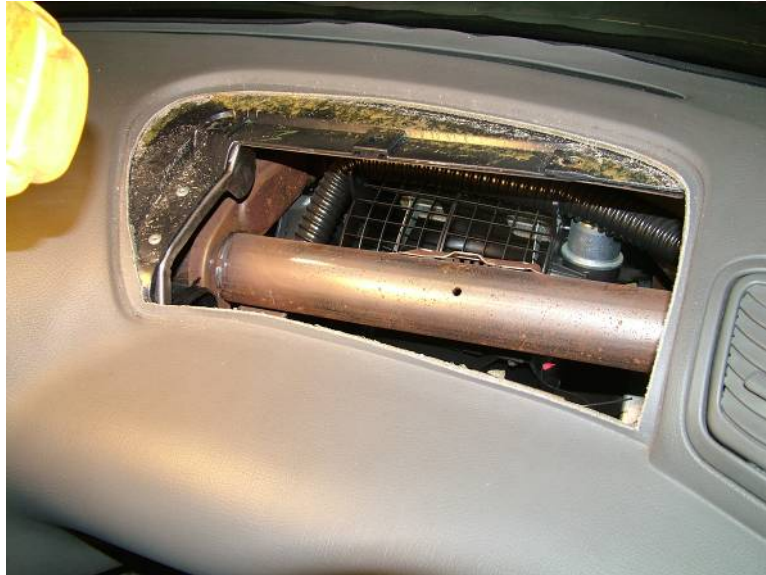
With respect to airbag deployment, a detailed inspection was made of the structure, layout, fabrication, and assembly of the passenger air bag area of a non-complaint vehicle (reference Figures 37 through 50). The instrument panel warpage involves the skin of the instrument panel. The inspection showed that the Supplemental Restraint System (SRS) passenger airbag cover was a metal plate that was bolted at its rear (closest to the front of the vehicle) to a metal support plate imbedded in the instrument panel.¹⁴ The SRS Passenger Side Airbag itself is bolted to the frame of the vehicle and its aim is not affected by the warpage. The SRS airbag cover also has two plastic fasteners in front (closest to the passenger) which will release when the airbag is deployed (see Figure 42). If the airbag deployed, the front of the plate had plastic tie downs that would release and the plate would deform, allowing the airbag to deploy.

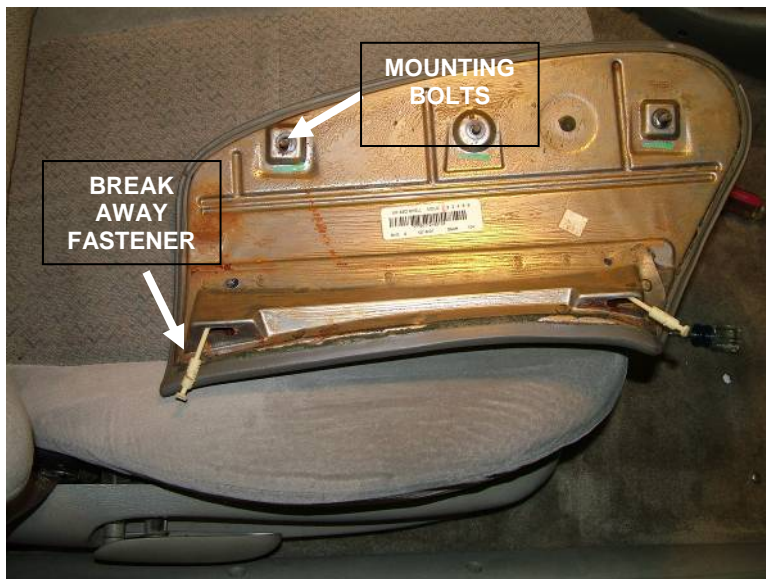
Figure 43 – SRS Cover, Bottom View

1999 Contour, bottom view of SRS cover with mounting bolts for the forward side of the cover and breakaway fasteners for the rear (closest to the passenger).

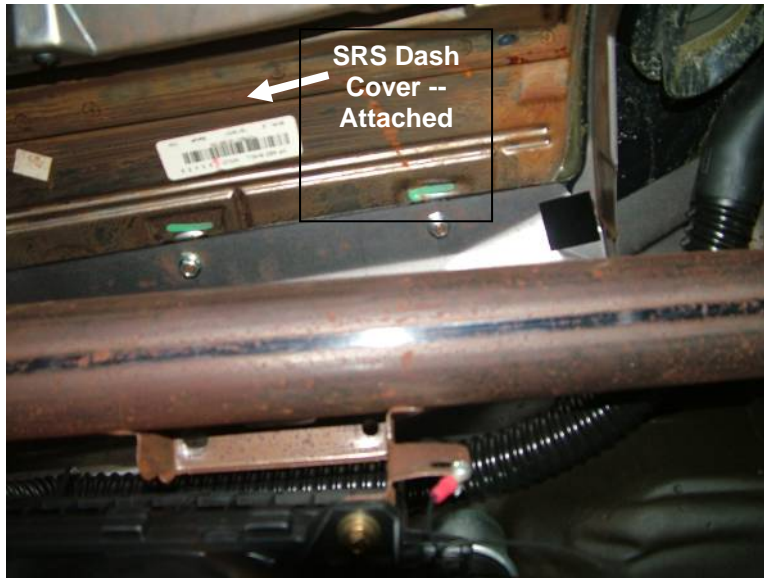
Figure 44 – SRS Cover as Attached to Frame

1999 Contour, bottom view of SRS cover in place attached to instrument panel frame. Note details of bolts attaching the cover to the frame cross member.

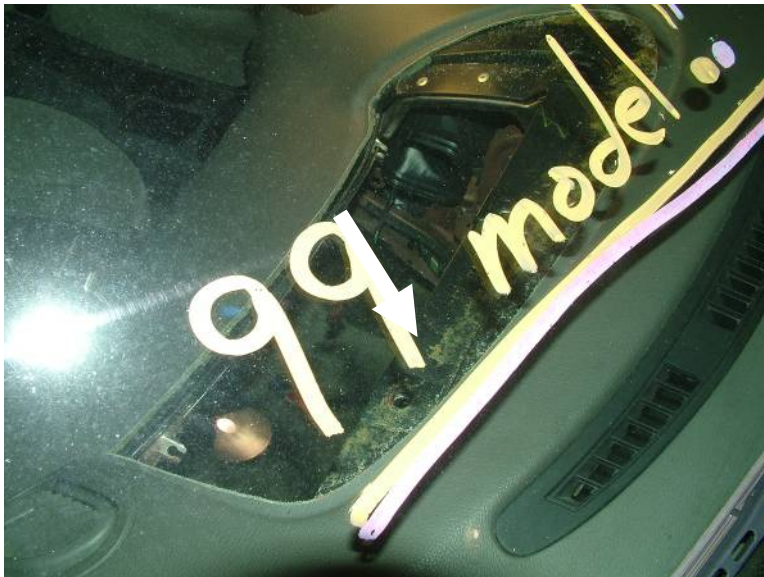
1999 Contour non-complaint vehicle showing position of defroster register with respect to SRS location.
Figure 47 – SRS Inspection Showing Register In instrument panel
