**MEMORANDUM REPORT VRTC-DCD-6099**  
**EA06-002**  
**Investigation of Rear Tire Puncture Due to Coil Spring Fracture**  
**on 2000 – 2001 Ford Taurus Vehicles**

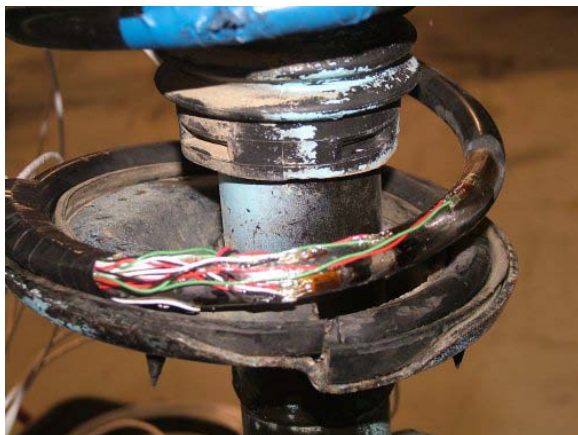
**Figure 6**  
**Lower Strain Gages**

A total of nine strain gages were mounted to a new spring<sup>1</sup> to measure both torsional and straight strain in two regions of the spring. Gages 1 – 7 measured straight strain in the spring. Gages 8 and 9 measured torsional strain in the spring. Gages 1 – 5 were located one rotation above the lower end of the spring. Gage 3 was mounted directly over the end of the spring, gages 1 and 2 were mounted approximately 2” and 1”, respectively, before gage 3, and gages 4 and 5 were mounted approximately 1” and 2”, respectively, beyond gage 3. These gages were all in the area where fractures have been documented. The upper gages (6 & 7) were located more or less in the center of the spring (top to bottom) at a point where there was no coil bind. These were used as reference. The lower torsional gage (gage 8) was mounted perpendicular to gage 3. The upper torsional gage (gage 9) was mounted between gages 6 and 7. Figure 6 shows the location of the lower strain gages, consisting of five straight strain gages (1 – 5) and one torsional strain gage (8). Figure 7 shows the upper strain gages, consisting of two straight strain gages (6 and 7) and one torsional strain gage (9).
