## ODI RESUME

Investigation: EA07-016

Subject: Overheating Disc Brake Caliper

## ENGINEERING ANALYSIS CLOSING REPORT

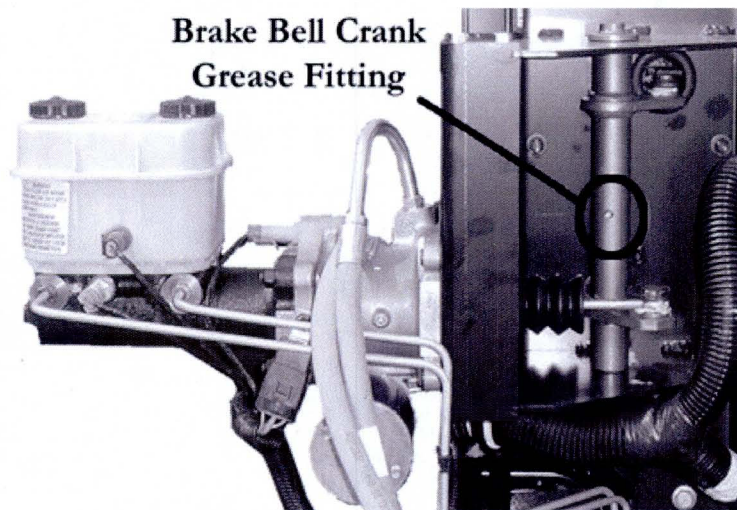
**Figure 3 – The Bellcrank Pivot Changes Longitudinal Brake Pedal Push Rod Action to a Lateral Direction for the Hydro-Max Booster and Master Cylinder**

**WCC BELLCRANK TESTING:** During PE07-032, ODI became aware of complaints that seemingly indicated a compromising condition preventing the full return of the bellcrank linkage which connects the brake pedal through the firewall to the master cylinder. Data trends showed a decline of related “drag” complaints after the factory began installing a “Zerk fitting” (grease fitting, see figure 3) onto the bell crank in June 2004. The Zerk fitting allowed for lubrication of the bellcrank to prevent the unit from sticking and causing dragging brakes. Although ODI initially focused on bellcrank-related brake drag, testing by WCC with an artificial stop on the bellcrank preventing full return showed that after a period of driving, the brake pressures would increase and then overpower the engine and cause the vehicle to stop before the brake fluid could boil. Further, few complaints of disabled vehicles were noted during ODI’s and VRTC’s assessments of complaints and warranty claims—the dominant issue was brake drag. Additionally, the field inspections (referenced on page 5) clearly identified an internal problem with the caliper.

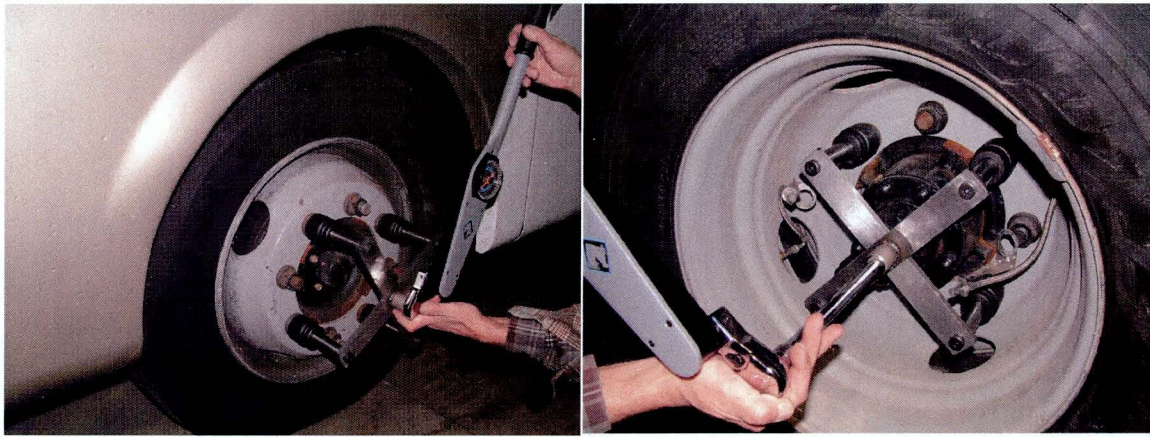
During the field inspection in Pasadena, TX, it was found that after a test drive, it was difficult to rotate the wheels after the vehicle was raised off the ground. As a result, to facilitate future testing a crossbar was subsequently designed at the VRTC test center and then tested at a local (Ohio) dealership with a beam-type torque wrench to quantify the drag on a raised wheel before and after driving the vehicle, as shown in Figure 4. The Ohio exemplar vehicle required approximately 10 ft-lbs to rotate a front wheel and 45 ft-lbs to rotate a rear wheel. This device helped the investigation team to quantify the amount of drag torque at each wheel and isolate the failed brake(s). A memorandum trip report on this field trip is available at the ODI website. A summary of the results of several inspections is shown in Table 3.

**Figure 4 - Wheel Torque Crossbar and Beam-Type Torque Wrench to Measure Normal and Abnormal Drag on Rotating a Raised Wheel**
