# ODI RESUME

Investigation: EA07-011  
 Prompted By: PE07-022  
 Date Opened: 08/14/2007  
 Principal Investigator: Derek Rinehardt  
 Subject: Engine Compartment Fire  
 Date Closed: 08/13/08

Manufacturer: BMW of North America, LLC. Bayerische Motoren Werke  
 Products: MY 2002 – 2003 Mini Cooper  
 Population: 50,000

**ENGINEERING ANALYSIS CLOSING REPORT**

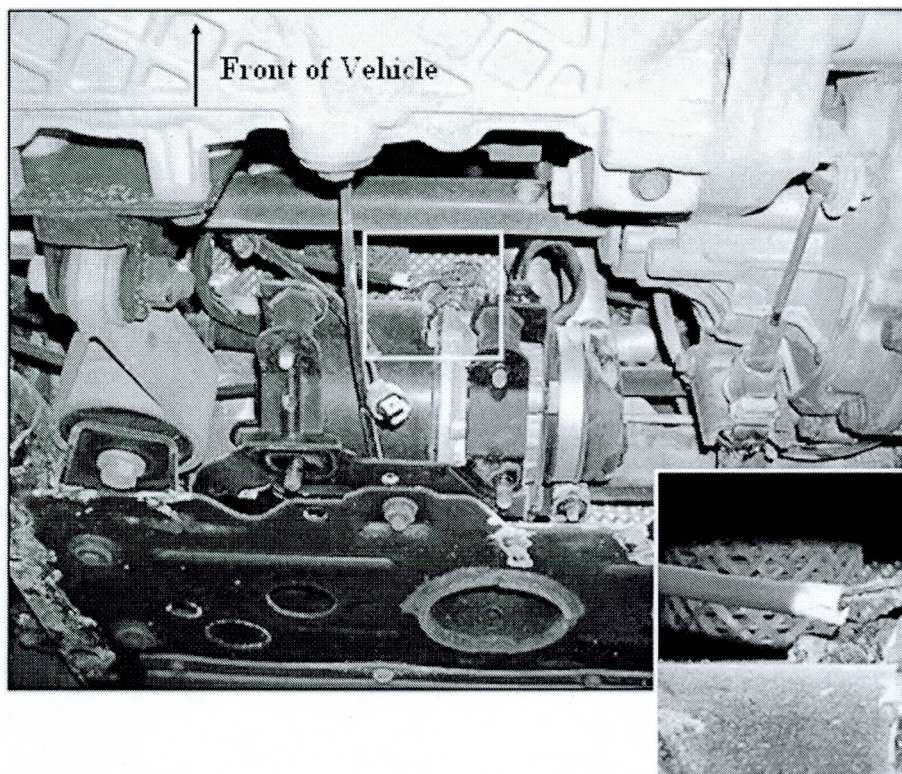
The EHPS provides a means to supply the driver with power assisted steering. The EHPS in the subject vehicles is primarily composed of an electro-hydraulic pump (see Figure 1), an auxiliary cooling electric fan (see Figure 2) and the associated wiring. The electric motor replaces the customary design whereby the hydraulic pump is driven by the engine via an ancillary belt. The EHPS is designed to save engine power, provide a reduction in fuel consumption, and requires less maintenance than customary belt driven systems.
