Monaco Motorhome Fire Trip Report

Date: November 29&30, 2007

Destination: Coparts Auto Auction
3300 Vandalia Road
Des Moines, IA

Purpose: Examine a vehicle that had experienced an engine compartment fire with representatives of the engine manufacturer, motorhome manufacturer, and vehicle owner's insurance company.

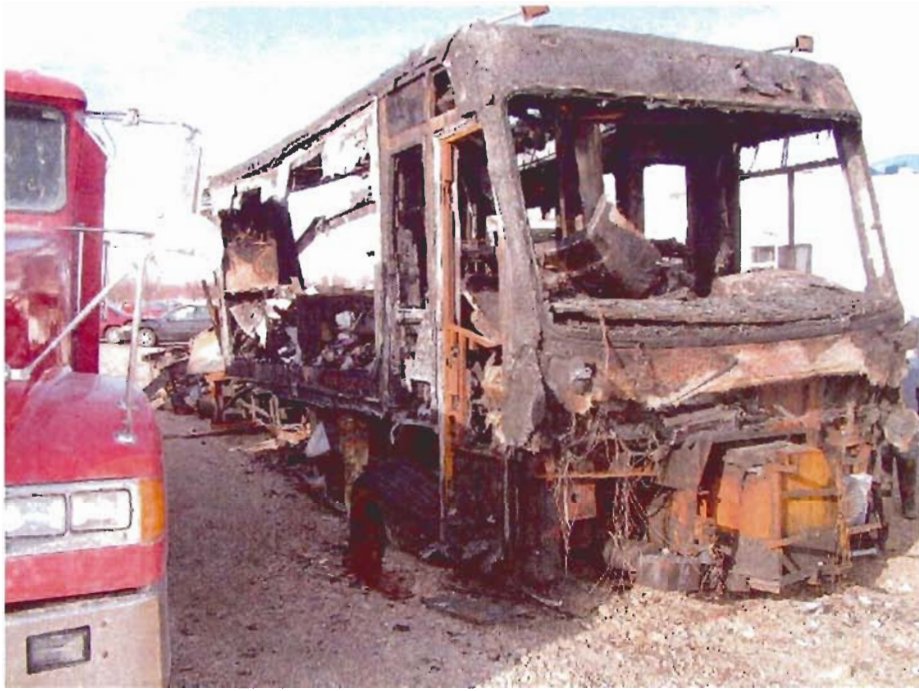
Figure 1 – Front View of the Motorhome at the Coparts Auto Auction Salvage Yard

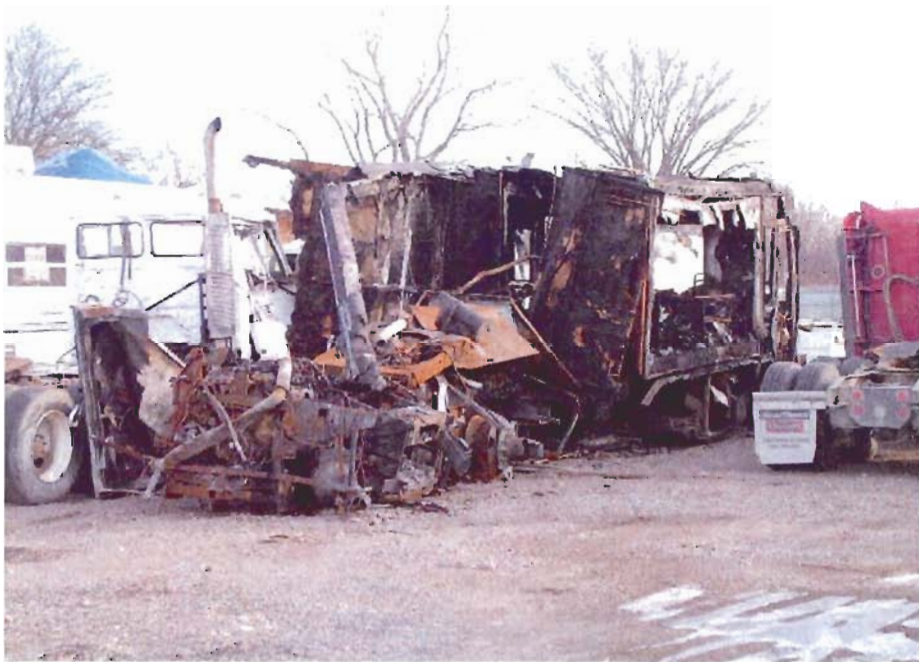
Inspection of Vehicle Results: The fire had consumed the secondary combustibles on the rear half of the motorhome. The strong crosswind had fed the fire toward the right berm side of the vehicle (left to right). The body of the rear of the motorhome was consumed, as shown in Figures 1 to 3. All figures appear in Appendix 1. The trailer the motorhome was towing was also destroyed, as shown in Figures 4 and 5. The left rear aluminum dual wheels were partially melted and distorted, but mostly intact. The right side rear wheels were completely melted leaving only a small puddle of aluminum in the axle hub, as shown in Figure 6. The engine block and the cylinder head were intact, but most of the accessories were at least partially destroyed, as shown in Figures 7 to 9. On the "hot" side of the engine (left), the series turbochargers and wastegate were intact. At the "cold" side of the engine (right) the intake manifold, fuel filters, and Engine Control Module (ECM) were melted and mostly missing. At the rear of the engine, the aluminum housings of the alternator and air conditioning compressor had melted away leaving only the alternator shaft/rotor and the a/c compressor clutch and reed plate, as shown in Figures 9 and 10. The molded carbon fiber cover on the cylinder head, which contains all of the higher-pressure components of the fuel injection system, was mostly burnt away. However, the insulation of the wiring to the electronically controlled injectors was intact, as shown in Figure 11. No codes could be retrieved because the ECM was destroyed.

Figure 2 – Rear-Quarter View of the Motorhome at the Coparts Auto Auction Salvage Yard

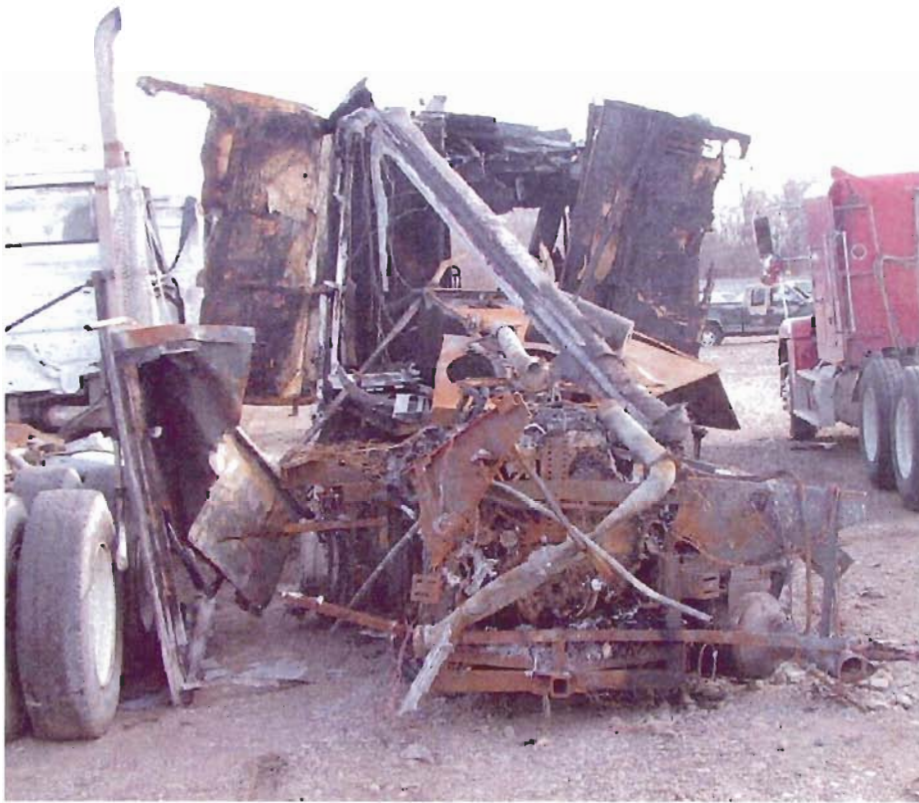
Figure 3 – Rear View of the Motorhome at the Coparts Auto Auction Salvage Yard

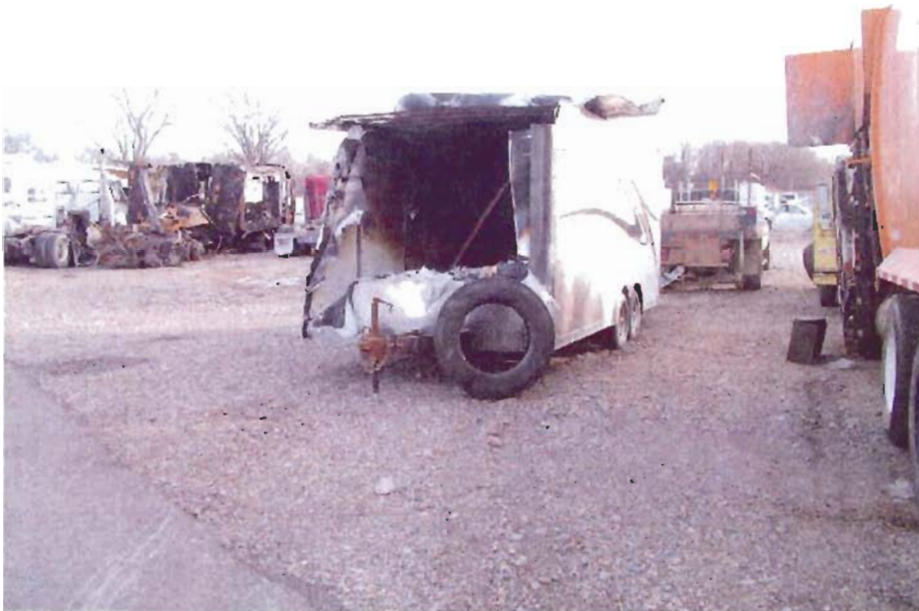
Figure 4 – Front View of the Trailer the Motorhome was Pulling Located at the Coparts Auto Auction Salvage Yard

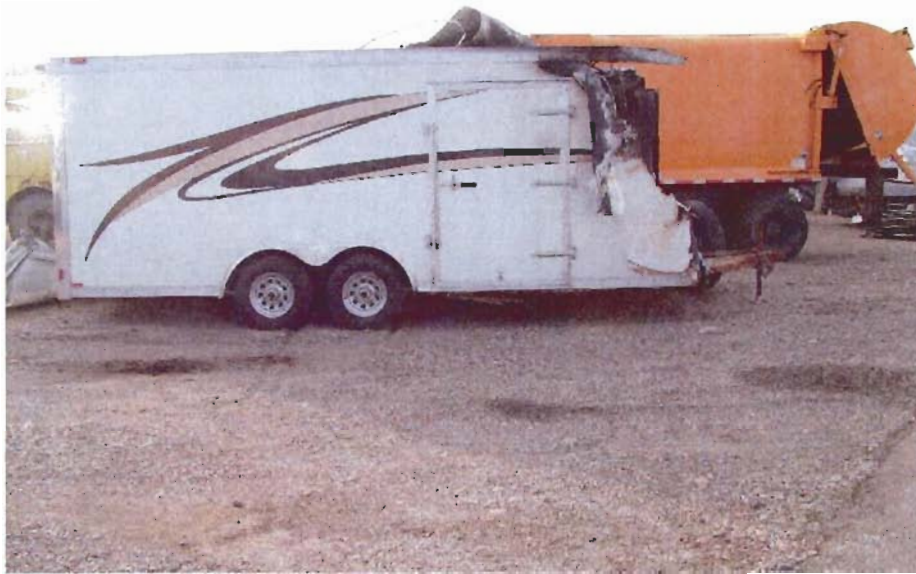
**Figure 5 – Side View of the Trailer the Motorhome was Pulling
Located at the Coparts Auto Auction Salvage Yard**

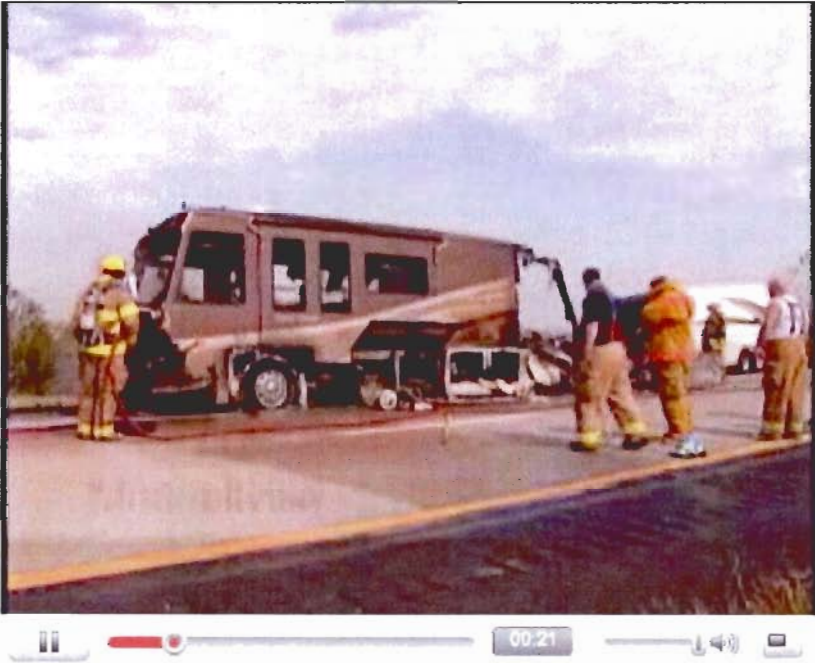
Figure 21 – The Motorhome at the Incident Site as the Firemen Secured the Scene

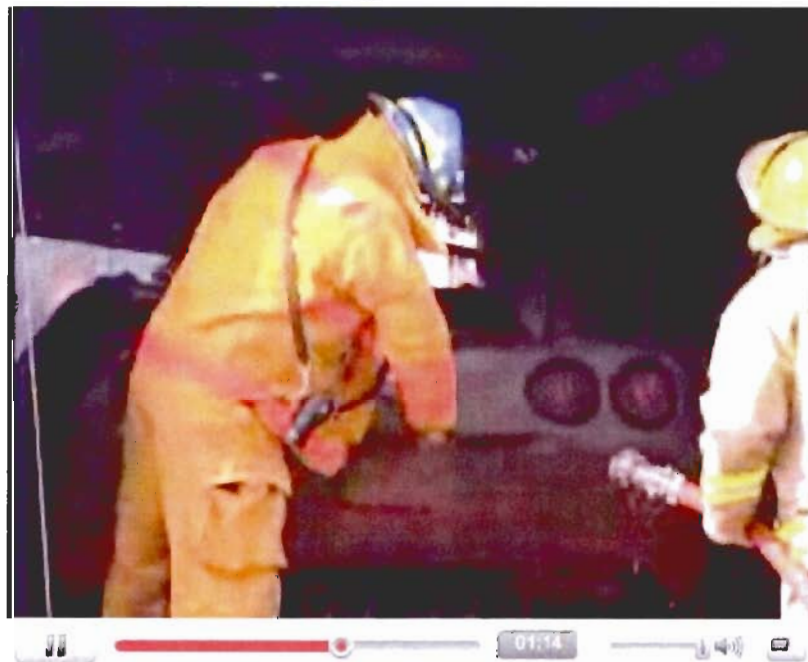
Figure 24 – Firemen Attempt to Open the Trunk of the Corvette to Fully Extinguish the Fire
