# ODI RESUME

**Investigation:** EA 08-015  
**Prompted by:** PE08-026  
**Date Opened:** 08/08/2008 **Date Closed:** 04/12/2010  
**Principal Investigator:** Michael Lee  
**Subject:** Unexpected Closing of Power Liftgate

**Manufacturer:** HONDA (AMERICAN HONDA MOTOR CO.)  
**Products:** 2005 Honda Odyssey Touring  
**Population:** 25,230

## **EA08-015: Honda Odyssey Power Liftgates**

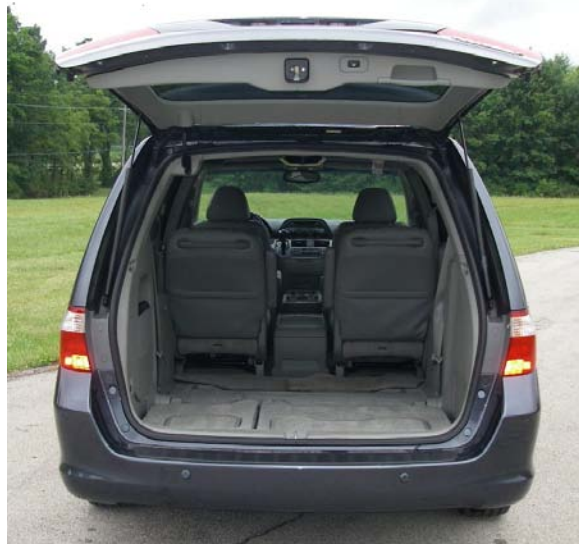
The power liftgate system has an “auto-reverse” feature. This feature automatically reverses the direction of the liftgate motion when the power liftgate control module detects an obstruction in the path of the moving liftgate. The control module detects an obstruction by monitoring the change in speed of the drive motor. When the motor speed drops, the module senses this as an obstruction in the path of the moving door, then the module reverses the direction of the motor rotation, the door reverses its direction, and three warning beeps are emitted. The “auto-reverse” feature also uses touch sensors (pressure or contact sensors) along the perimeter (side edges) of the liftgate. If the touch sensors detect an object caught between the perimeter of the liftgate and the body of the vehicle during power-closing operation, an electrical signal is sent to the control module and the module will reverse the direction of motor rotation and initiate power-opening.
