## Engineering Analysis Closing Report

**SUBJECT:** Intermediate Steering Shaft Binding

**EA No.:** EA08-024

**SUBJECT VEHICLES:** Model year (MY) 2004 through 2006 Toyota Sienna minivans.

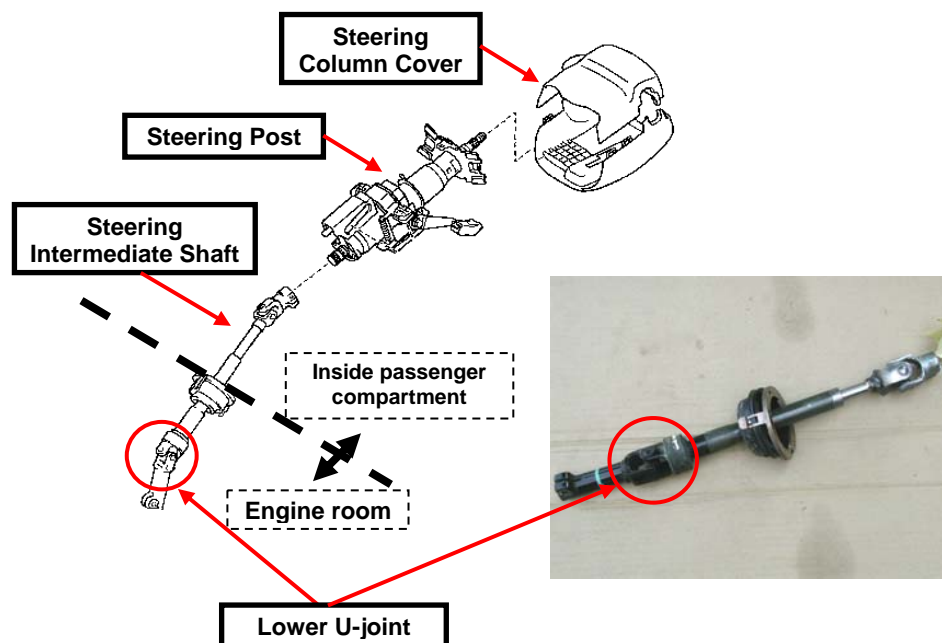
**DESCRIPTION OF COMPONENT:** The steering intermediate shaft (SIS) allows for connection of the primary steering column/shaft and the power steering rack input shaft. Because of the change in angle required, the SIS is equipped with a universal joint (Figure 2). This universal joint allows for off-axis rotation and allows steering wheel hand forces to smoothly apply torque to the steering rack input shaft.

Figure 2. Component detail – steering intermediate shaft.
