DRAFT FINAL REPORT: VRTC-DCD9143 for EA08-018 and

PE08-041 "Evaluation of Changes in Steering Effort Resulting

MEMORANDUM REPORT for VRTC-DCD9143

Evaluation of Changes in Steering Effort Resulting from Corroded Intermediate Shafts in 2002-2004 Kia Sedonas and 2004 Toyota Siennas

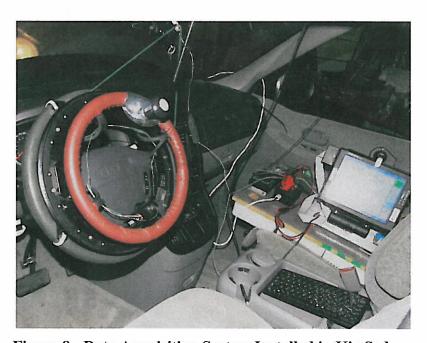
Figure 8 - Data Acquisition System Installed in Kia Sedona

5.2.1 Suspended Static Steering Test – Both vehicles were instrumented with a data acquisition system that could monitor and record the following inputs: steering wheel angle, driver steering effort, vehicle yaw rate, and vehicle speed (Figure 8). It was found that the binding condition is most prevalent after the vehicle has been sitting dormant for an extended period of time. Once the wheel was rotated at least two times, the binding force was greatly reduced. Forces required to turn the steering wheel in a normally operated Sedona, measured in hand wheel pounds force, varied from one to three pounds (Figure 9). When a complaint shaft was tested, the required force varied from one to five pounds. With regard to the Sienna, a normally operating intermediate shaft required one to four pounds, while a defective intermediate shaft required one to eleven pounds (Figure 10). A sinusoidal pattern can be seen in the Toyota defective shaft as a result of only one of the two axes of the universal shaft corroding. The sinusoidal pattern is created because each axis rotates at a non-constant rate while articulated. During the highest rate of rotation, the bind becomes most evident.

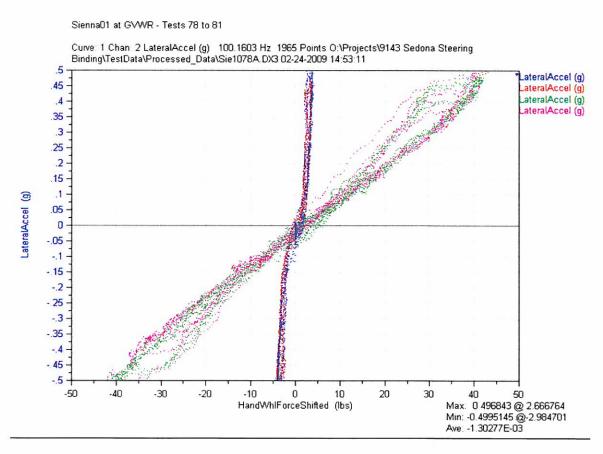
Figure 11- Sienna Steering Gain with Normally Operating Steering Shaft

5.2.2 Dynamic Steering Gain Test – Graphical representation of the steering forces can be seen in Figures 11 through 14. Figure 11 shows two traces of steering wheel forces required to generate increasing lateral acceleration in a Toyota Sienna with a non-defective steering shaft. The first trace (the more vertical of the two) is generated while the engine is running with normal power assist. The second trace is generated with the engine turned off to remove power assist. Figure 12 is the same test with a defective shaft installed in the Toyota Sienna. Figure 13 is also the same test but with the Kia Sedona and a non-defective steering shaft. Finally, Figure 14 is the same test with the Kia Sedona but a defective steering shaft.
