QIS #SHJA-071012-01

QUALITY IMPROVEMENT SHEET (Q.I.S.)

05M - 07M Odyssey

PTG Open Stay problem summary

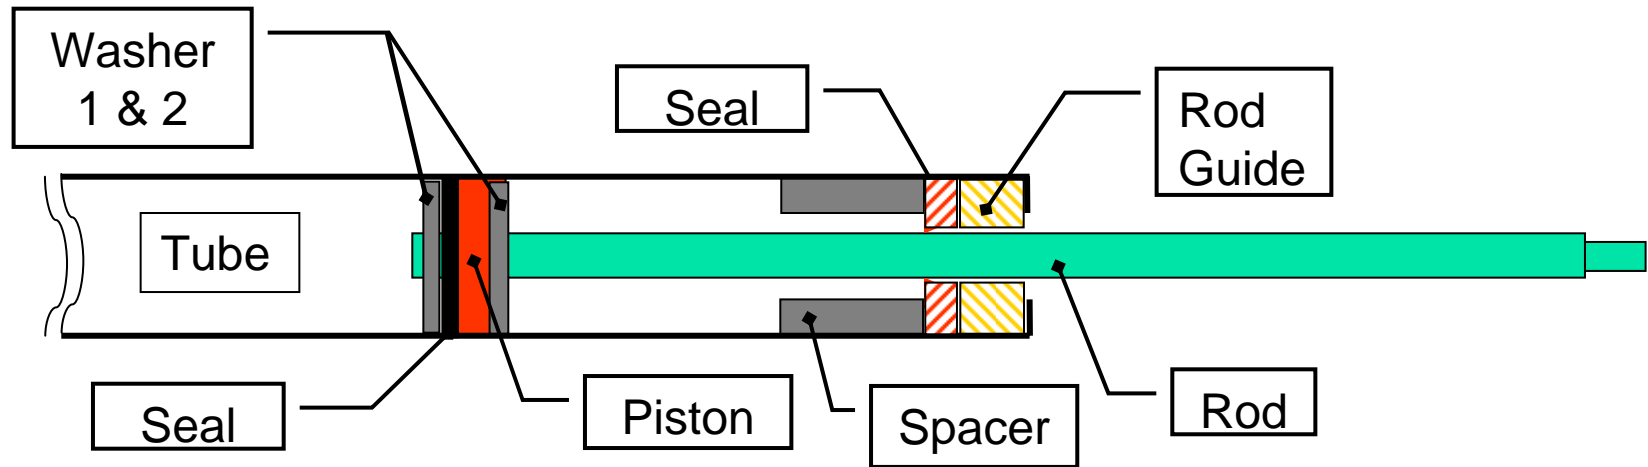
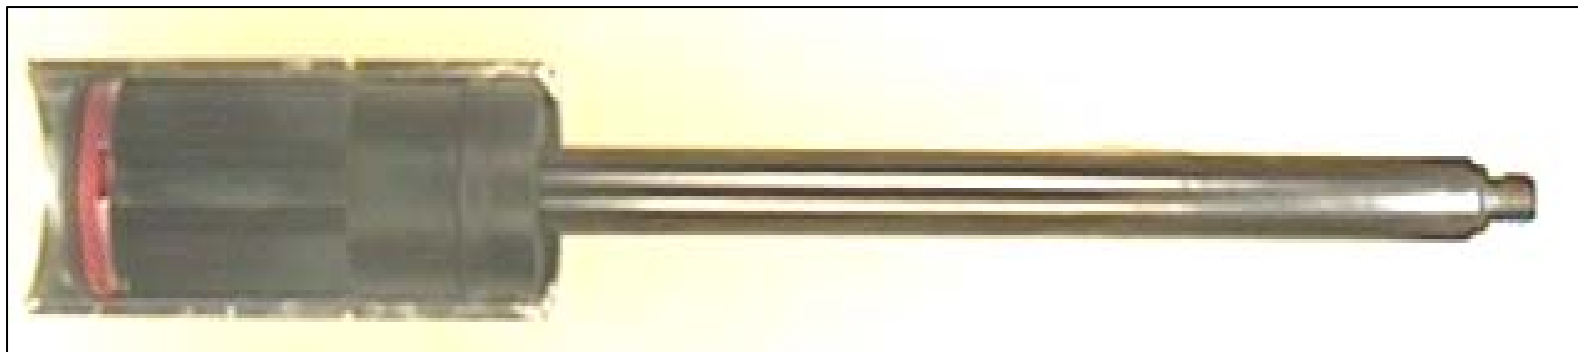
SHJ Open Stay Diagram

Contention: Tailgate doesn't hold/sags.
Problem on CBU: Can't hold tailgate due to lowered open stay reaction force.
Problem cause: **[1]** Gas leak due to rod scratch
[2] Contamination during manufacturing process
[3] Stud bold weld location shifted

[4]- ① Seal installation tool ("bullet") was damaged.
 - ② Piston package concentricity out of spec
 - ③ Material defects in the rod (voids and laps/seams)

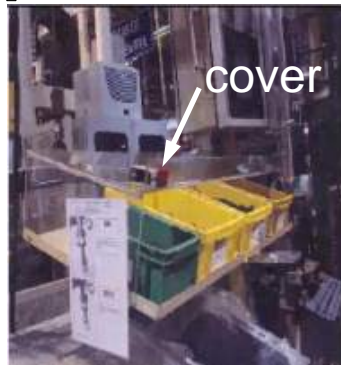
[Part Shield Added]

Assembly Contamination / NG Weld

For contamination issues, a polycarbonate cover was made to cover the component parts bins to prevent airborne contaminants from getting into the bins.

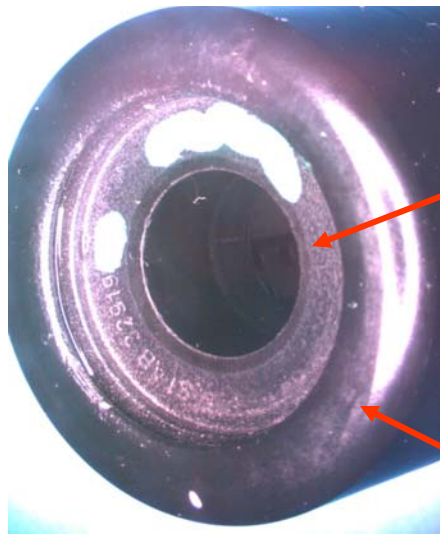
Rod Guide ★

Rod Guide Material is hard and abrasive. Under a side load pieces may break off and damage seal and rod.
