**PE08029/HYUNDAI-KIA
2001 EF FIELD REPORTS**

HYUNDAI
Field Product Observation Report

**PE08029/HYUNDAI-KIA
1999 EF FIELD REPORTS**

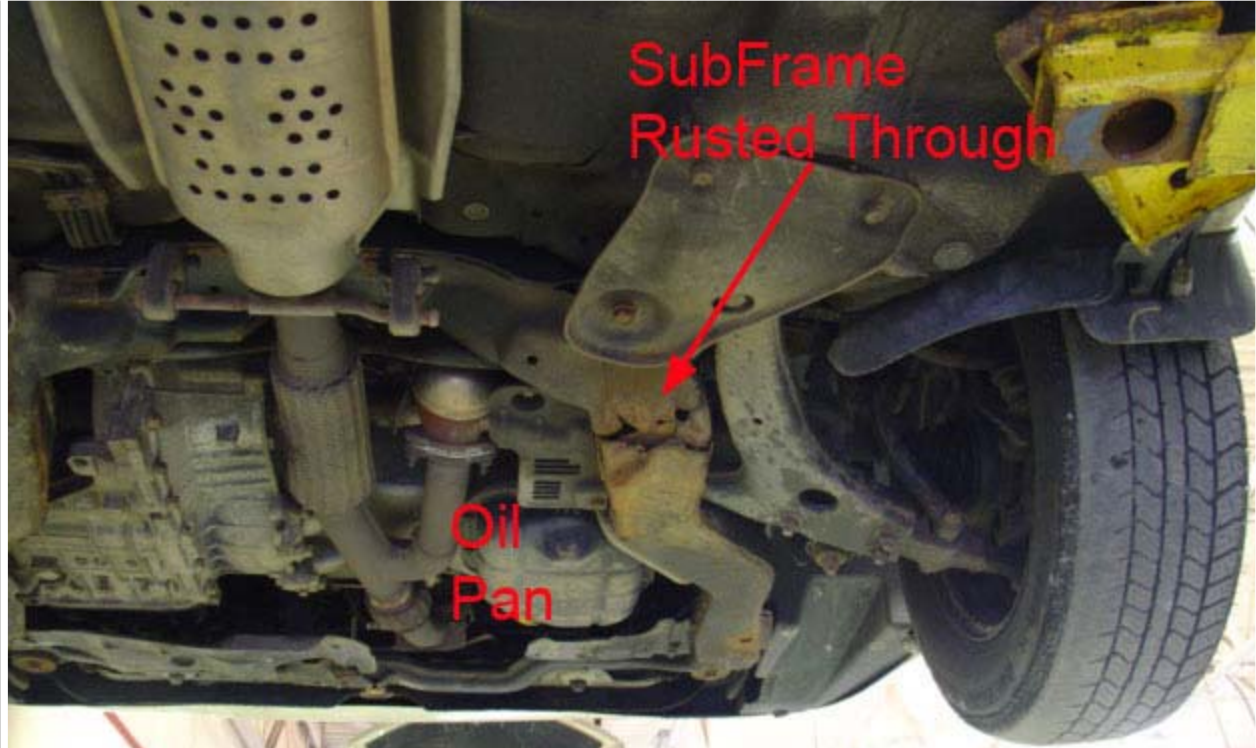
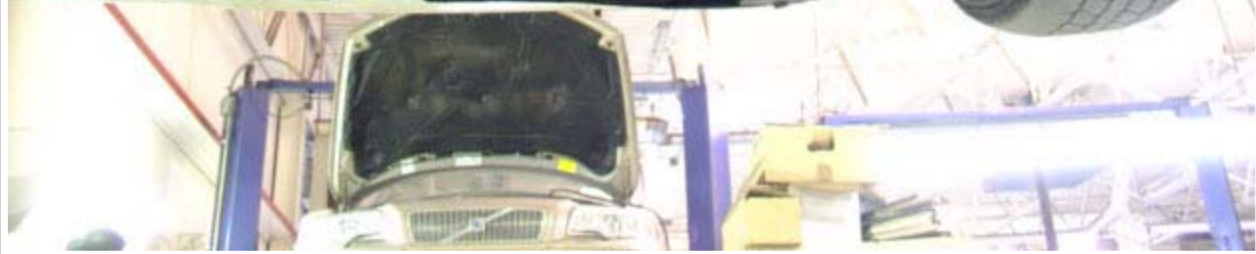
SubFrame

Target Date:	Comment:
12/14/2005	Dealer visit 12/15/05. FTS inspected vehicle and found rust/corrosion on subframe. Rust appears to be propagating from within subframe. FTS contacted DPSM and new subframe was ordered for vehicle.

Subframe corroding from within, due to moisture accumulating in subframe rails.

Replace subframe.
