**PE08029/HYUNDAI-KIA
2002 EF FIELD REPORTS**

2002 Sonata SUBFRAME RUSTED THROUGH- POTENTIAL VDS ISSUE

**PE08029/HYUNDAI-KIA
2000 EF FIELD REPORTS**

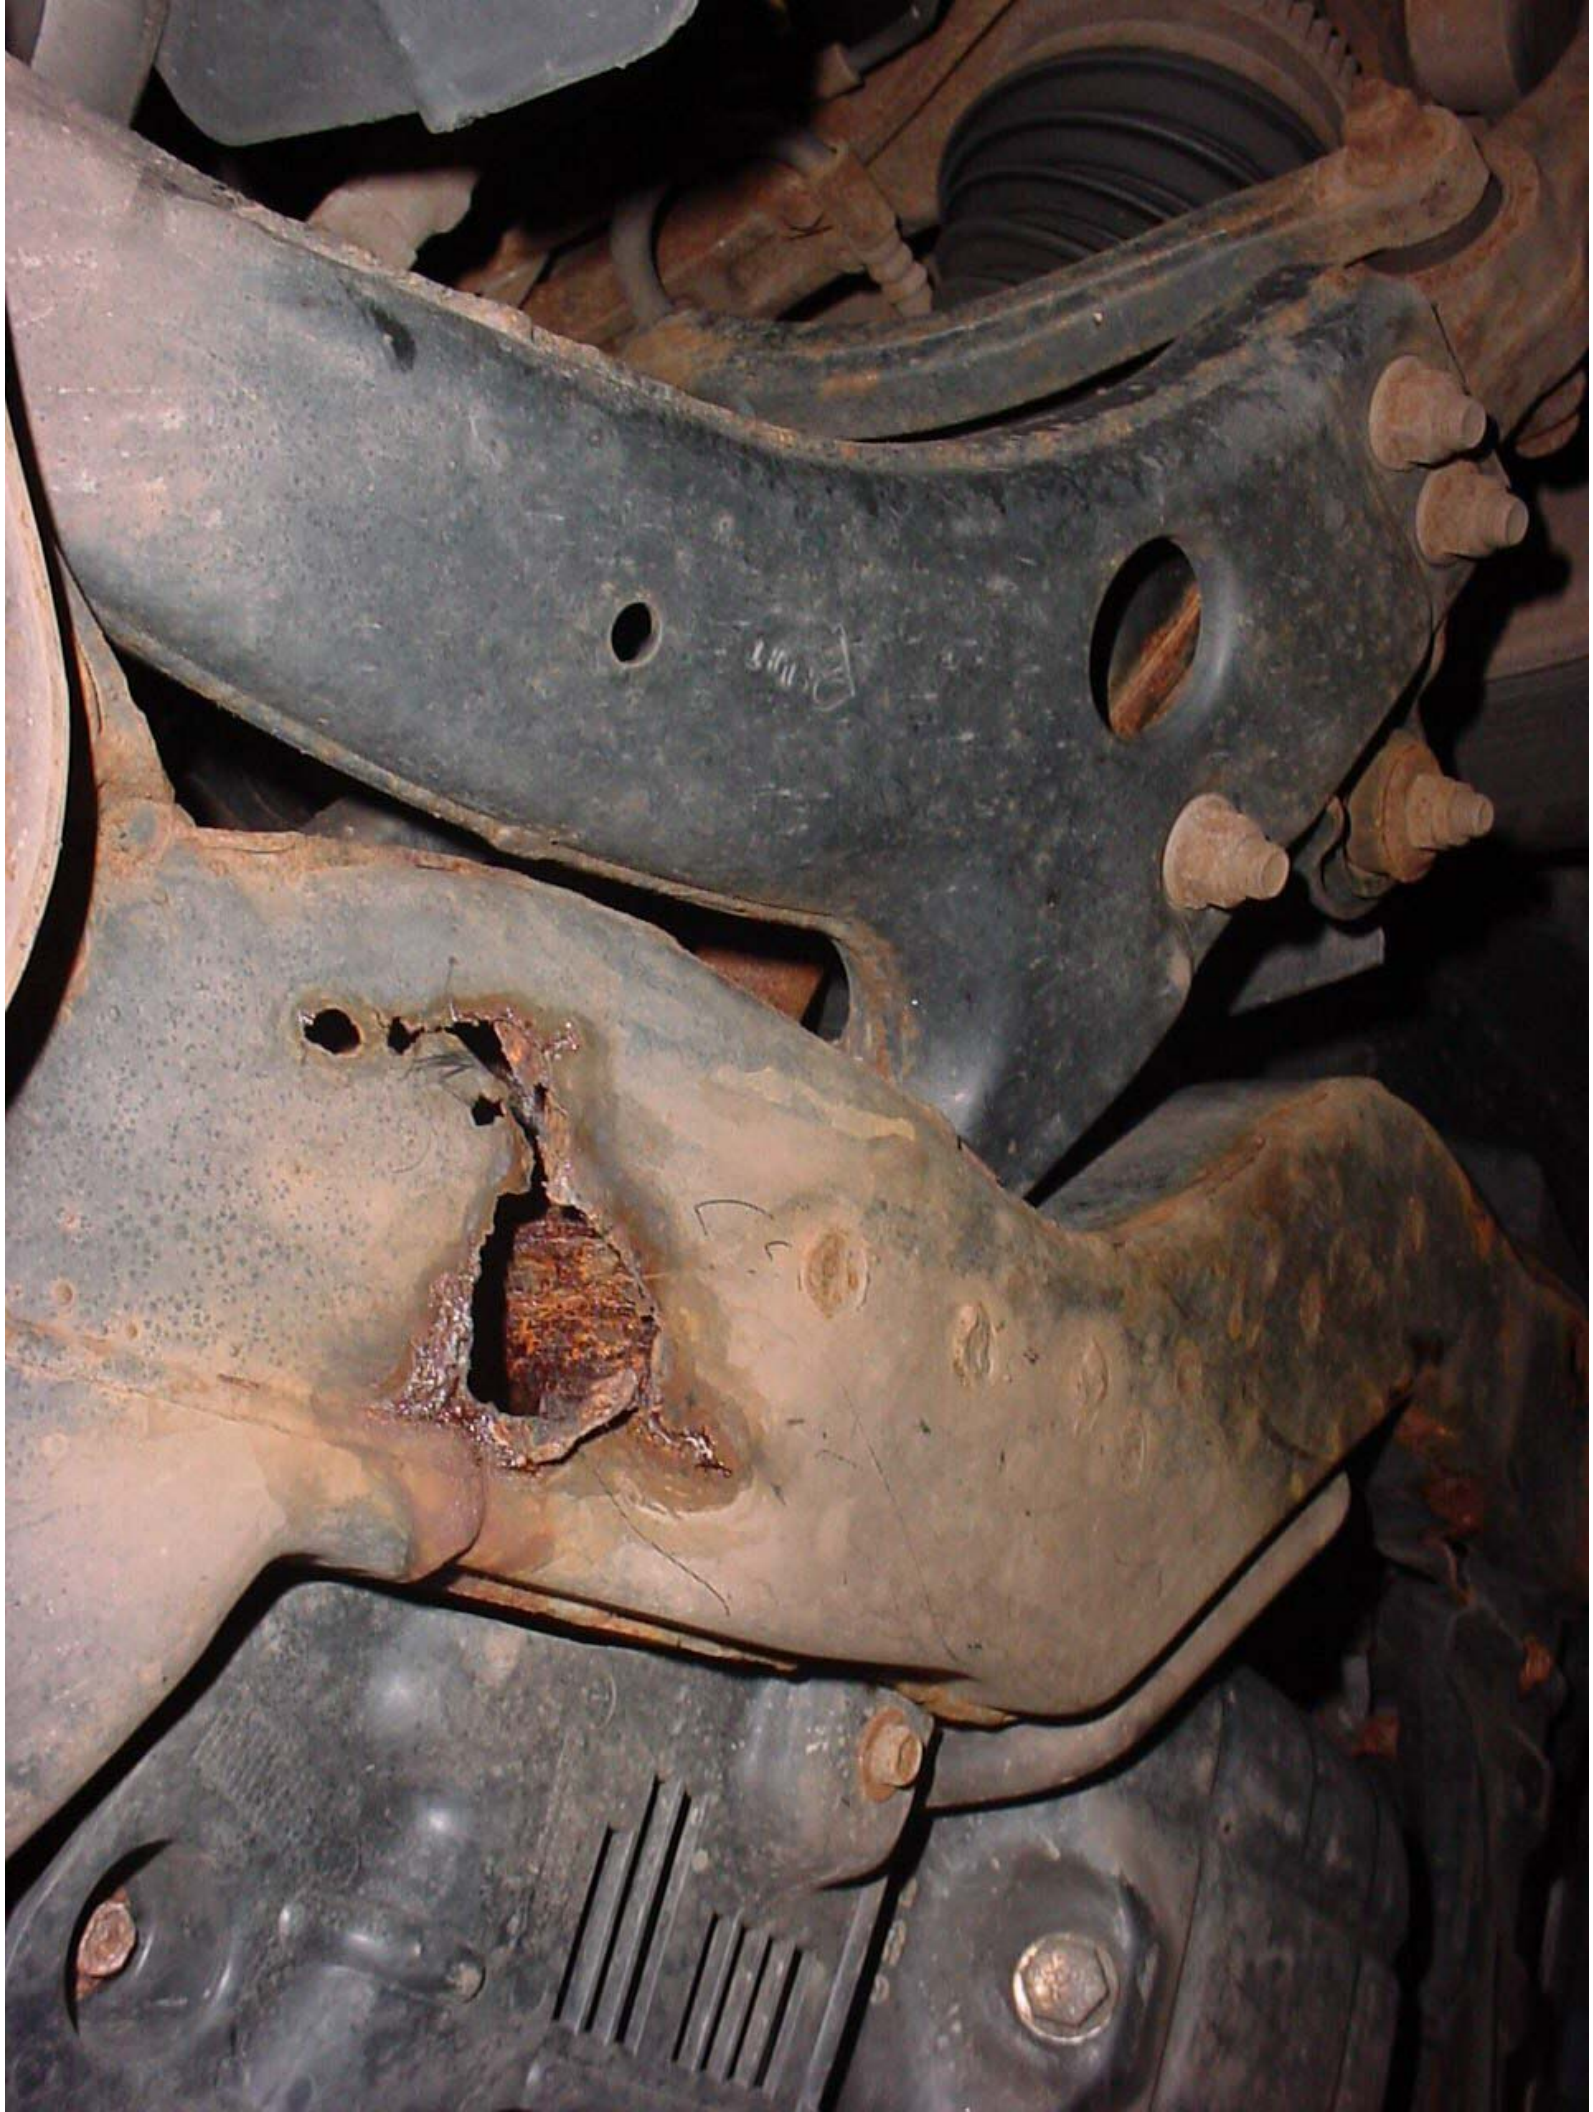
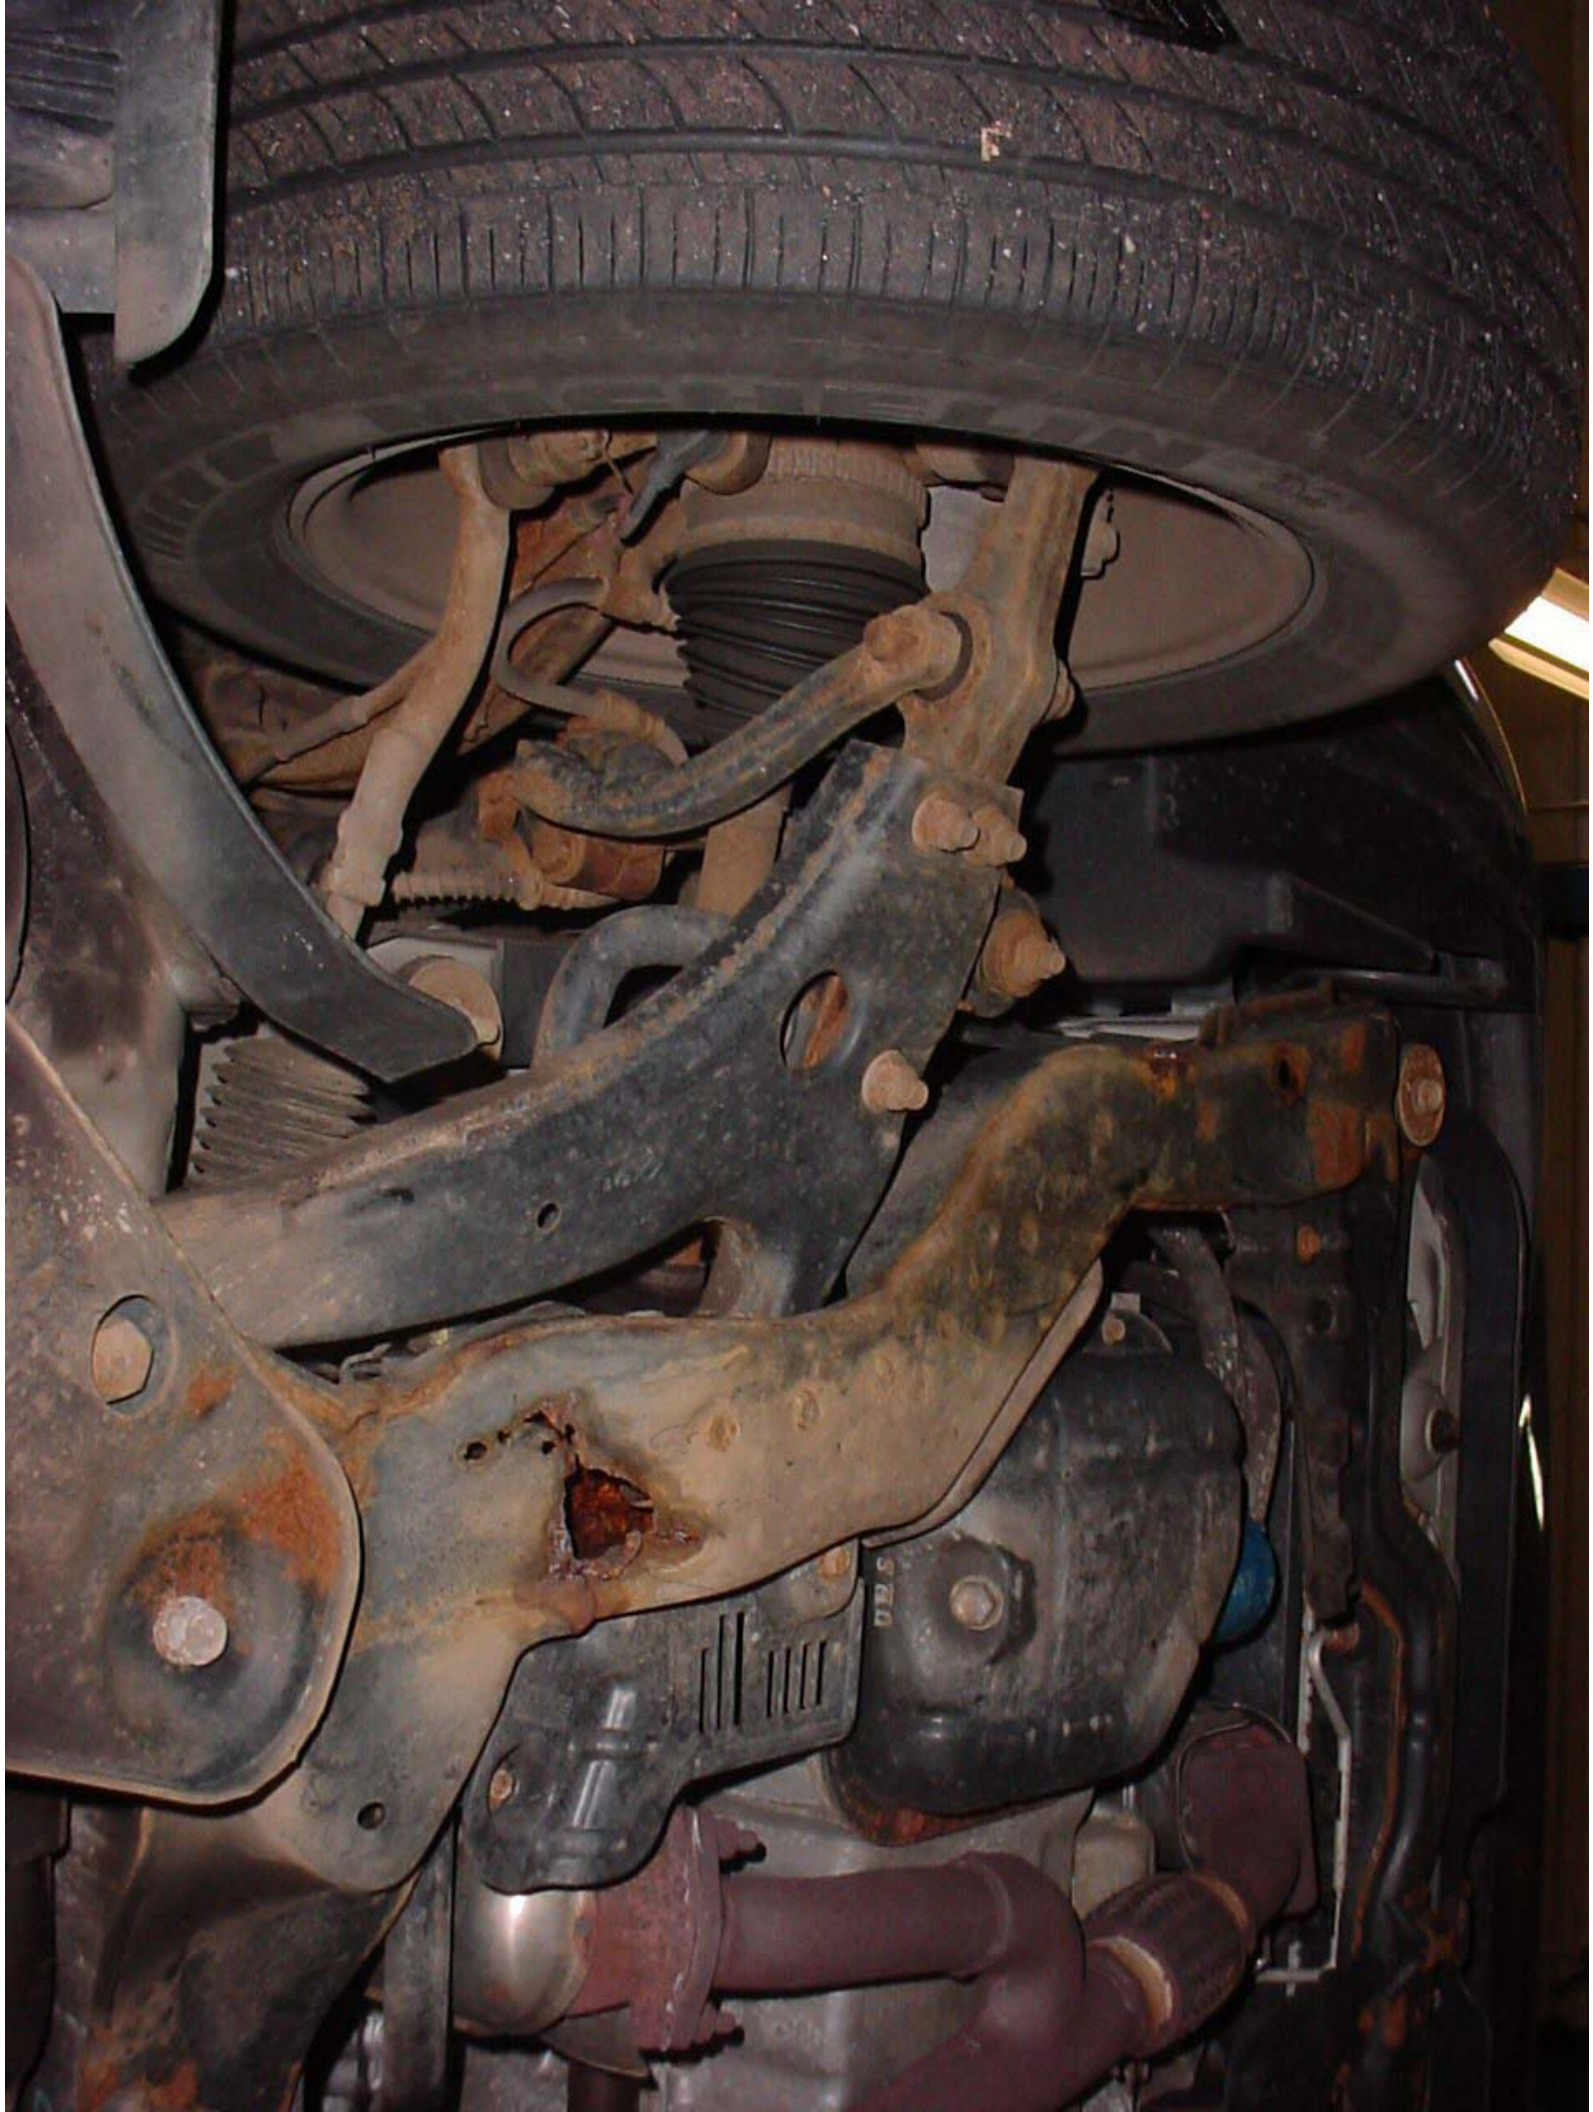
Photos attached. Dealer shippin MVC-002F.JPG old part to Casey Shah at HMA. MVC-001F.JPG

To: FPOR <-- optional Note: An e-mail copy is always sent to National, in addition to above e-mail recipient(s).		
Subject: Rust perforation		UPC:
Originator: John Ketwig	Report #: 1104001	Date: 11/29/2004
Dealer Code: CT028	Contact Person: Ken Chitjian	
VIN: KMHWF35V1YA [REDACTED]	Mileage: 58298	
Model: Sonata*	Model Year: 2000*	
Production Date:	Category: 16 Structure*	
Part Name: Crossmember complete	Part Number: 62405-38101	
Customer Complaint: No customer complaint, condition was seen while changing oil		
Dealer Observations: Crossmember / subframe has significant rust perforation		
Corrective Action: Replace crossmember		
Did this action resolve condition? <input checked="" type="radio"/> Yes <input type="radio"/> No		
Condition verified by personal inspection of company employee? <input checked="" type="radio"/> Yes <input type="radio"/> No		
Were Photos Taken? <input checked="" type="radio"/> Yes <input type="radio"/> No

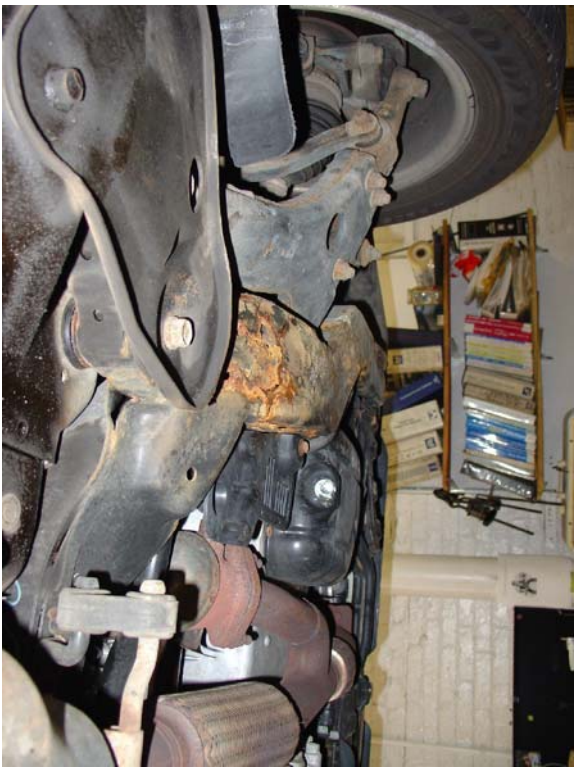
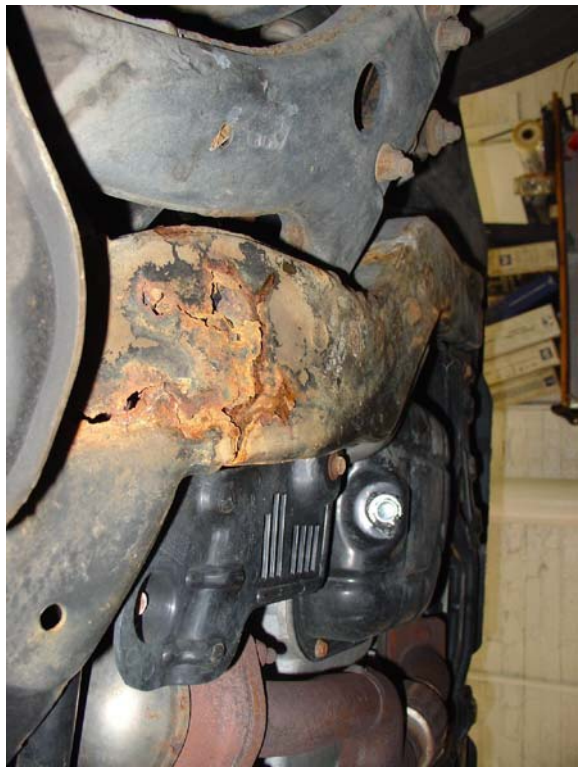
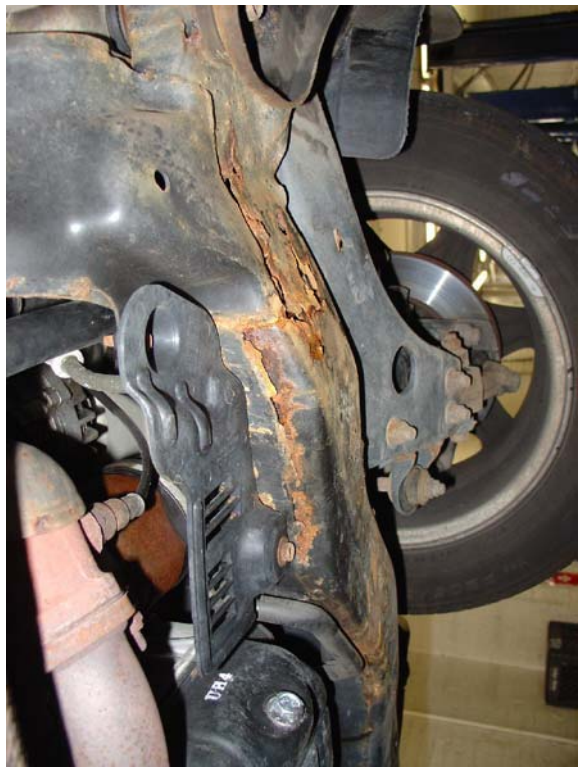
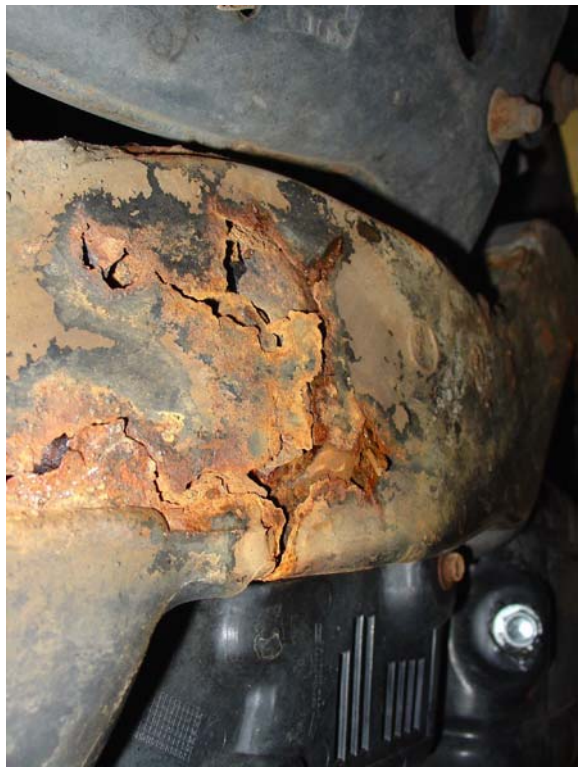
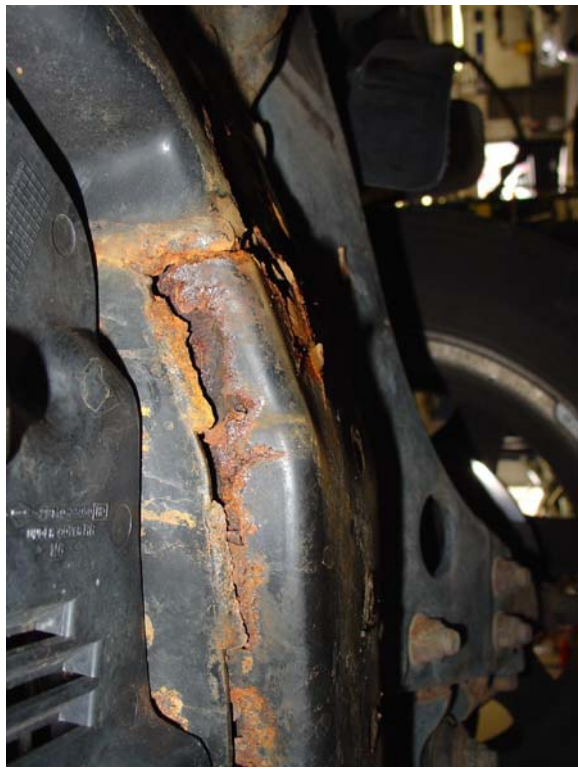
Sonata frame PA063 004.jpg

2000 SONATA - FRAME OXIDATION / RUST THROUGH OF RIGHT REAR CROSSMEMBER.

Customer stated the engine cradle has rusted out.

Right side frame section rusted through

Replace complete crossmember assembly.

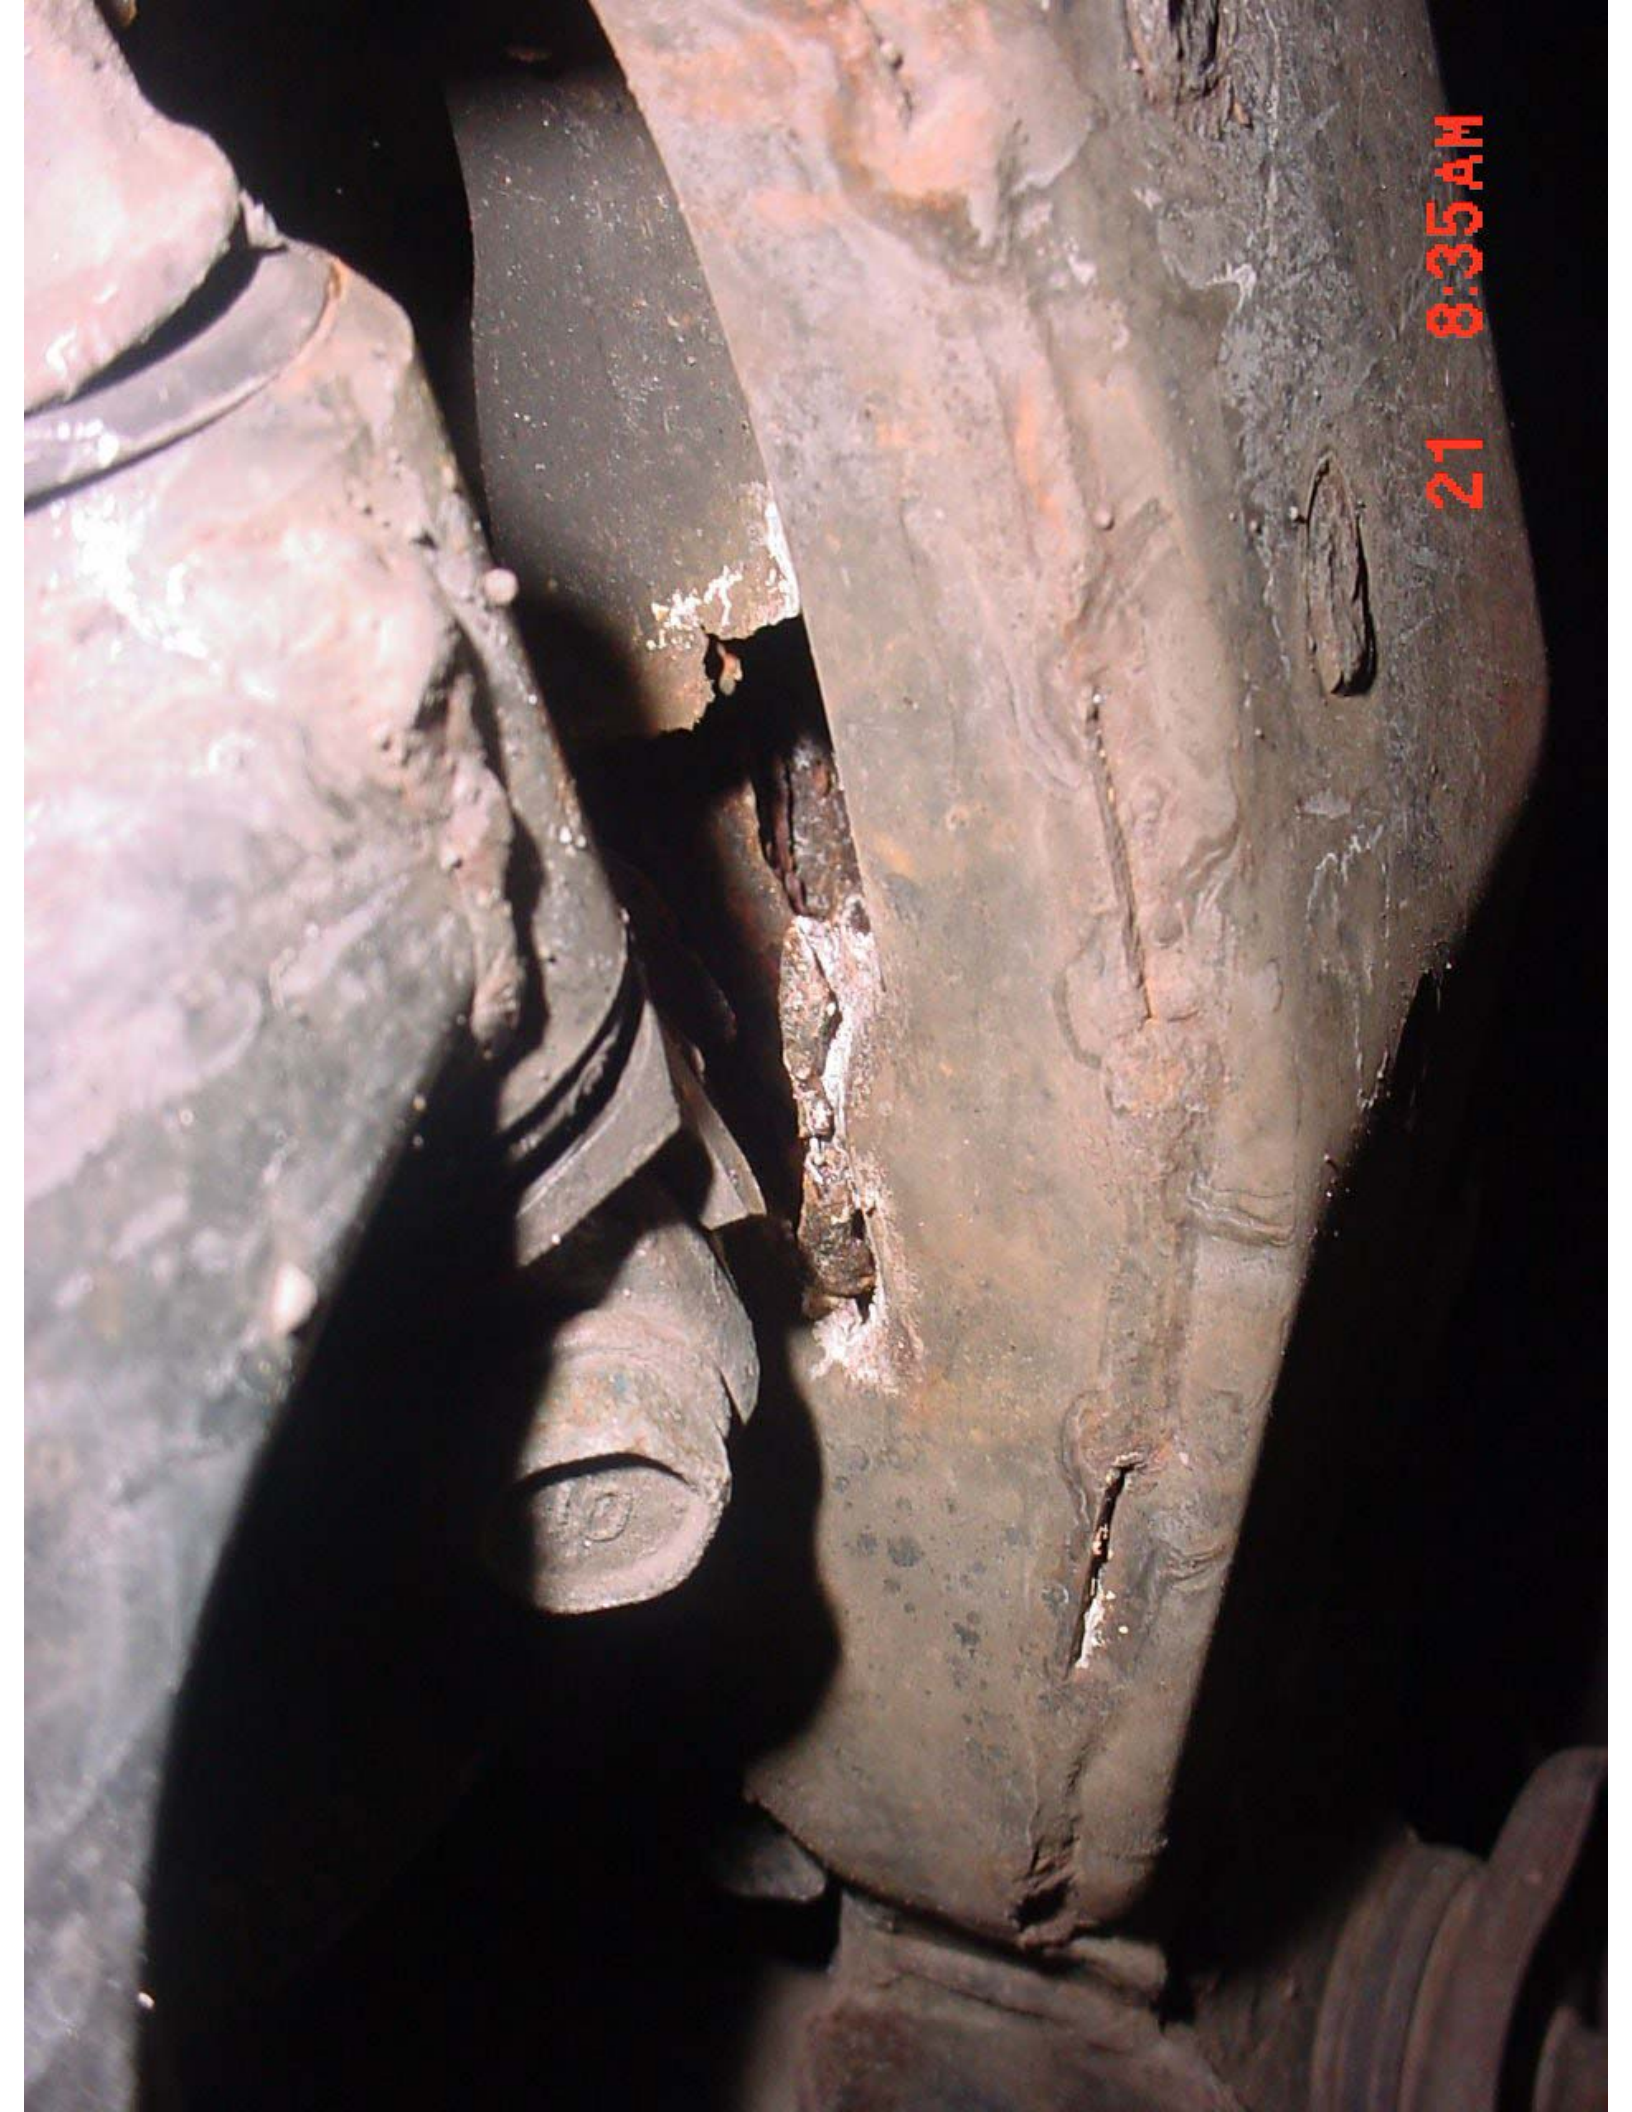
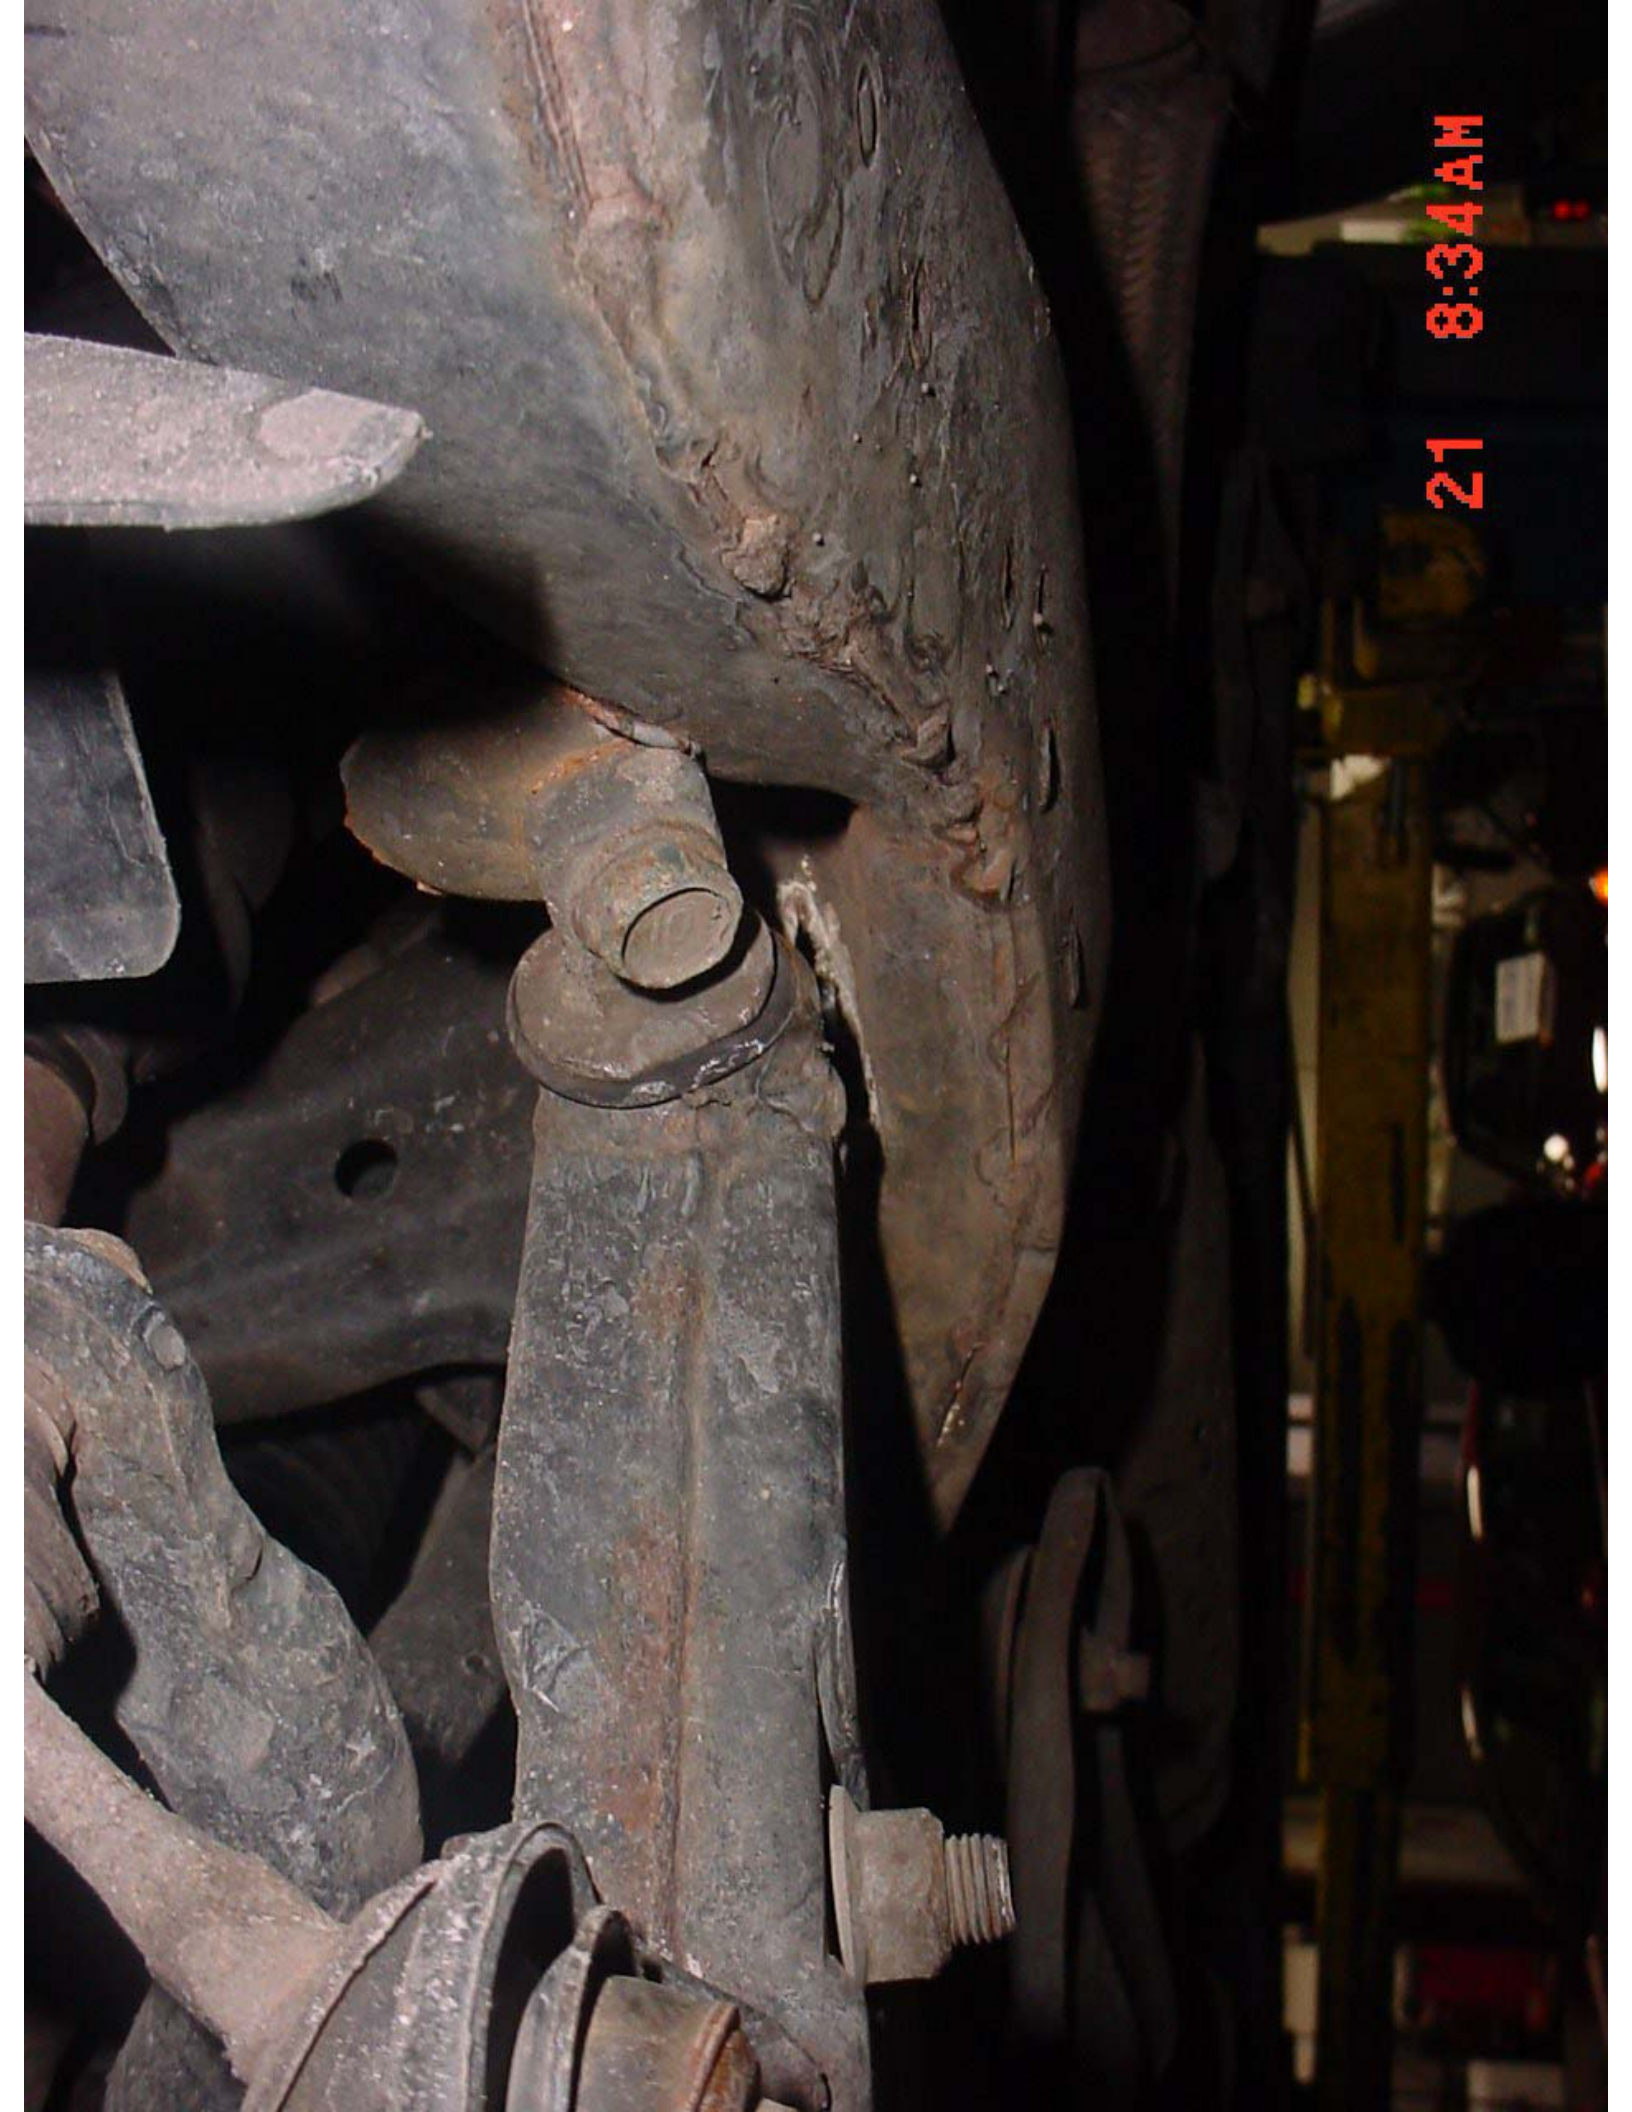
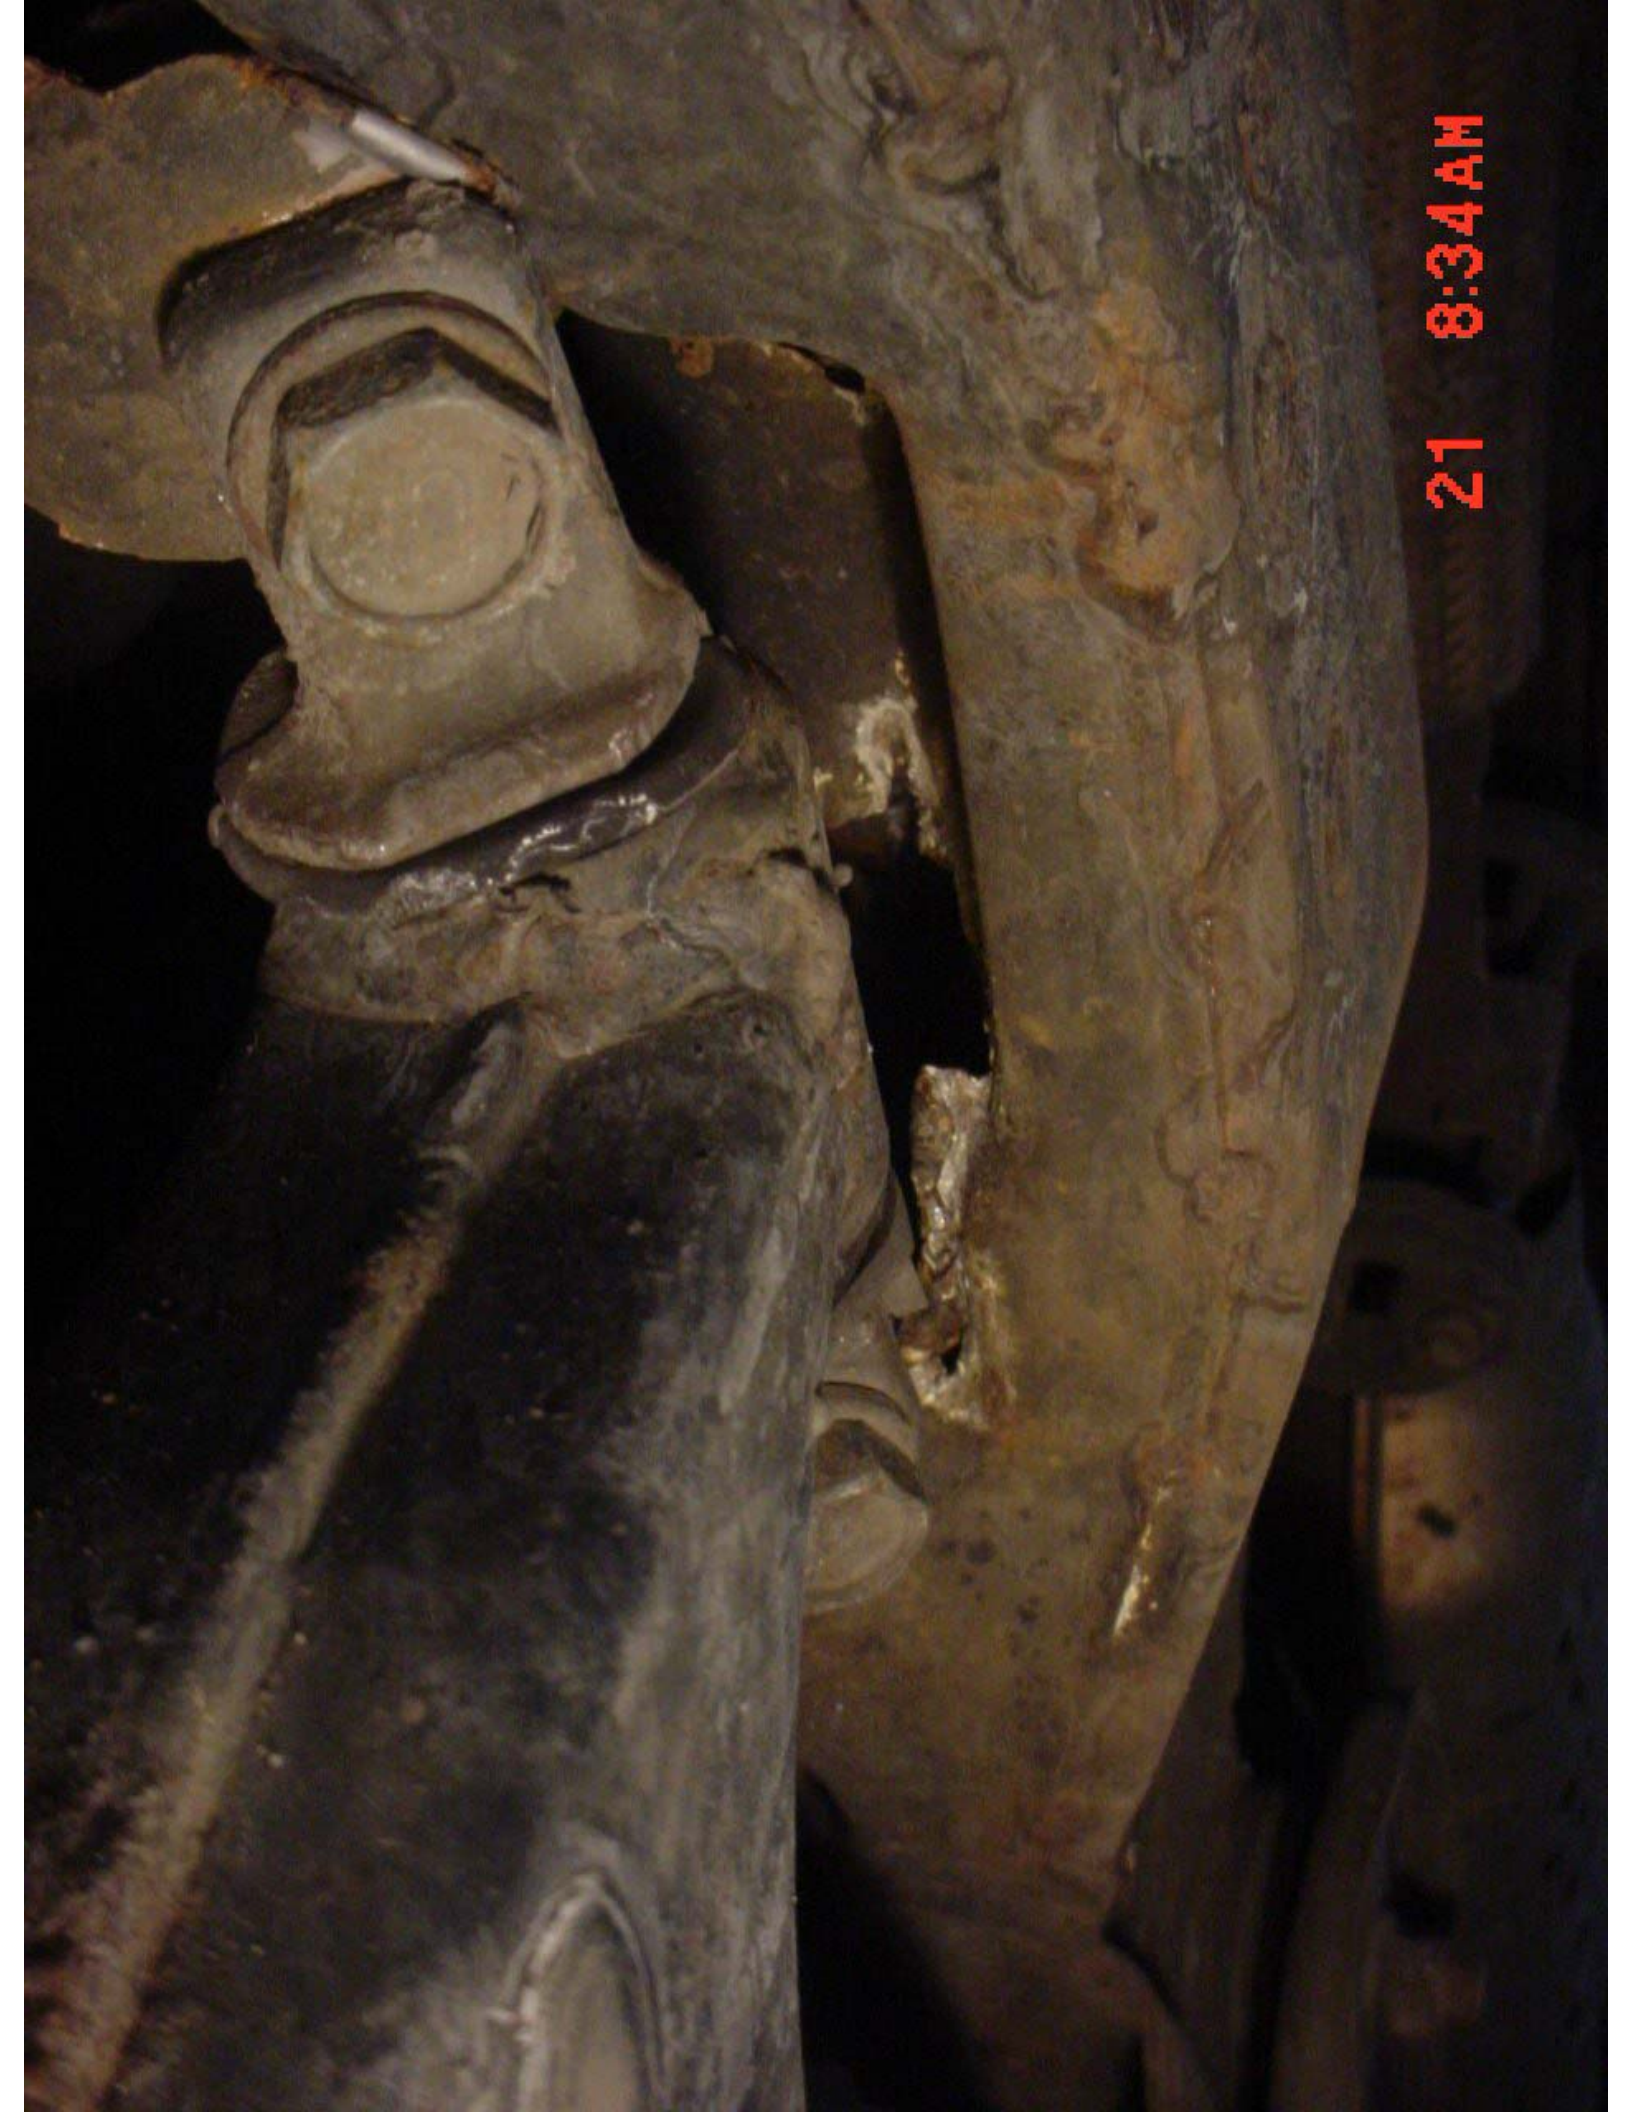
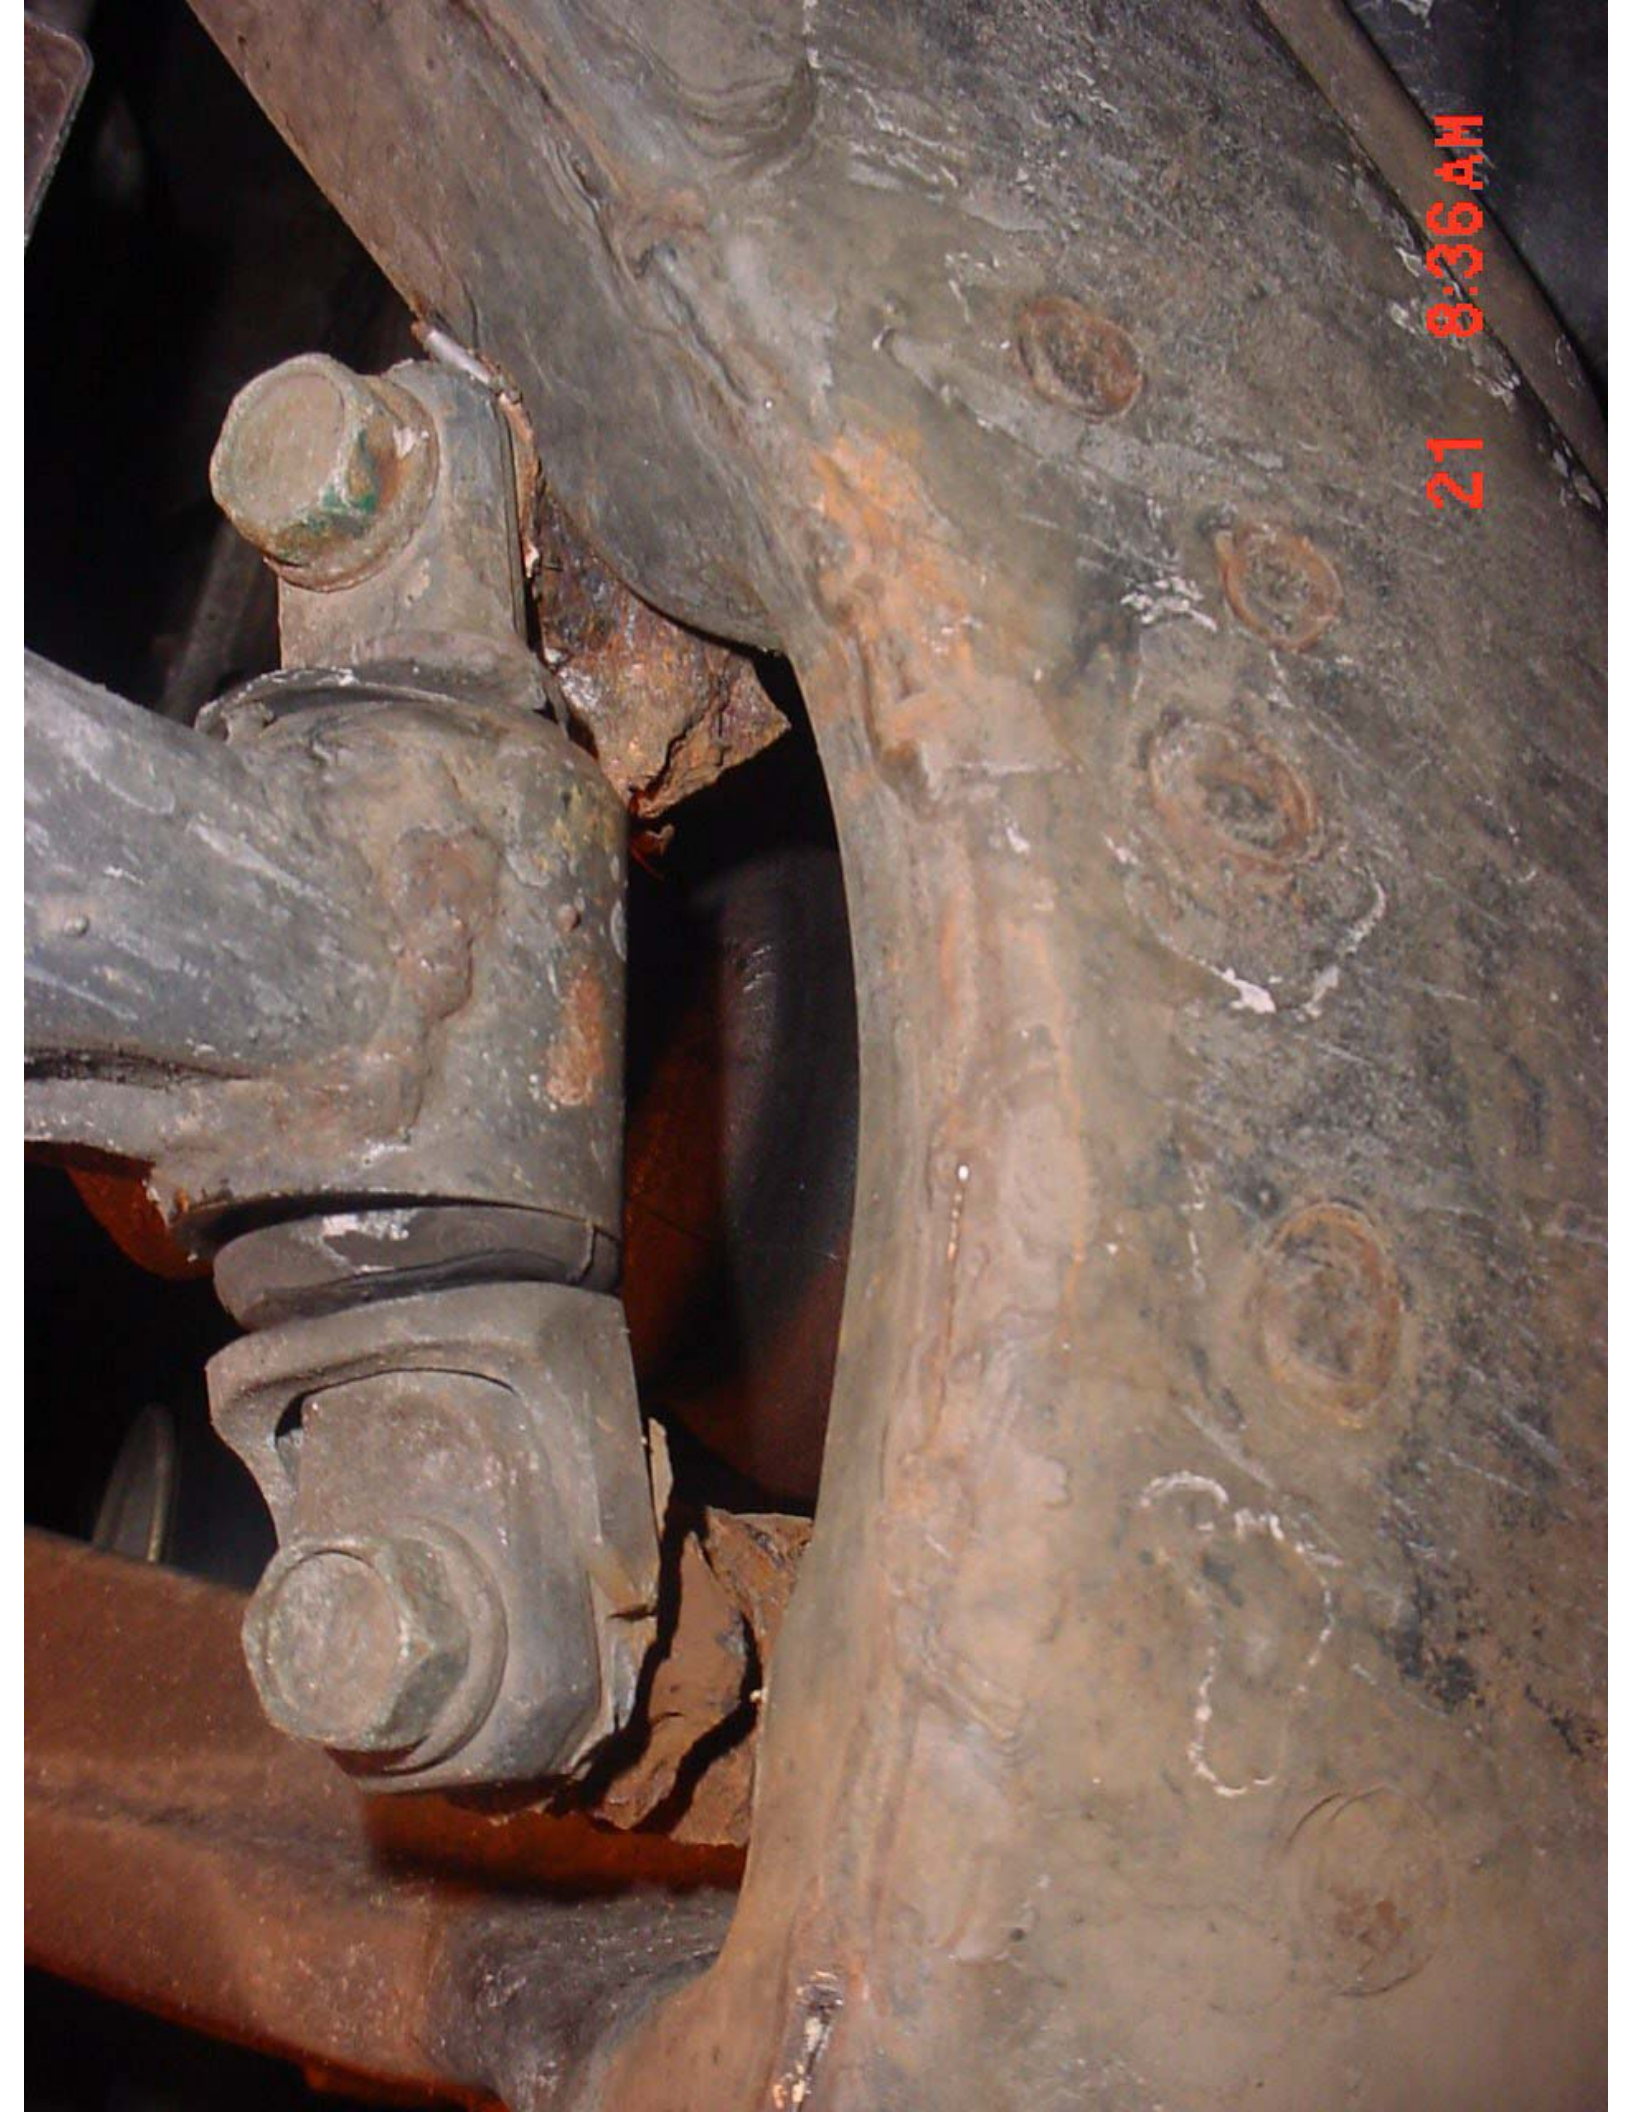
Control Arm & Subframe - 5.JPG</div> </div>

Target Date:	Comment:
03/29/2006	<p>This is a durability issue that is beginning to present itself.</p> <p>The dealer attempted to get / locate a used frame section, the ones he did locate had damage in the inner section of the frame where the control arms bolt in.</p> <p>The cage nuts were damaged / stripped out while attempting to remove / replace / exchange the lower control arms.</p> <p>Ultimately the dealer had to install a new frame assembly.</p>
