**PE08029/HYUNDAI-KIA
2002 EF FIELD REPORTS**

2002 Sonata SUBFRAME RUSTED THROUGH- POTENTIAL VDS ISSUE

**PE08029/HYUNDAI-KIA
2000 EF FIELD REPORTS**

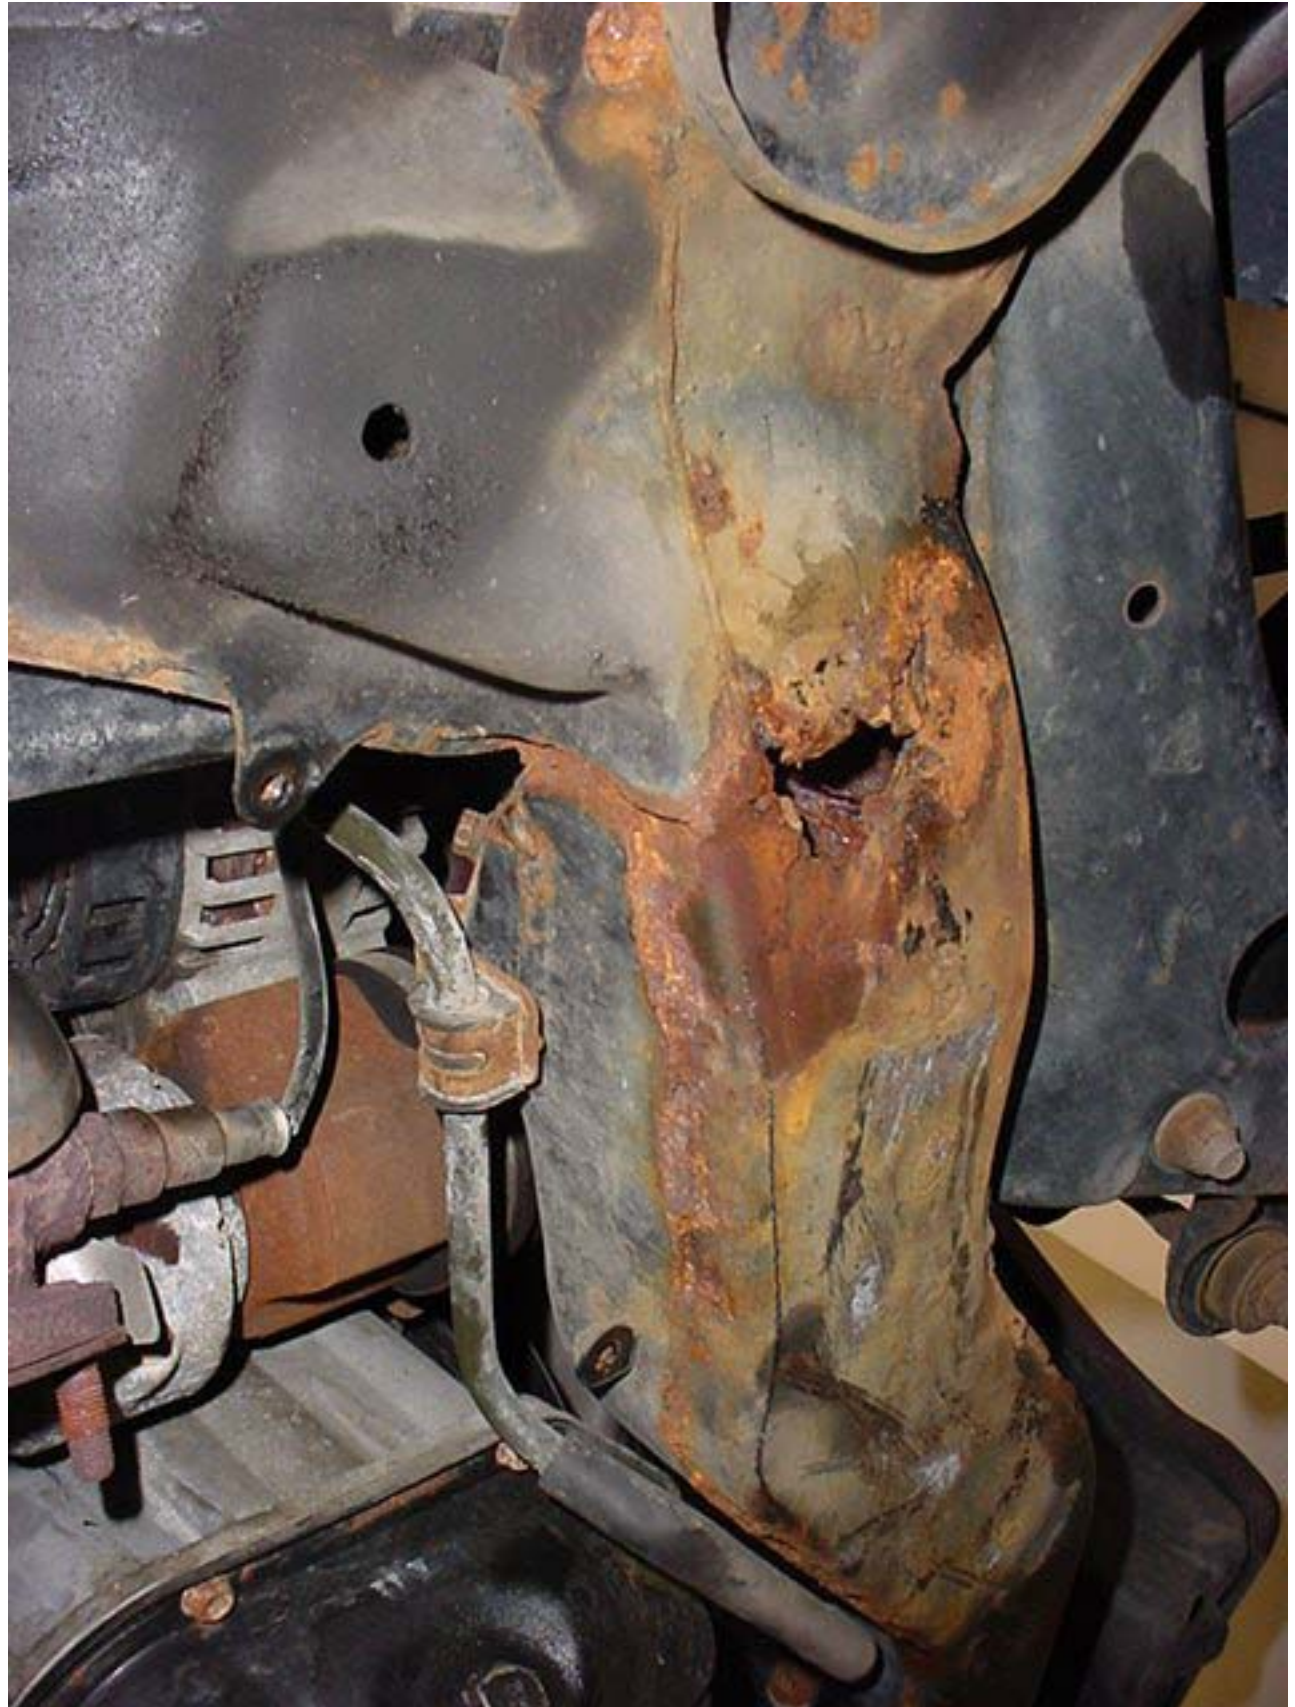
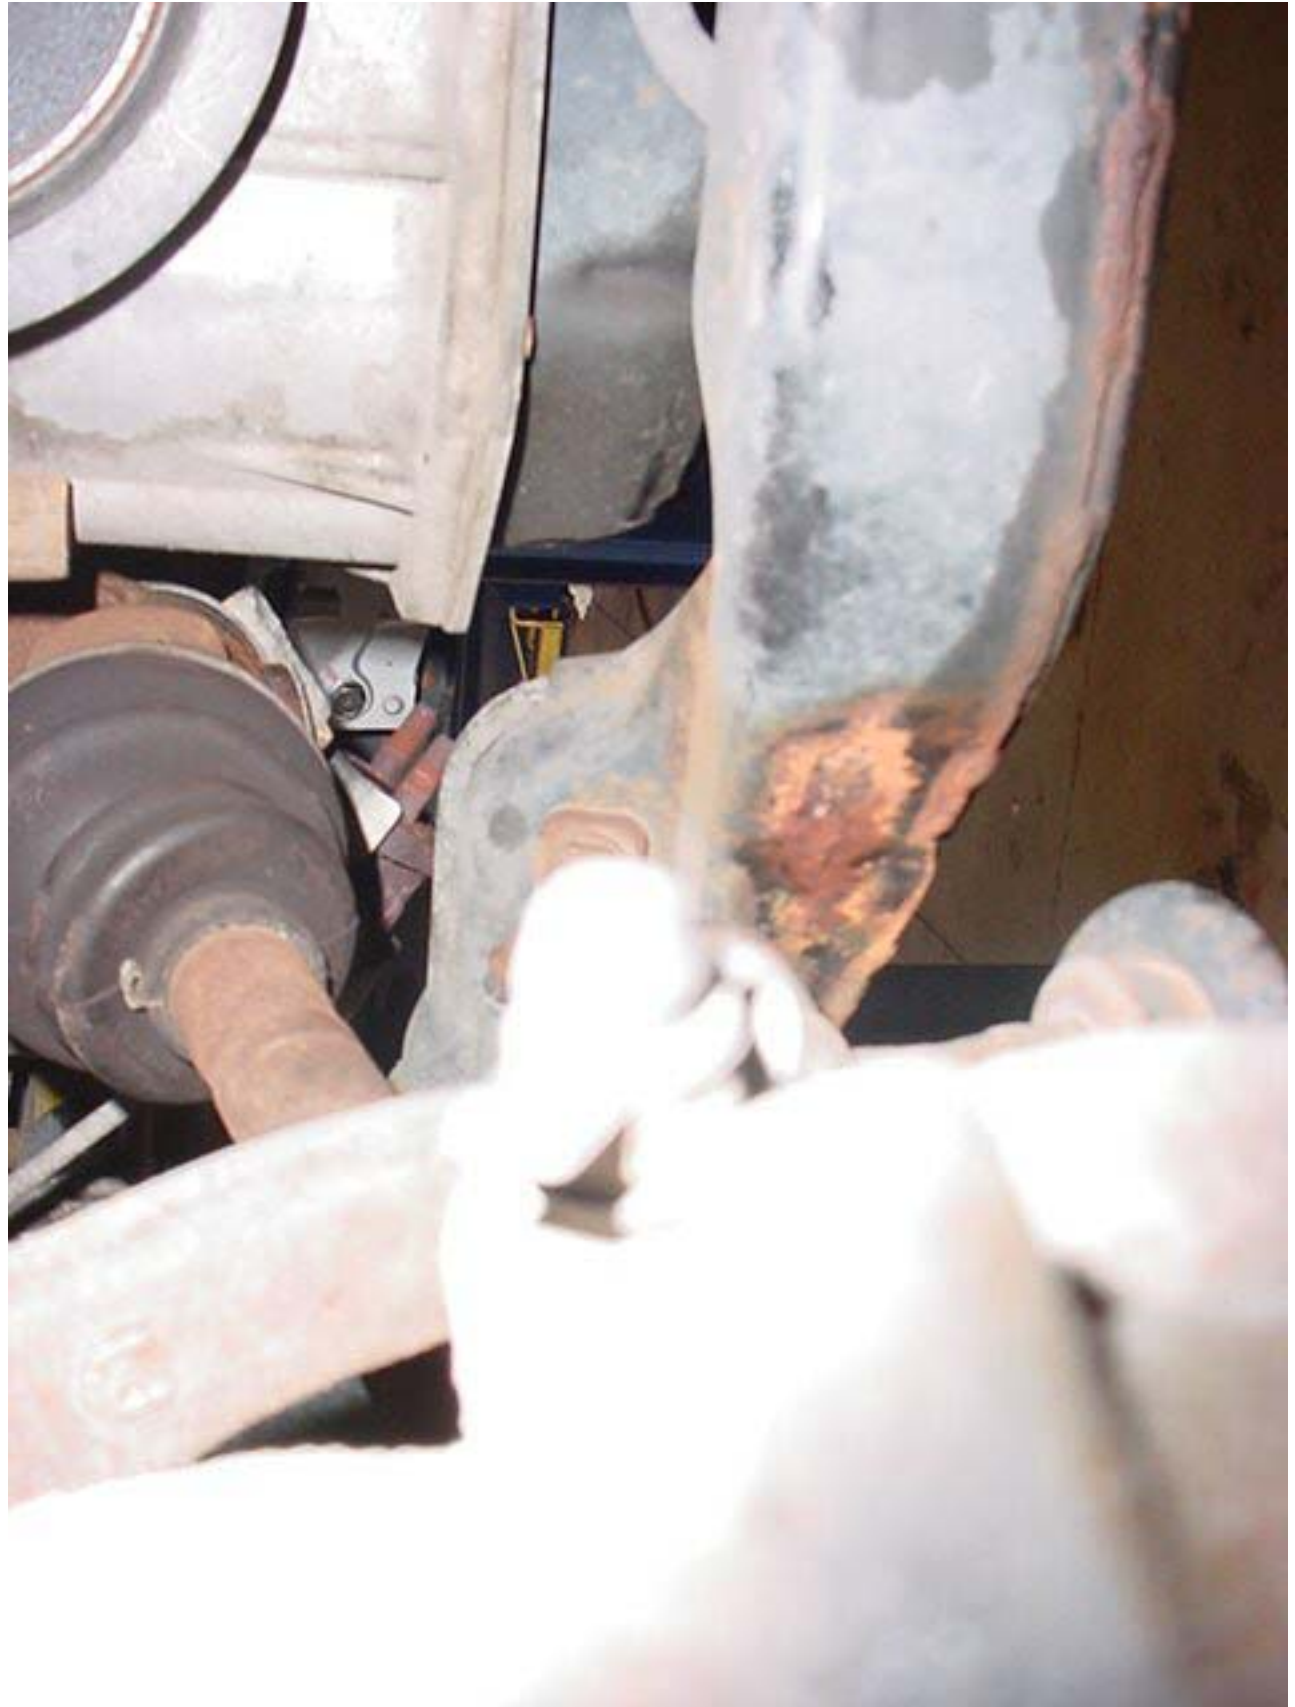
Sonata Rust 001.jpg Sonata Rust 002.jpg

2000 SONATA - FRAME OXIDATION / RUST THROUGH OF RIGHT REAR CROSSMEMBER.

Customer was advised of a large amount of rust on the engine cradle. This was observed during a state inspection.

Close up of rusted area. RR frame area

Replace complete crossmember assembly.

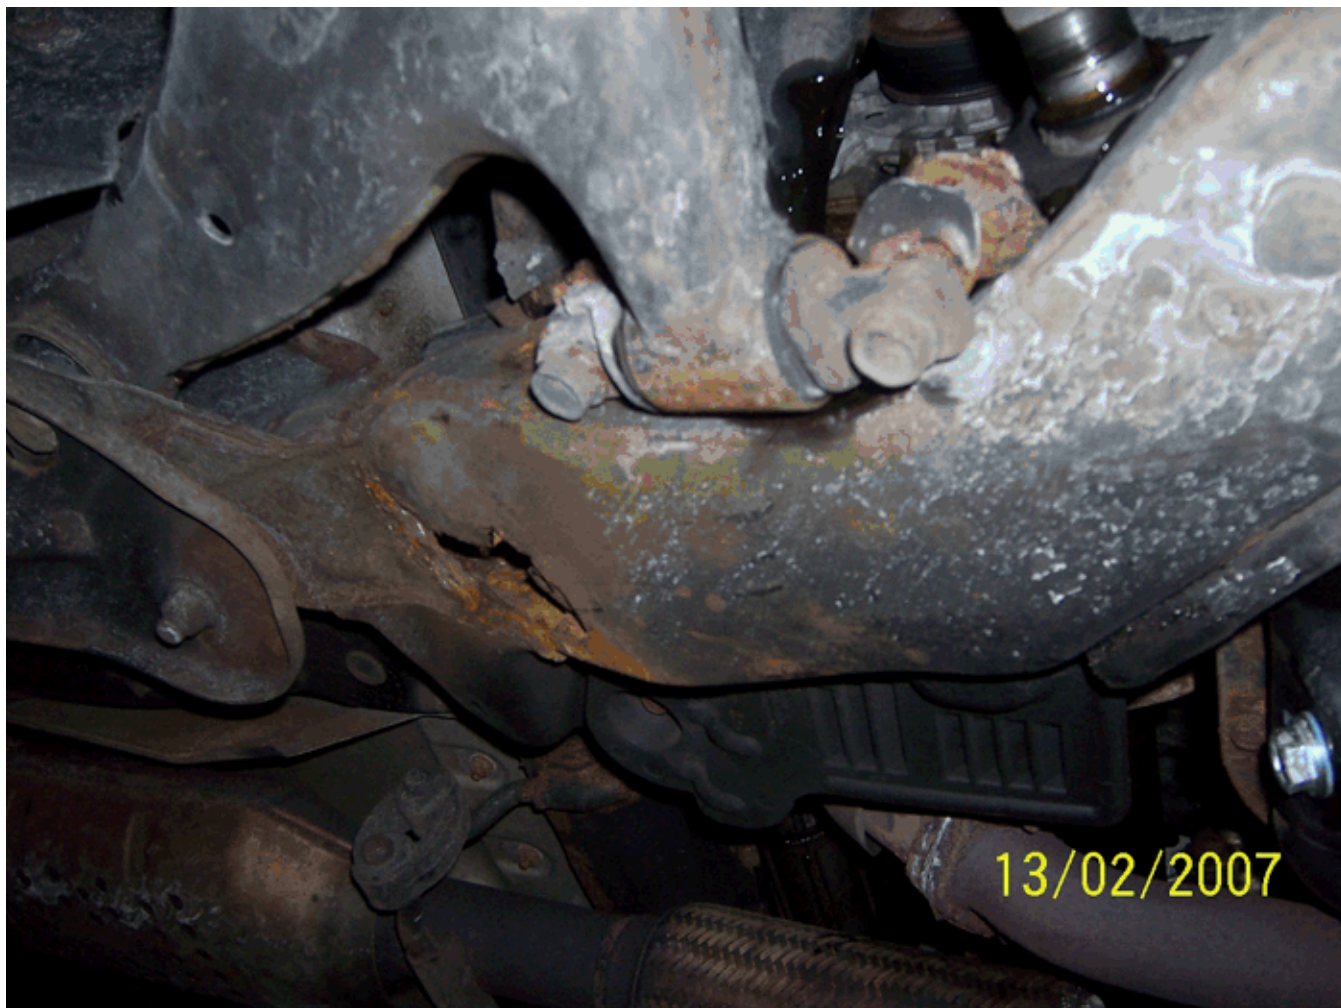
Sub frame rusted through.

Right front control arm rusted and pulled away from sub frame.
