**PE08029/HYUNDAI-KIA
CROSSMEMBER
ASSEMBLY CORROSION
01**

PE08029/HYUNDAI-KIA
QAEF-C-050701

Report Number : QA EF - C - 050701

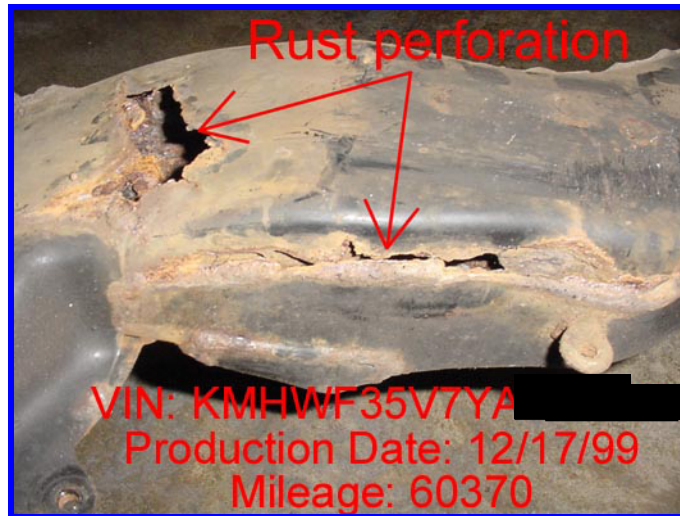
No.	VIN	Production Date	Mileage	Condition
1	* KMHWF35V2XA [REDACTED]	9/26/98	98555	Crossmember rust perforation
2	* KMHWF35V7YA [REDACTED]	12/17/99	60370	Crossmember rust perforation
3	* KMHWF35V6YA [REDACTED]	9/06/99	60364	Crossmember rust perforation
4	KMHWF35V9XA [REDACTED]	4/30/99	53053	Crossmember rust perforation
5	KMHWF35V1YA [REDACTED]	8/24/99	58298	Crossmember rust perforation
