**PE08029/HYUNDAI-KIA
EF 1999 CROSSMEMBER
UPDATE 01**

- Purpose of this QIR is to provide updated information regarding the crossmember corrosion condition.

PE08029/HYUNDAI-KIA
QAEF-C-061202

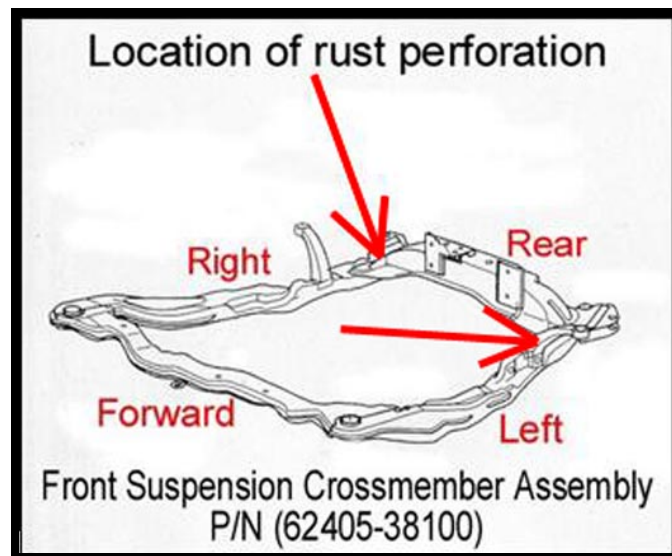
- Inspection of the Crossmember Assembly P/N (62405-38100) revealed the right rear section had corrosion perforation.

- Corroded section of the Crossmember Assembly appears to be below the air conditioning evaporator drain hose.

- Corrosion of the crossmember assembly is more evident at the right rear section of the crossmember assembly which may possibly be related to the air conditioning evaporator water dripping unto it.

- See attached photographs and illustration.

- Replace the Crossmember Assembly P/N (62405-38100)
- Repair cost \$ 1,116.61

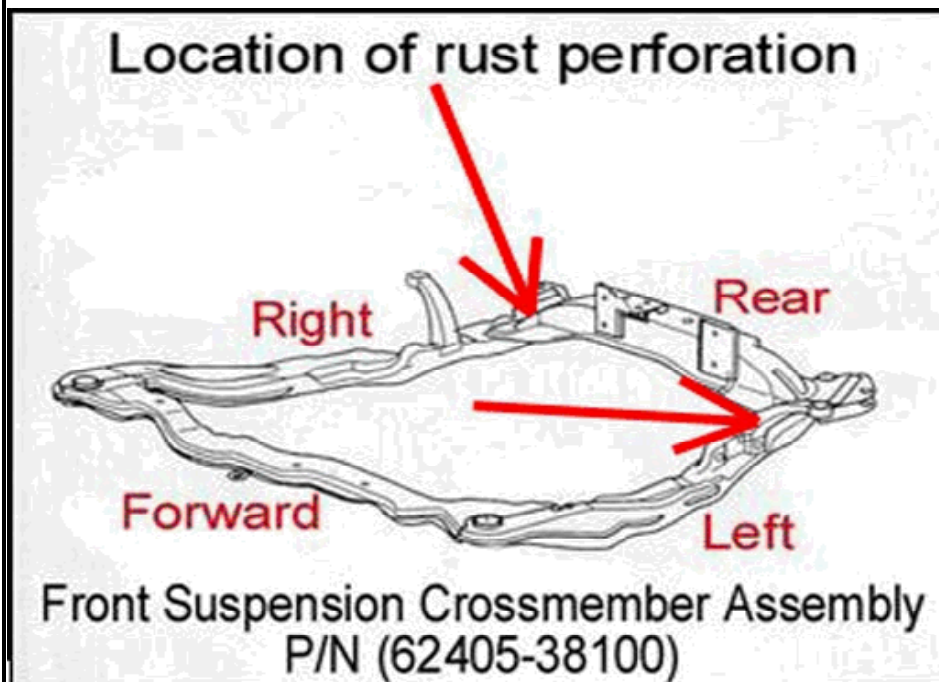
- Inspection of the Crossmember Assembly P/N (62405-38100) revealed the right rear section had corrosion perforation.

- Corrosion of the crossmember assembly is more evident at the right rear section of the crossmember assembly which may possibly be related to the air conditioning evaporator water dripping unto it.

- See attached photographs and illustration.

- Replace the Crossmember Assembly P/N (62405-38100)
- Repair cost \$ 1,116.61
