# Service Request Detail Report

**SB531014****Date: 05/21/08****Model: MP8****(Also applies to Mack Trucks Australia)****Revised Air Compressor Discharge Line — MP8 Engines**

## Revised Air Compressor Discharge Line — MP8 Engines

**QJ Id:** 561-104  
**Description:** GU/CHU/CXU MP8 Air Compressor Discharge Line Leaks  
**Case Manager:** Brad Keller  
**Solving Responsible:** Tim Lancaster  
**VMT:** VMT048 : Powertrain Installation

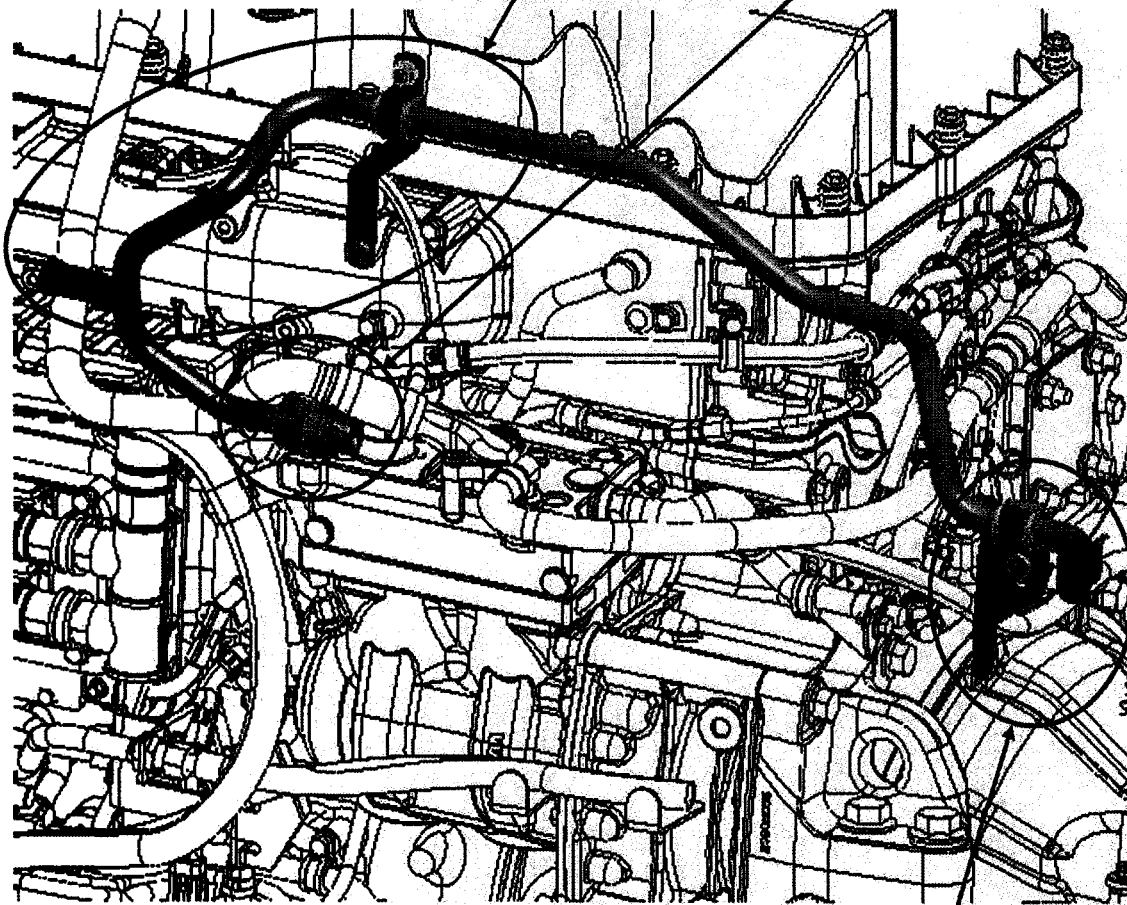
2008-02-13 Cooling coil leaking at ferrule fitting connection to air compressor.

2008-02-13 Leaking at compression fitting due to ferrule locking on pipe before sealing. 2008-02-22 Applies to US07 VE13 and VE16 engines.

DCN's D-13713-06 and K-10816-70 have been released. 21206950 Nipple replaces 947628 Gasket and 990698 Nipple on both VE13 and US07 VE16. Cooling coils: 21206841 replaces 21065580 for VE13; 21206849 replaces 21101708 for US07 VE16.

1. HAND TIGHTEN SO THAT THERE IS NO PLAY BETWEEN THE TUBE END AND THE NIPPLE
  2. TORQUE 1 1/16"-12 FITTING TO 80 ± 8.0 FT LBS (109 ± 11.0 Nm)
- AFTER INITIAL INSTALLATION, IF THE FLARE FITTING MUST BE LOOSENED, MARK THE FITTING BEFORE LOOSENING, THEN RETIGHTEN TO THIS MARK. DO NOT TIGHTEN FURTHER.
