TQCN DOC# FTR-5YA212841		Affiliate TMS	Dept. QA-Chassis	Source FTS	Location REG-SET	Ref 22367-1	Date 5/7/2004
Problem Area Base Vehicle	Primary Model Sequoia	Model Year 2003	Production Date 03-2003	Odometer 6251 mi	VIN (confirm 17 characters): 5TDZT34A03S [REDACTED]		
Condition Title 03 Sequoia contaminated wheel speed sensor

FIELD TECHNICAL REPORT

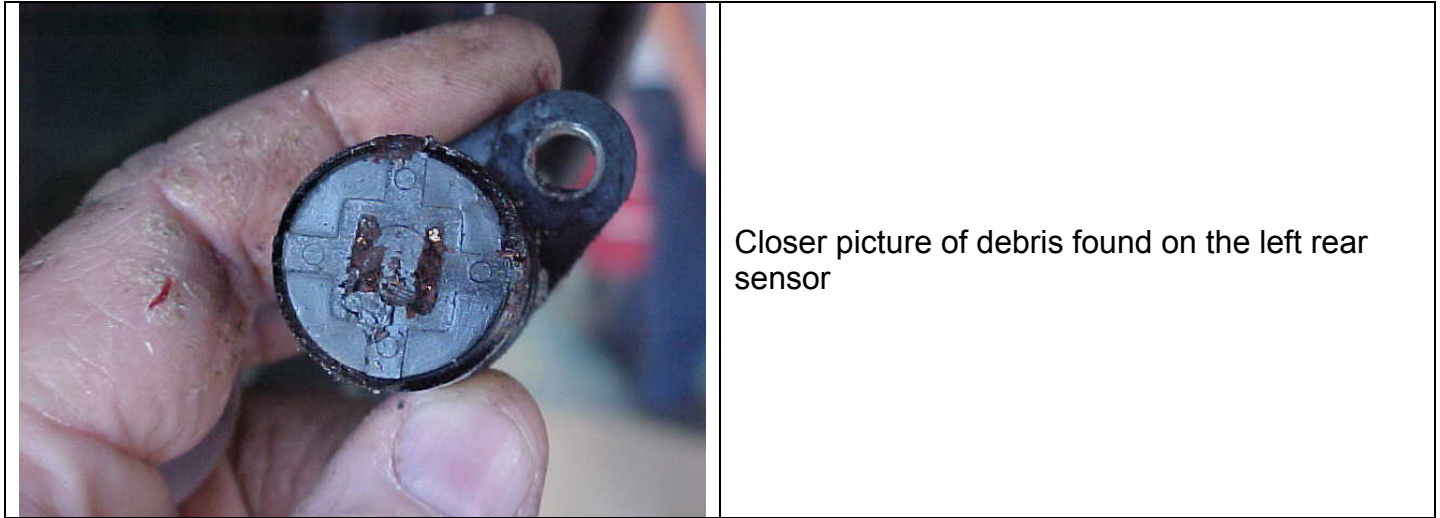
Technician removed and inspected all 4 ABS wheel speed sensors. The left rear wheel speed sensor was found to be contaminated with what appeared to be rust particles. Origin of the contamination/debris is unknown.

Debris found on left rear wheel speed sensor

Technician cleaned the sensor and reinstalled it. The condition no longer occurred after cleaning the left rear sensor.
