Document 1 QIS SCWA-030618-04

QUALITY IMPROVEMENT SHEET (Q.I.S.)

**Document #2
QIS MV20040426180508**

**Document #5
Analysis Report of Failed Part**

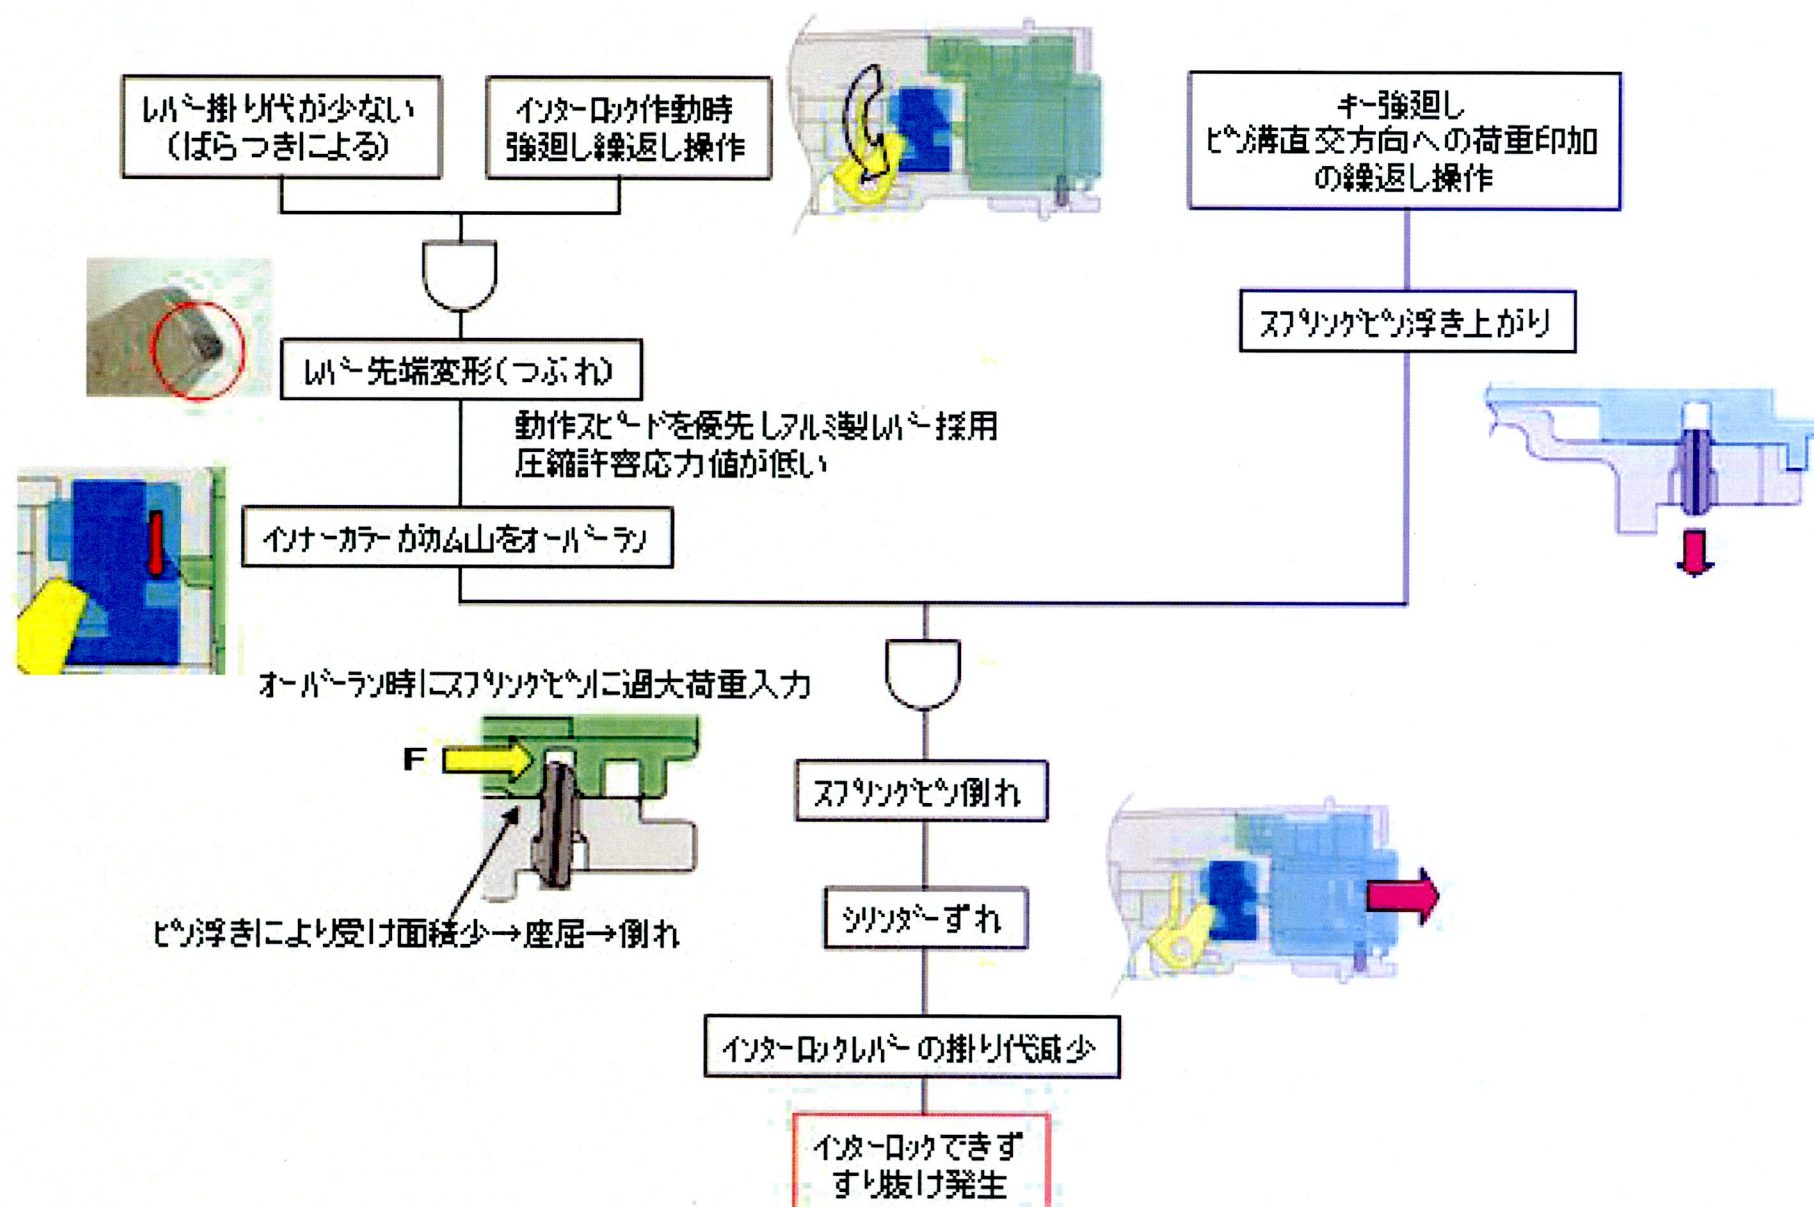
不具合発生メカニズム

Regarding the failure this time, the overlap margin when returned was 1.04 mm compared to the required margin 1.06 mm. Repeated strong turning of key beyond expectation at interlock blocking with overlap margin of 1.06 mm or below leads to slip out. Therefore we judge that the failure occurred with the returned part due to worn lever from repeated strong turning of key beyond expectation.

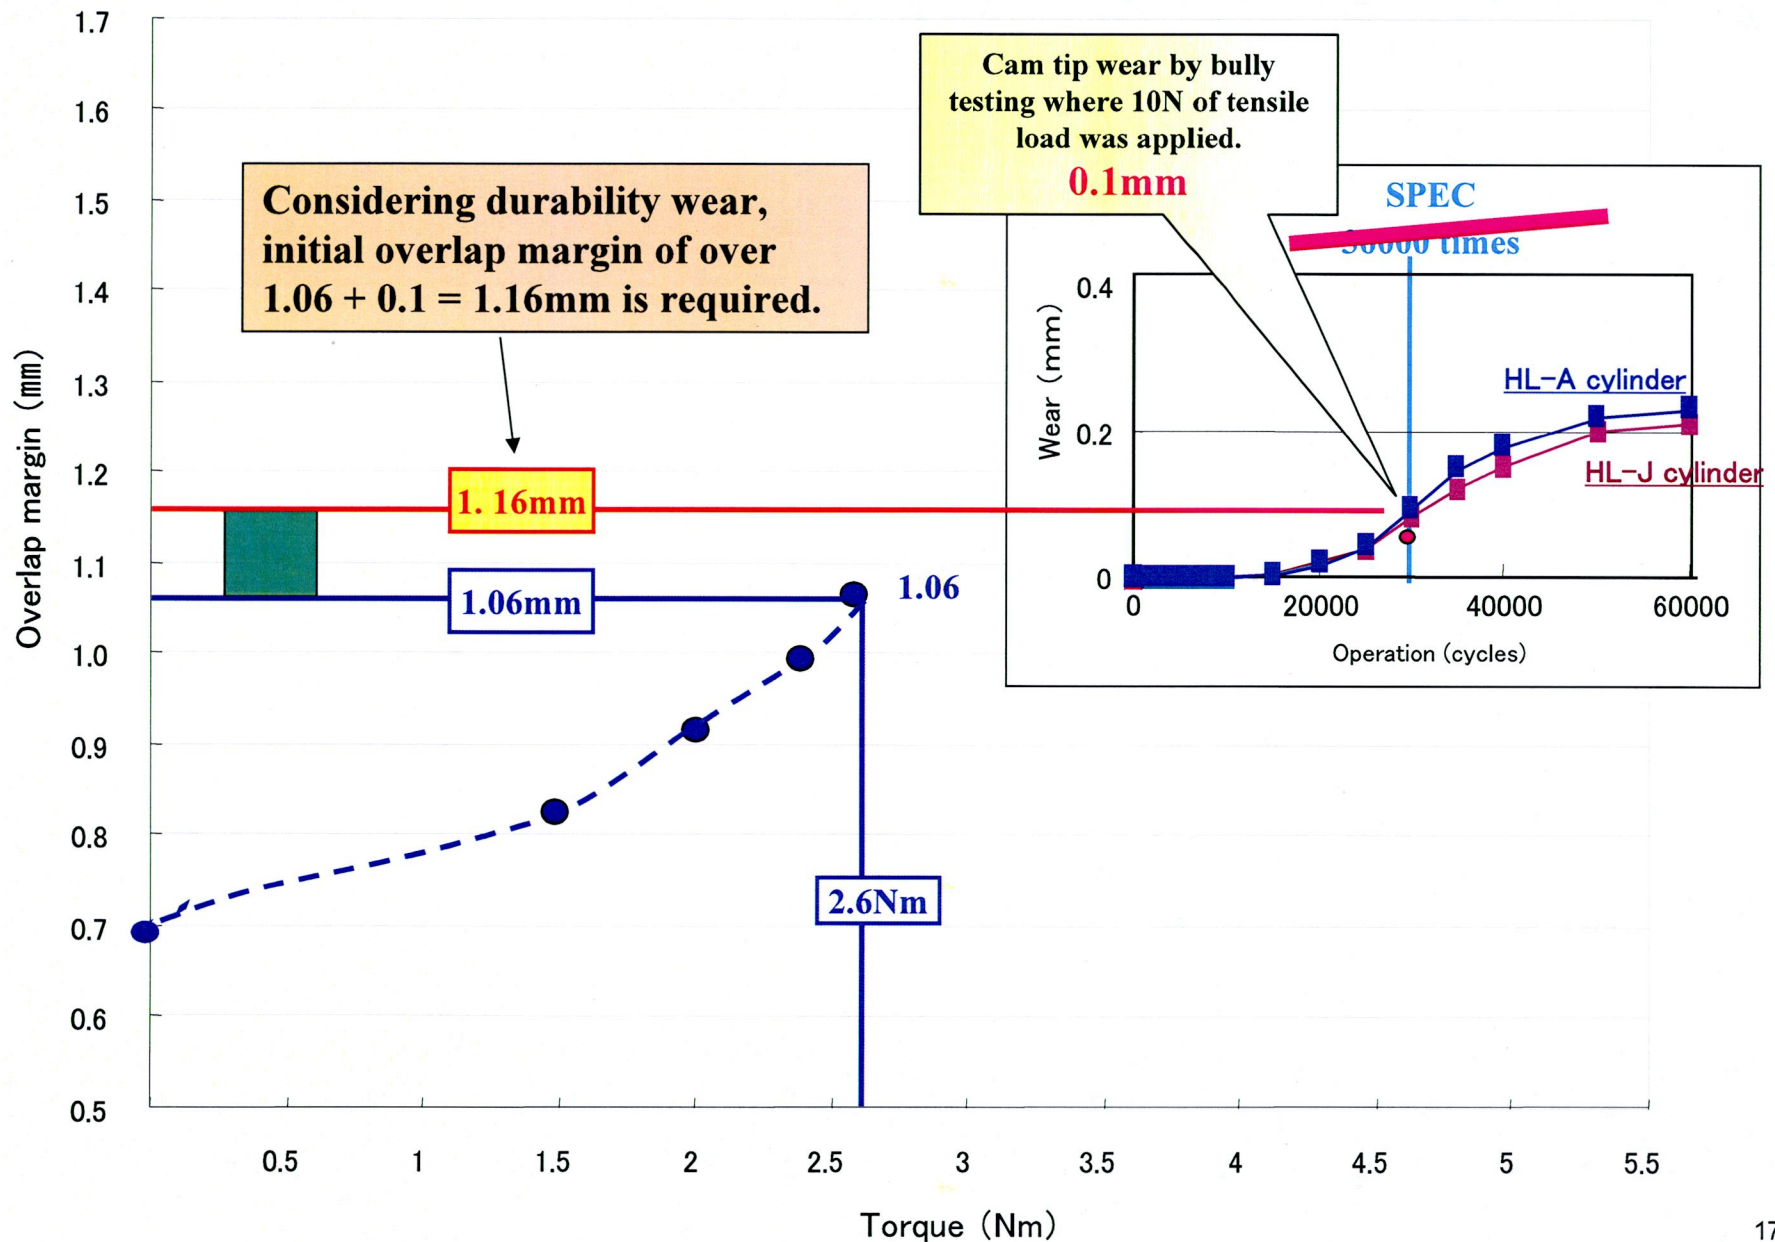
Required lever overlap margin considering durability deterioration (US market)

: Blocking cycles: Max 5,000
(from verification of handling methods)
Result: 1.06 mm is the limit value with 2.6Nm.
Required initial overlap margin becomes 1.2 mm considering the cam tip wear and cylinder offset.

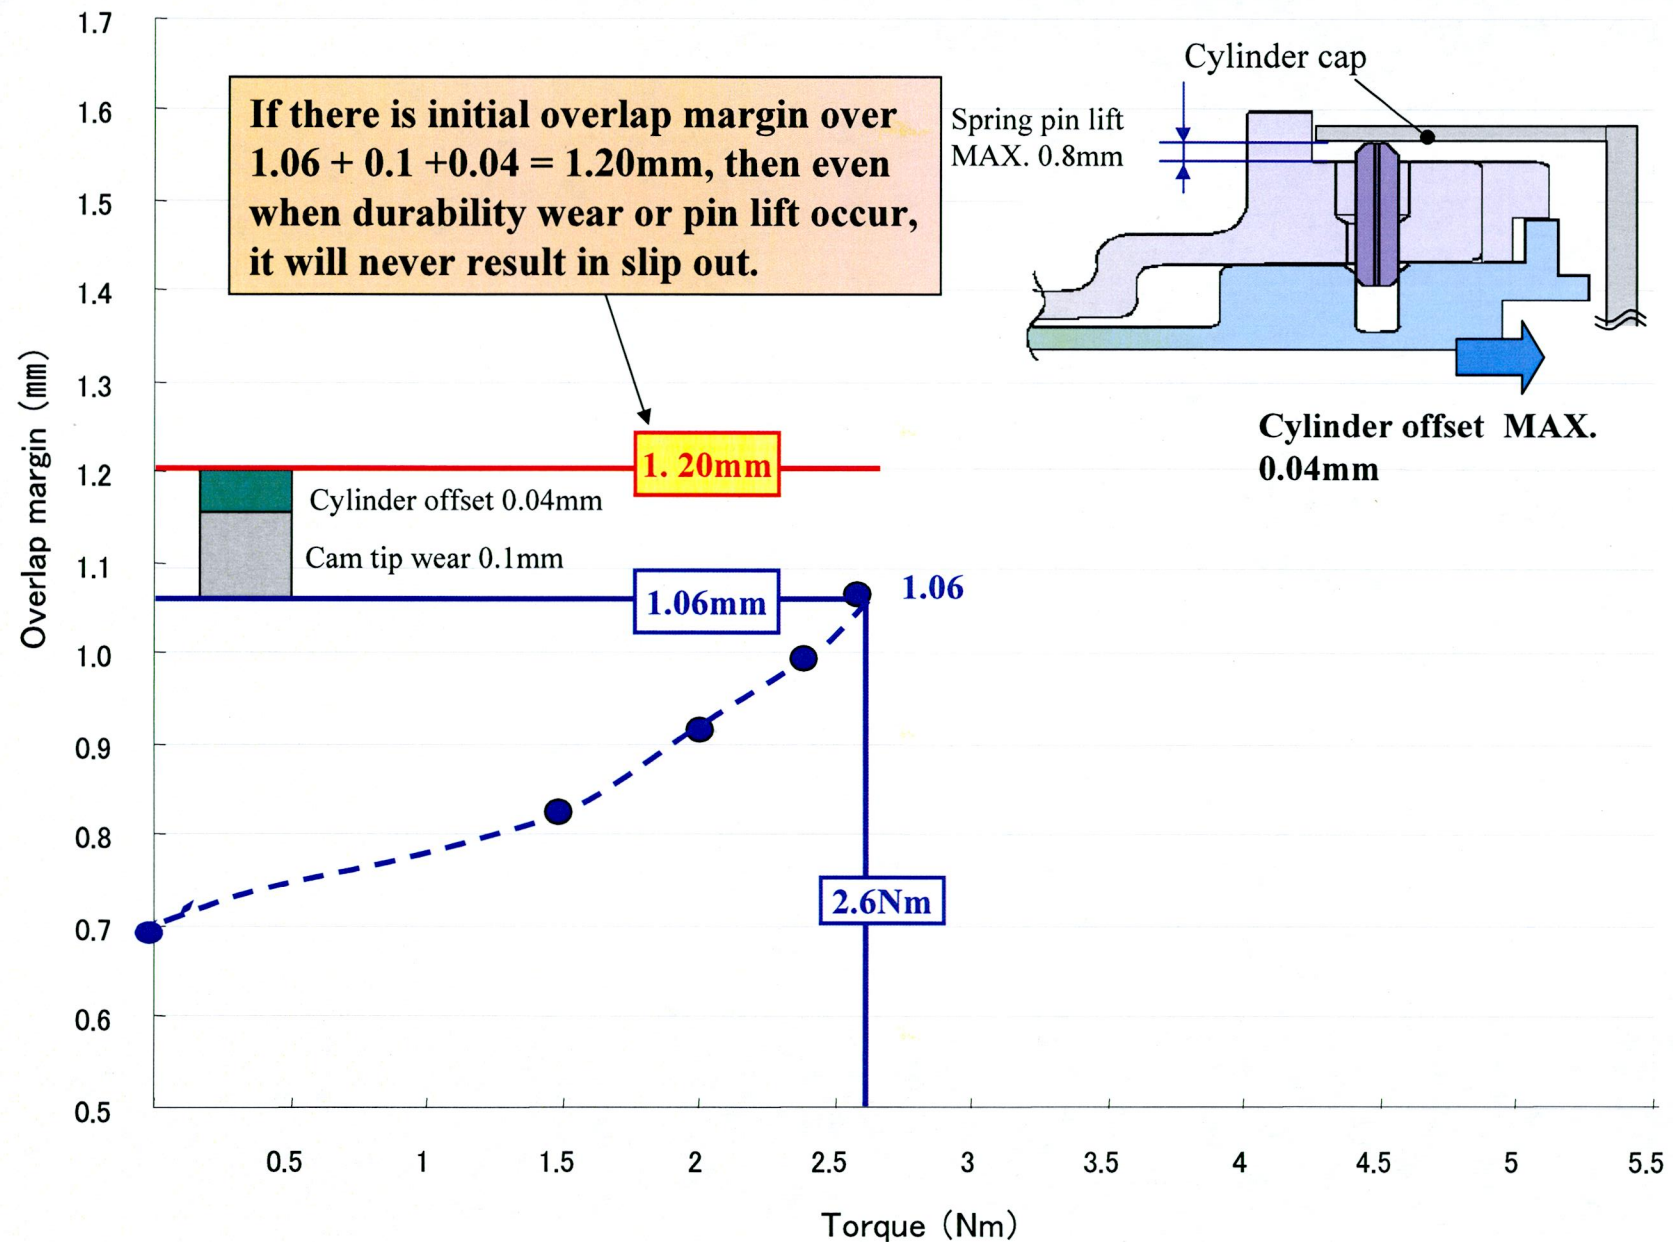
Required overlap margin considering spring pin lift (US market)

(Initially required margin becomes 1.20 mm when considered aging deterioration and spring pin lift.)

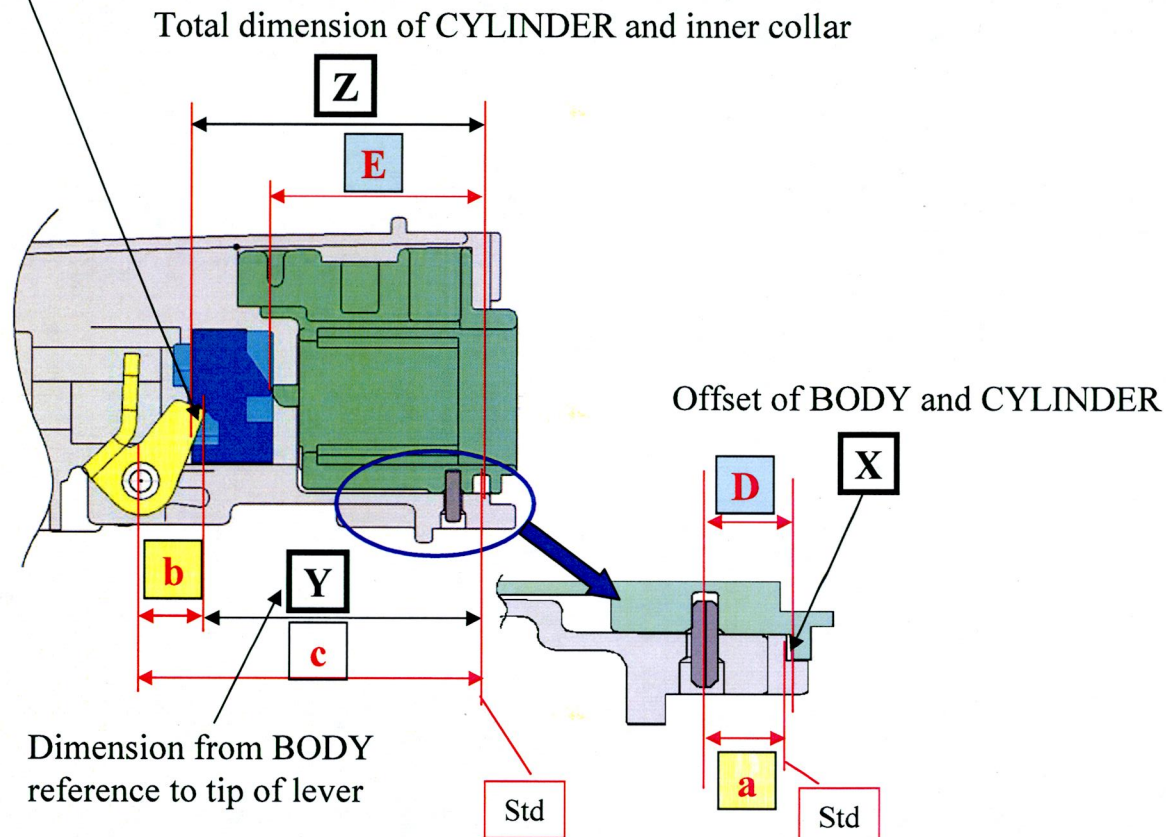
Verification of lever overlap margin

Molding accuracy of BODY and CYLINDER + inner collar result in variation of lever overlap margin.

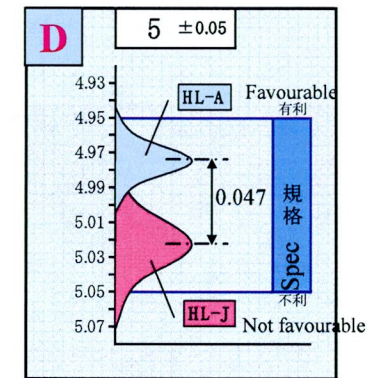
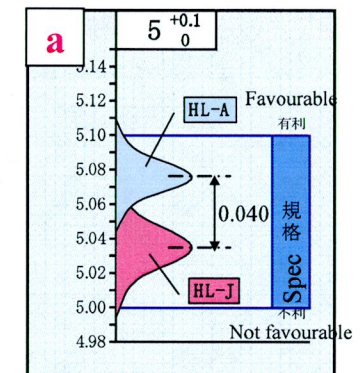
Overlap margin
initially required

HL-J made BODY/CYLINDER have some bias toward less overlap margin by dimension, so I and II falls below initially required overlap margin.

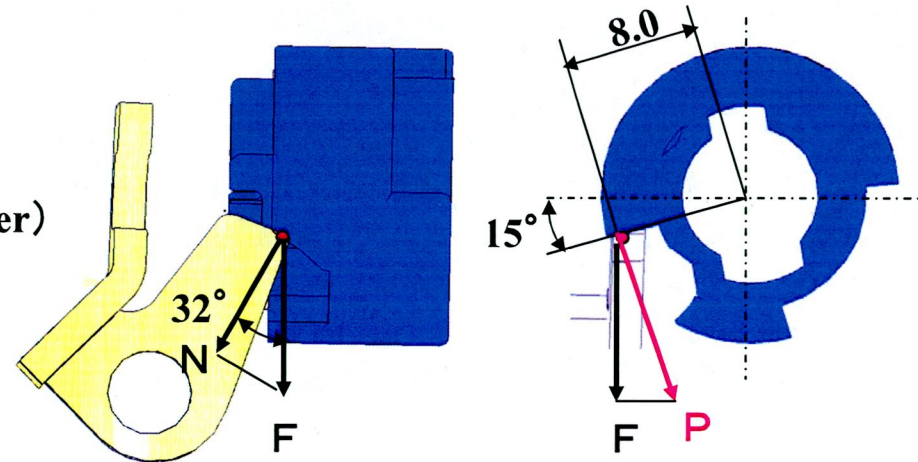
$$F = P \times \cos 15^\circ = 314\text{N}$$

$$N = F \times \cos 32^\circ = 266\text{N} \quad (\text{load applied to lever})$$

Allowable compression stress of lever material aluminium (A5052P-H38) = 340N/mm^2 ,

So when contact surface (S) between lever and inner collar reach below

Buckling deformation occur on the aluminium

Deformation will not progress with contact surface more than 0.78mm^2

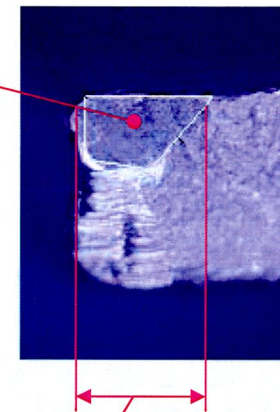
With less lever overlap margin, contact area will also be small, so more buckling deformation = slackening of the lever occur.

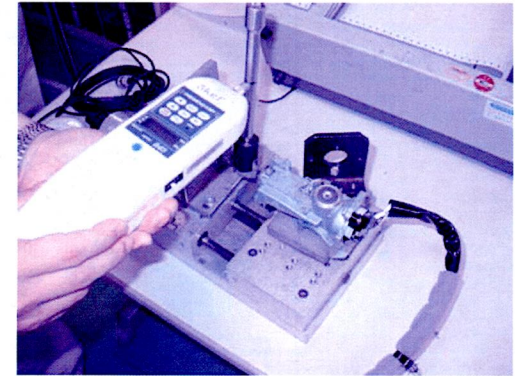
Load of 450N is generated, and is over allowable stress for the cylinder material so cylinder buckles \Rightarrow spring pin tilts \Rightarrow cylinder offsets

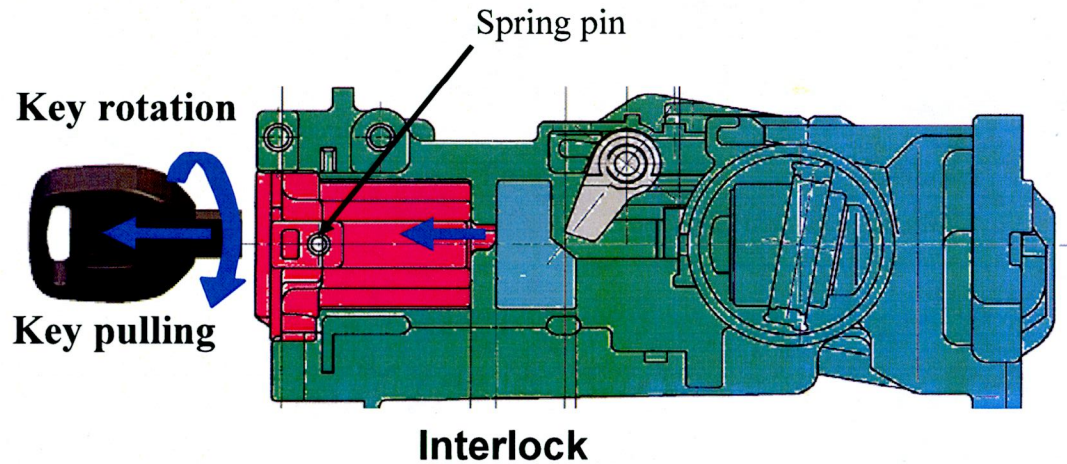
Occurrence mechanism (spring pin lift)

Load is input to spring pin with normal key operation.

Load input to radial direction of the spring pin cause spring pin to repeatedly be stretched/compressed, lifting gradually.

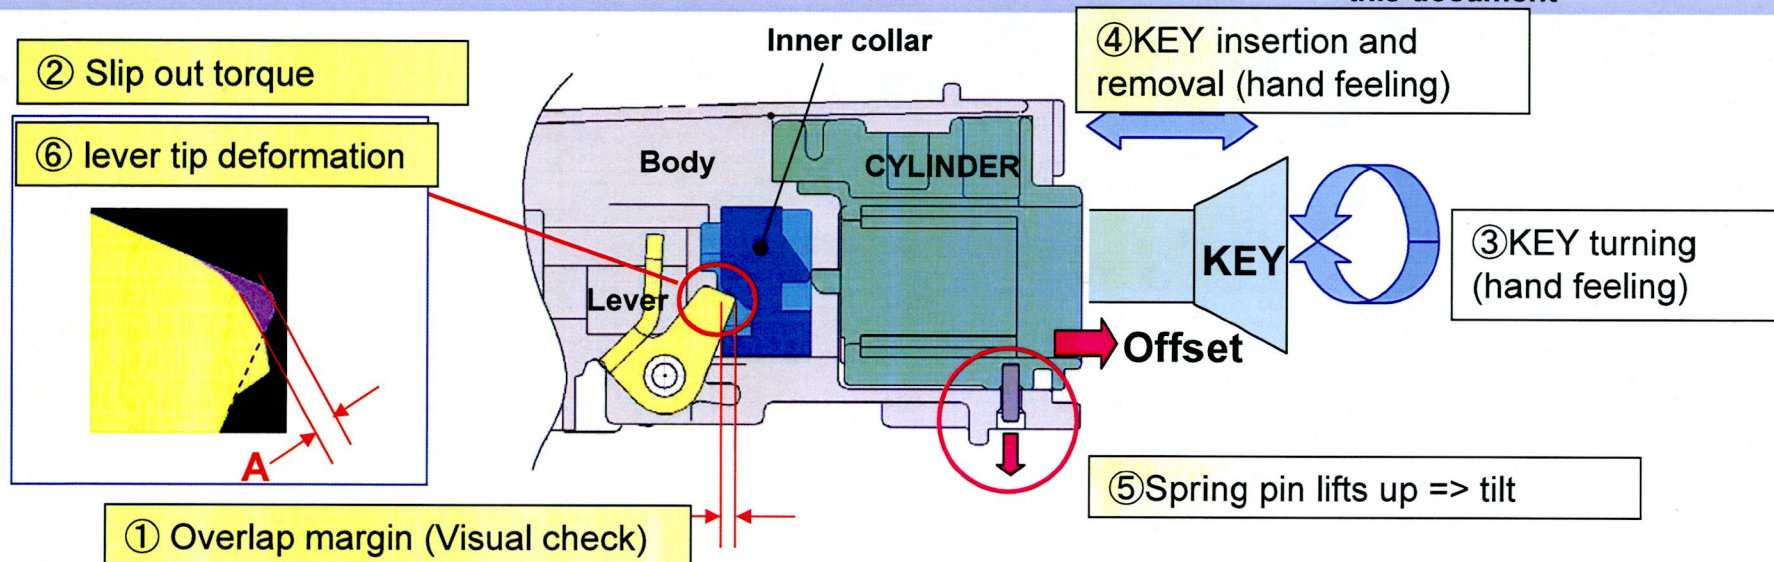
Items confirmed	Failure part
	No1
① Overlap margin (mm)	0.7
② Slip out torque (Nm)	0.25
③ KEY rotation (hand feeling)	OK
④ KEY insertion and removal (hand feeling)	OK
⑤ SPG pin lifts up (mm)	Lifted up: 0.85
⑥ Lever tip shape (mm)	0.25 (strong rotation + wear)

① Lever overlap is 1mm or below.

* No abnormalities found on other areas.

◆ Overlap margin decreases due to worn lever and slipping out was recreated. (SPG pin lifted up too.)

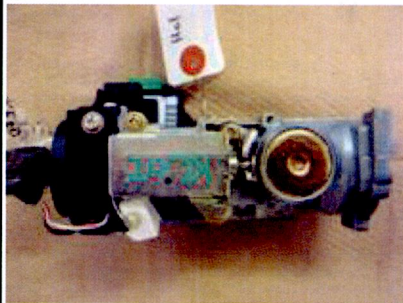
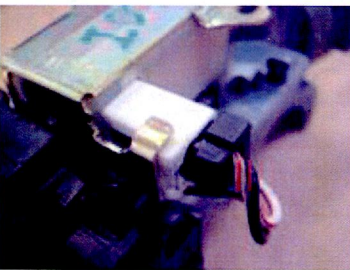
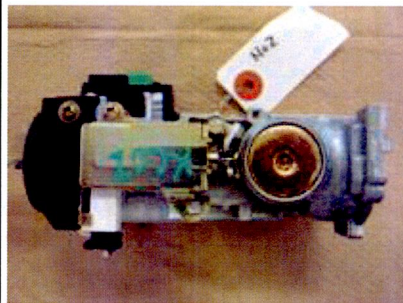
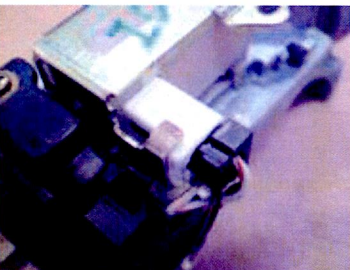
Overall	Coupler	Solenoid	BODY-LOT	Prod. stamp
Part No1

No abnormalities were observed on the exterior of the assembled condition.

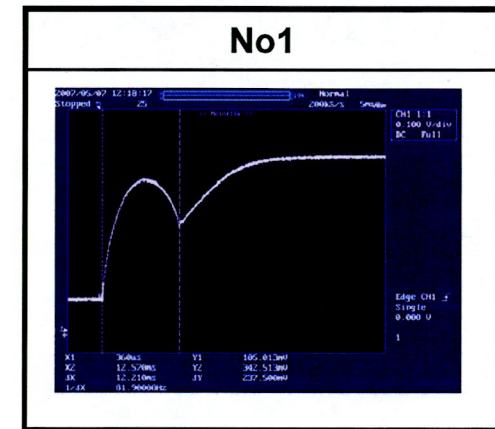
<Ref: response waveform>

Part
Item	Spec	No1
Operating voltage (V)	7V or below	4.55
Recovery voltage (V)	0.3V or over	0.67
Lever response (msec)	15msec or below	12.21
Judgment		OK

* No abnormalities observed in the electrical interlock lever operation

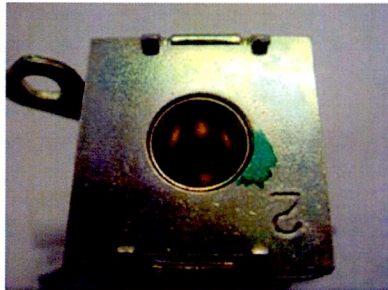
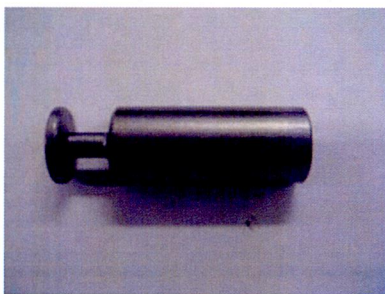
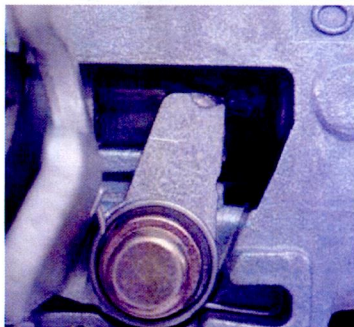
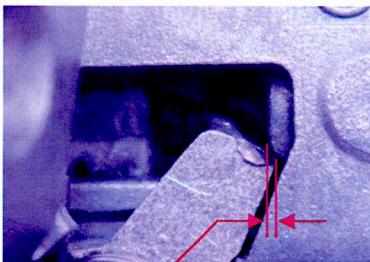
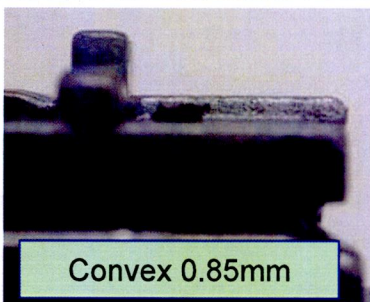
Part No1	Solenoid	Plunger	Lever installatin	Lever overlap margin

Ref: 0.7mm (Visual check)
	SPG pin	Interlock lever seating surface	CYL stamp	CYL cam

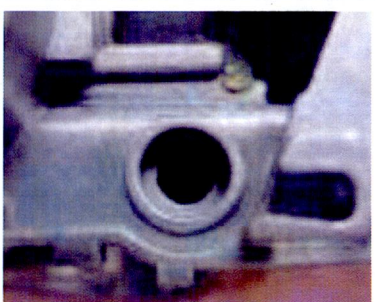
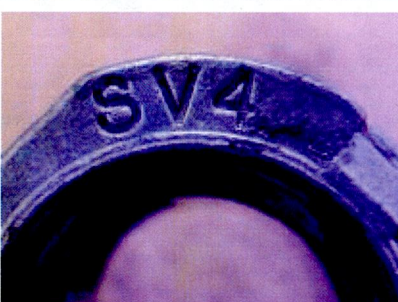
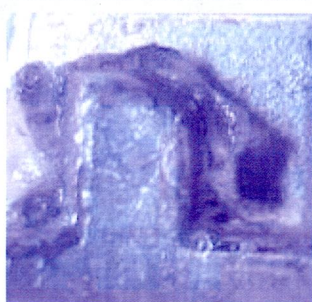
Convex 0.85mm

Inner cam	Lever tip	<div> <ul style="list-style-type: none"> - Lever tip is worn - With SPG pin lift up </div>

Wear confirmed

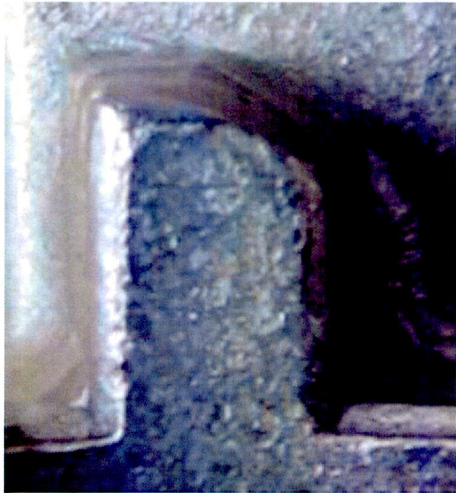
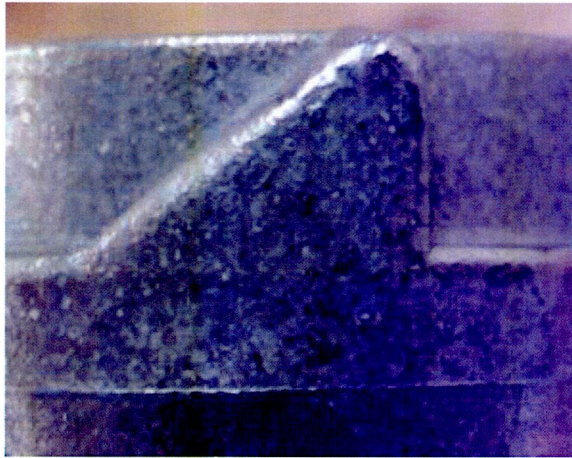
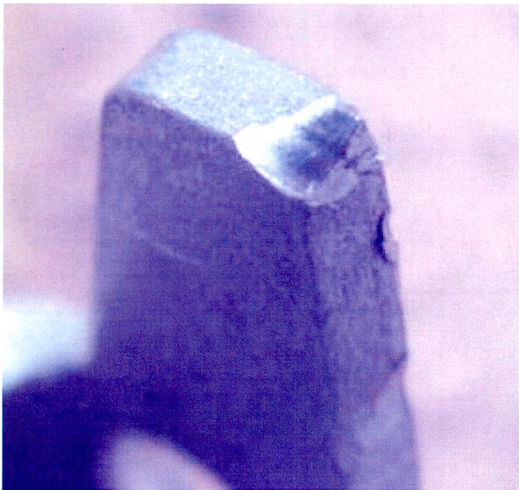
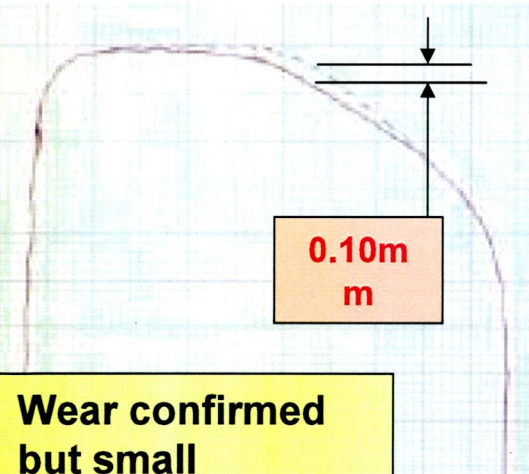
CYL cam	Inner cam	Lever tip

<p>0.10m m</p> <p>Wear confirmed but small</p>

<p>0.13m m</p> <p>Wear confirmed</p>

<p>0.25m m</p> <p>Large wear</p> <p>* It has trace of strong turning of key</p>

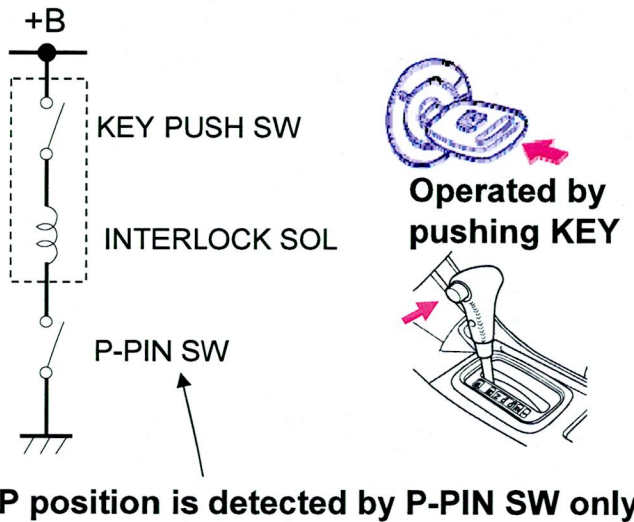
<p>Inner collar</p> <p>Interlock lever (Alluminium)</p>

<p>+B</p> <p>KEY PUSH SW</p> <p>INTERLOCK SOL</p> <p>P-PIN SW</p> <p>Operated by pushing KEY</p> <p>P position is detected by P-PIN SW only</p>
03Accord

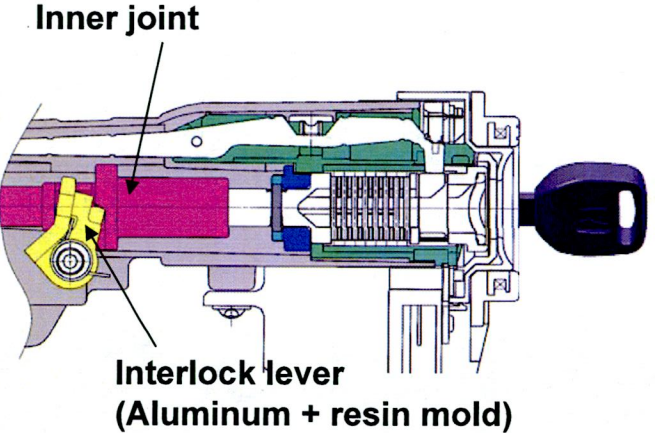
<p>Inner joint</p> <p>Interlock lever (Aluminum + resin mold)</p>

<p>ACC</p> <p>Constant conduction of SOL by ACC</p> <p>MICU</p> <p>AT-P SW</p> <p>P-PIN SW</p> <p>INTERLOCK SOL</p> <p>P position is detected by AT-P SW & P-PIN SW (Redundancy)</p>
