**National Highway
Traffic Safety
Administration**

ODI RESUME

Investigation: EA 09-010
Prompted by: RQ08-058
Date Opened: 06/18/2009
Investigator: Tom Bowman
Approver: Richard Boyd
Subject: Air Brake System

Manufacturer: NEW FLYER INDUSTRIES LTD
Products: MY 2004 -2008 NEW FLYER TRANSIT VEHICLES
Population: 1,000
Problem Description: DIMINISHED VEHICLE BRAKING / STOPPING PERFORMANCE

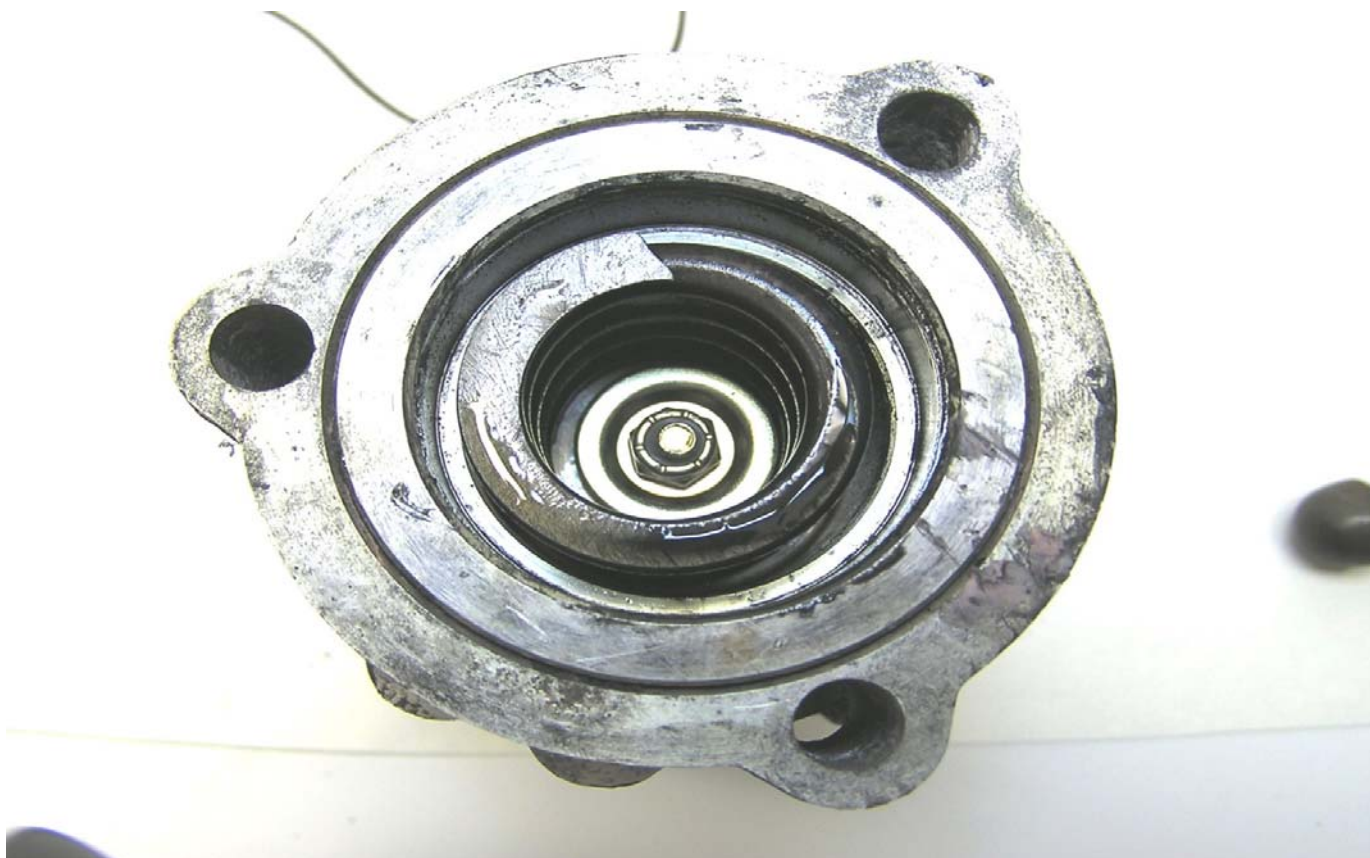
Steel Spring Adapter Assembly – Retainer Ring & Plunger Cap Removed

It was discovered that the O-ring seal between the primary body and steel spring adapter had been cut, resulting in a leakage path from the primary supply cavity to atmosphere. The valve showed a moderate amount of liquid oil contamination on both the primary and secondary pistons and in both delivery cavities. Both inlet/exhaust seals appeared to show some wear at the seat contact points. The following pictures illustrate the condition of the internal seals and cavities:

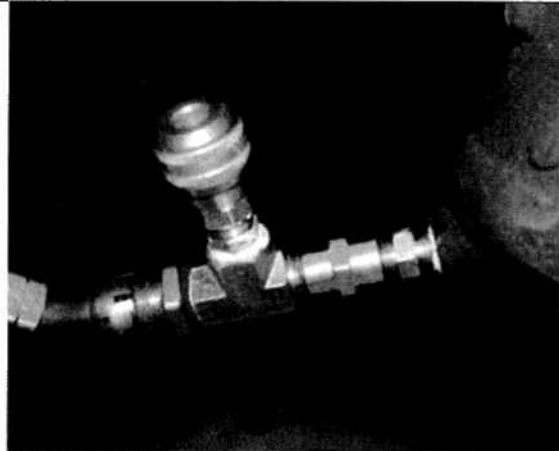
Rear “tee” installed between the control valve and the rear air chamber
