**National Highway  
Traffic Safety  
Administration**

## ODI RESUME

**Investigation:** EA 09-013  
**Prompted by:** PE09-020  
**Date Opened:** 08/18/2009  
**Investigator:** Derek Rinehardt  
**Approver:** Frank Borris  
**Subject:** Vehicle Rollaway Allegations

## EA09-013 Closing Report

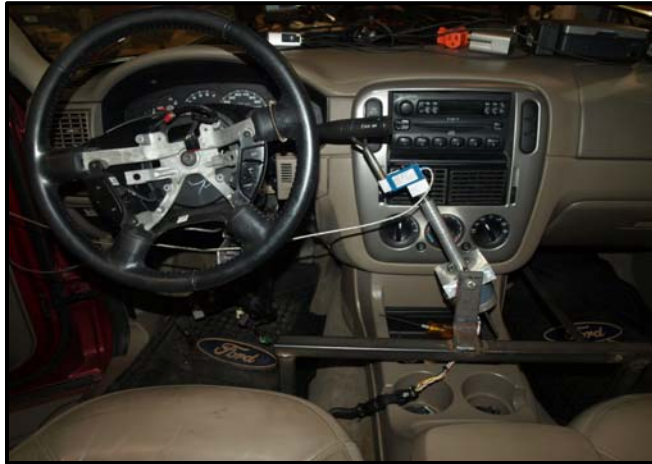
After installing this steering column into the test vehicle, an attempt was made to determine the force/movement characteristic. When the mechanical device (see Figure 15 below and the complete test report) could not push through the divot on the swing arm, a hand-held mechanical force gage was used and force was manually applied in an attempt to push the divot area on the swing arm past the BSI. Several loadings of 50 lb. failed to push through the divot, consistent with

the consumer's experience of having difficulty getting the vehicle in Park. The vehicle owner did not allege a rollaway incident.

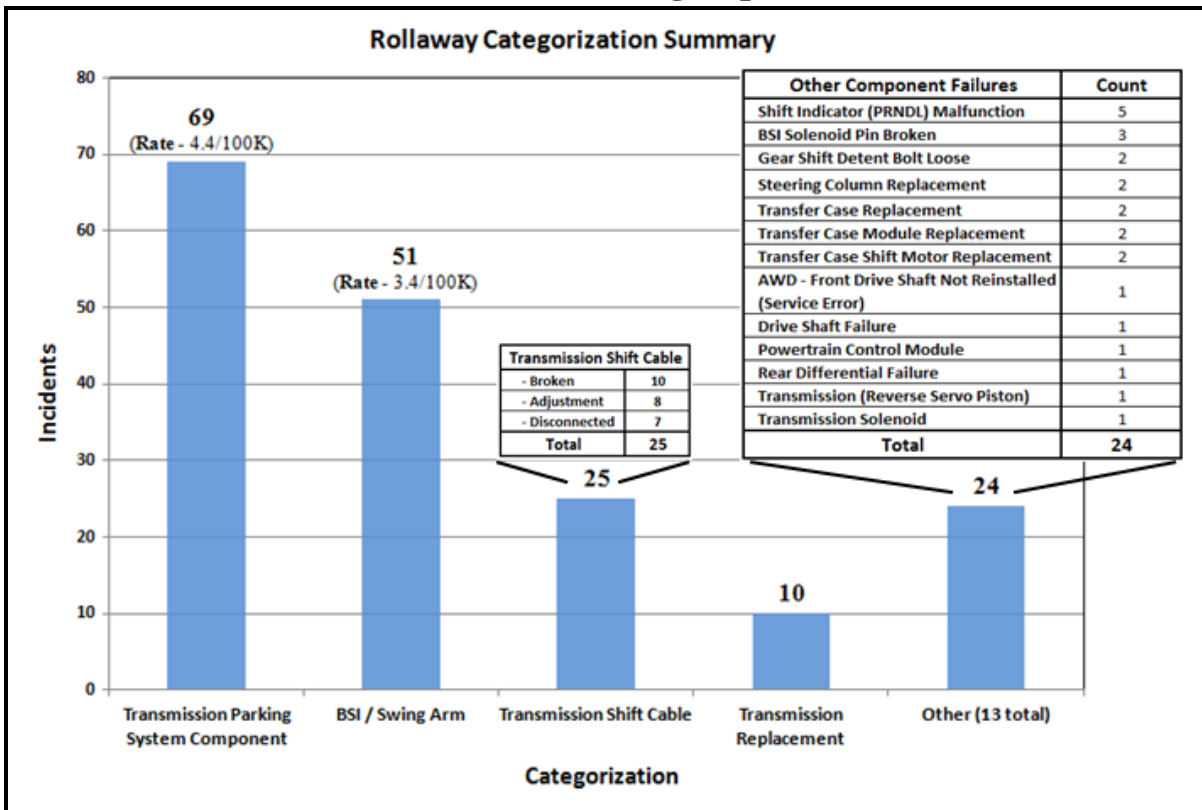
**Figure 16**

In order to identify the failure mechanism(s) that were relevant to the present investigation, ODI categorized these 180 incidents into the failure mechanism that, based on ODI's review of the available evidence, was the most likely cause of the incident. As shown in the summary in Figure 16, the BSI System and the Automatic Transmission Parking System accounted for the vast majority of the rollaway incidents. In addition, there were multiple transmission shift cable conditions, including shift cable breakage, shift cable adjustment and shift cable disconnection from the transmission or the steering column. Individually, each of these conditions related to the transmission shift cable had a failure rate of less than 1.7 / 100K. Therefore, the investigation focused on incidents associated with either the Automatic Transmission Parking System or the BSI System.

\* The BSI /Swing Arm data is applicable only to the Explorer / Mountaineer vehicles that have a steering column mounted gear selector.

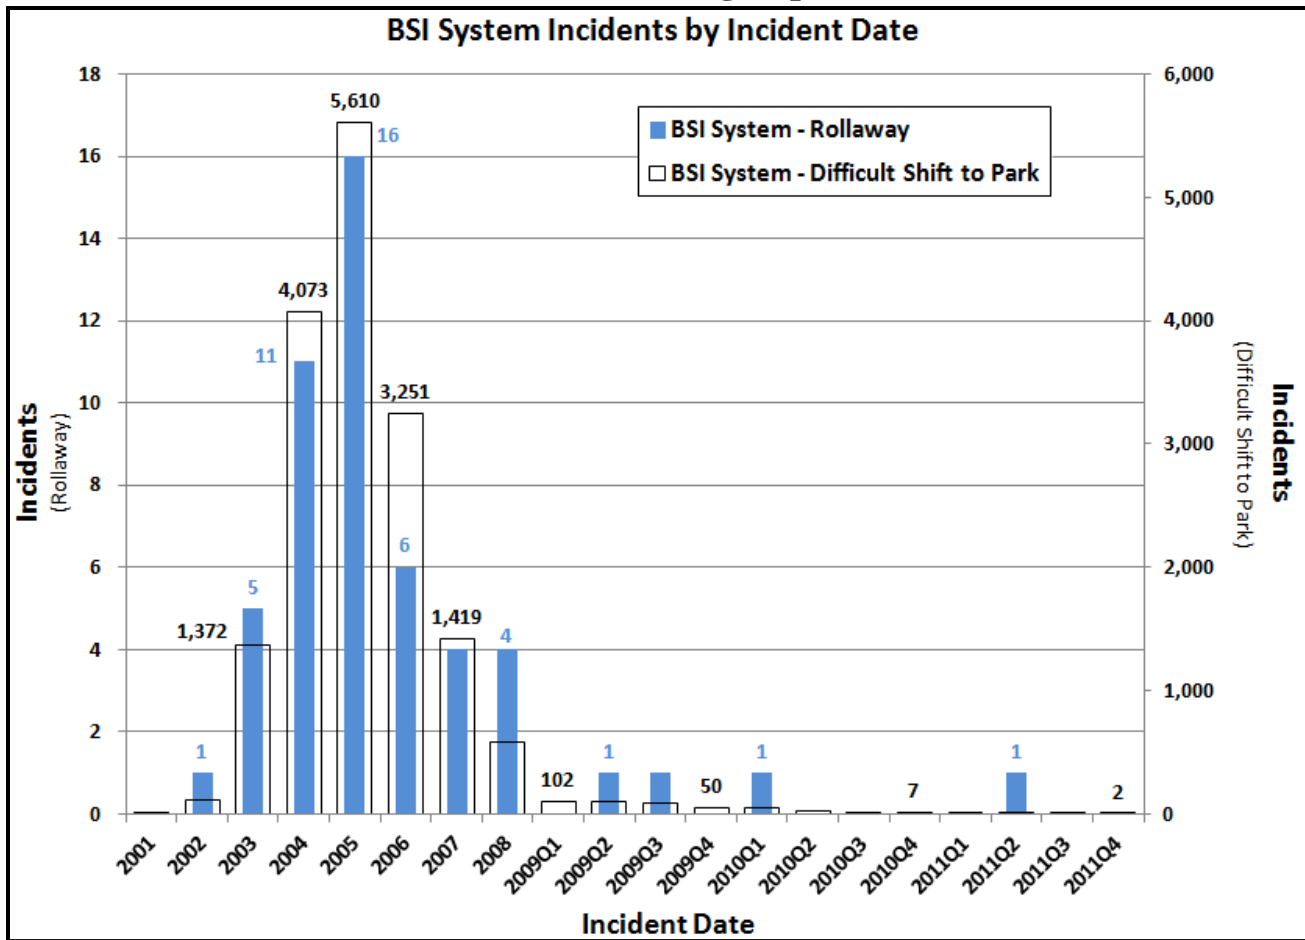
**Figure 17**

The data analysis in this section of the report is related only to the Explorer and Mountaineer, which have a steering column-mounted gear shift lever. ODI identified 51 rollaway incidents in a population of over 1.49M vehicles that are likely related to the failure of the BSI system. This equates to a very low rate of 3.4 / 100K of the subject vehicle population. ODI also identified 16,872 (~1.1% of the vehicle population) incidents in which drivers reported difficulty shifting to Park however none of these reports alleged vehicle rollaway. As shown in Figure 17 below, the incident rate drastically decreased after calendar year 2008 for both conditions.

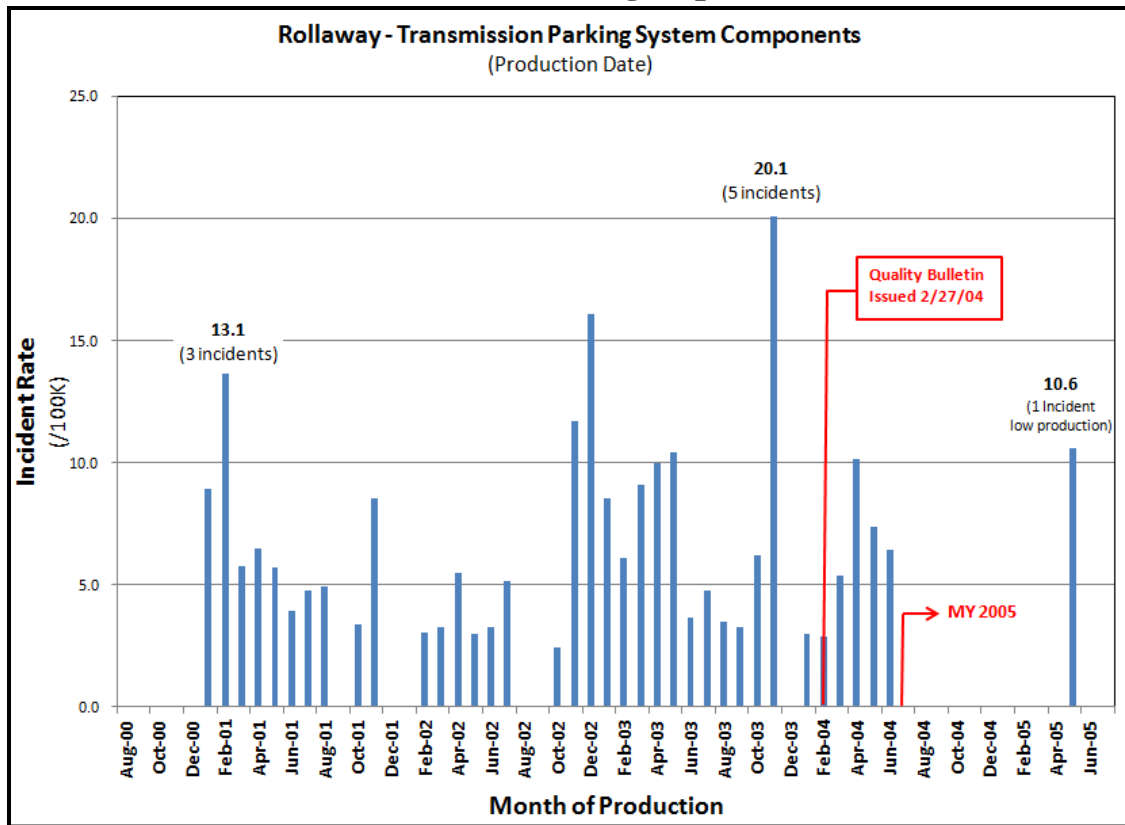
**Figure 18**

ODI identified 69 incidents in the population of over 1.56M vehicles that are likely related to failure of one or more of the Automatic Transmission Parking System components. Overall this equates to a very low failure rate of 4.4/100K. After issuance of the Quality Bulletin during the latter part of MY 2004, MY 2005 showed a drastic reduction in incidents (see Figure 18 below).

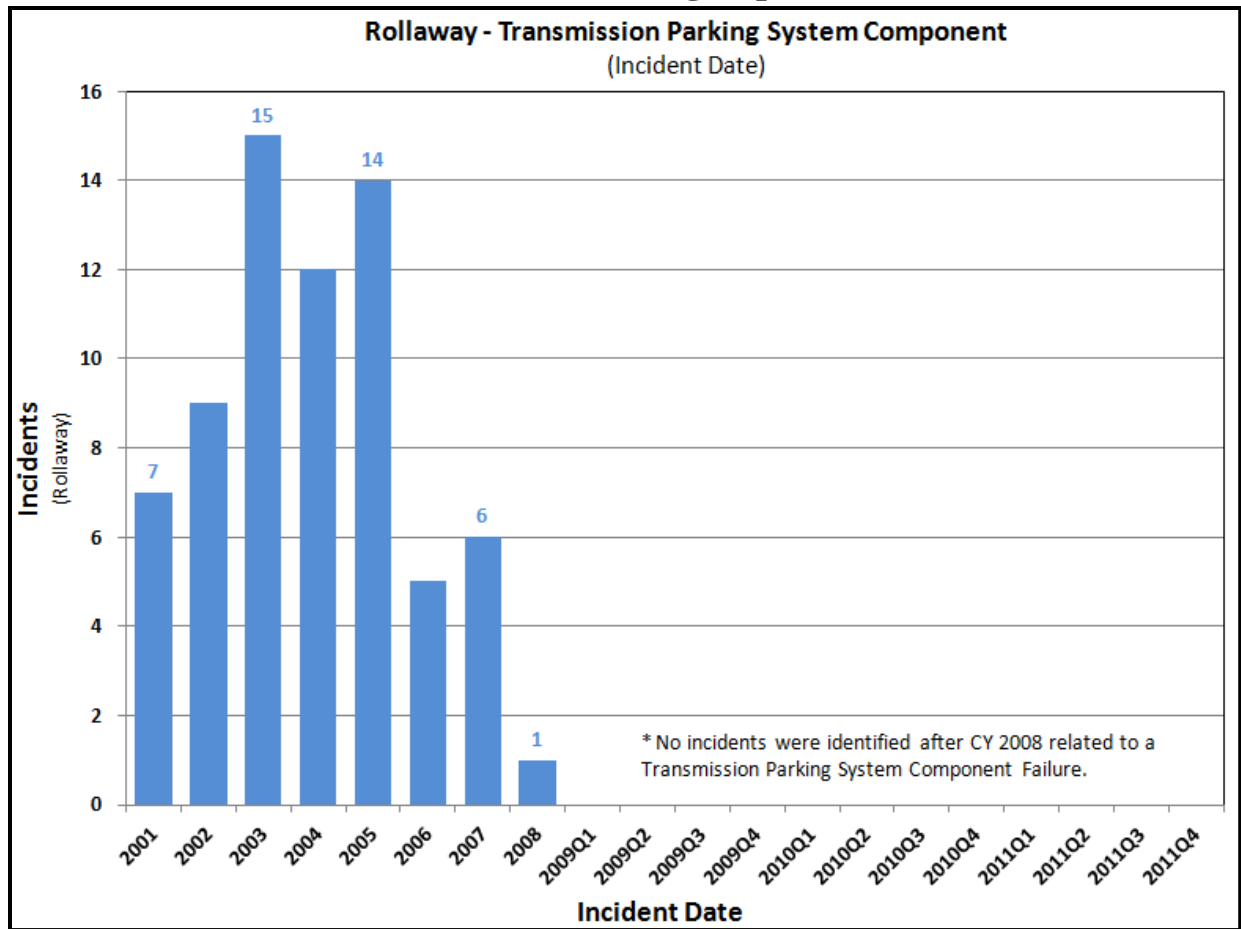
**Figure 19**

Regarding incident occurrence, there have been no reported incidents since calendar year 2008 (see Figure 19 below) related to a Transmission Parking System component failure.

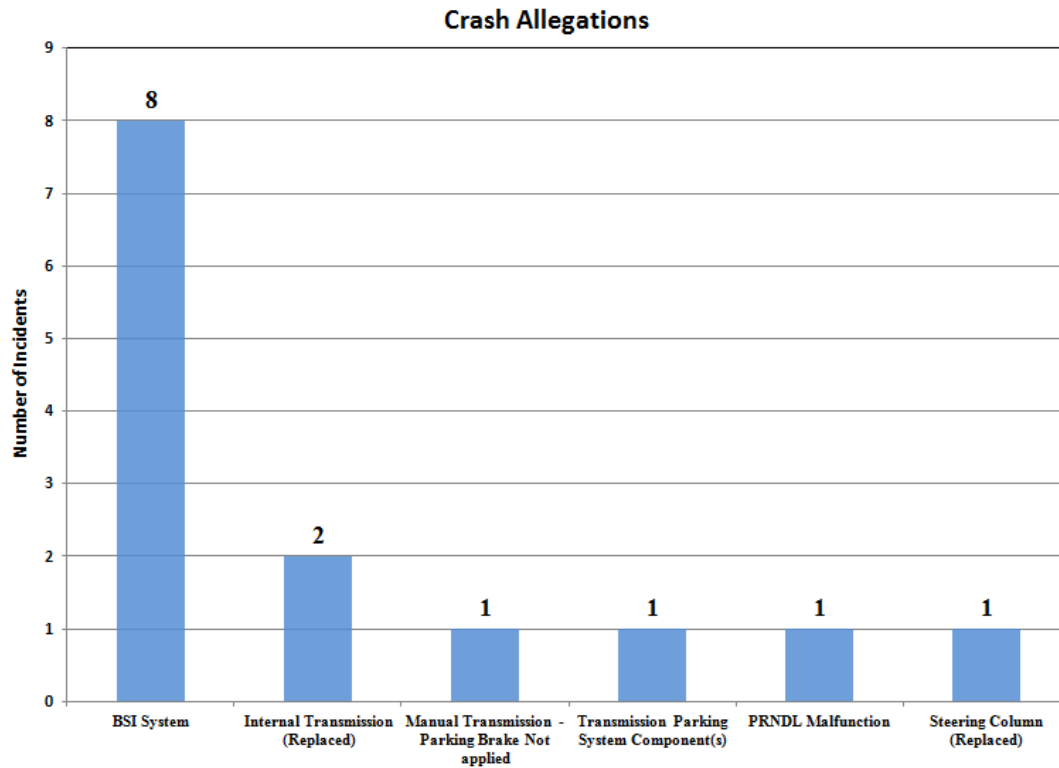
**Figure 20**

Of the 180 rollaway incidents, 14 involved a crash. Eight of these incidents were likely related to a BSI System failure, and one was related to a failure of the Automatic Transmission Parking System (See Figure 20 below.)

Four of the 8 BSI-related incidents involved an allegation of injury. The nature of the injuries ranged from cuts and bruises to a fractured rib.
