From: Hershman, Larry (NHTSA)
Sent: Wednesday, January 20, 2010 10:09 AM
To: Howell, Rosa (NHTSA)
Cc: Yon, Scott (NHTSA)
Subject: FW: Grand Cherokee Vulnerable Fuel Hose & Lines
Attachments: MVFRI Fuel Filler Tube Leakage Test Report.pdf; 2004 Jeep Grand Cherokee Fuel Hose Under Frame Rail.JPG; ZJ_FFH-1.JPG; ZJ_FFH-4.JPG; ZJ_FFH-2.JPG; ZJ_FFH-3.JPG; ZJ_Mesh_Close-up.JPG; ZJ_FFH_Part_Label-1.JPG

From: Clarence Ditlow [mailto:cmdiii@autosafety.org]
Sent: Tuesday, January 19, 2010 11:22 PM
To: Demeter, Kathleen (NHTSA)
Cc: Yon, Scott (NHTSA); KDIGGES@aol.com
Subject: Grand Cherokee Vulnerable Fuel Hose & Lines

MVFRI Fuel Filler Tube
Leakage Test Report

JEEP GRAND CHEROKEE
VULNERABLE FUEL HOSE
& LINE

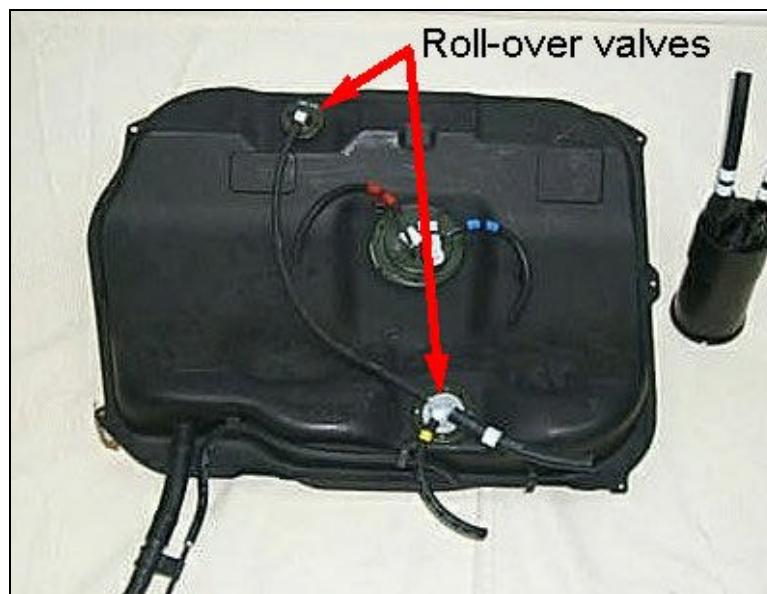
Figure 9: Rollover valves mounted directly to the Kia Spectra tank.

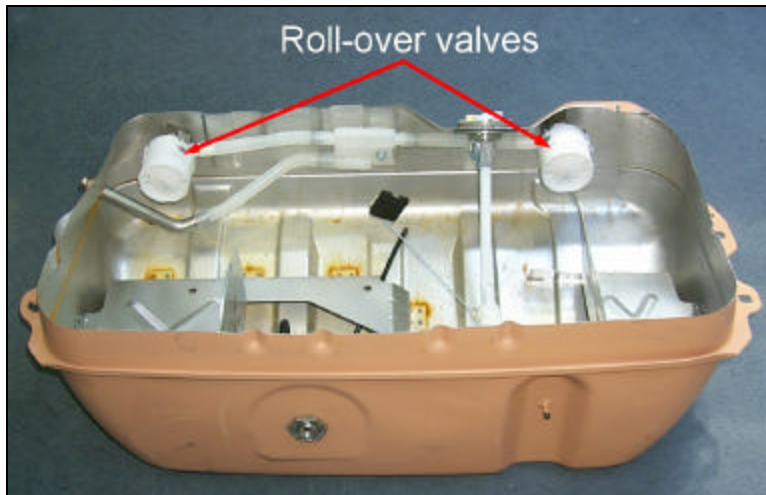
Figure 10: Rollover valves contained inside the Mercedes S430 tank.

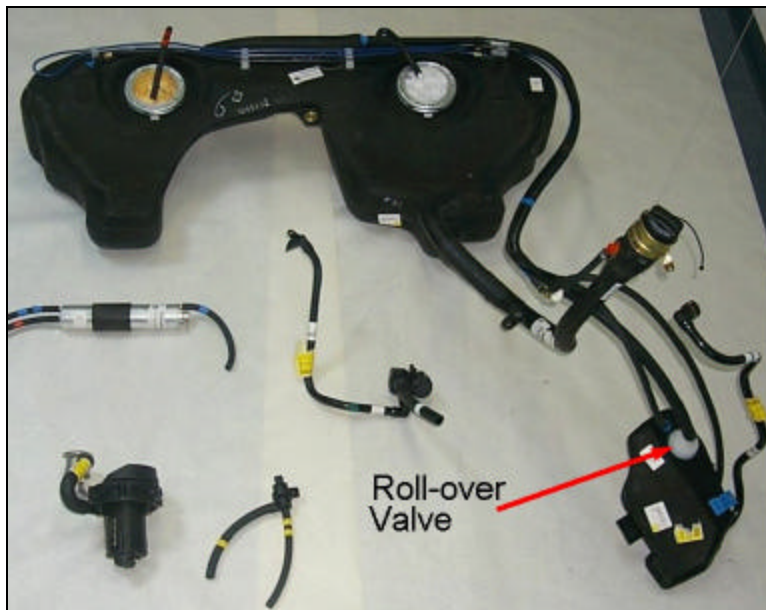
Figure 11: Rollover valve mounted on a secondary reservoir in the BMW 325 tank system.

Audi A8 and the BMW 325 tanks, excessive leakage was recorded at various inversion angles. Although the rollover valves for these vehicles appeared to function they were located on a secondary reservoir tank at a remote location to the main tank and it was the vent hoses leading to the secondary reservoir that leaked when severed. These vent hoses connected directly to the main tank without the benefit of a rollover valve.

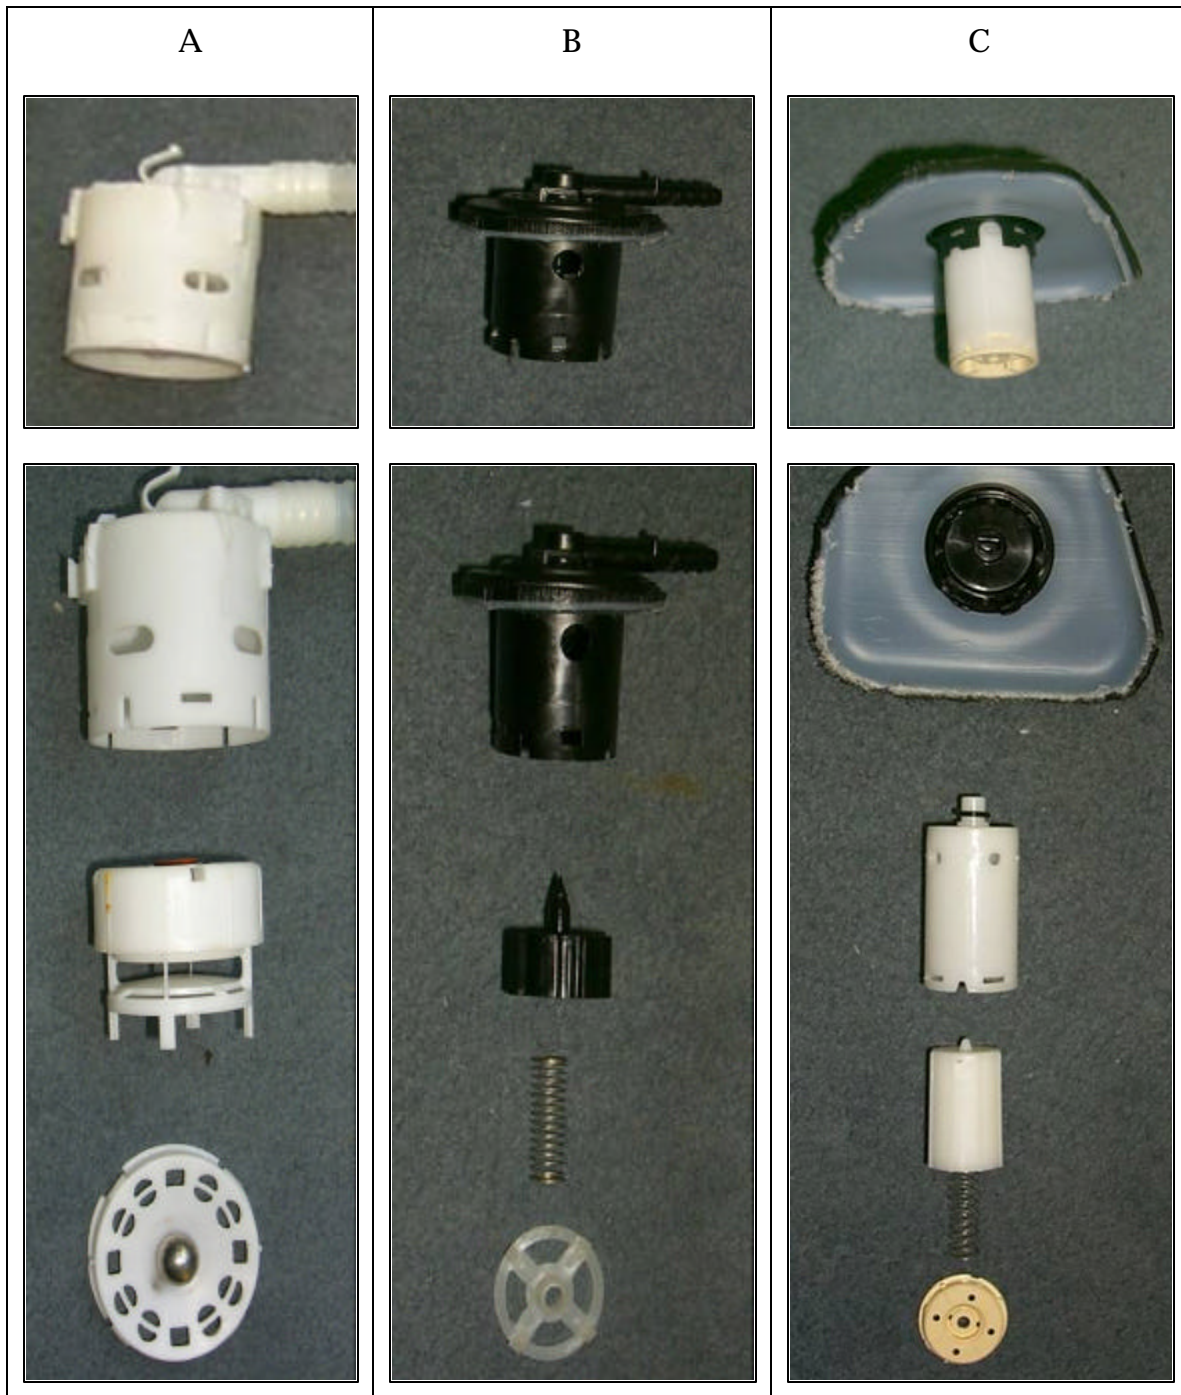
Figure 12: Examples of rollover valves from: a) Mercedes S430, b) Dodge Neon and c) Honda Odyssey.

The various rollover valve designs encountered all appeared to be effective at preventing fuel leakage when the tank was inverted. Nevertheless, for both the

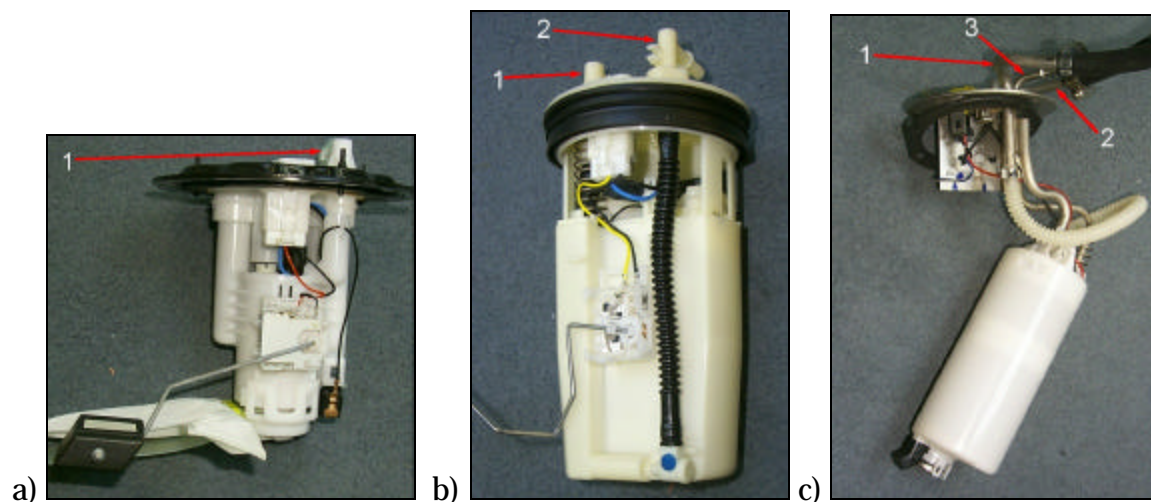
Of the 11 sending unit designs that leaked, 7 of them incorporated a fuel return line, each of which also leaked. Furthermore, the two sending units that included a sender vent return line leaked from that connection.

Figure 13: Sending units with 1, 2 or 3 fuel line connections from: a) Mazda MPV, b) Honda Odyssey and c) Chevrolet Corvette.

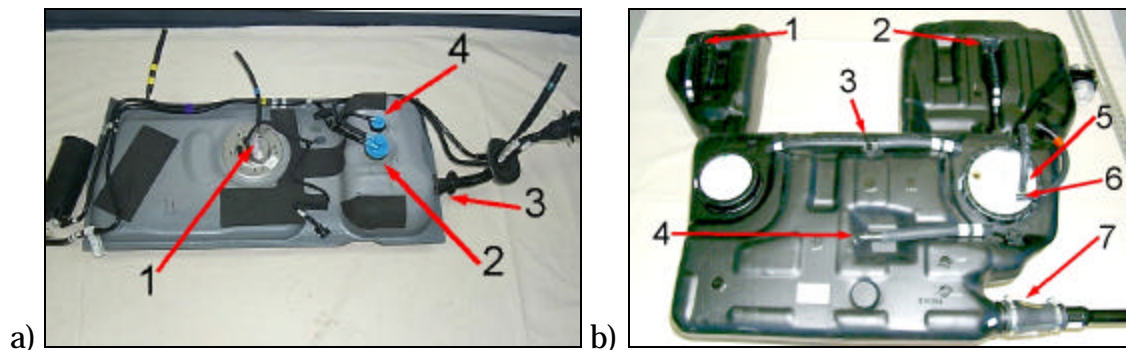
Figure 14: Tanks systems with, a) 4 hose connections; and with, b) 7 hose connections.

Ultimately, what is important for tank design considerations is that each line emanating from the main tank must have a spill prevention device such as a rollover valve or a check valve installed. The tanks that passed the leak test in all orientations complied with this principle. As an example of non-compliance with this principle, ten of the tanks inspected did not employ a rollover valve on the filler vent. Consequently, in these instances a severed line essentially equates to a hole directly into the tank which will leak if below the fluid level, as was observed in the testing.

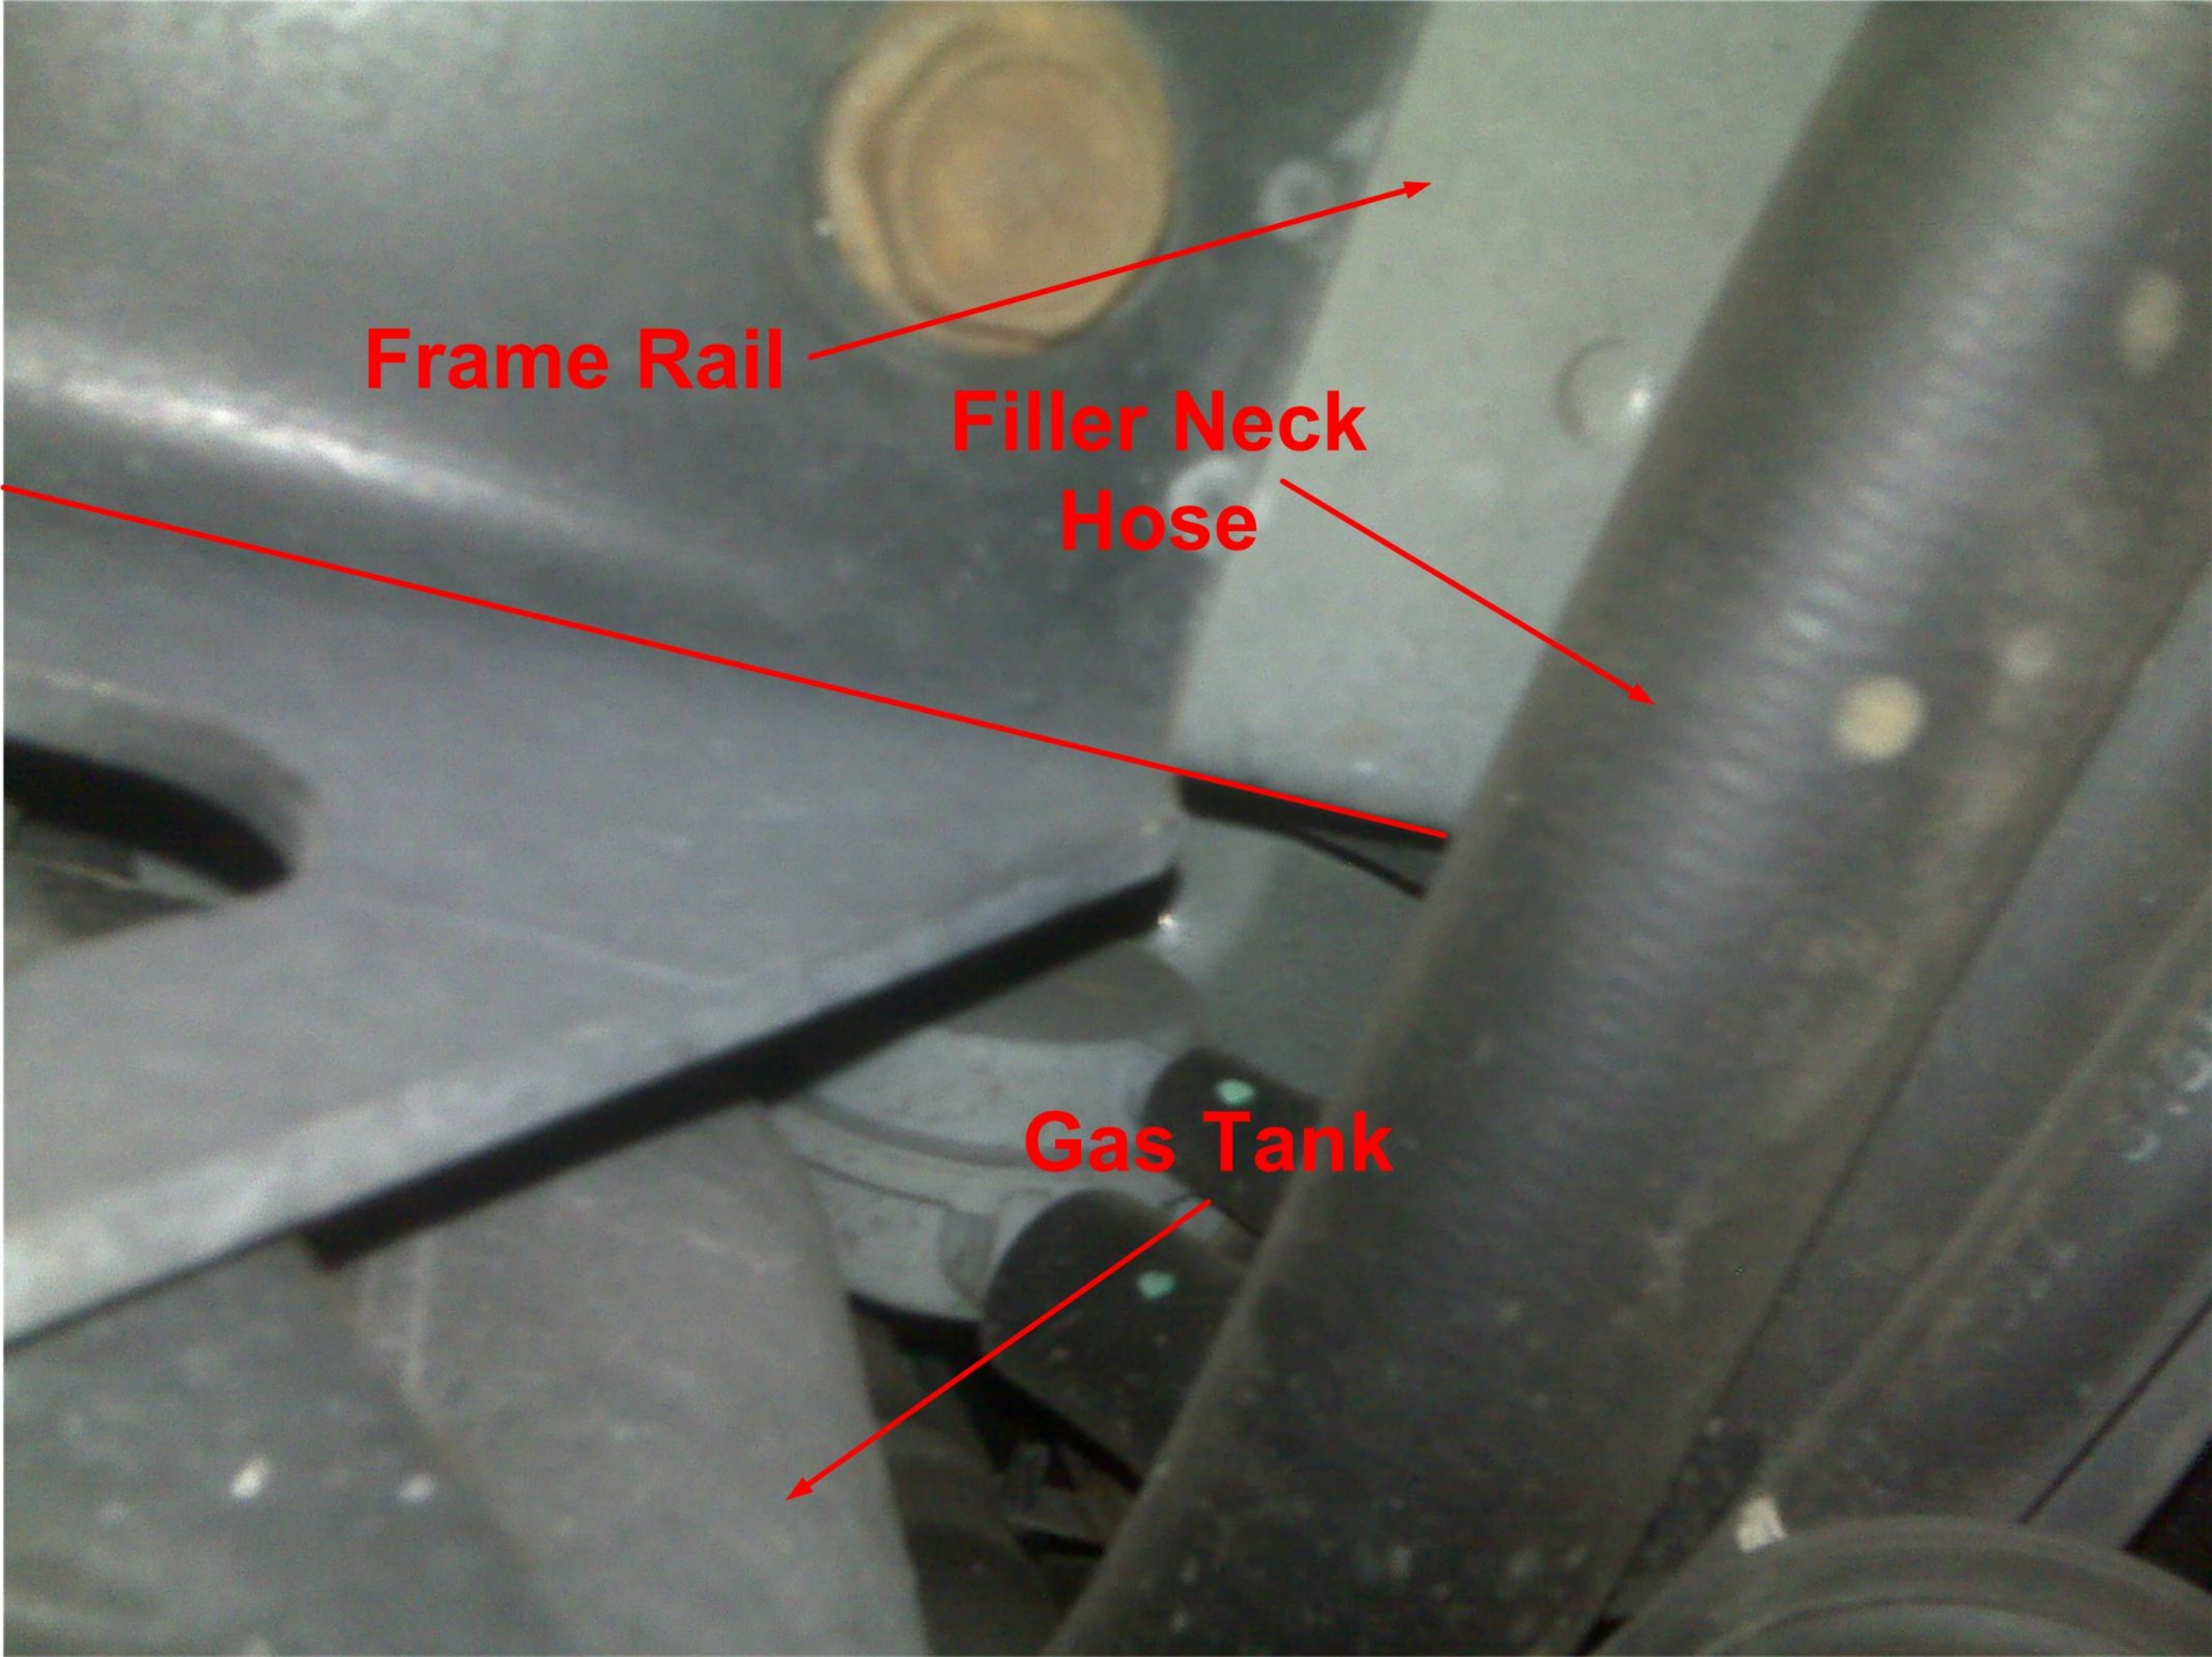
**Filler Neck
Hose**

Gas Tank
