FAILURE REPORT SUMMARY

A defect petition was received by the Office of Defects Investigation (ODI) requesting "an additional investigation into the unwanted and unintended acceleration of model year [MY] 2007 Lexus ES350 as the initial investigation (PE07-016) was too narrow in scope and did not adequately address all complaints made to the NHTSA with respect to vehicle speed control concerns."

DP09-001

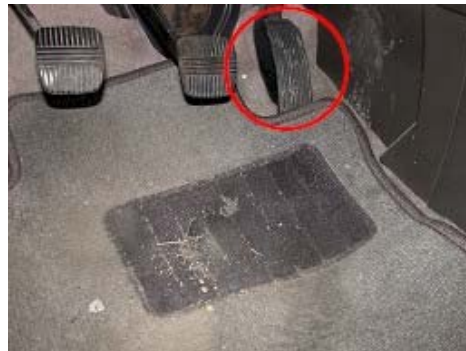
During Transport Canada's investigations of alleged sudden vehicle accelerations and stuck throttles, we frequently discover that the problem relates to some interference between the vehicle floor mats and the pedals. Typically, the interference occurs when non-original equipment floor mats are used without properly being retained to the vehicle floor. The floor mat can then move under the driver's feet and become lodged either between the pedals, on top of the pedals or under the pedals. Another common problem occurs when consumers install multiple floor mats on top of each other, reducing the clearance between the vehicle floor and the pedals.

After installing floor mats, make certain they cannot move and that they do not interfere with the gas or brake pedals. Use only one set of mats.

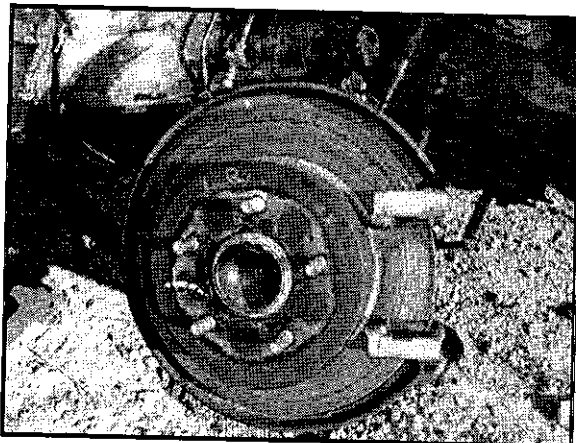
Image 14: Disc 3\DCIM\100CANON\IMG_0050.JPG

It should be noted that the brake caliper and brake pads are not present in images 14 and 15. As previously mentioned, MCS-I Hearst assisted NHTSA investigators by removing these components from Vehicle #1 on Thursday, September 3, 2009.

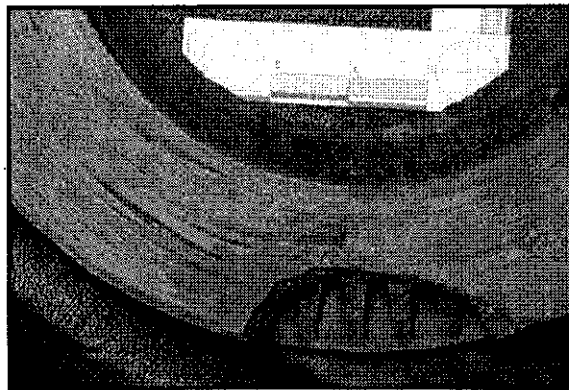
Image 21: Disc 5\DCIM\274CANON\IMG_0090.JPG

There was an area of crescent-shaped dents within the swept area of the inner disc (Image 20 boxed). A section of the inner disc was fractured and missing along the outer circumference. This missing section was crescent-shaped, 3 1/2-inches in length, and 1-inch wide, exposing the cooling fins. The fractured surface was silver in luster with a rough crystalline appearance (Image 21).

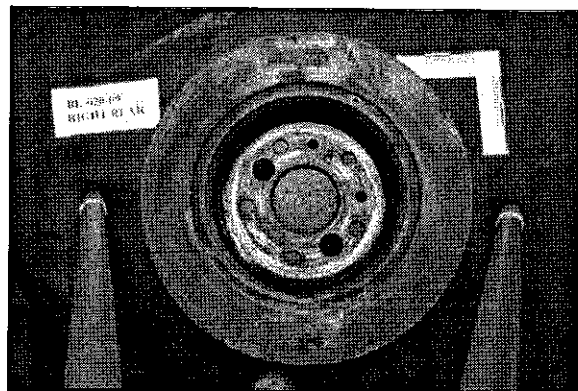
Image 30: Disc 5\DCIM\274CANON\IMG_0375.JPG

The right-rear rotor was circumferentially scored and the swept areas were discolored to various shades of white, gray, blue, and black (Images 29 and 30). This rotor also had sections that were discolored lighter than the surrounding areas of the disc and were similar to the dimensions of a brake pad (Image 31). The inboard side had a large amount of friction material bonded to the surface of the disc (Image 32). This rotor also had discernible ridges about the inner and outer circumference of the brake rotor disc adjacent to the swept areas. This rotor was soiled with dirt, and the circumferential coating of friction material on the outboard side of the disc was narrower and more intermittent compared to the left-rear rotor.

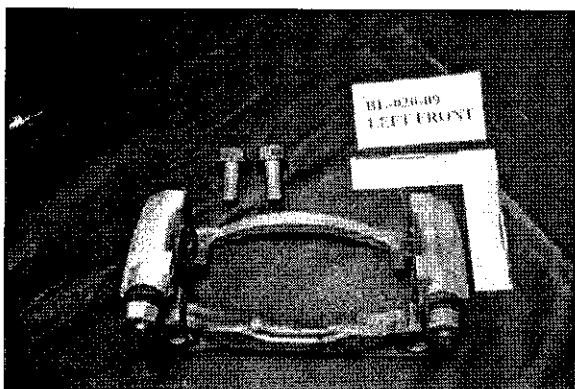
Image 40: Disc 5\DCIM\274CANON\IMG_0052.JPG

The exterior of the caliper and bracket was soiled with dirt. The caliper rubber dust boot and both bracket dust boots were complete and pliable. The surface of the caliper, adjacent to the piston and surrounding pad inspection opening, was soiled with a glossy resin-like material (Image 38). The banjo bolt on the inlet port and the bleeder screw were fractured and separated at their respective ports (Image 39). Each of the fractured surfaces had a rough crystalline appearance. Other than being soiled, the bracket and the anti-vibration springs were generally unremarkable (Images 40 and 41).

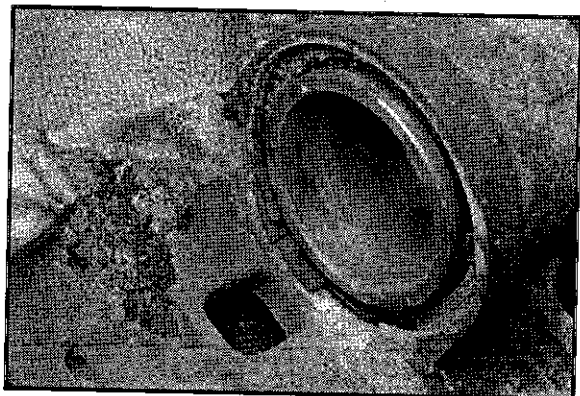
Image 43: Disc 5\DCIM\274CANON\IMG_0152.JPG

The exterior of the caliper was charred and discolored to various shades of black, gray, and white (Image 42). The majority of the rubber dust boot, between the caliper housing and piston, was missing and the remaining pieces were pitted, fractured, and brittle (Image 43). The rubber brake fluid hose was missing from the crimped fitting attached to the caliper (Image 44). The interior of the crimped fitting was charred and soiled with dirt. The exterior of the bracket was charred and discolored to various shades of black, gray, and white. Both the rubber dust boots, which were normally attached between the sliding pins and the bracket, were missing (Image 45). The anti-vibration springs were generally unremarkable.

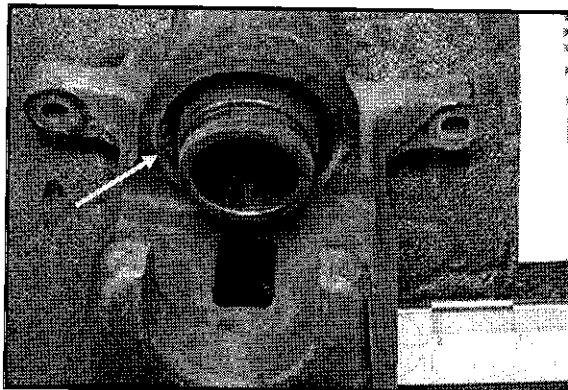
Image 51: Disc 5\DCIM\274CANON\IMG_0338.JPG

The exterior of the caliper was charred and discolored to various shades of black and brown (Image 50). Almost the entire rubber dust boot, between the caliper housing and piston, was missing. The small section remaining was charred (Image 51, arrow). The caliper piston was discolored to various shades of purple and blue. The rubber brake fluid hose was missing from the crimped fitting attached to the caliper. The interior of the crimped fitting was charred and soiled with dirt. The exterior of the bracket was charred and discolored to various shades of black and brown (Image 52). Both the rubber dust boots, which were normally attached between the sliding pins and the bracket, were missing (Image 52, circles). The anti-vibration springs were generally unremarkable.

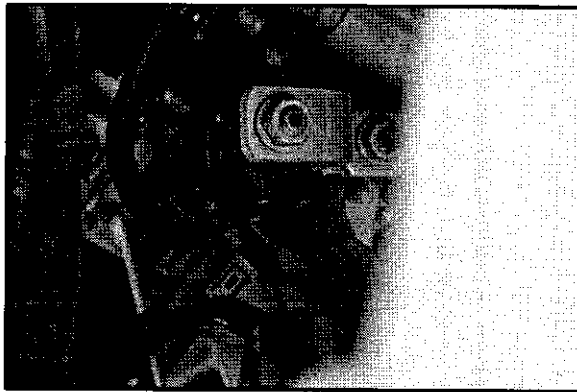
Image 53: Disc 4\DCIM\115CANON\IMG_2889.JPG

On Friday, September 25, 2009, at 0945 hours, Investigator Parent and MCS-I Hearst arrived at Seaside Buick Pontiac GMC, located at 6435 Miramar Road, San Diego, California, to conduct a visual inspection of the shift lever on an exemplar 2008 Lexus ES 350 in its various positions: park (Image 53), reverse (Image 54), neutral (Image 55), and drive (Image 56).

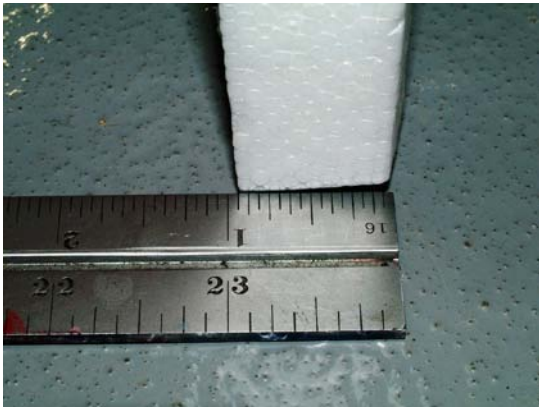
Photograph 1

ODI diagramed their observation and concern with the fact that the accelerator pedal on the ES 350 at full stop is below the surface plane of the carpet created by a 1" Styrofoam block inserted on the floor pan, underneath the carpet, on the driver's seating side of the accelerator pedal. Photographs 1, 2, & 3 were shown to TMC. Also a video clip of an unsecured original equipment floor mat trapping the accelerator pedal in the petitioner's car was shown to TMC (video clip attached as attachment 1). Copies of complaints (VOQs) filed with ODI related to ES 350 pedal entrapments were presented to TMC. At the meeting TMC had an ES 350 for available for inspection. TMC also provided, for comparison inspection, examples of the following vehicles: IS 250, Camry, Prius (generation 2 and generation 3), Tundra, Avalon, Tacoma, Highlander (generation 2), Venza, and 4Runner. ODI also presented to TMC VOQs related to those vehicles.
