**Response 7**

### **Response 9**

### **Cause:**

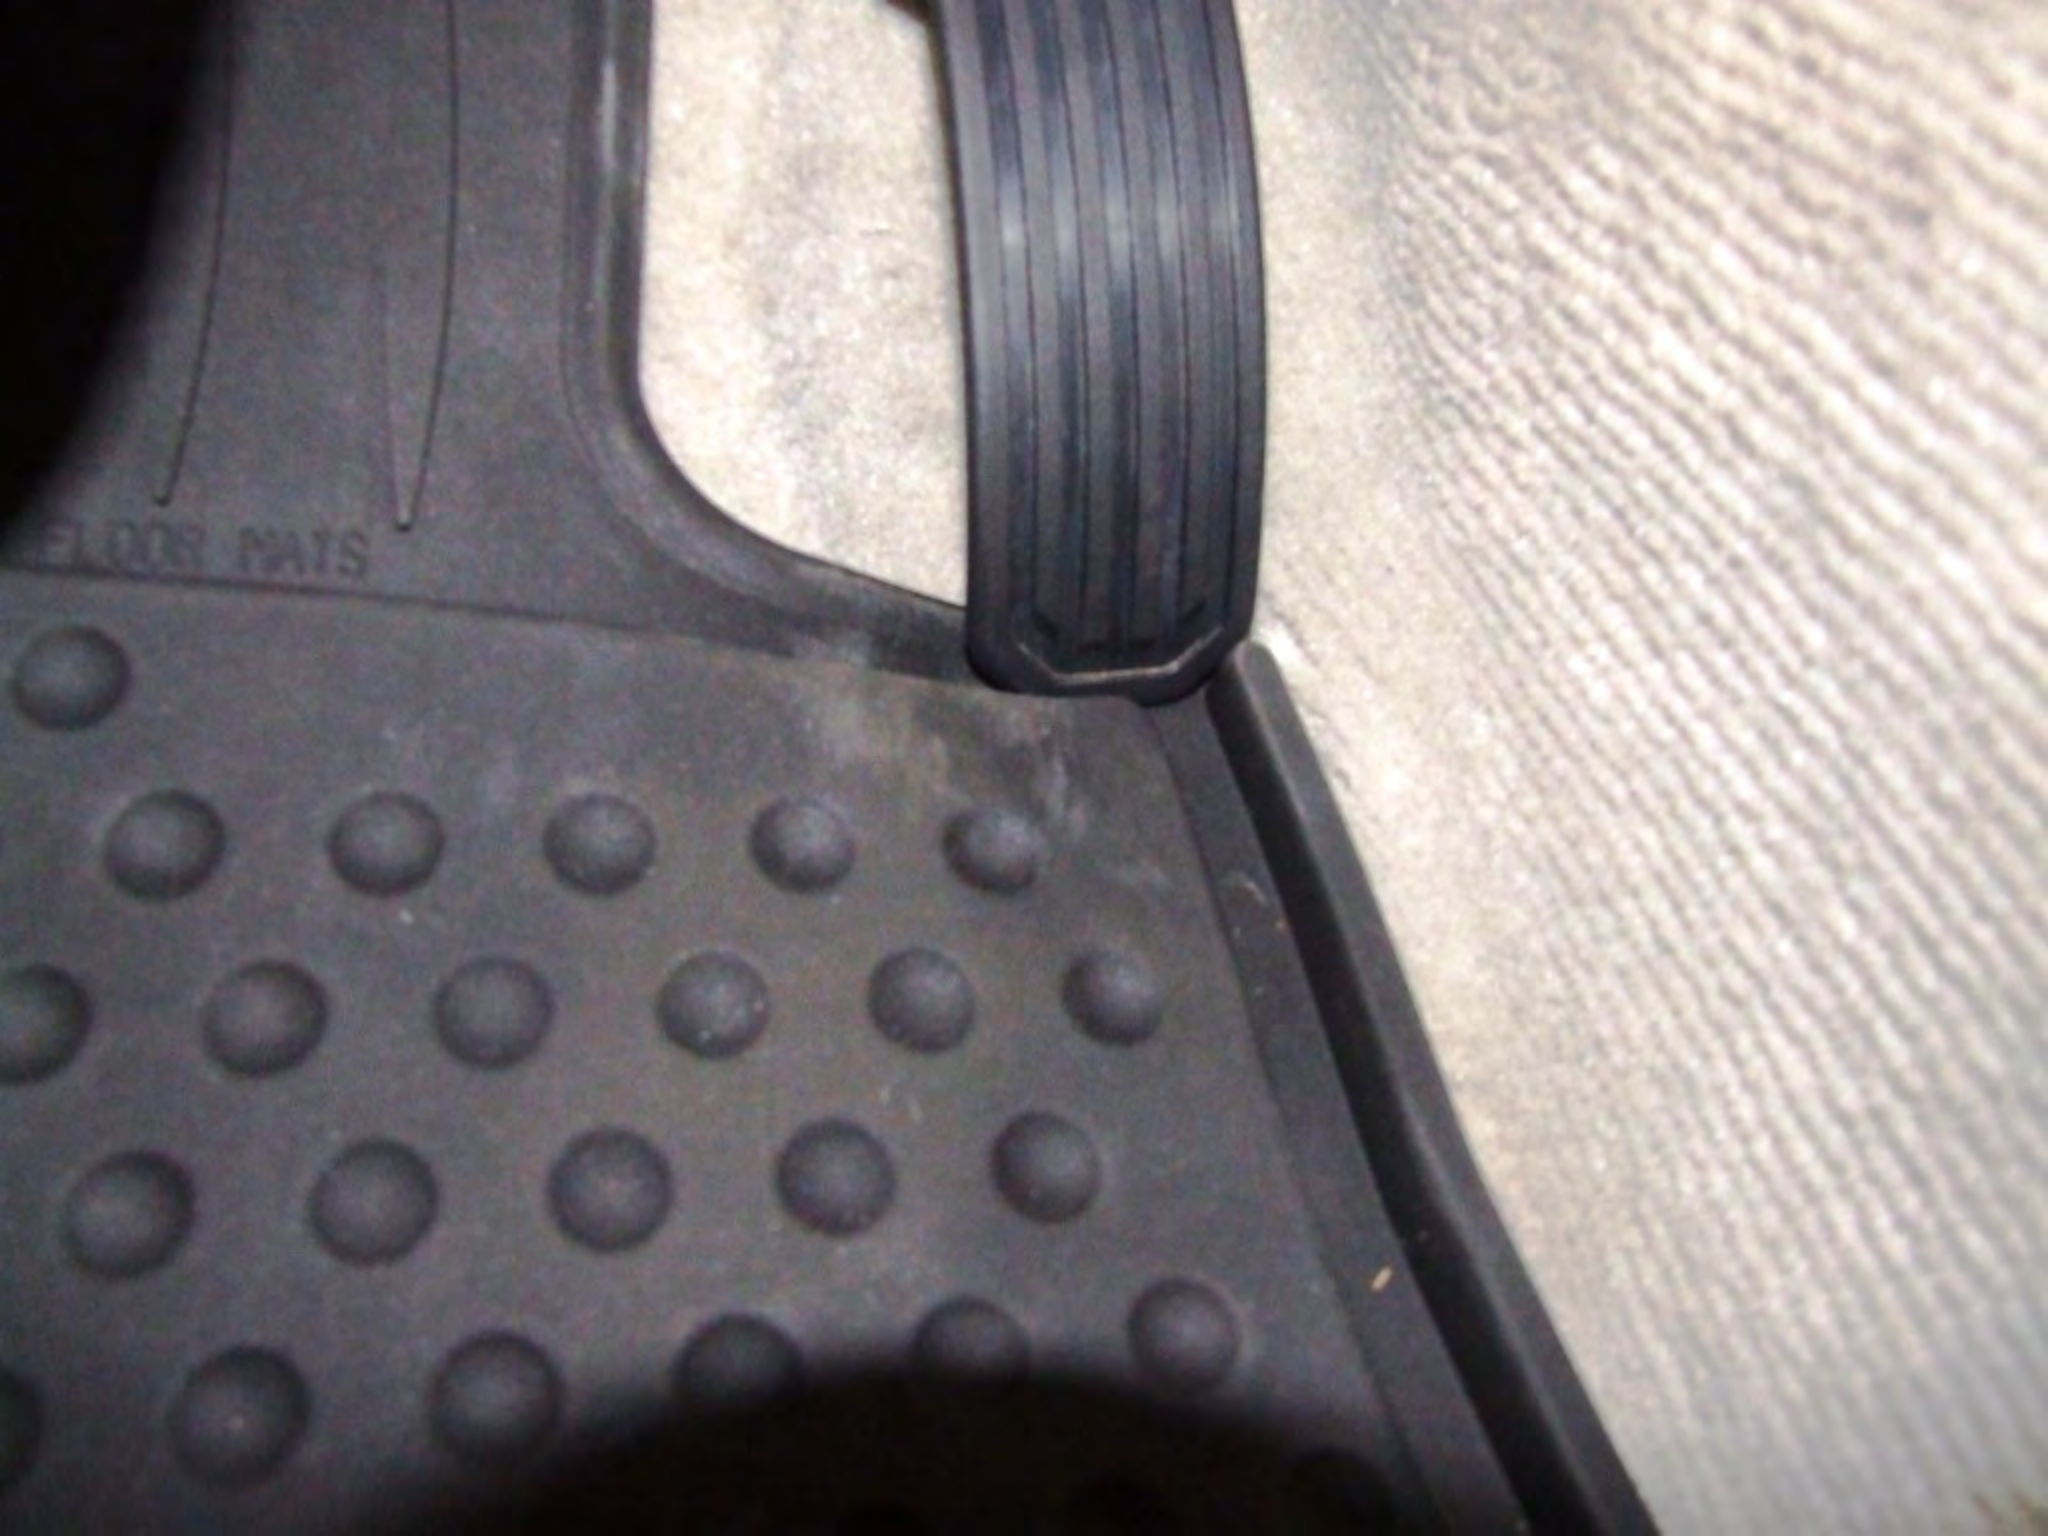
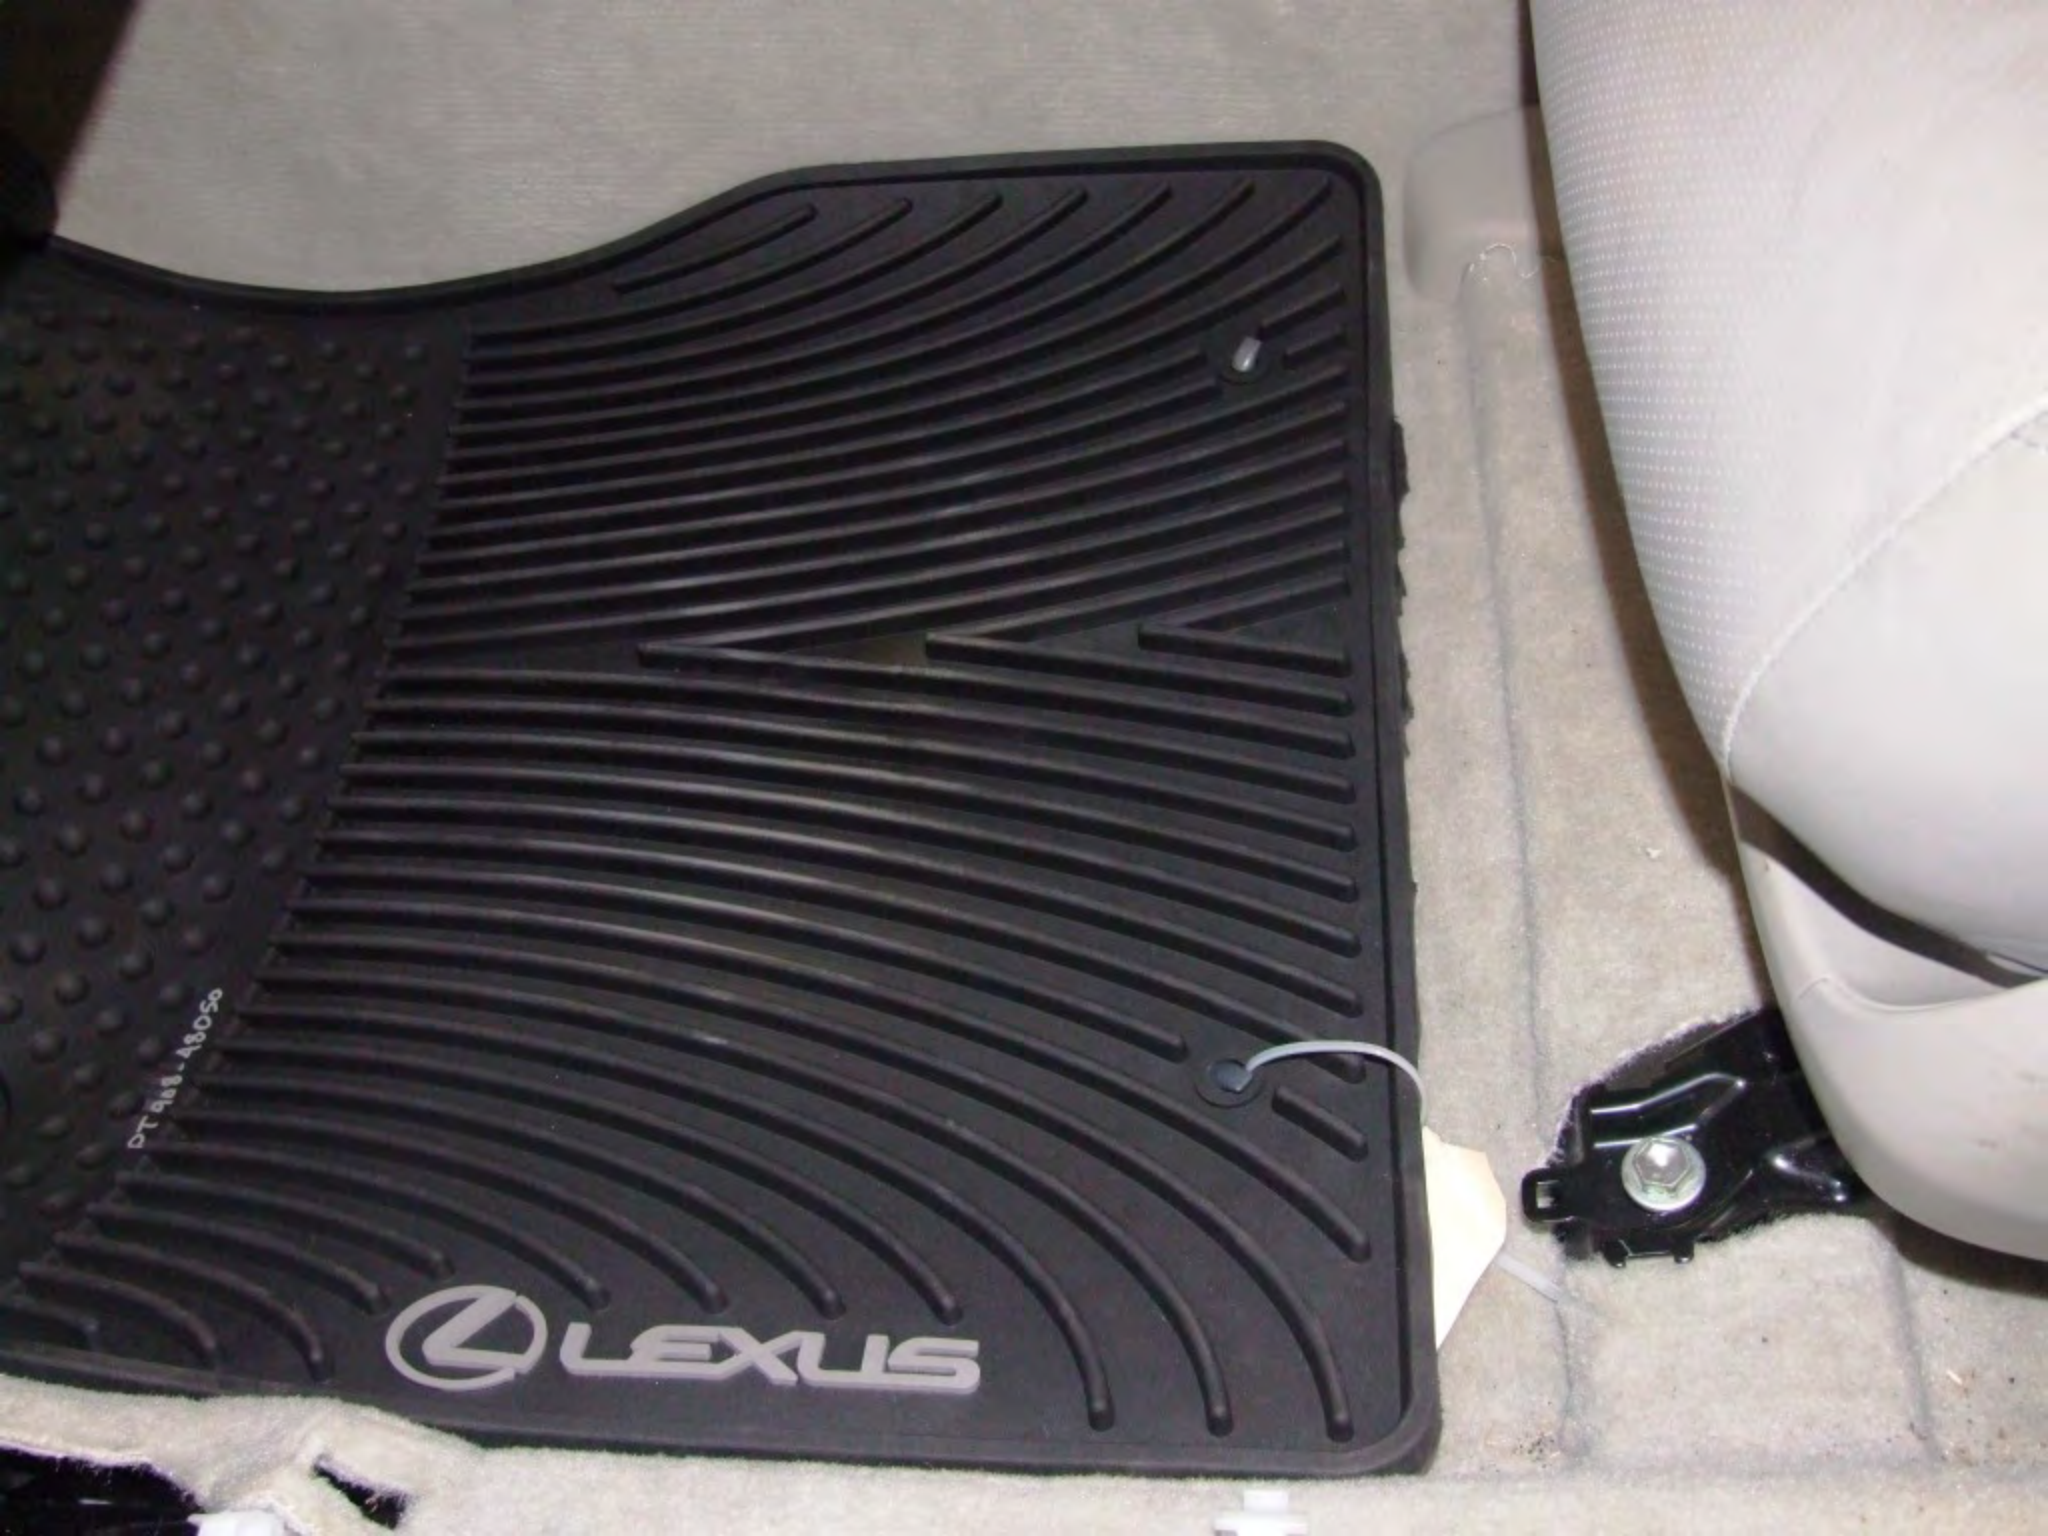
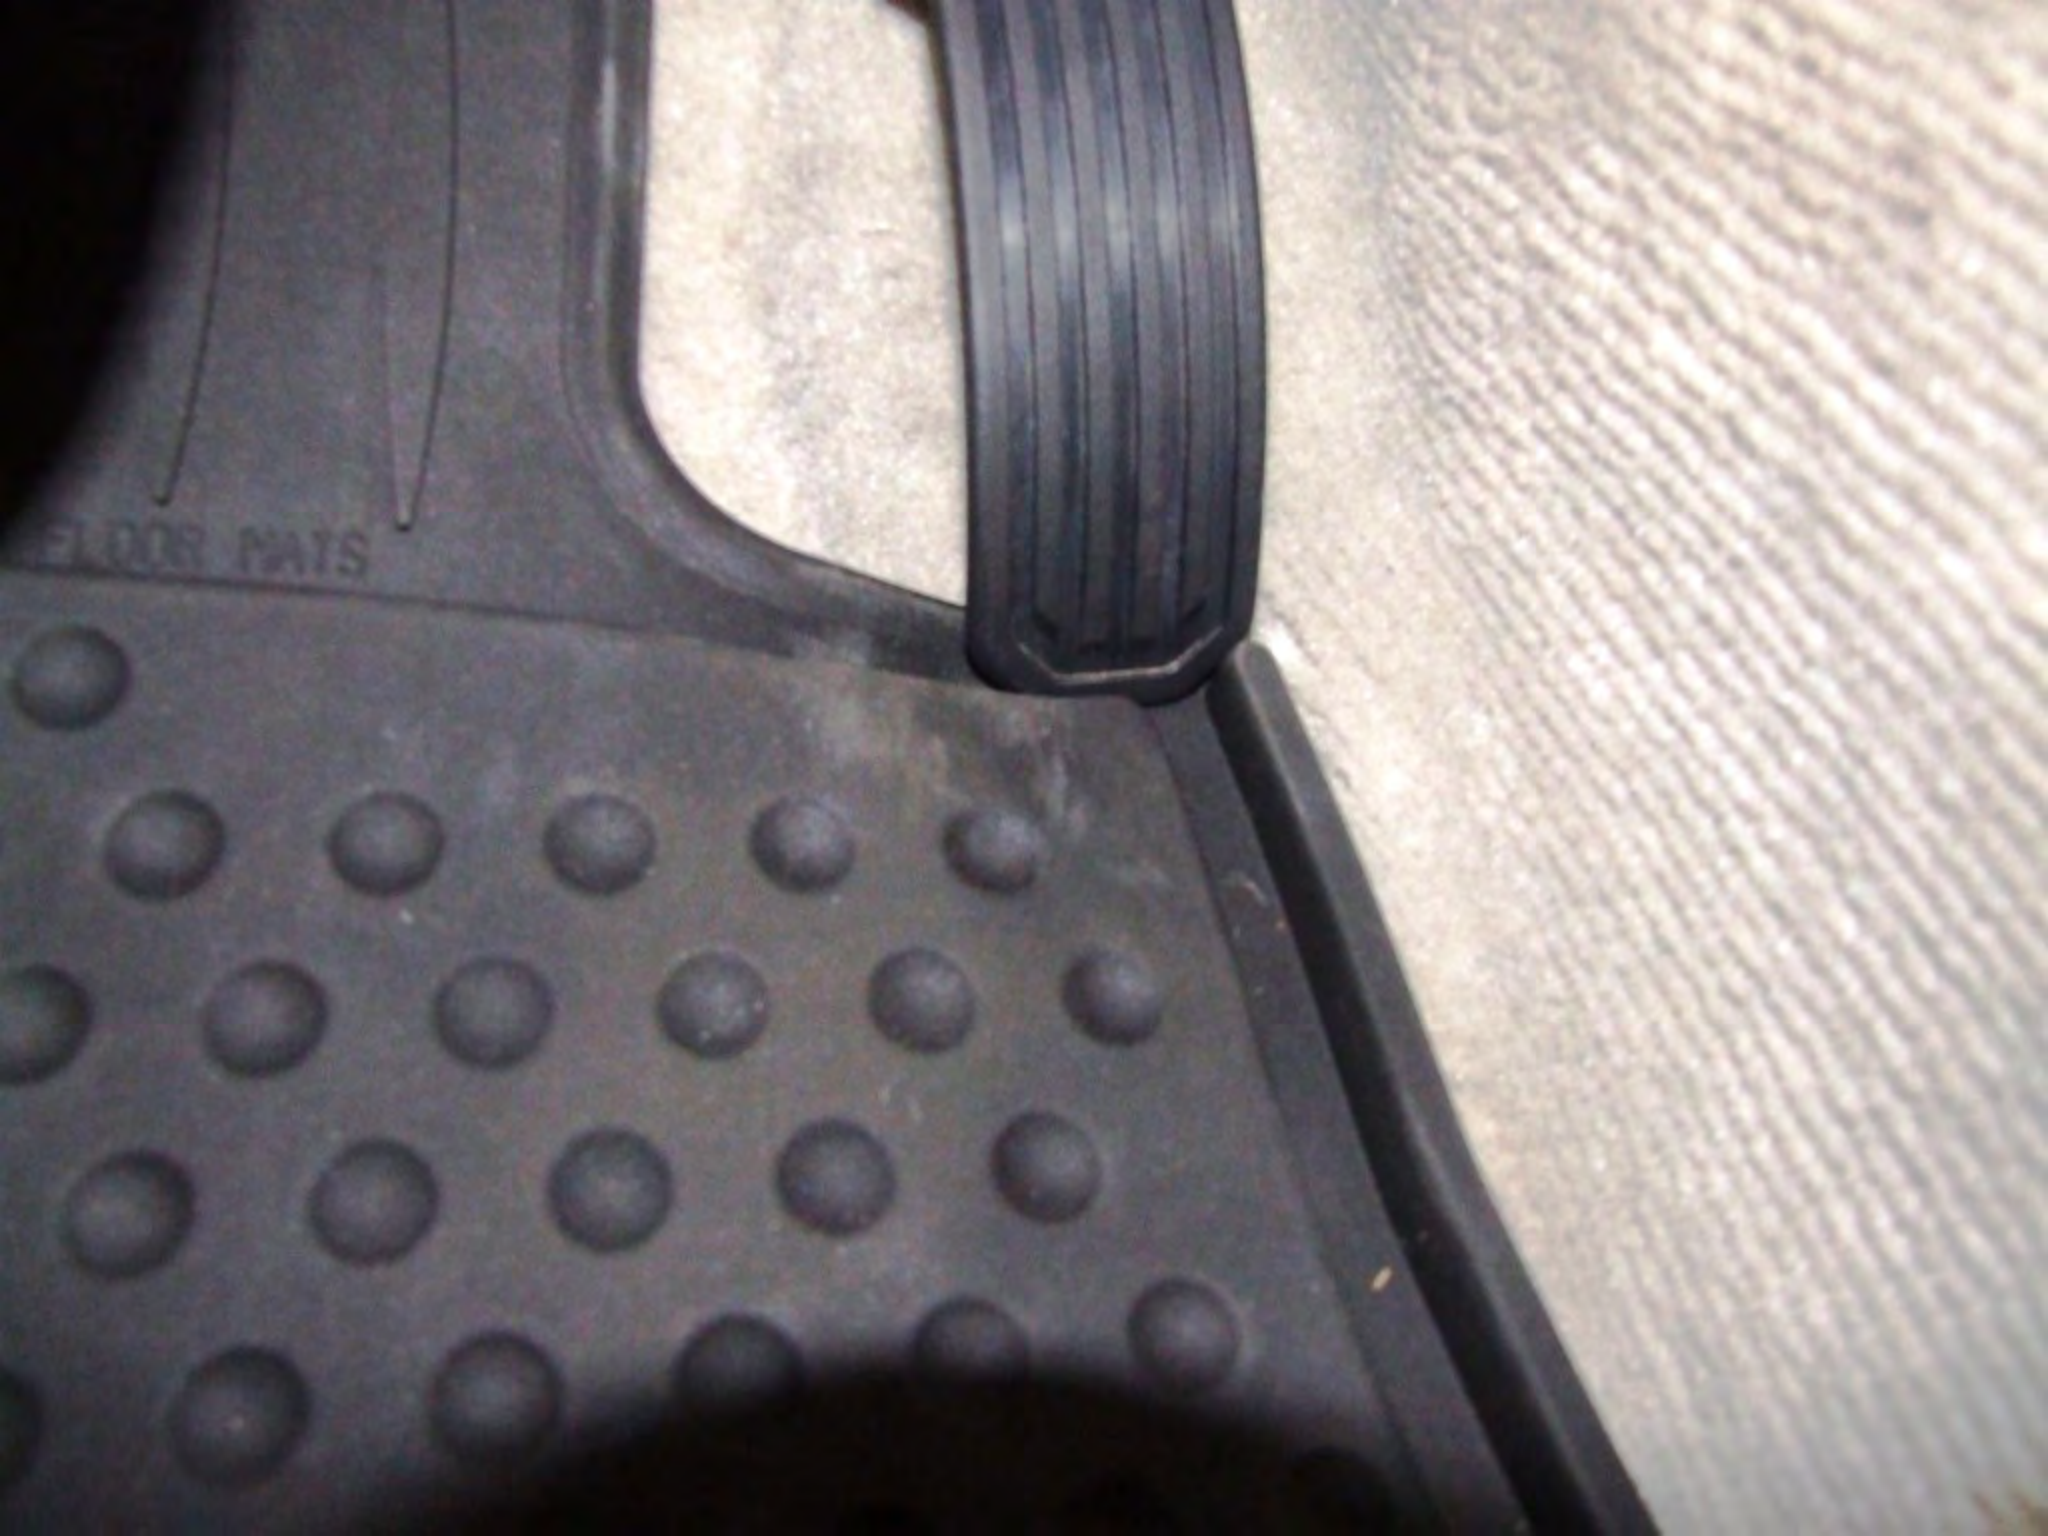
Attachment-Response 9-1

FLOOR MATS

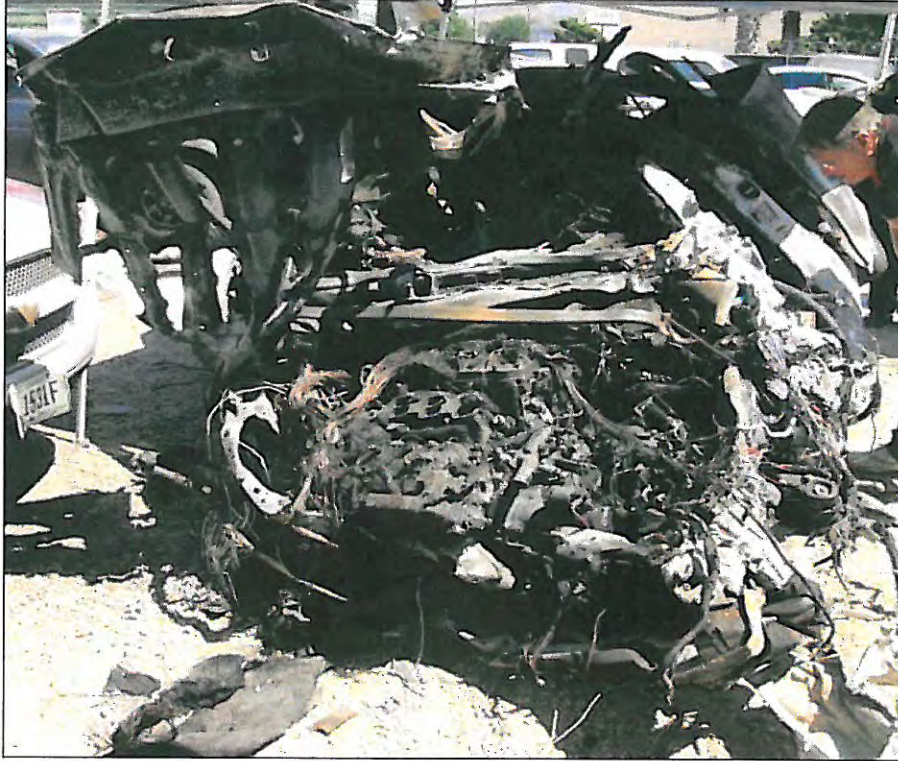
**Figure 1 - Subject Vehicle 2009 Lexus ES-350 – Front**

Vehicle condition at time of inspection: Catastrophic damage caused by severe frontal impact, roof impact, side impact, & fire damage. The driver's seat buckle was observed in a closed, connected condition.

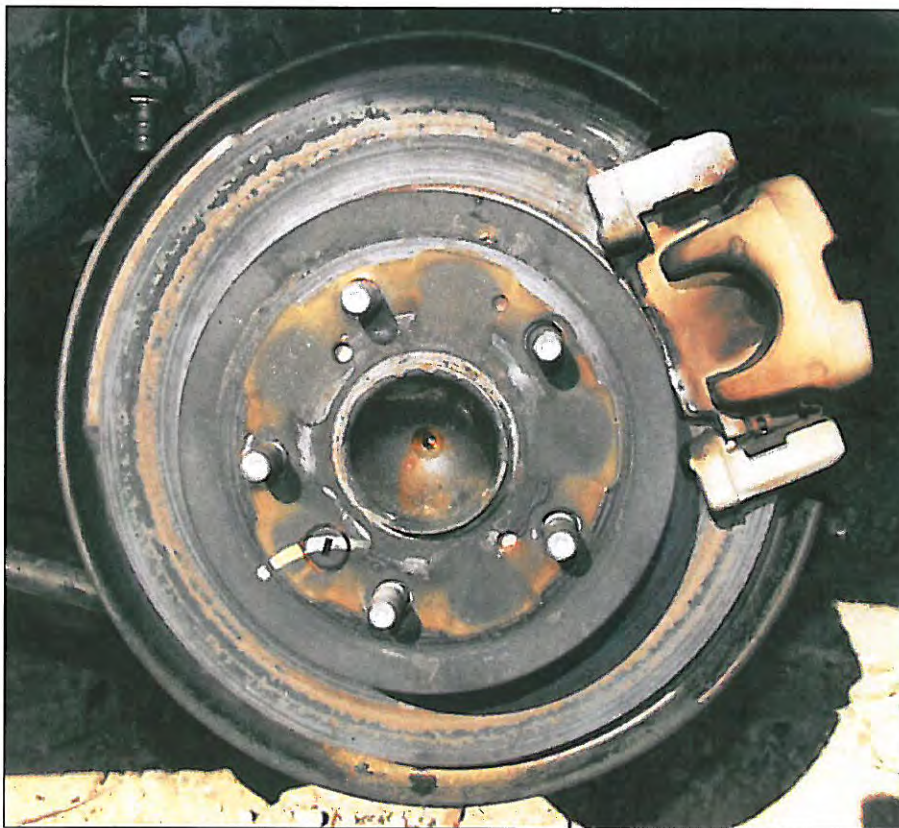
- 4- The brake pads and rotors were inspected for heat generated by emergency braking. While there was significant fire damage to the majority of the vehicle, the pads, rotors, and calipers could still be observed. The left front wheel assembly and suspension were torn from the vehicle in the crash and had not been involved in the fire. Other rotors on the vehicle generally exhibited similar conditions. Rotors were discolored and heated, had very rough surfaces, had substantial deposits of brake pad material, and showed signs of bright orange oxidation on the cooling fins consistent with endured braking. Pads were melted and rough with a considerable amount surface material dislocated to the leading edge. The friction surfaces were burned but somewhat reflective. The edges of the pads were bubbled. The calipers were also heat discolored with heat patterns in the area adjacent to the rotor.

**Figure 2 - Rear Left Caliper and Rotor Exhibiting Signs of Endured Braking**

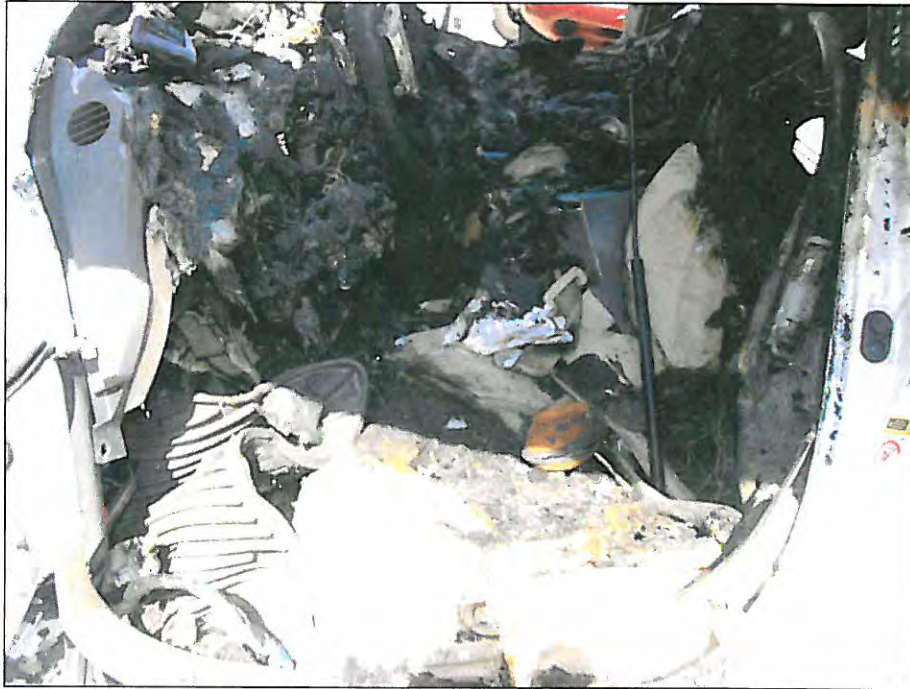
- 2- Upon inspection of the crashed vehicle, it was found that an all-weather floor mat bearing the Lexus insignia was present in the driver's foot well vehicle with very minor fire damage. The mat was not secured by either of the two retaining clips. The right clip was installed into the grommet of the carpeting but not installed into the mat. The left clip was found under the middle of mat but was not clipped to either the carpet or the rubber mat. Removal of the mat was difficult because the bottom edge of the accelerator pedal had melted to the upper right corner of the mat. Further inspection of the mat revealed that while it was a Lexus brand mat, it was not the correct application for the vehicle. The mat part number was stamped and still visible on the reverse side. It read "PT 48050

**Figure 3 - Driver's Compartment with Lexus All Weather Floor Mat**

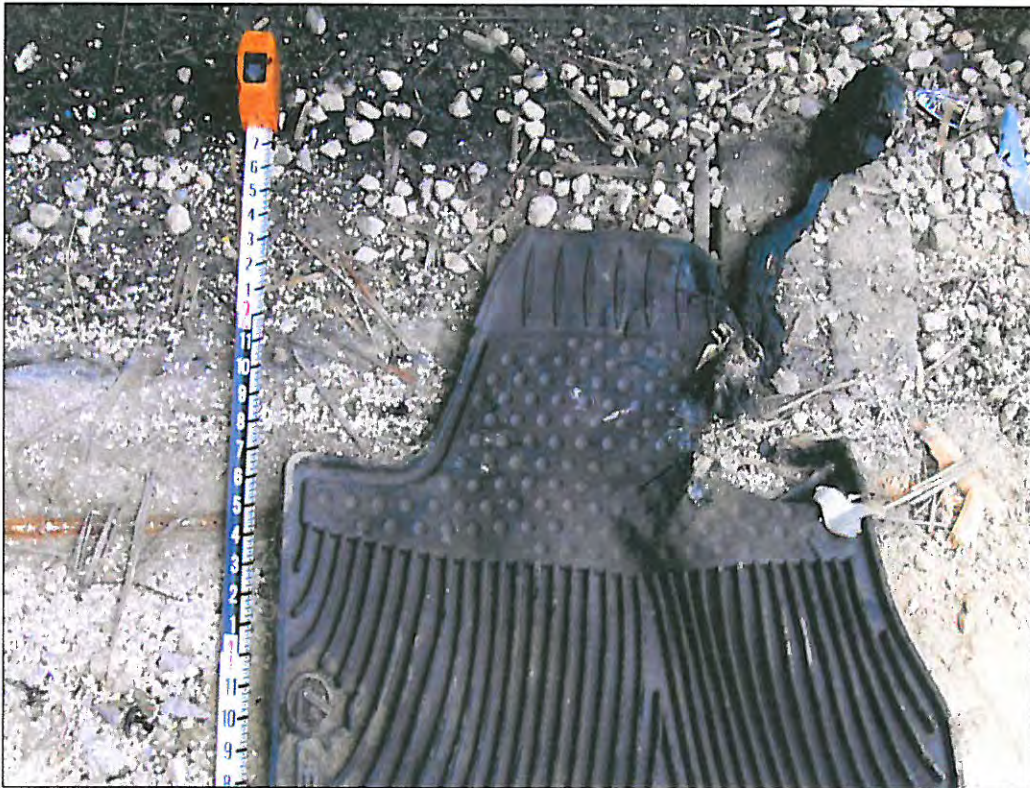
- 1- Accelerator Pedal – The pedal is made from a composite plastic that forms a rigid, one-piece lever. Beyond the main pivot, the lever is not hinged and has no means for relieving forces caused by interferences. Upon removing the pedal from the vehicle, the rotating motion of the pedal assembly was confirmed to still be operational. The return spring action was smooth and unencumbered.

**Figure 4 - All Weather Floor Mat Removed from Driver's Footwell, Bonded to Lower Edge of Accelerator Pedal Assembly**

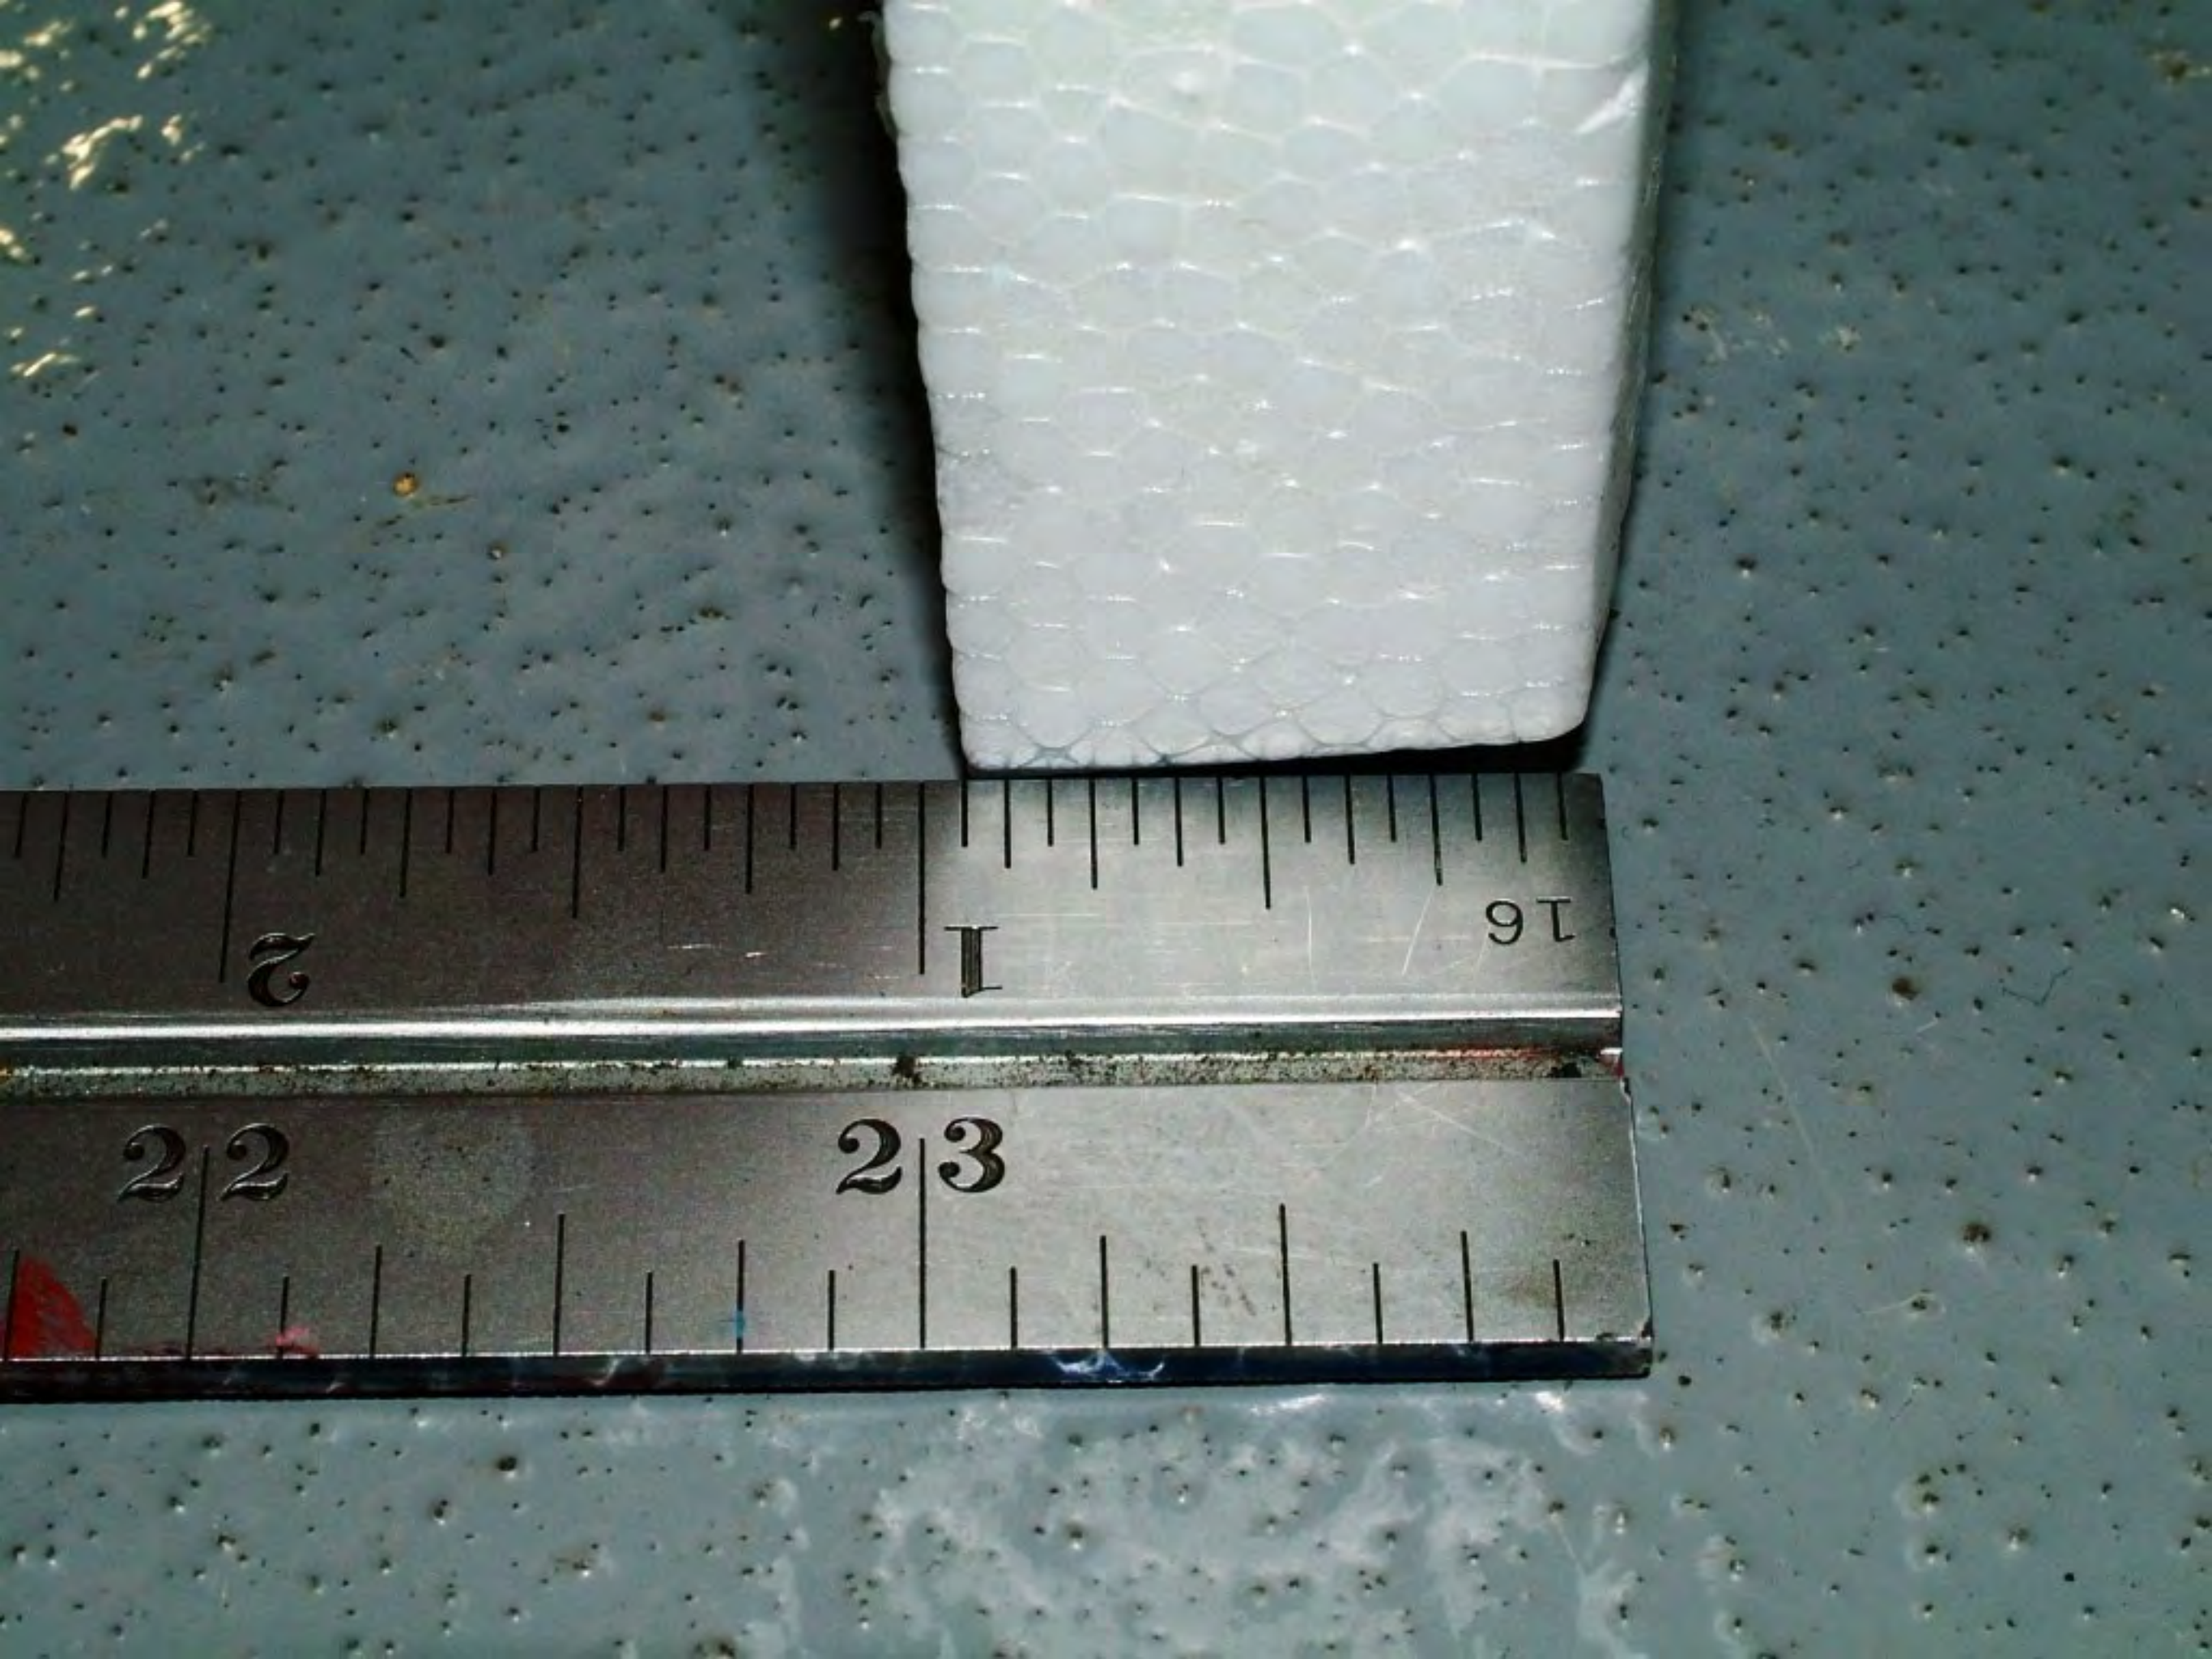
styrofoam block under carpet
