U.S. Department of Transportation
National Highway Traffic Safety Administration

Investigation: EA07-010
 Prompted By: PE07-016, Consumer Complaints
 Date Opened: 08/08/2007 Date Closed: 10/11/2007
 Principal Investigator: Scott Yon
 Subject: Unwanted Acceleration, Floor Mat

Manufacturer: Toyota Motor Corporation
 Products: MY 2002 - 2008 Lexus ES350 and Toyota Camry
 Population: 55,000 (estimated)

Problem Description: The accessory all weather floor mat can entrap the throttle pedal.

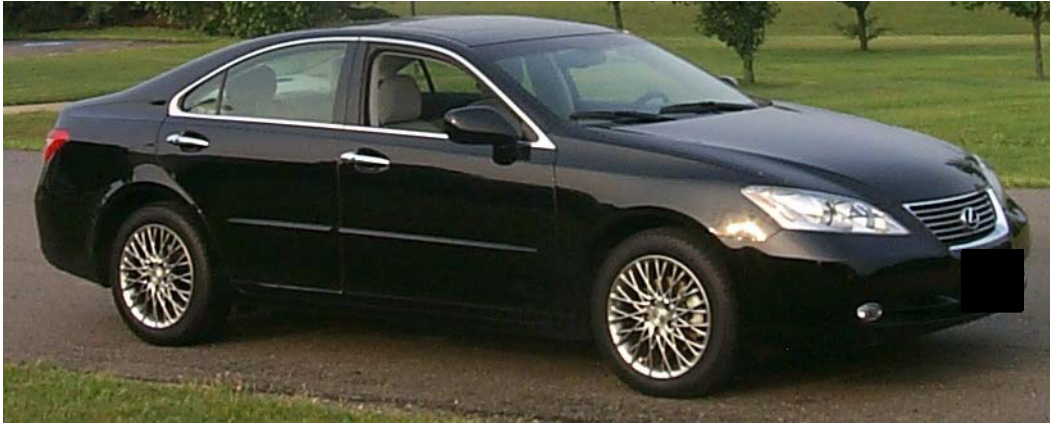
Figure 1 – 2007 Lexus ES-350

The Vehicle Research and Test Center obtained a Lexus ES-350 for testing (see Figure 1). The vehicle was fully instrumented to monitor and acquire data relating to yaw rate, speed, acceleration, deceleration, brake pedal effort, brake line hydraulic pressure, brake pad temperature, engine vacuum, brake booster vacuum, throttle plate position, and accelerator pedal position. Multiple electrical signals were introduced into the electrical system to test the robustness of the electronics against single point failures due to electrical interference. The system proved to have multiple redundancies and showed no vulnerabilities to electrical signal activities. Magnetic fields were introduced in proximity to the throttle body and accelerator pedal potentiometers and did result in an increase in engine revolutions per minute (RPM) of up to approximately 1,000 RPM, similar to a cold-idle engine RPM level. Mechanical interferences at the throttle body caused the engine to shut down. Mechanical interferences at the accelerator
