**Bendix Commercial Vehicle Systems LLC**  
901 Cleveland Street, Elyria, Ohio 44035  
Tel: 440.329.9000 • Fax: 440.329.9203

Re: **EA09-009**

This letter is to provide you with test findings of the Bendix valves you provided to us and requested to have inspected and tested from the field evaluation conducted the week of August 3, 2009.

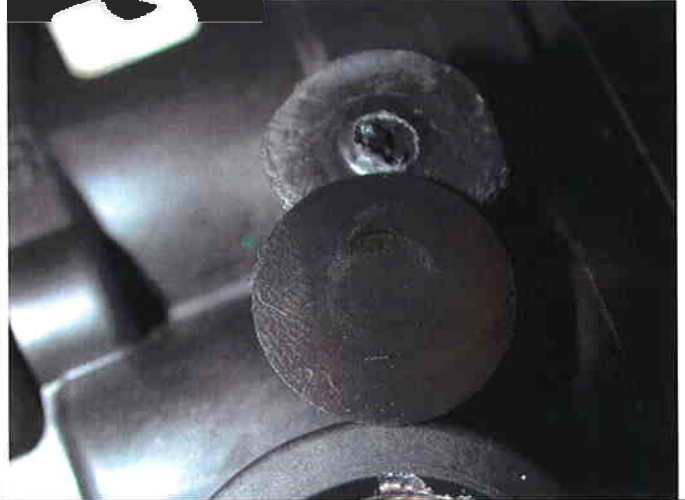
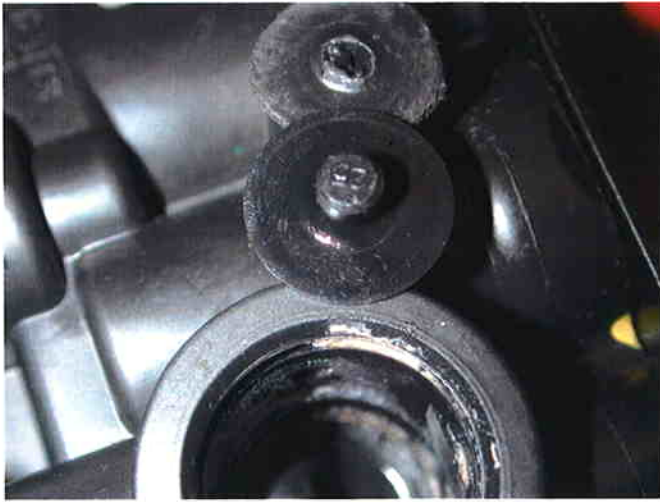
Double check valve

The valves were disassembled and inspected for foreign contaminants, degradation of rubber seals, or damage to internal components. The double check valve on all three valves were contaminated with oil and damaged in one valve (...1696). This caused the leakage in the “buttons in” test. When the damaged double check valve was replaced in the one valve (...1696), the valve passed all performance requirements. The exhaust seal of the tractor plunger was contaminated and damaged in two of the valves (...4367 & 4366). Material analysis determined that the substance found on the o-rings and exhaust seal was a mixture of the standard Bendix grease, water and an alcohol. The durometer of several o-rings was found to be under specification, which may have contributed to the Buttons In leakage results.
