From: Ruth, Richard (R.R.)
Sent: Thursday, August 17, 2006 10:54 AM
To: Clement, Charles (C.A.)
Subject: FW: 04 F150 Airbag deployment

From: Ruth, Richard (R.R.)
Sent: Tuesday, July 25, 2006 9:54 AM
To: Clement, Charles (C.A.); Oswald, Greg (G.G.)
Cc: Fonseca, Lourdes (L.C.)
Subject: 04 F150 Airbag deployment

04 F150, VIN 1FTPW14574KB03029, Build date 10/09/03, 90000miles, Durand Auto Group, Svc Mgr James McDonald in Vermont 802 463 3300. Dealer says customer described event as pulled in gas station to refuel, turned key off, driver airbag allegedly deployed as he was exiting the driver door. Dealer took codes and got B2293 only, took PIDS and both DAB1 and DAB2 were 25.5 ohms. Dealer installed simulators and both DAB1 and DAB2 read 3.2 ohms (normal). Dealer did not find any visible signs of impact. Customer stated he is a physician and needed the use of his vehicle, at customer request Dealer installed a new driver airbag so customer would have a horn and no airbag sticking out, but did not connect new airbag pending results of investigation in to root cause. Customer is currently driving the vehicle.

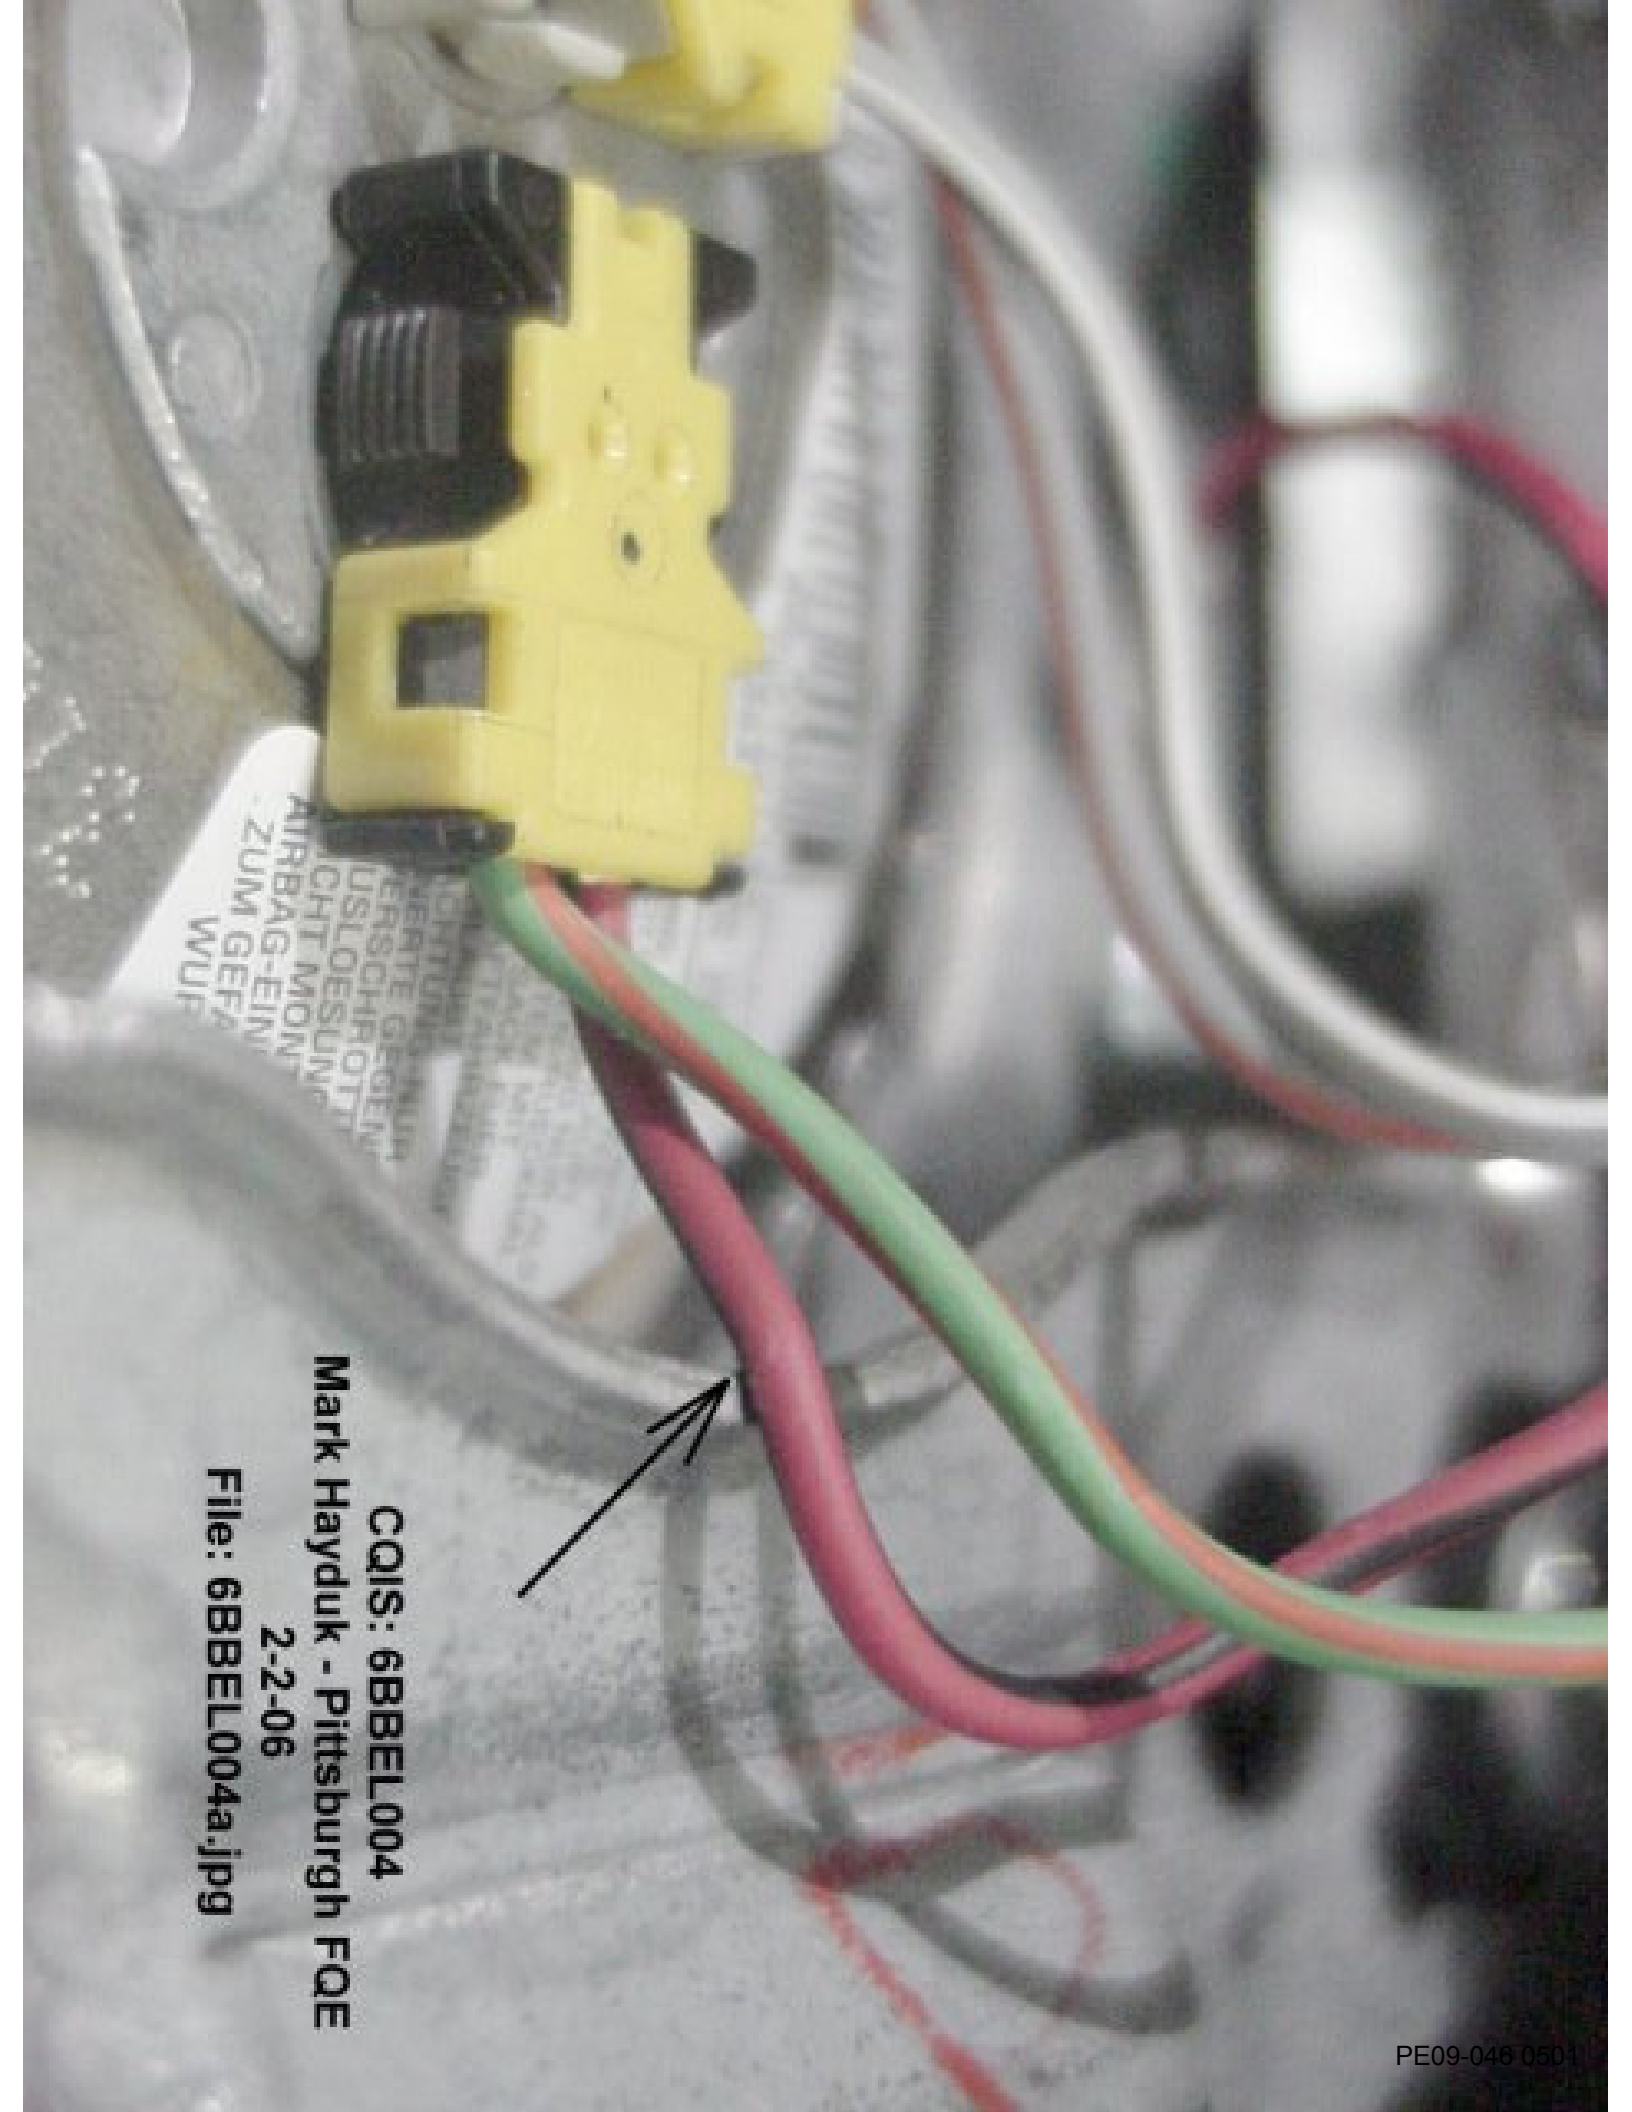
CAIS: 6BBEL004
Mark Hayduk - Pittsburgh FOE
2-2-06
File: 6BBEL004a.jpg

TECH/C **02/02/2006 02:04PM MARK HAYDUK MSS - FCSD - CQD - FQE**
TECH. FOUND P0581 (CRUISE CONTROL MULTI-FUNCTION INPUT CIRCUIT HIGH.)
AND B2293 (AIR BAG FAULT.). RESTRAINT SYSTEM PID DATA SHOWS FAULTS
FOR: 2293_29_CM, 2293_29_OD, 2293_21_CM AND 2293_21_OD. RESISTANCE
VALUES MEASURED WITH WDS FOR BOTH THE 1ST STAGE AND 2ND STAGE CIRCUITS
OF THE AIR BAG RANGED FROM 3.2 OHMS TO 7.1 OHMS WHEN TURNING THE WHEEL
AND OCCASIONALLY THE 1ST STAGE AND/OR 2ND STAGE RESISTANCE WOULD GO TO

25.5 OHMS. ALSO FOUND THE RED WITH BLACK STRIPED WIRE, GOING TO THE
BLACK CONNECTOR ON THE BACK OF THE STEERING WHEEL AIR BAG, TO BE
AGAINST THE EDGE OF THE STEEL BRACKET. THE WIRE COVER WAS DAMAGED BUT
DID NOT PENETRATE TO THE COPPER WIRES. THE BLACK COVER OF THE WIRES
PLUGGED INTO THE CLOCK SPRING CONNECTION ON THE PASS. SIDE OF THE
CLOCK SPRING SHOWED A WITNESS MARK FROM THE STEEL BRACKET PUSHING ON
IT, BUT THE COVER WAS NOT CUT THROUGH. TECH. INSTALLED A NEW CLOCK
SPRING, CLEARED CODES AND THE CONCERN WAS RESOLVED. PHOTOS ARE
ATTACHED TO THIS REPORT. CLOCK SPRING IS BEING RETURNED TO DEAN
MCCLLENAGHAN. MARK HAYDUK - PITTSBURGH FQE - 724-413-9113.

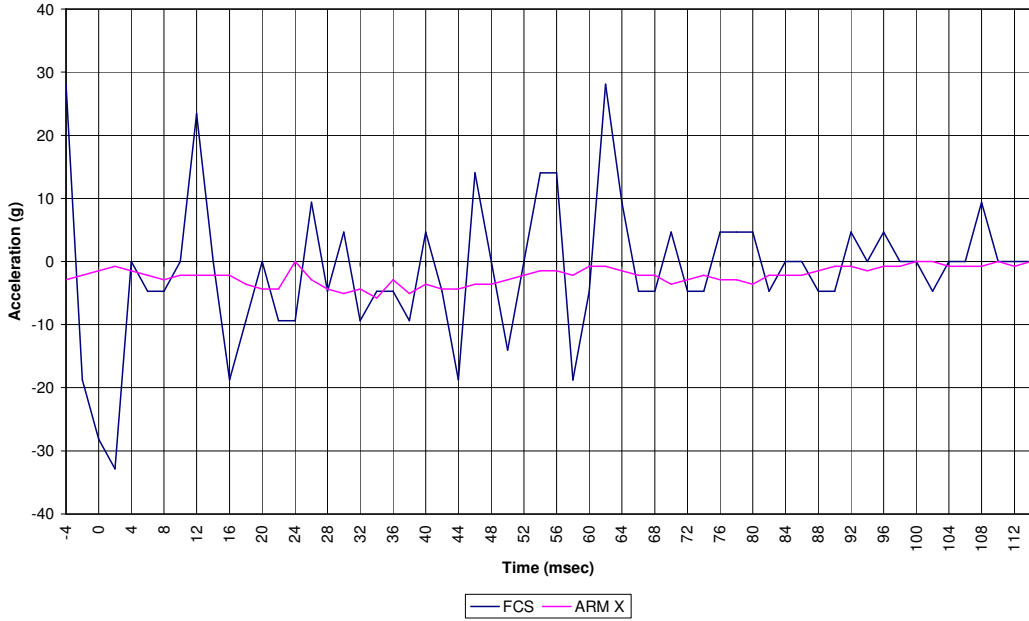
Frontal Algorithm Acceleration Crash Data
(0msec = Algorithm Wakeup)

J46 05 F150 Acceleration and Delta Velocity Plots Acceleration and Delta Velocity Charts

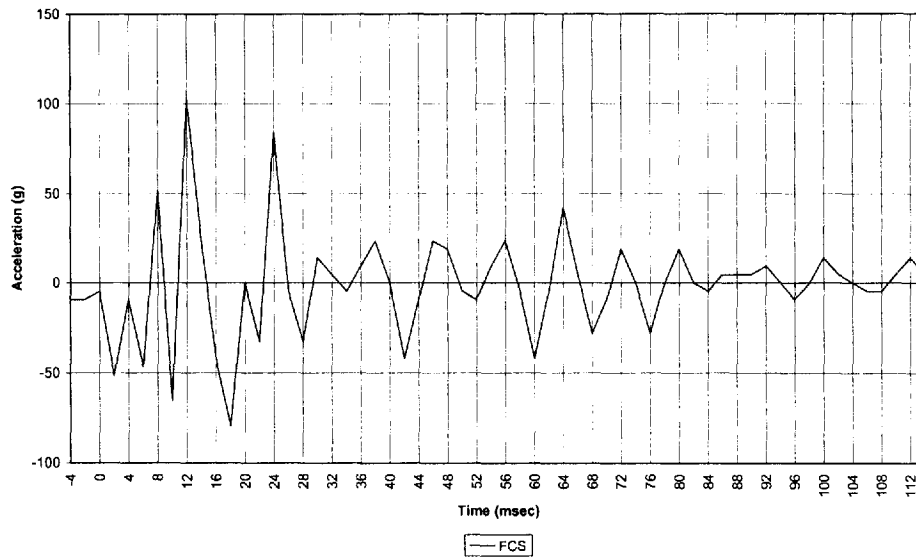
Frontal Algorithm Acceleration Crash Data
(0msec = Algorithm Wakeup)

H. The accelerations and delta velocity plots are below.

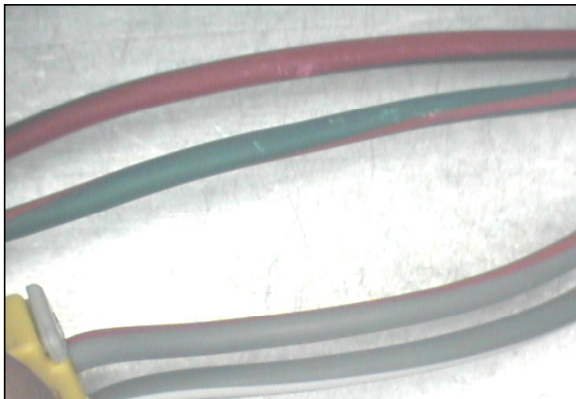
3. VIN FA40851 Slight abrasions to wires near FCI connector

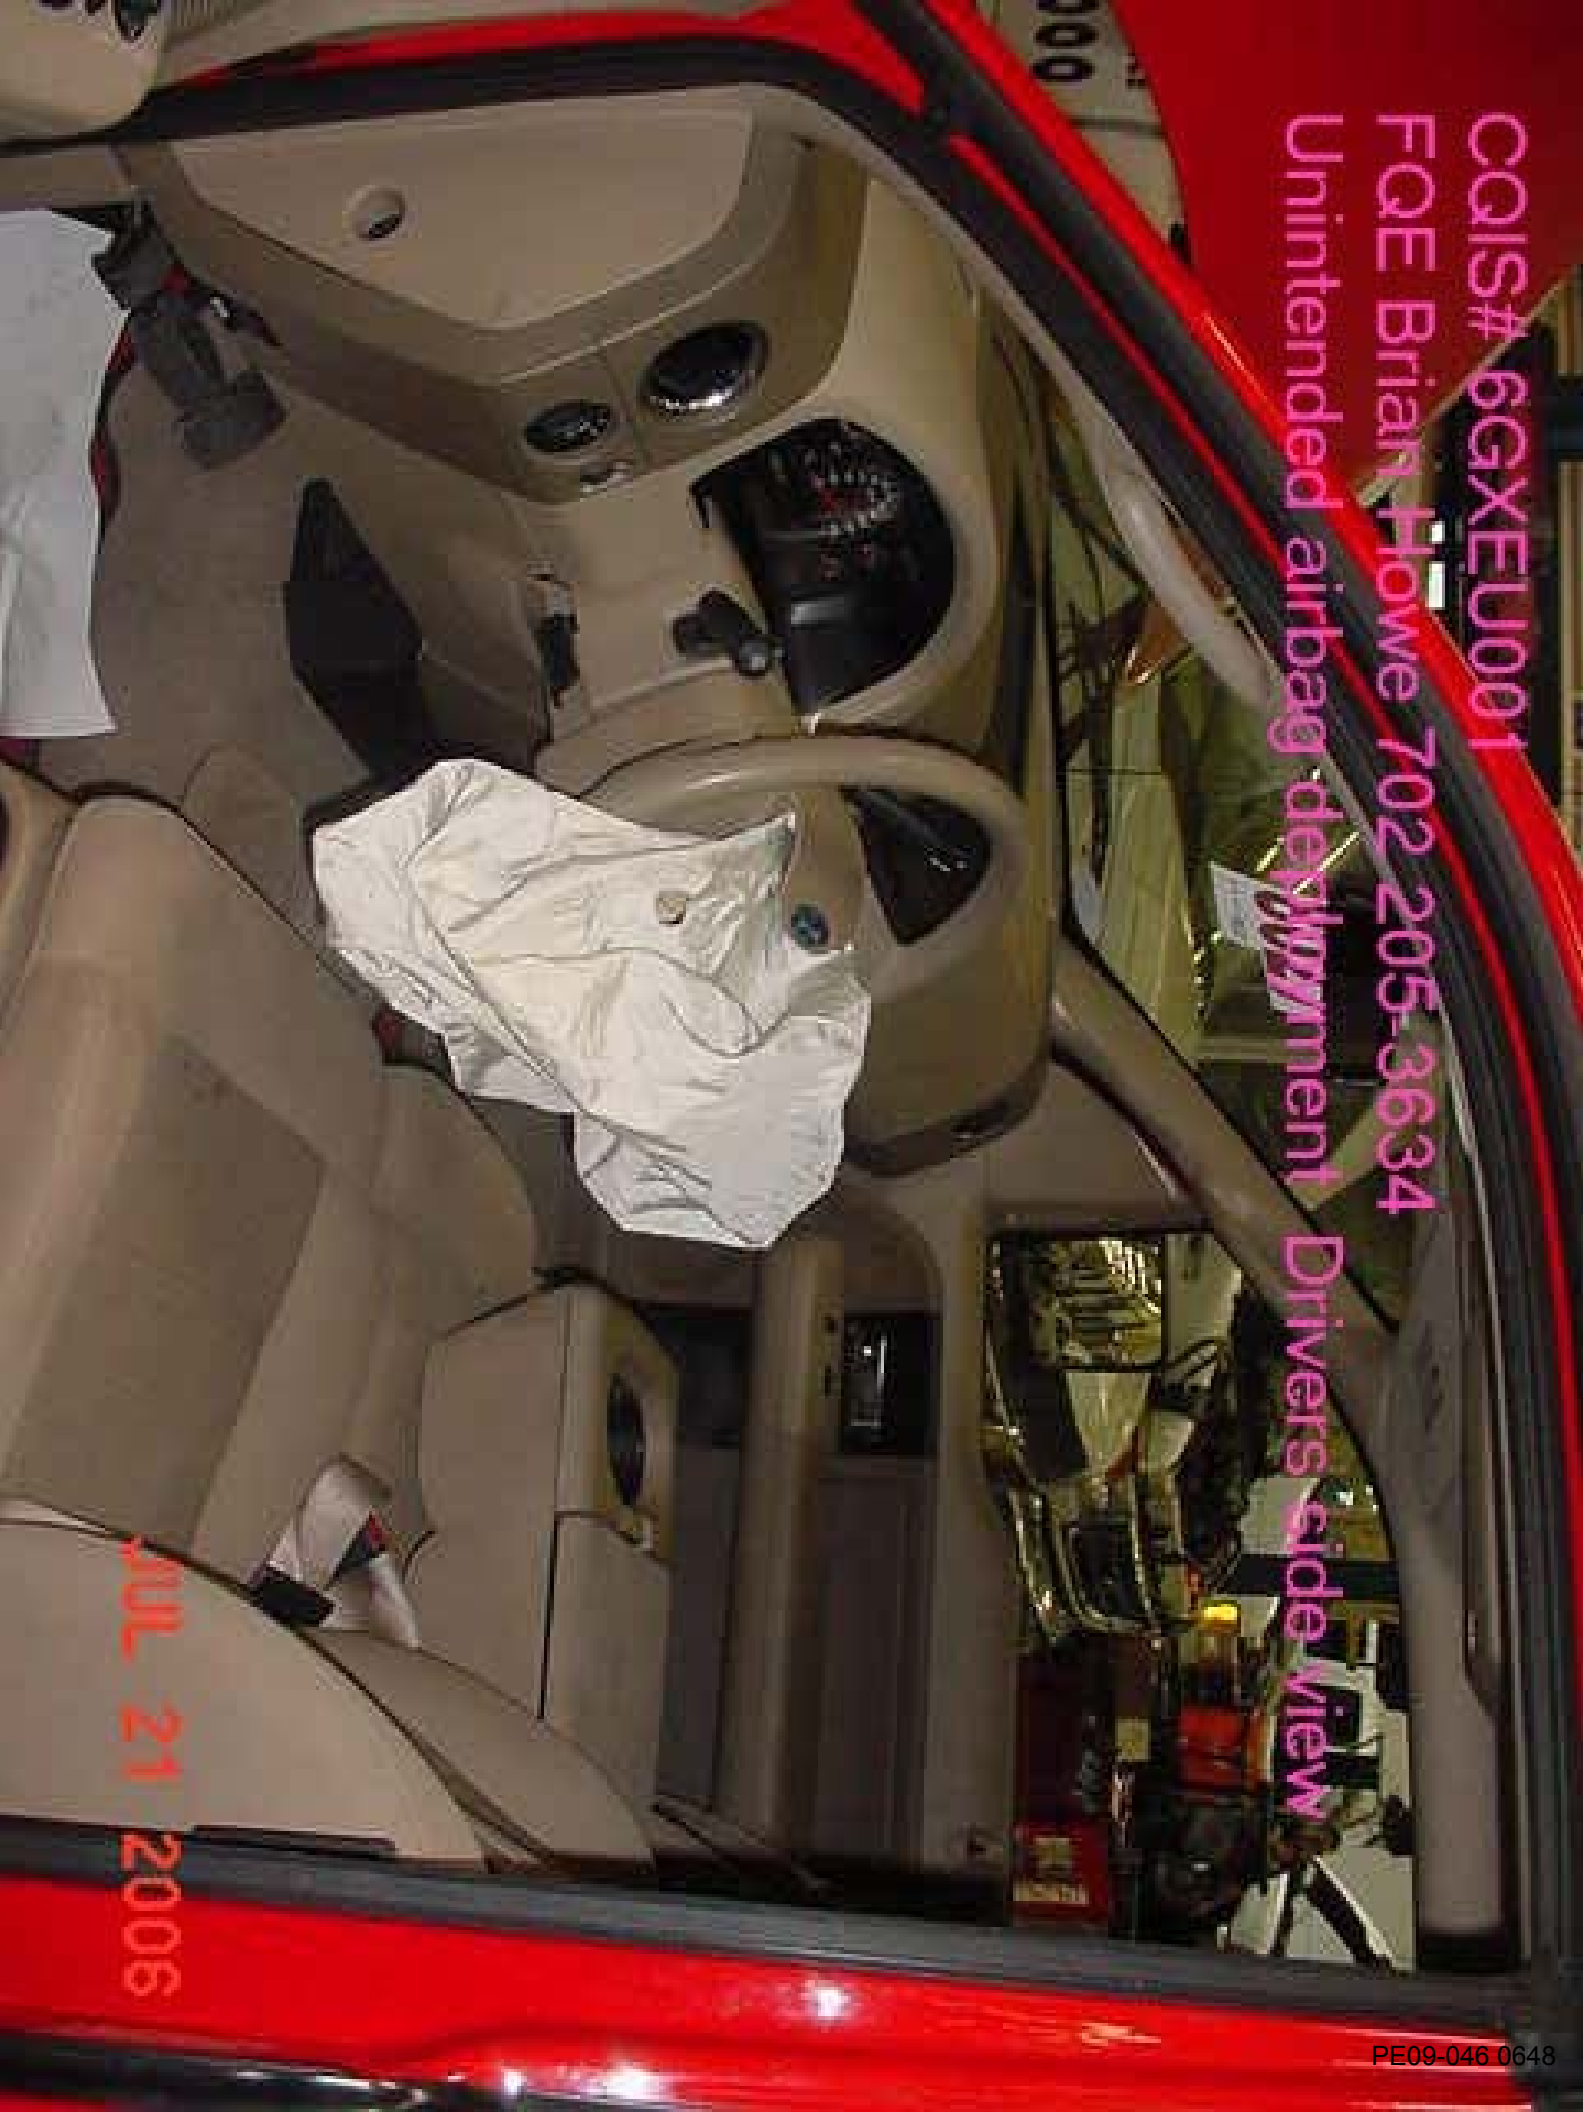
COIS# 6GXEU0001

Unintended airbag deployment Drivers side view

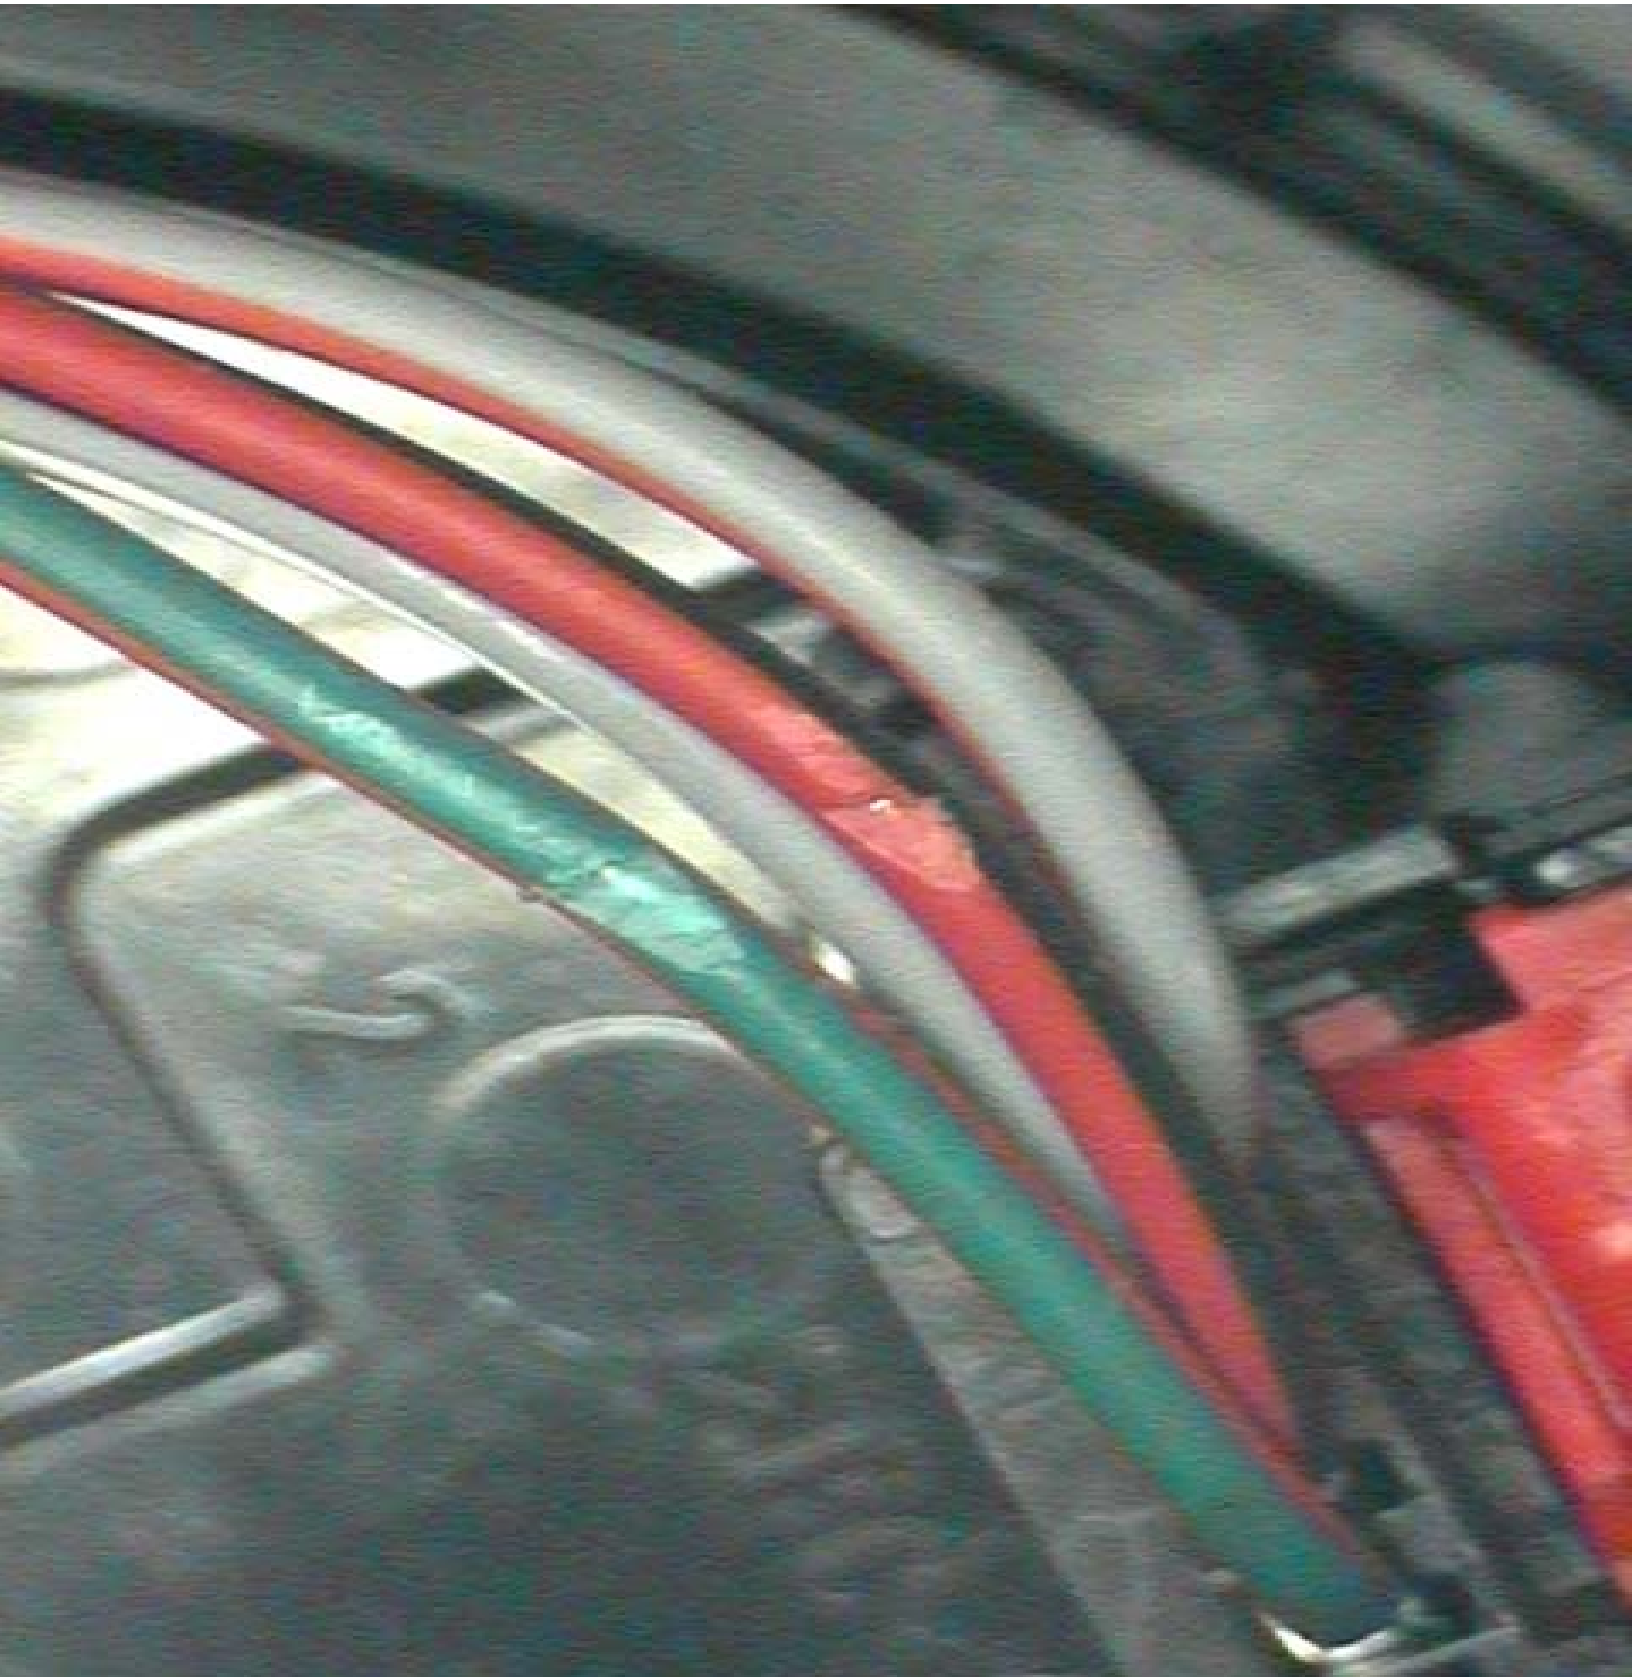
<<Claim095905.jpg>>

Roy,
There is a good reason why Methode is not seeing cut wires. I checked a couple of the claims where the squib wires were missing and the production date on the returned part is later than the vehicle build date. This implies that the technician removed the wires from a new Clock spring and replaced the pigtail only and then returned the new clockspring.

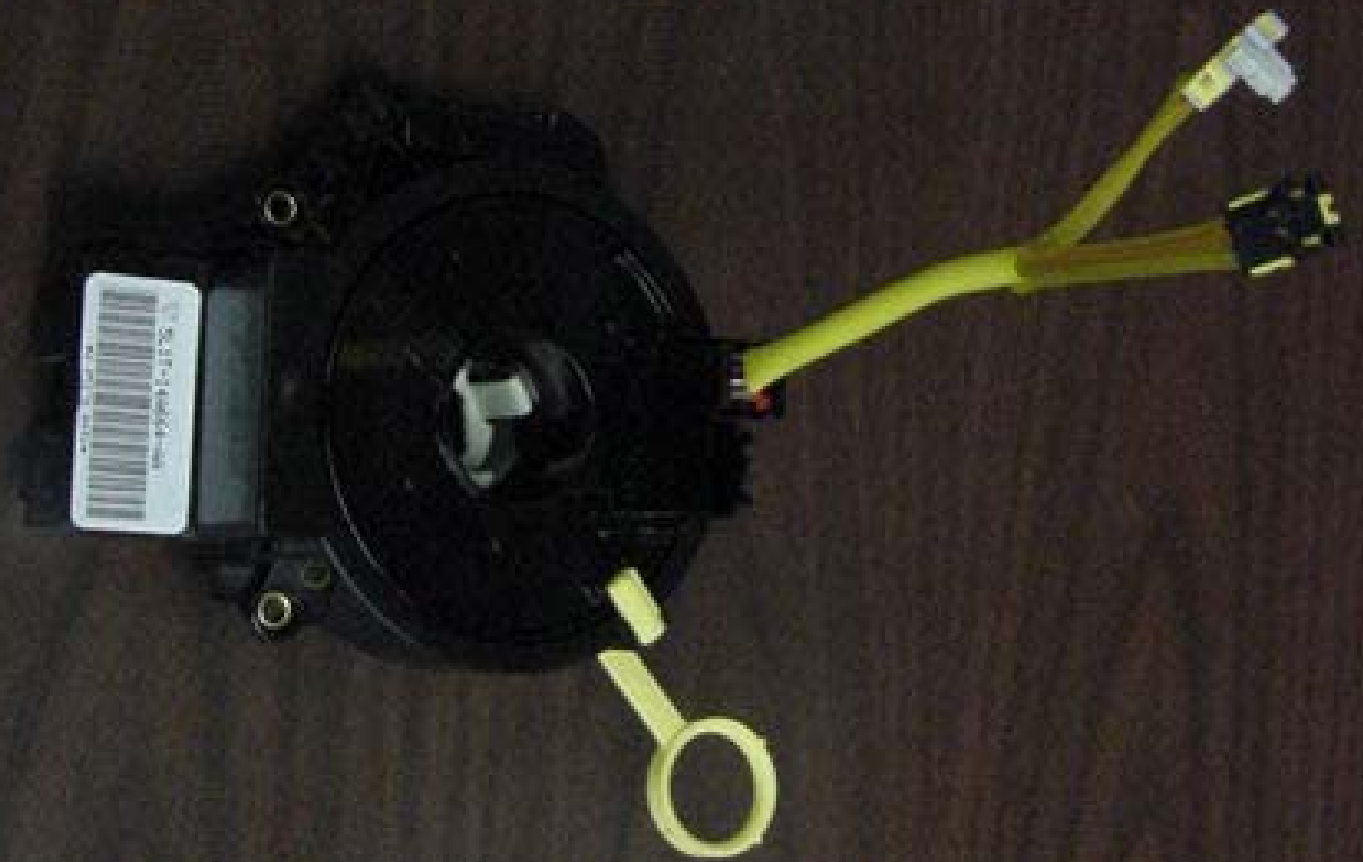
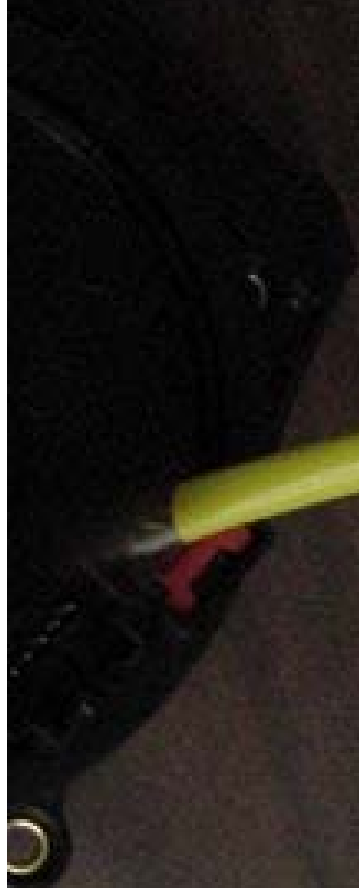
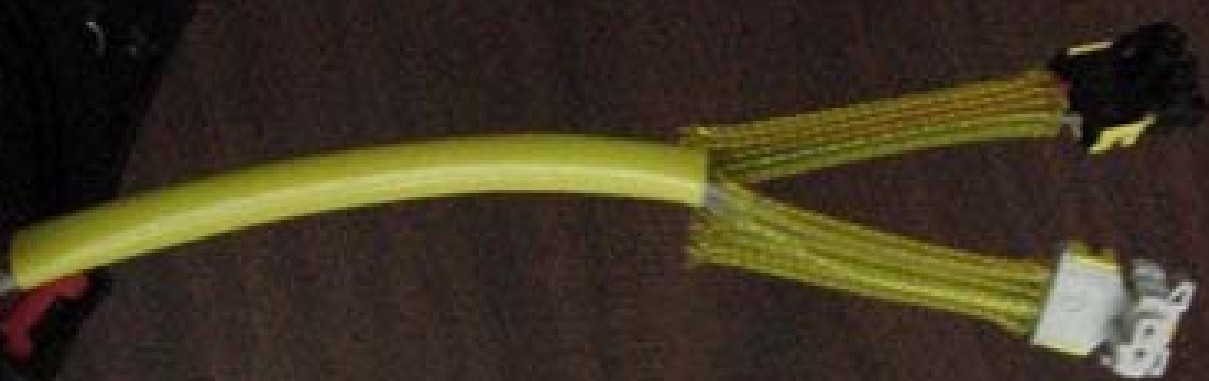
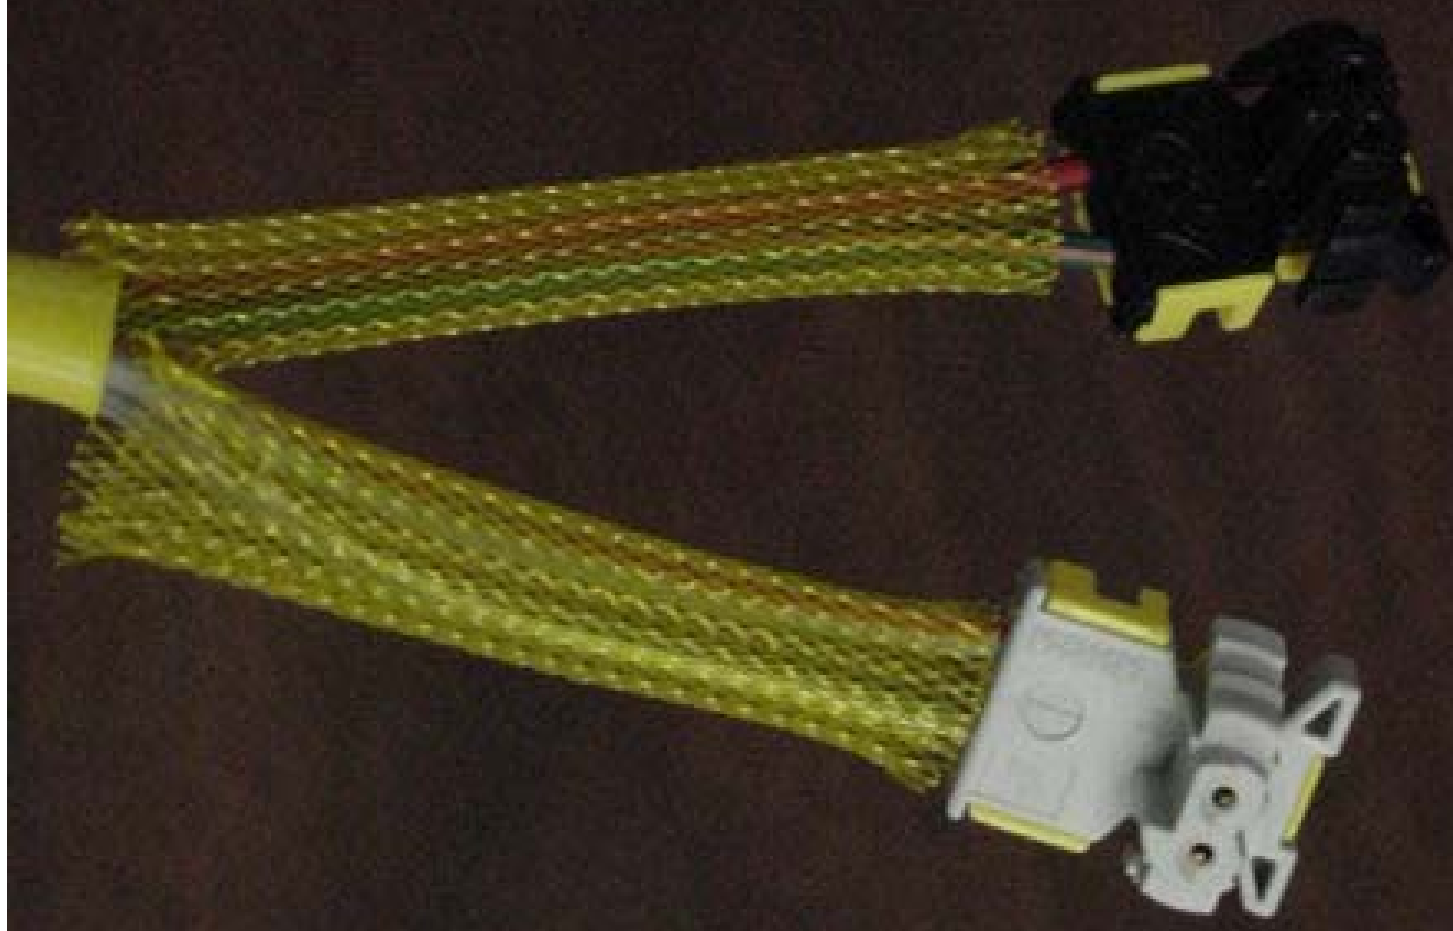
It appears to be feasible. I have attached some pictures indicating what the part would look like with the tubing added. I will put this part in the mail to your attention today. The part I am sending was just laying around my desk, so don't use it any vehicle.

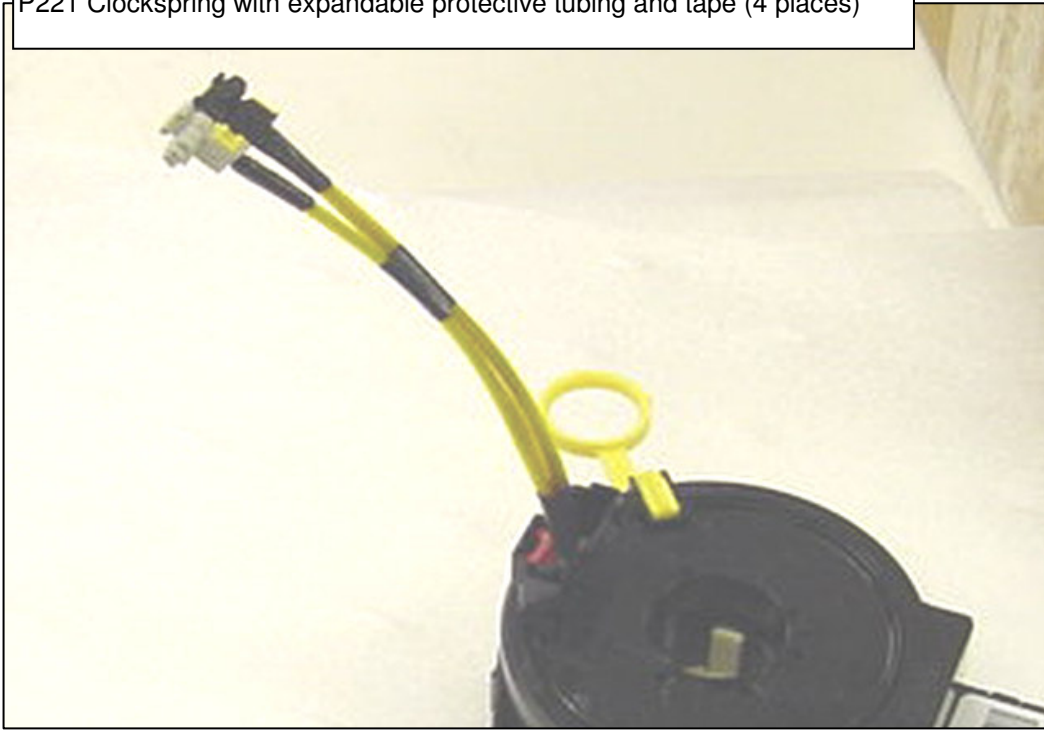
P221 Clockspring with expandable protective tubing and tape (4 places)
