Mazda's response: NHTSA Inquiry NVS-213kmb, RQ09-002

Mazda records indicate that the approximate total number of 2001 – 2004 Model Year Mazda Tribute vehicles subject to NHTSA recall number 07V-157 sold in the United States (the 50 states and the District of Columbia) and its protectorates and territories (American Samoa, Guam, Northern Mariana Islands, Puerto Rico, US Minor Outlying Islands, and Virgin Islands) is 95,349.

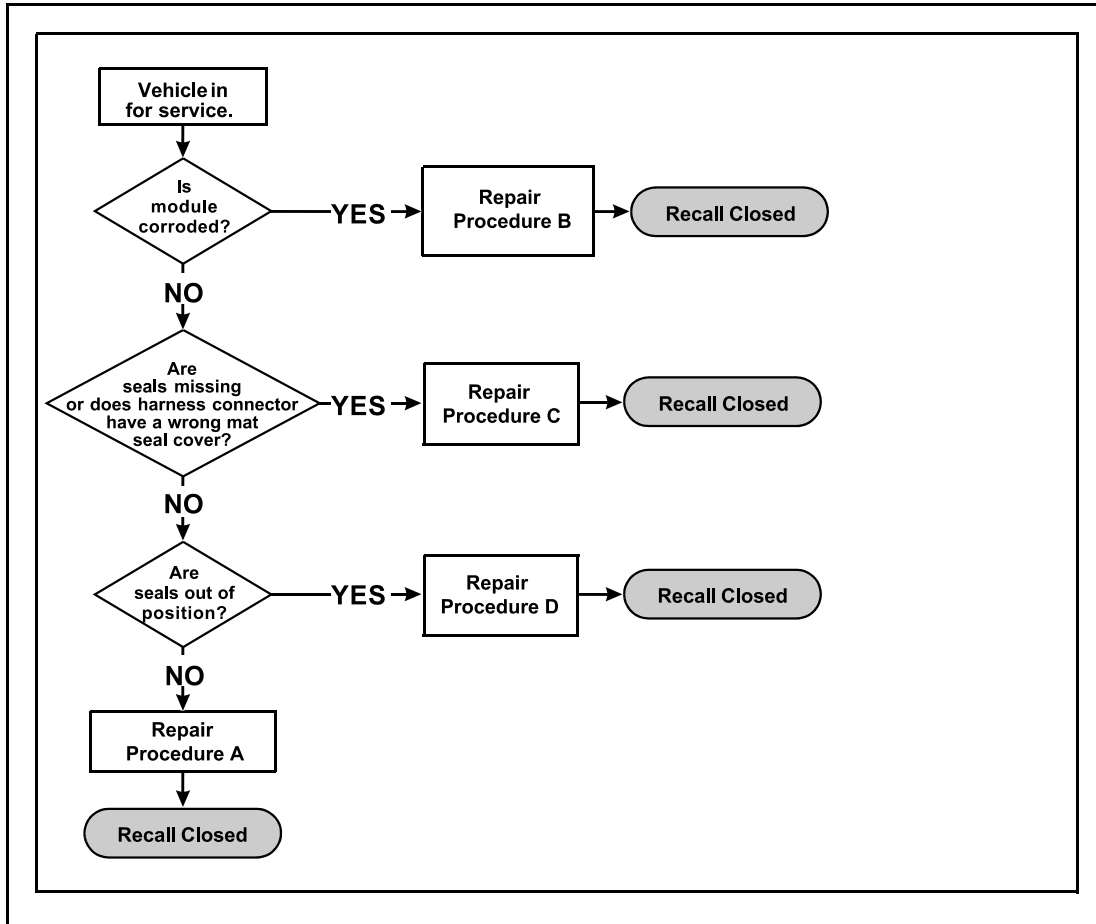
4507Cu

This program includes making sure the wiring harness connector is properly sealed against moisture/contamination, and inspecting the ABS module for evidence of corrosion resulting from an inadequately sealed connector.

During the inspection, we expect that most of the affected vehicles will not have any evidence of corrosion in the ABS module. However, the ABS wiring harness connector still needs to be inspected for missing or improperly seated seals and/or incorrect connector number.

If the ABS module is corroded, the ABS module and connector must be replaced.

A flow chart has been developed to help direct you to the proper repair.

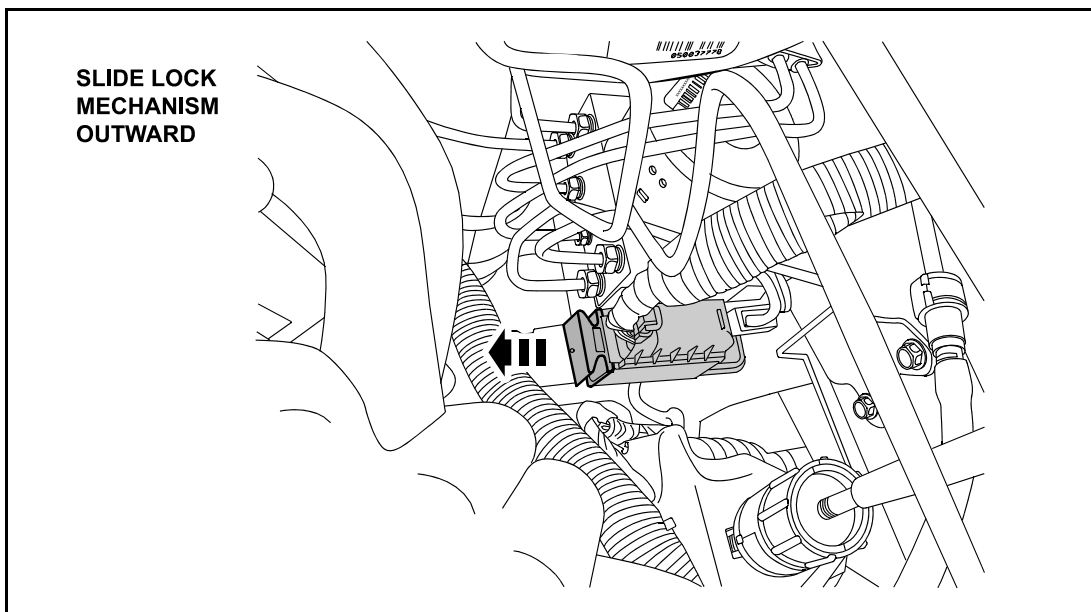
4507Cr

6. Inspect the ABS module connector pins for corrosion.
 - If corrosion is present, proceed to "REPAIR PROCEDURE B".

5. Disconnect the speed sensor harness, then remove the two (2) harness retainers from the studs and position the harness above the air cleaner assembly to provide access for inspection of the connector.

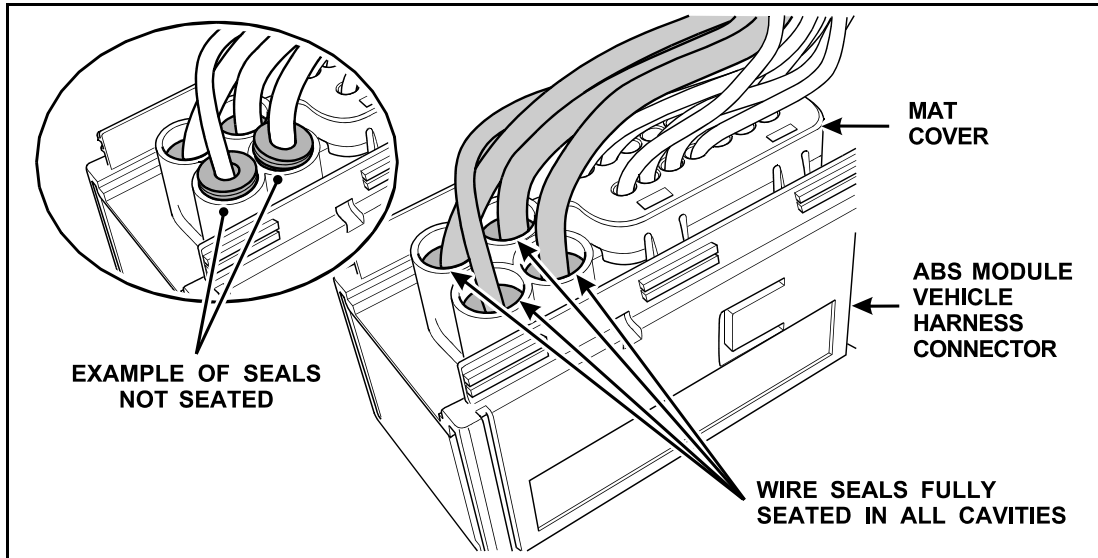
4507Ce

8. Verify the wire seals are present on the four (4) heavier gauge wires.

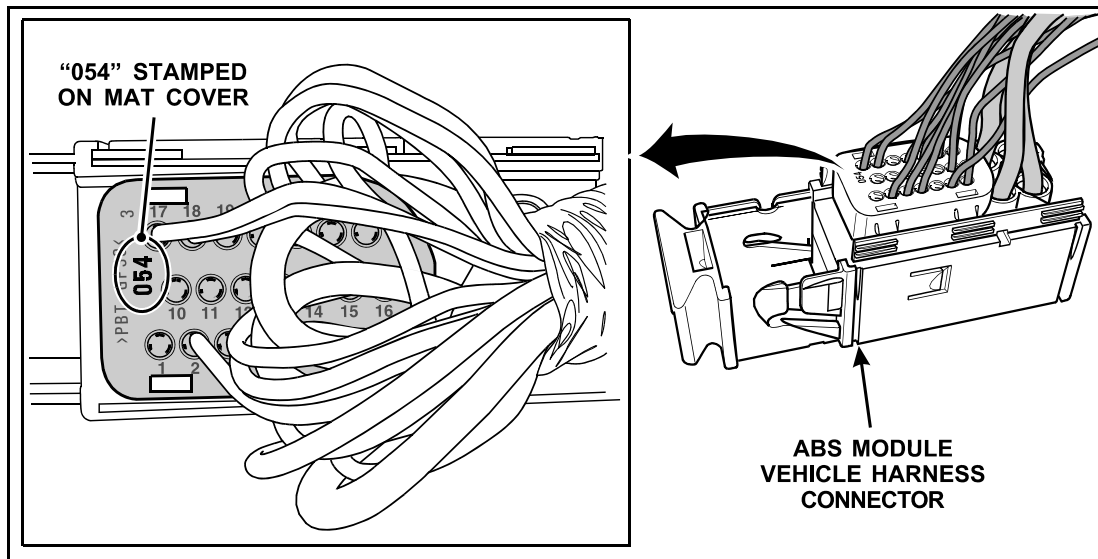
4507Cd

9. Verify the number “054” is stamped on the slide-lock end of the mat cover (wipe mat cover clean if necessary to view).

NOTE: Mat covers with any other number will be missing plugs in the unused pin locations.

- If the module is not corroded, **AND** all the wire seals are present, **AND** all the wire seals are fully seated, **AND** the number on the mat cover is “054”, proceed to “REPAIR PROCEDURE A”.
- If any of the wire seals are missing, **OR** if the number on the mat cover is not “054”, proceed to “REPAIR PROCEDURE C”.
- Verify all four (4) heavier gauge wire seals are fully seated in the cavities. Each seal should sit approximately 1-2 mm (1/16 in) below the top of the round cavity. If any of the wire seals are not seated properly, proceed to “REPAIR PROCEDURE D”.

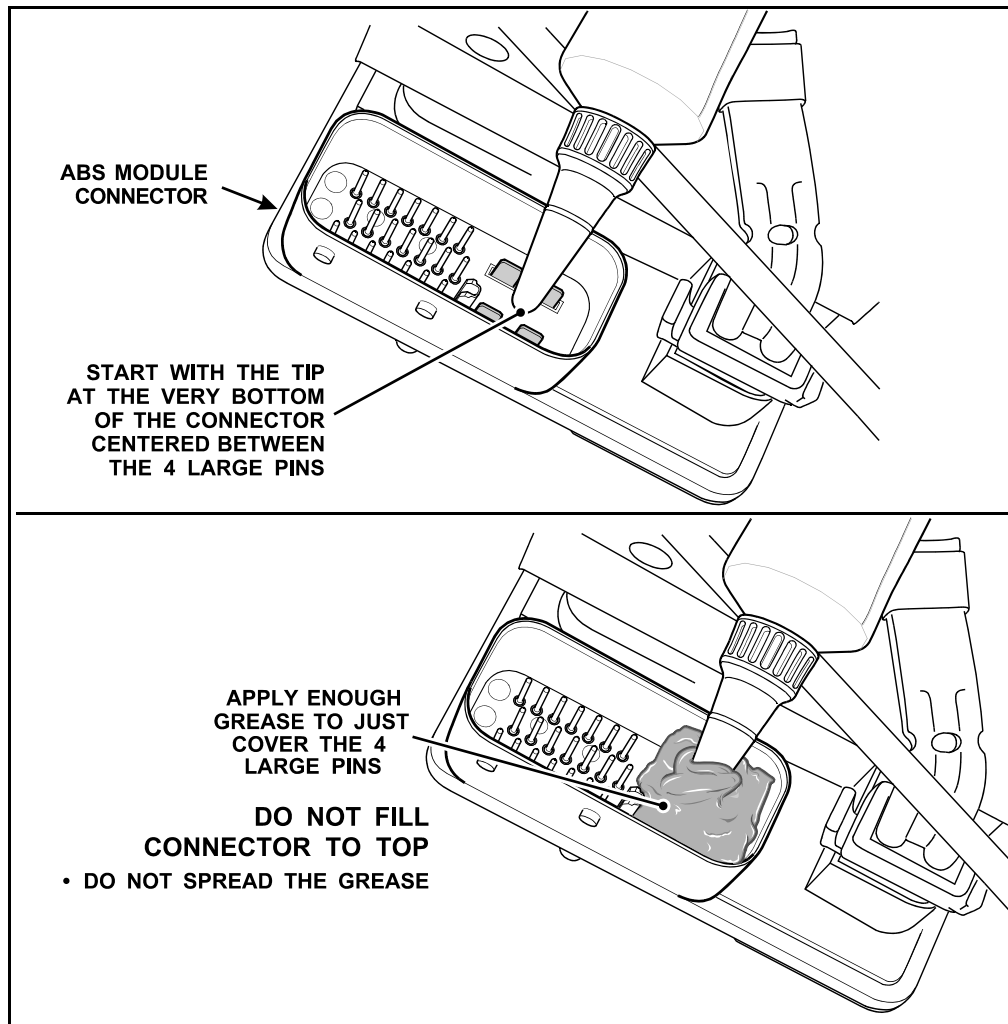
4507Ch

NOTE: DO NOT spread the grease around the connector. Applying an excess amount of grease into the connector cavity will cause a "hydro lock" condition which will not allow the connector to fully seat or lock in place.

- a) Reinstall dress cover.
- b) Use ONLY dielectric grease.
- With the tip of the applicator tube snipped off, position the end of the tip between the four (4) large flat pins at the bottom of the ABS module connector. Squeeze out enough grease to just cover the four (4) flat pins.

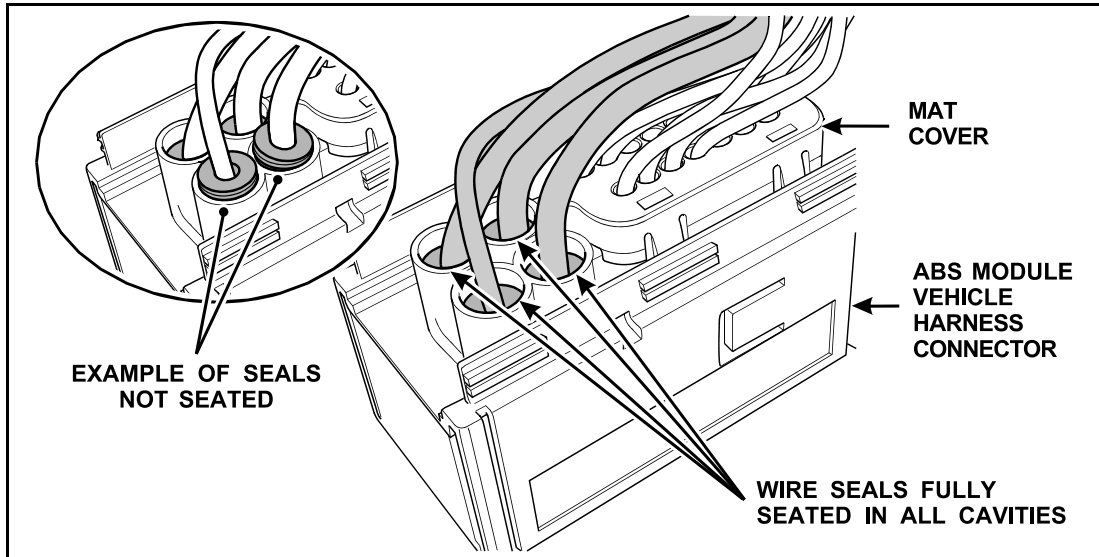
NOTE: DO NOT use anything sharp such as a screwdriver, awl or punch that could penetrate the seal and allow moisture to enter the terminal.

1. If the seals are not fully seated, reseat any seals not fully seated with a blunt tool.

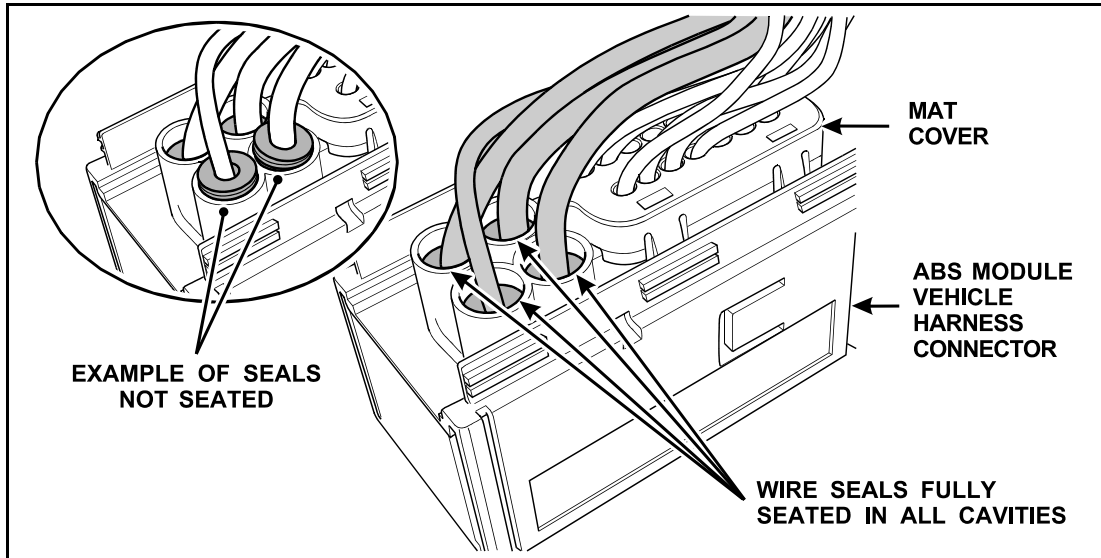
4507Ce

8. Verify the wire seals are present on the four (4) heavier gauge wires.

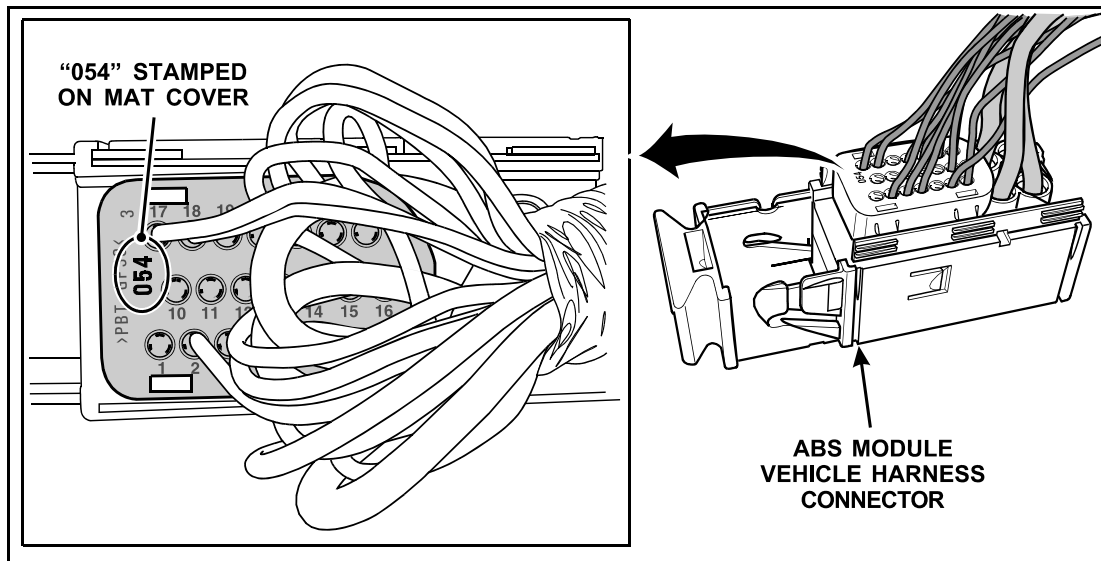
4507Cd

9. Verify the number “054” is stamped on the slide-lock end of the mat cover (wipe mat cover clean if necessary to view).

NOTE: Mat covers with any other number will be missing plugs in the unused pin locations.

- If the module is not corroded, **AND** all the wire seals are present, **AND** all the wire seals are fully seated, **AND** the number on the mat cover is “054”, proceed to “REPAIR PROCEDURE A”.
- If any of the wire seals are missing, **OR** if the number on the mat cover is not “054”, proceed to “REPAIR PROCEDURE C”.
- Verify all four (4) heavier gauge wire seals are fully seated in the cavities. Each seal should sit approximately 1-2 mm (1/16 in) below the top of the round cavity. If any of the wire seals are not seated properly, proceed to “REPAIR PROCEDURE D”.

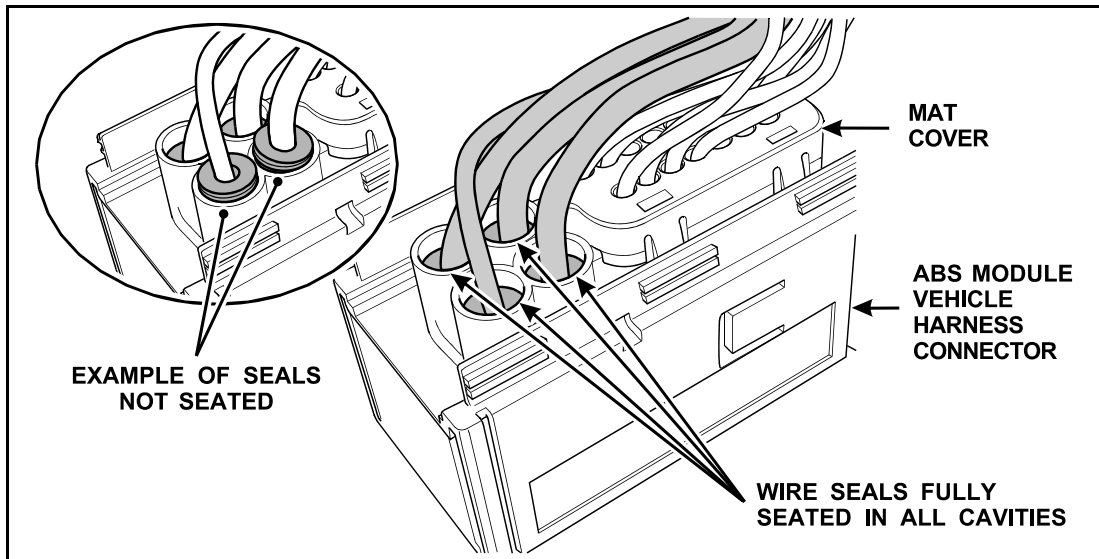
NOTE: DO NOT use anything sharp such as a screwdriver, awl or punch that could penetrate the seal and allow moisture to enter the terminal.

1. If the seals are not fully seated, reseat any seals not fully seated with a blunt tool.
