RQ09-002

FORD

c39371 grease over corrosion

**From:** Murphy, Gregory [mailto:MurphyG1@autonation.com]  
**Sent:** Thursday, September 06, 2007 8:21 PM  
**To:** sssc@renkim.com  
**Subject:** 2001 escape fire at abs control module pig tail

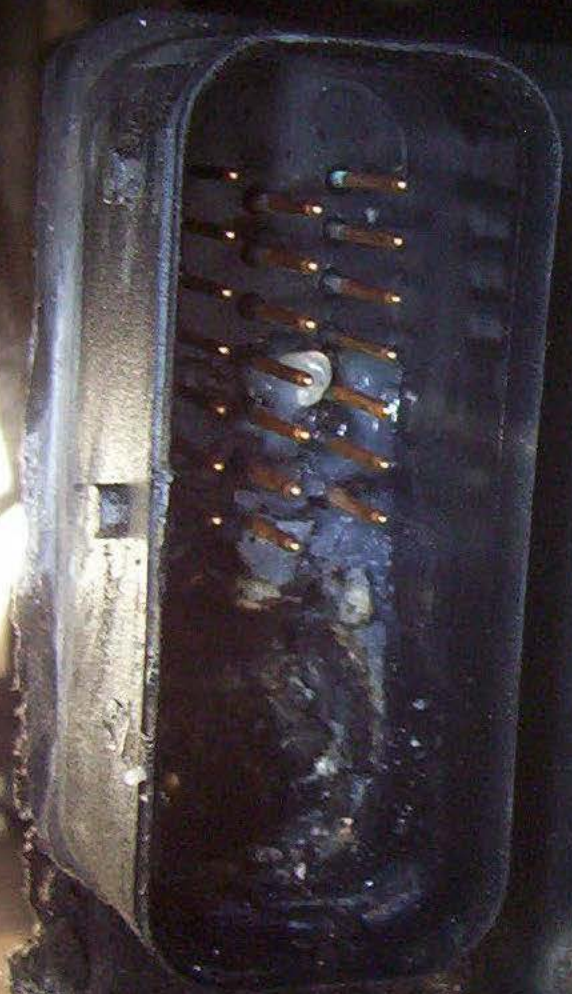
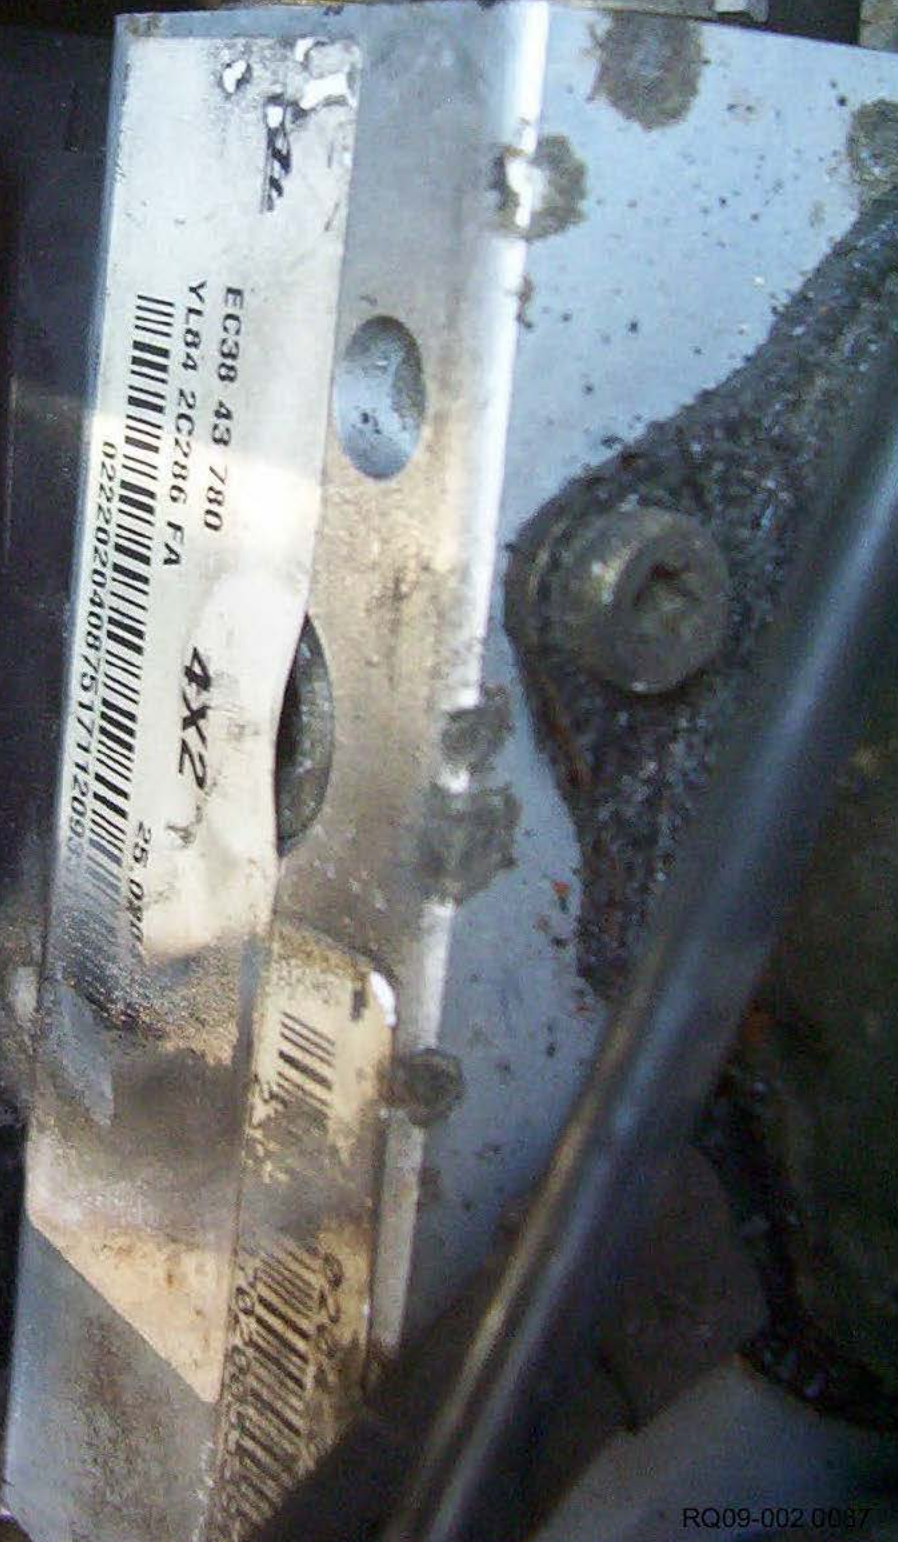
This one to me appears that they installed grease in a corroded pigtail. I am basing that on the fact that it got hot, but there are no pins left in the module at all. I can see some green corrosion on the smaller pins that did not get any grease on the extreme left of the picture.
