# ODI RESUME

**Investigation:** EA 10-003  
**Prompted by:** Consumer Complaint  
**Date Opened:** 04/13/2010 **Date Closed:** 03/05/2012  
**Investigator:** Bruce York-B  
**Approver:** Frank Borris  
**Subject:** HVAC Switch Failures

**Manufacturer:** FORD MOTOR COMPANY  
**Products:** 1997-2008 E350/450 Ford Cab/Chassis  
**Population:** 1,076,975  
**Problem Description:** The Blower Motor Control Switch on certain Ford E350/450 vehicles may overheat/melt and catch fire.

**ENGINEERING ANALYSIS CLOSING REPORT****SUBJECT VEHICLES: 1997-2008 E350/450 Ford Cab/Chassis Vehicles****EA No.: 10-003****Date Opened: 13-Apr-10****Date Closed: 05-Mar-12**

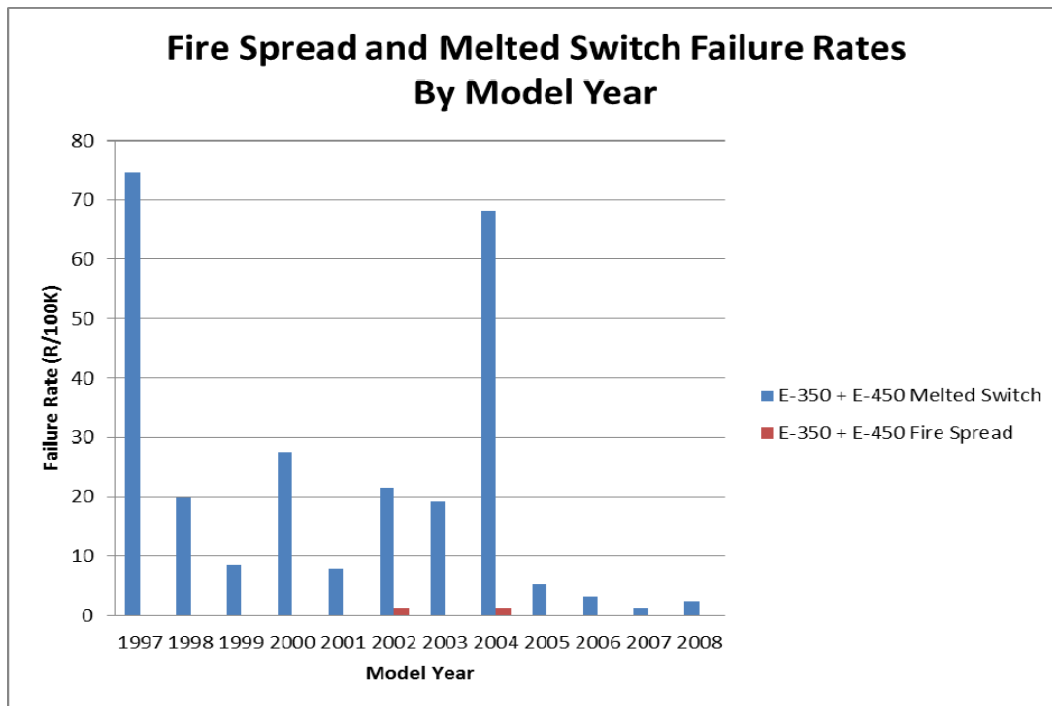
Chart 1. Complaint Rate Analysis

Chart 1. indicates the failure rate of blower motor control switches that resulted in a fire spreading to components other than the switch itself is very low. There were only two incidents where ODI believes this type of fire occurred. The overall failure rate for fire spreading from the blower motor control switch is 0.2 R/100K for the entire population of subject vehicles.

Chart 1. also shows that the rate of blower motor control switches melting or burning is higher for certain model year vehicles. ODI believes the reason for the large differences in failure rates between the model years results from how the failures were reported to the office. The majority of the failures were reported to ODI from 4 fleets. These fleets often do not have large numbers of vehicles from each model year and in some cases may only have vehicles from select model years. For this reason the majority of the data reported to ODI was from a very narrow group of model year vehicles and resulted in certain model years being over represented. ODI does not believe there is a design or manufacturing difference that is driving these differences in failure rates. ODI's opinion is supported by the warranty claims data that is derived from a much larger population of vehicles. The overall rate for melted or burned switches is 20.6 R/100K for the entire subject vehicle population. The average (first switch failure) mileage for these vehicles is 139,010 miles.

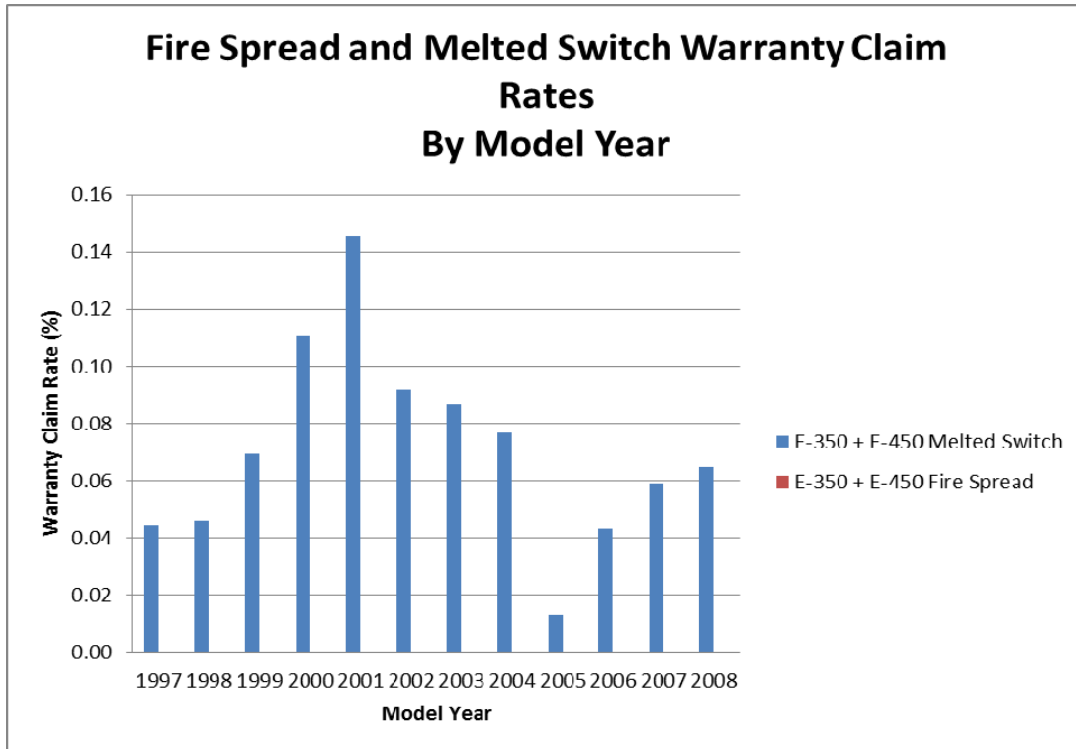
Chart 2. Warranty Rate Analysis

**WARRANTY DATA:** Warranty data submitted by Ford in response to ODI's December 14, 2009 and June 17, 2010 information request (IR) letters identified 746 warranty claims potentially related to the alleged defect condition in the subject vehicles. The data indicate that the alleged defect condition, identified from claims of blower motor control switches melting, smoking, burning or developing open flame and becoming inoperable, has been reported on 0.07 percent for the subject vehicles. These warranty claim rates are shown in Chart 2 for each model year vehicle. Of the 746 claims, none was found to have developed open flame caused by a blower motor control switch failure. The standard warranty coverage for the subject vehicles is 3

years or 36,000 miles. Although the average failure mileage for complaint vehicles is 139,010 miles (well outside the warranty coverage period), the average failure mileage for the warranty claims provided by Ford is 56,246 miles (also outside standard coverage) and shows that the warranty data does provided some indication of blower motor switch failure rates. The switches in these claims were covered by “good will” or extended warranty policies.
