# ODI RESUME

**Investigation:** PE 10-048  
**Date Opened:** 12/07/2010  
**Investigator:** Tom Bowman  
**Approver:** Frank Borris  
**Subject:** Hitch Receiver Fracture

**Manufacturer:** Winnebago Industries, Inc  
**Products:** 2006 Model Year Winnebago Itasca  
**Population:** 9,300 (Estimated)

### Hitch Receiver Assemblies Installed in Model Year 2006 Winnebago and Itasca Recreational Vehicles: Concern that Hitch Receiver May Fracture in Service Resulting in the Separation of the Towed Vehicle

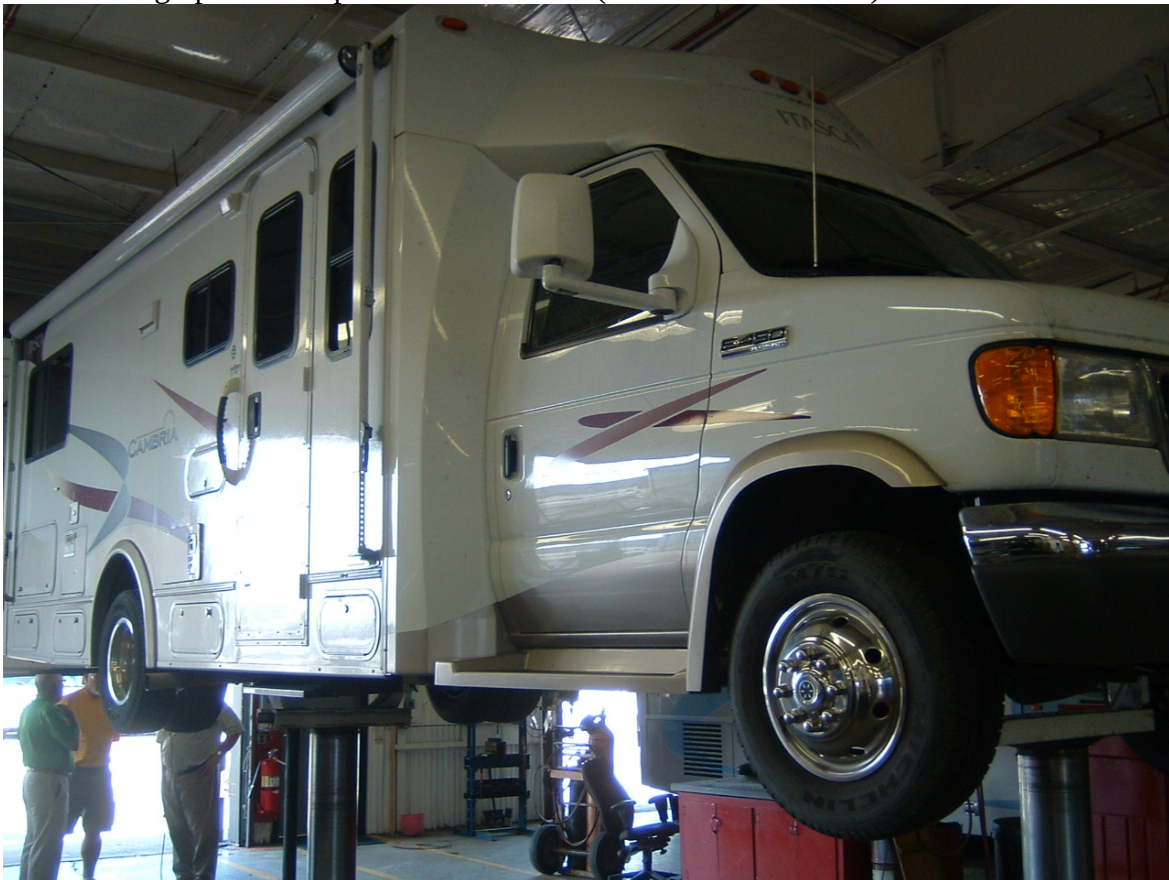
Photograph 1 - A representative vehicle (2006 Itasca Cambria) on a vehicle lift.

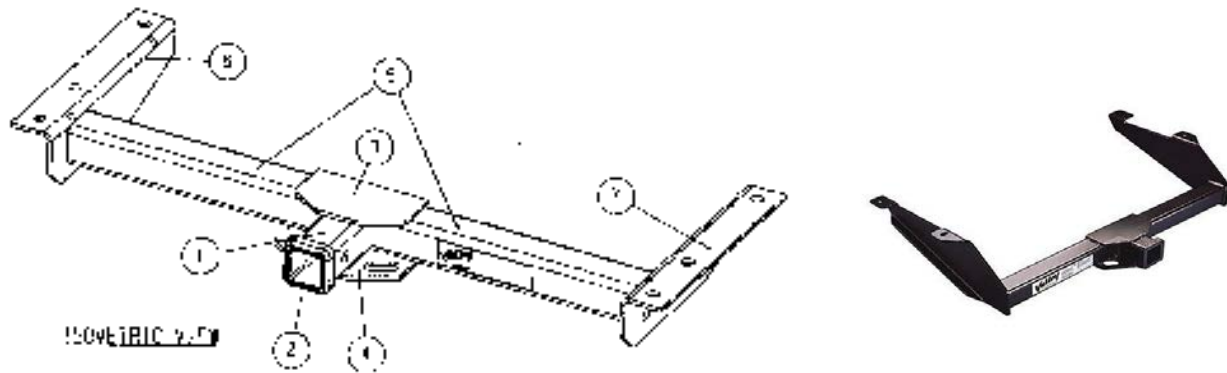
### Engineering Sketch # 1 – Representative Hitch Receiver (two depictions)

Engineering Sketch # 1 (below) depicts a representative hitch receiver assembly. The hitch receiver assembly is mounted to the vehicle frame using bolts installed through the holes provided in the right-angled brackets that are welded to each end of the transversely-mounted round-corner-square shaped tube.

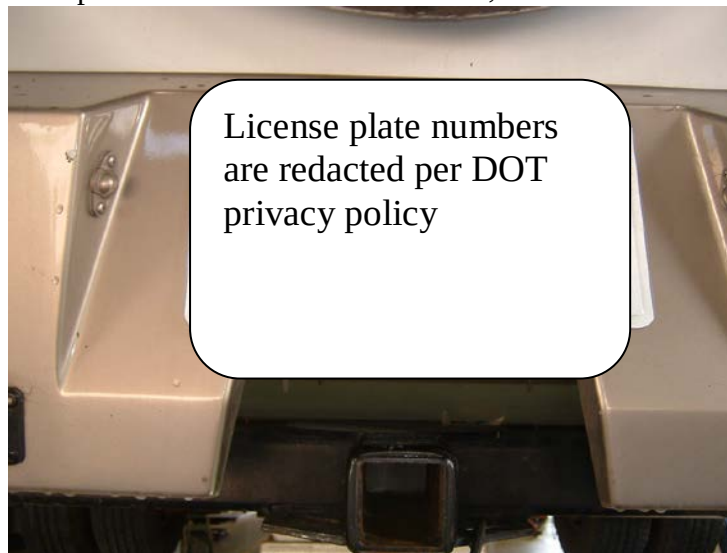
The ball-mount (hitch) is inserted into an exposed round-cornered, square-shaped hole (identified as Number 2 in the left side sketch above and also shown in Photograph 2 below) mounted at the rear of the towing vehicle. The exposed square-shaped hole of the hitch receiver “hosts” a mating hitch assembly. Photograph 2 below depicts this square-shaped hole without a hitch installed.)

Photograph 2- Exposed Portion of Hitch Receiver, Location for Hitch Installation

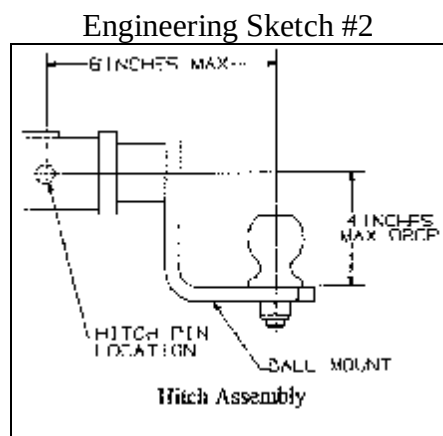
Engineering Sketch # 2 (shown below) depicts the profile of a representative hitch that may be installed in a hitch receiver assembly and illustrates the maximum allowable offset dimensions of 4 inches vertical and 8 inches horizontal that Winnebago has warned against exceeding for use with the hitch receiver assembly mounted to their vehicles. The hitch is secured with a transversely installed locking pin or equivalent.

The horizontal and/or vertical offsets associated with the installed hitch assembly affect the magnitude of the forces imposed on the hitch receiver affecting the hitch receiver's structural integrity and durability.
