### GM 4/14/2010 ATTACHMENT Q 07 04-03-08-006D Steering and Front Suspension Noise Concerns

### #04-03-08-006D: Steering and Front Suspension Noise Concerns - Clunk, Thump, Rattle, Knocking, Pop, Shudder, Vibration (Diagnosis and Perform Necessary Repairs) - (Feb 24, 2009)

Models: 2005-2009 Chevrolet Cobalt (Including SS) 2006-2009 Chevrolet HHR (Including SS) 2005-2006 Pontiac Pursuit (Canada Only) 2007-2009 Pontiac G5 2003-2007 Saturn ION

### This bulletin is being revised to add Condition #3. Please discard Corporate Bulletin Number 04-03-08-006C (Section 03 - Suspension).

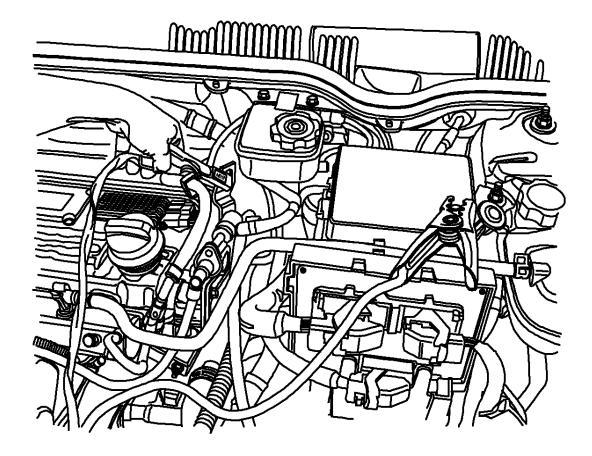
• For 2003 and 2004 model year IONs, attach the black negative (-) cable to the engine lift

*hook* of the dead battery vehicle, about 18 inches (45 cm) away from the remote positive (+) terminal, but not near engine parts that move.

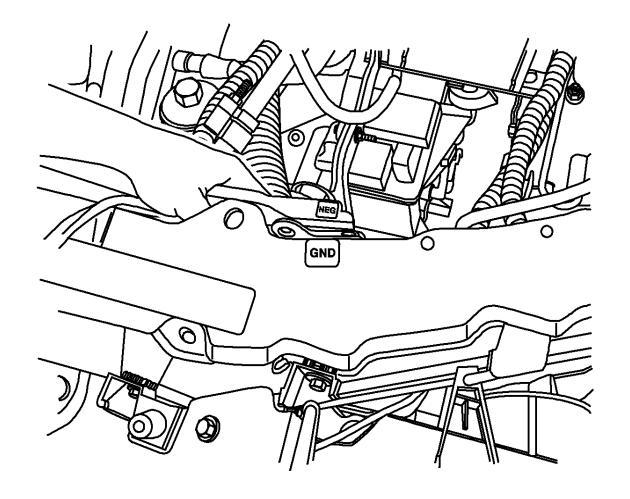
• For 2005 and 2006 model year IONs, attach the black negative (-) cable to the *remote negative terminal*. The remote terminal is located under the GND (-) sticker on the driver side of the radiator support bar (near hood prop rod).

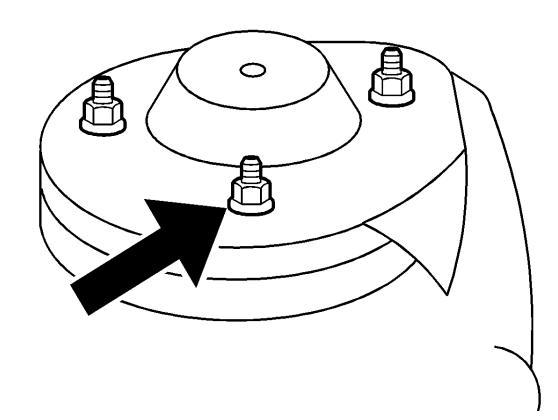
- For 2006 HHRs, attach the black negative (-) cable to the *remote negative terminal*. The remote terminal is located on the driver's side shock tower and is marked with a GND (-) sticker.
- 10. Now start the vehicle with the good battery and run the engine for a while.
- 11. Press the unlock button on the remote keyless entry transmitter to disarm your security system, if equipped.
