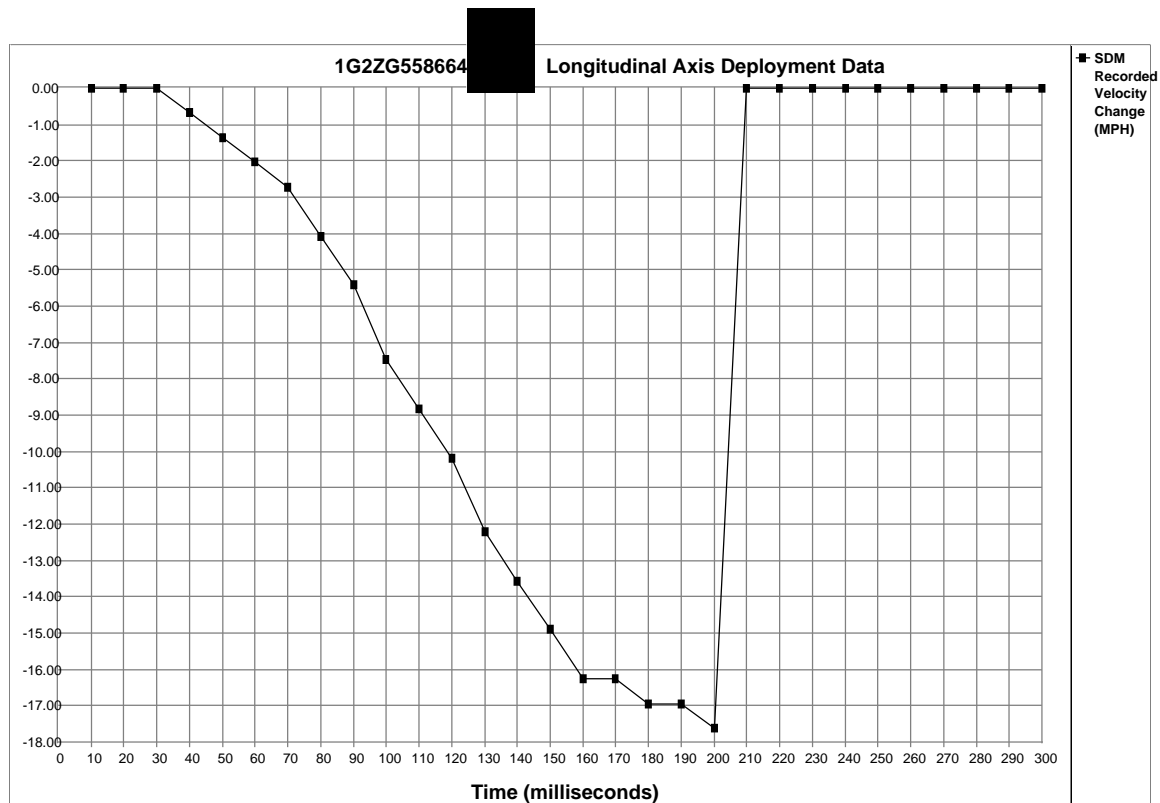
Time (milliseconds)	10	20	30	40	50	60	70	80	90	100	110	120	130	140	150
Longitudinal Axis Recorded Velocity	0.00	0.00	0.00	-0.68	-1.36	-2.03	-2.71	-4.07	-5.42	-7.46	-8.81	-10.17	-12.20	-13.56	-14.91
Time (milliseconds)	160	170	180	190	200	210	220	230	240	250	260	270	280	290	300
Longitudinal Axis Recorded Velocity	-16.27	-16.27	-16.95	-16.95	-17.62	0.00	0.00	0.00	0.00	0.00	0.00	0.00	0.00	0.00	0.00

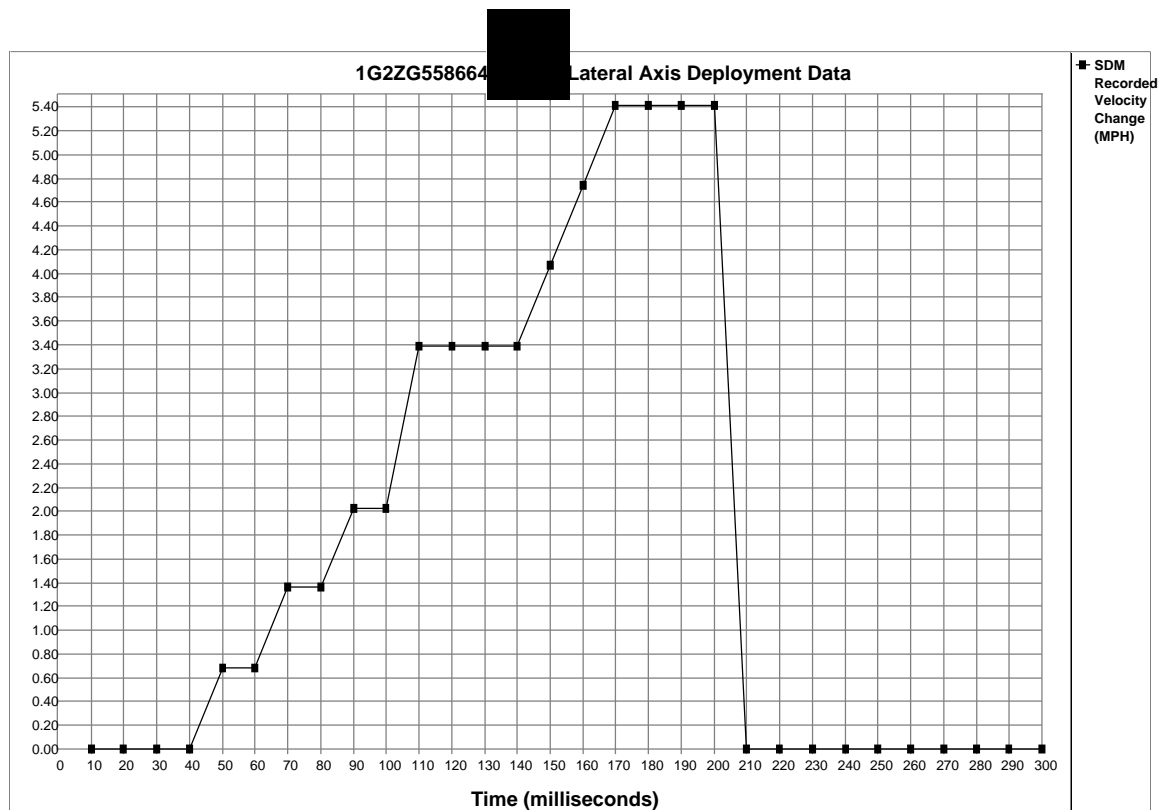
Time (milliseconds)	10	20	30	40	50	60	70	80	90	100	110	120	130	140	150
Lateral Axis Recorded Velocity Change (MPH)	0.00	0.00	0.00	0.00	0.68	0.68	1.36	1.36	2.03	2.03	3.39	3.39	3.39	3.39	4.07
Time (milliseconds)	160	170	180	190	200	210	220	230	240	250	260	270	280	290	300
Lateral Axis Recorded Velocity Change (MPH)	4.74	5.42	5.42	5.42	5.42	0.00	0.00	0.00	0.00	0.00	0.00	0.00	0.00	0.00	0.00

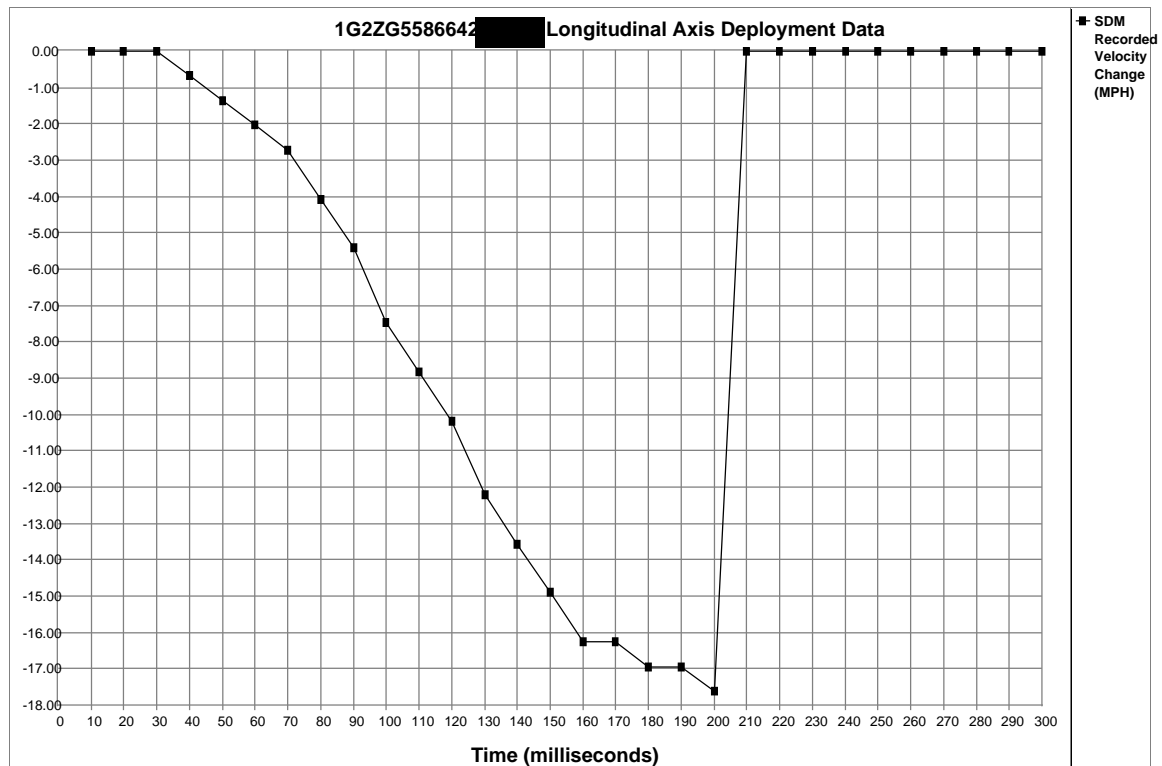
Time (milliseconds)	10	20	30	40	50	60	70	80	90	100	110	120	130	140	150
Longitudinal Axis Recorded Velocity	0.00	0.00	0.00	-0.68	-1.36	-2.03	-2.71	-4.07	-5.42	-7.46	-8.81	-10.17	-12.20	-13.56	-14.91
Time (milliseconds)	160	170	180	190	200	210	220	230	240	250	260	270	280	290	300
Longitudinal Axis Recorded Velocity	-16.27	-16.27	-16.95	-16.95	-17.62	0.00	0.00	0.00	0.00	0.00	0.00	0.00	0.00	0.00	0.00

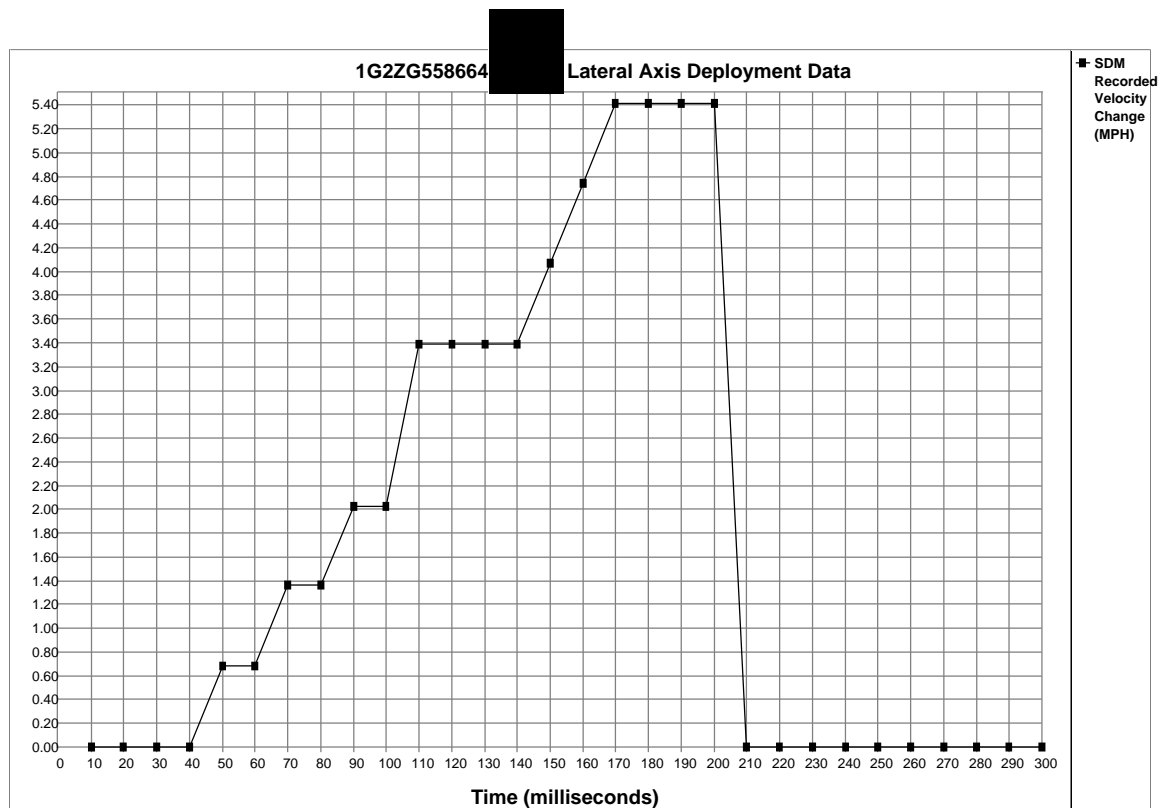
Time (milliseconds)	10	20	30	40	50	60	70	80	90	100	110	120	130	140	150
Lateral Axis Recorded Velocity Change (MPH)	0.00	0.00	0.00	0.00	0.68	0.68	1.36	1.36	2.03	2.03	3.39	3.39	3.39	3.39	4.07
Time (milliseconds)	160	170	180	190	200	210	220	230	240	250	260	270	280	290	300
Lateral Axis Recorded Velocity Change (MPH)	4.74	5.42	5.42	5.42	5.42	0.00	0.00	0.00	0.00	0.00	0.00	0.00	0.00	0.00	0.00
