**Photo Log**  
**PAR 1-401424761**  
**1G1ZS52F05FXXXXXX**  
**Photographs by Donald J. Hutelin, EAA**  
**4/13/2006**

Vehicle Identification Number	1G1ZS52F05F [REDACTED]
Investigator	Donald J Hutelin, EAA
Case Number	1-401424761
Investigation Date	Thursday, April 13 2006
Crash Date	Saturday, March 25 2006
Filename	1G1ZS52F05F [REDACTED].CDR
Saved on	Thursday, April 13 2006 at 10:57:50 AM
Collected with CDR version	Crash Data Retrieval Tool 2.800
Collecting program verification number	9238B95E
Reported with CDR version	Crash Data Retrieval Tool 2.800
Reporting program verification number	9238B95E
Interface used to collected data	Block number: 00 Interface version: 4A Date: 11-08-05 Checksum: 7500
Event(s) recovered	Non-Deployment

Customer's Name: (REDACTED) Inspection Date: 4/13/2006  
 Vehicle Brand: Chevrolet Model: Malibu  
 File # 1-401424761 VIN: 1G1ZS52F05FXXXXXX

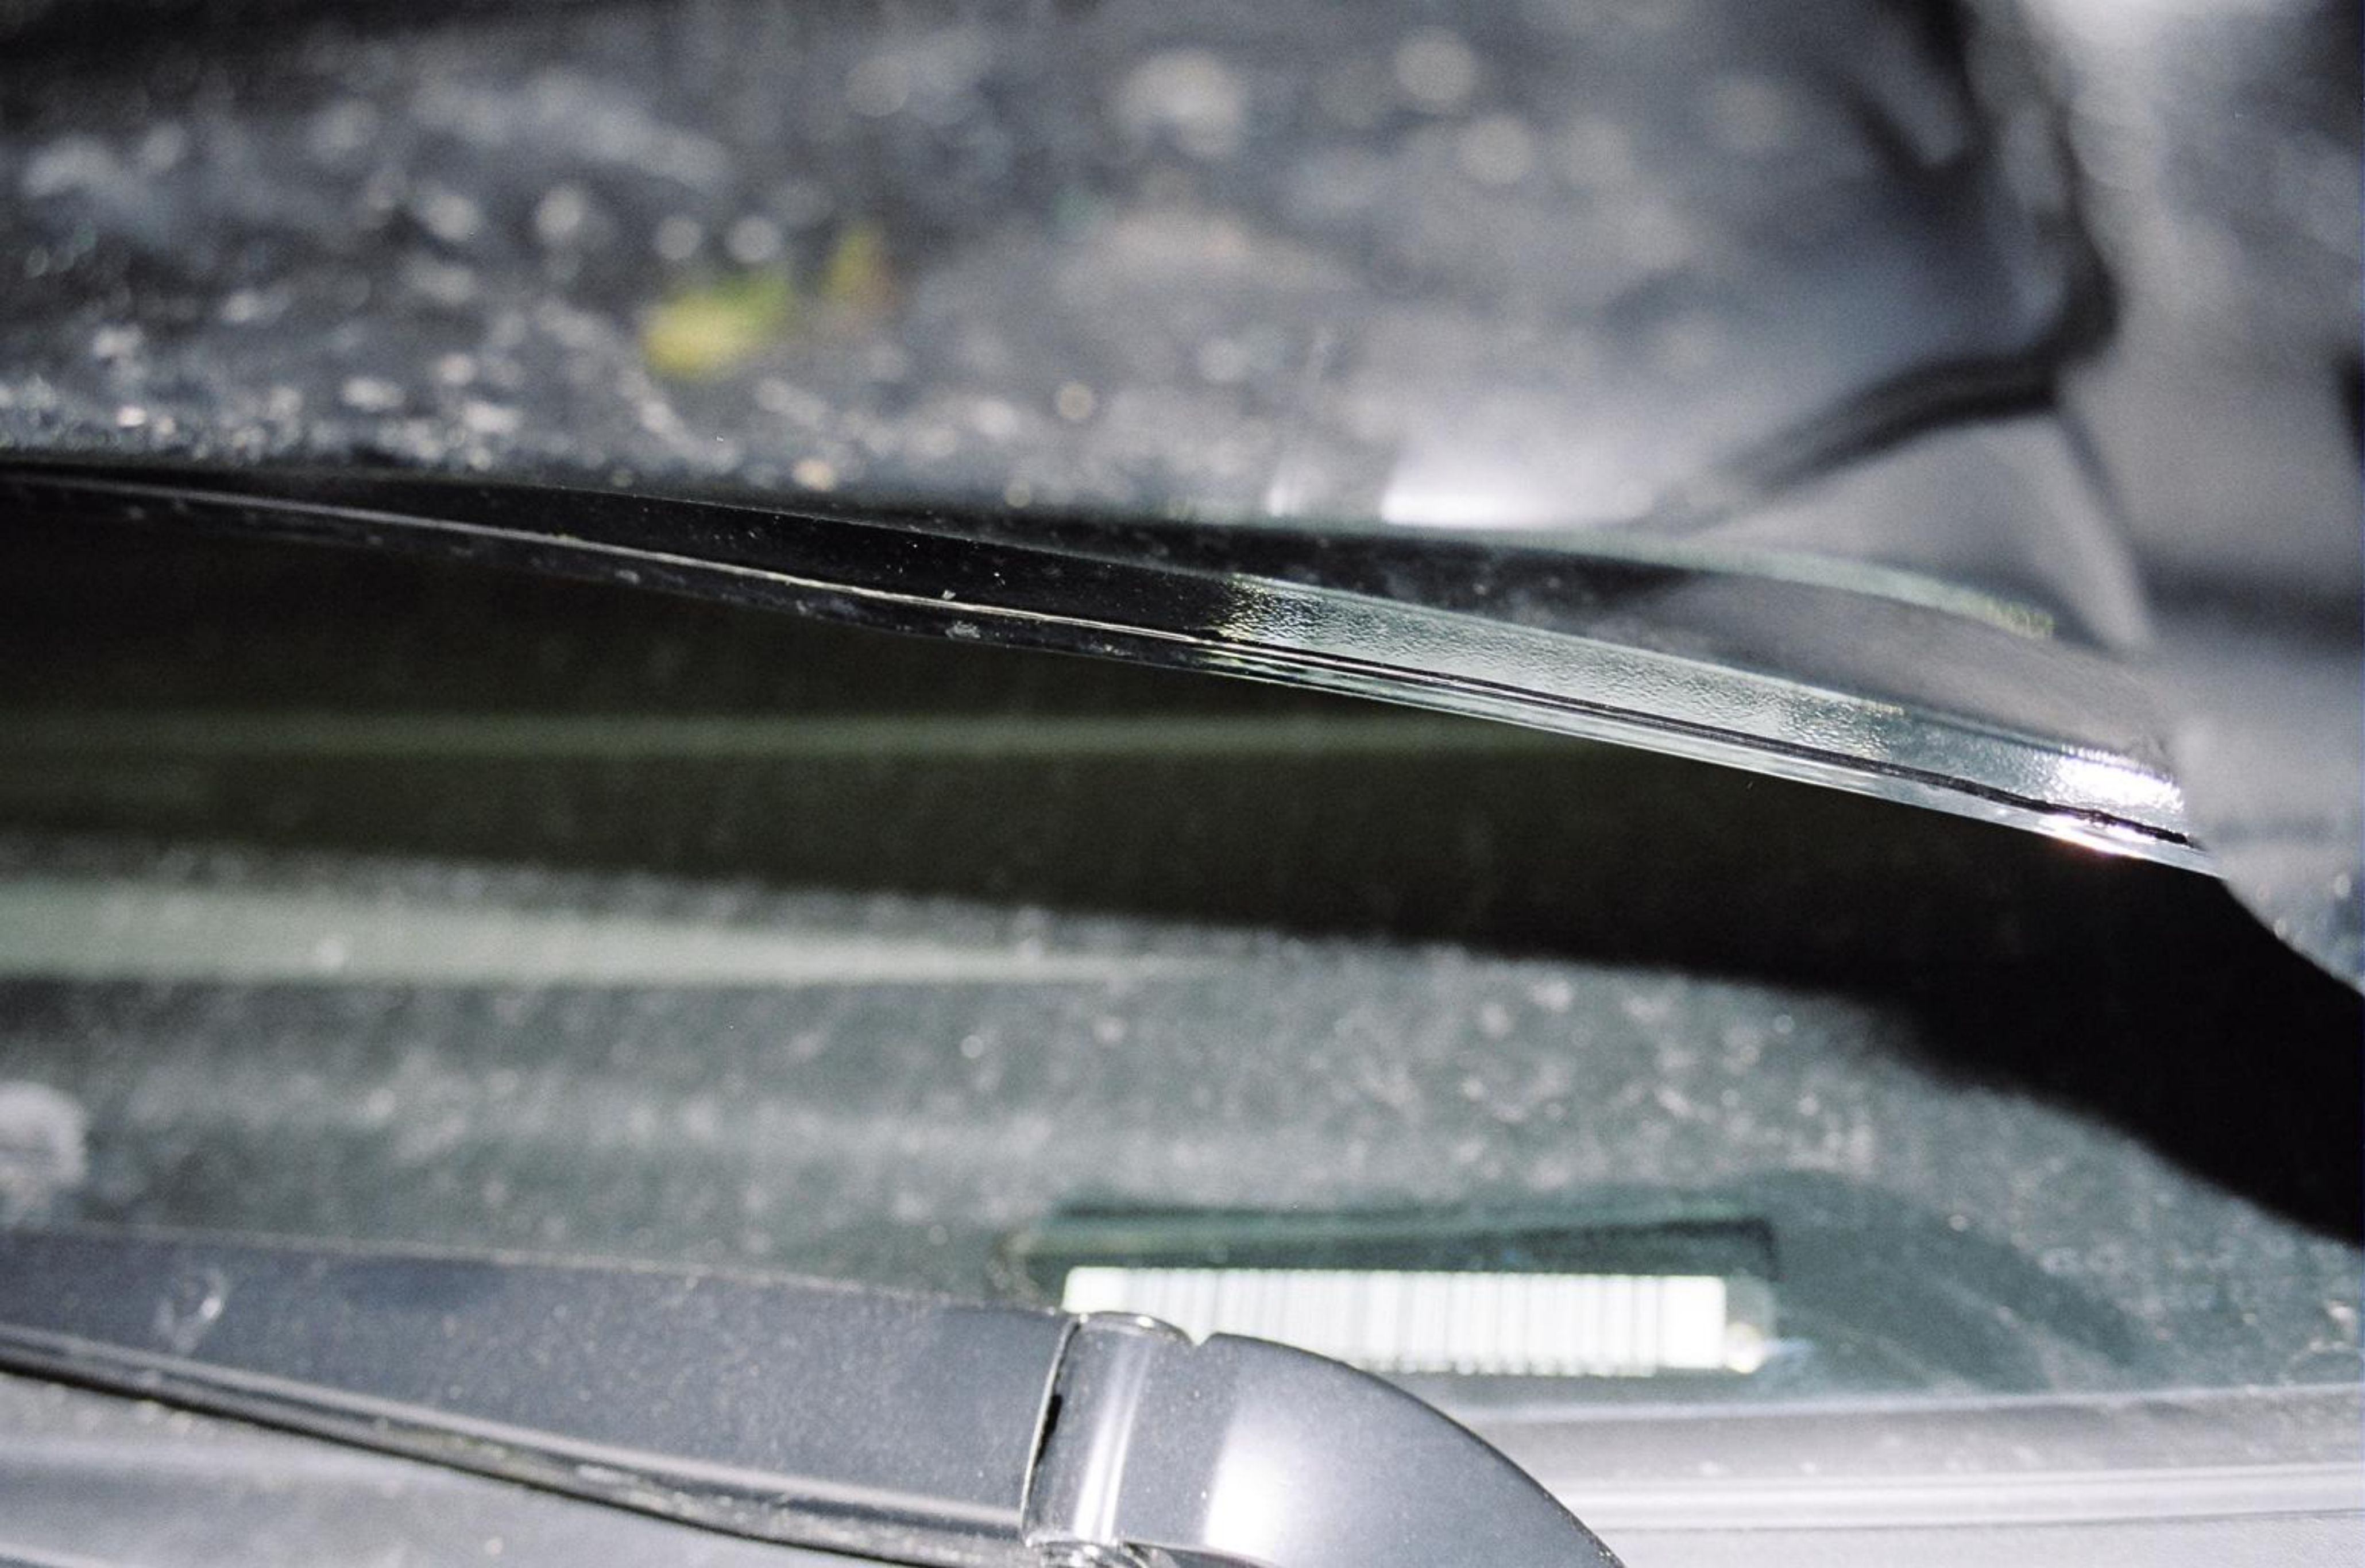
MFD BY GENERAL MOTORS CORP

DATE	GVWR	GAWR FRT	GAWR RR
08/04	1845 KG	949 KG	896 KG
	4068 LB	2093 LB	1975 LB

1G1ZS52F05F

TYPE: PASS CAR
