**Title** CEM Fault Tracing

**Ref No** US16352.1.2 en-GB

SUBJECT: CEM harness terminal corrosion due to water entrance in plenum (Instruction for new harness installation)

Various electrical function and communication symptoms may occur in M/Y 2005-2006 vehicles caused by wet corrosion in the CEM connector.

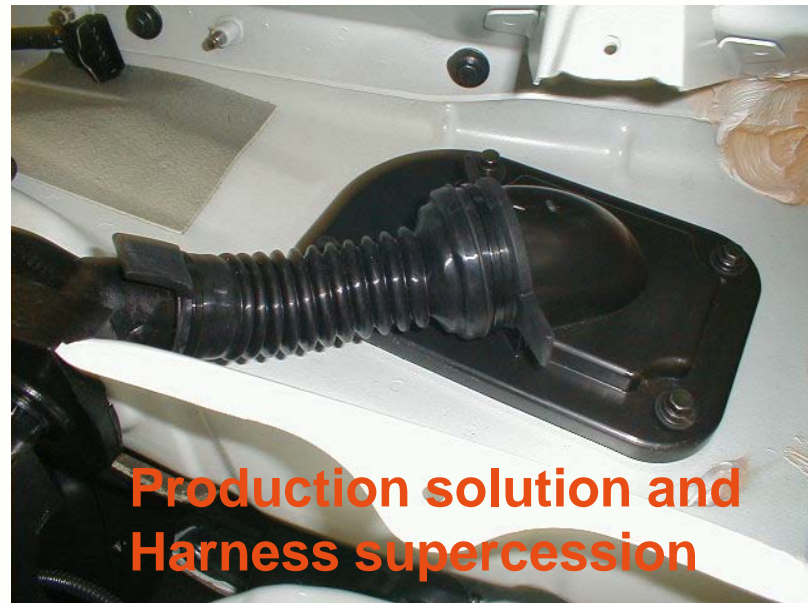
Water entrance through plenum cover corroding the CEM harness Terminals.

**NOTE!** If there is any evidence of moisture In the CEM connectors, the harness Must be replaced. The terminals will Eventually be compromised

Harness with integrated lid can be used on cars from W520 to W540 with 2 exceptions "NM" and "S" harness. These 2 can be used on cars back to W446.

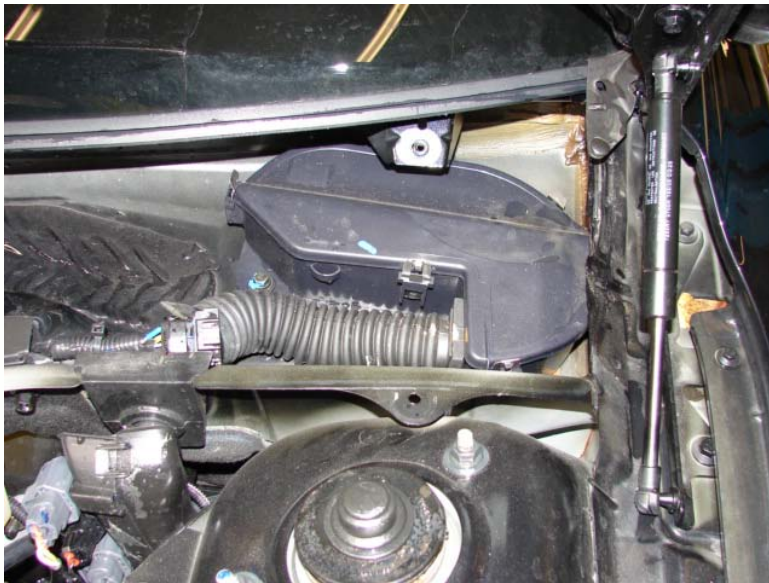
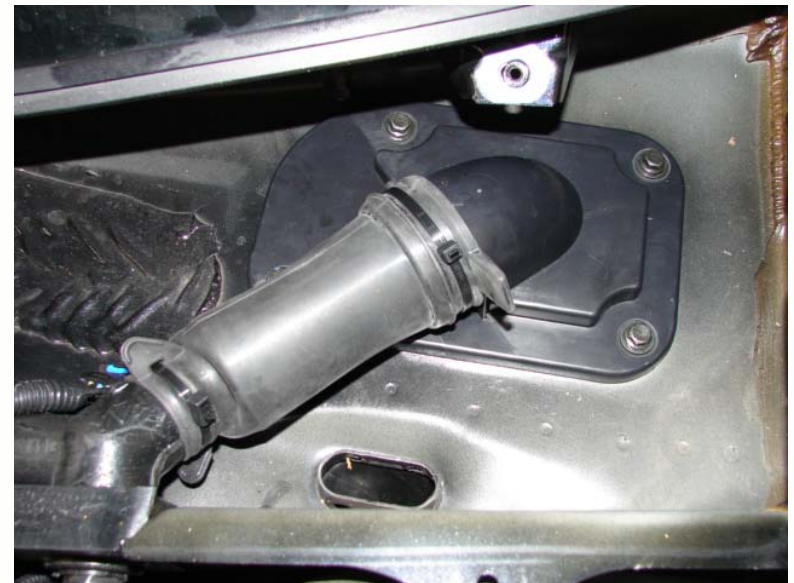
**NOTE!** If there is any evidence of moisture  
In the CEM connectors, the harness  
Must be replaced. The terminals will  
Eventually be compromised

The grommet will be removed from the new harness and replaced with the service grommet and lid.

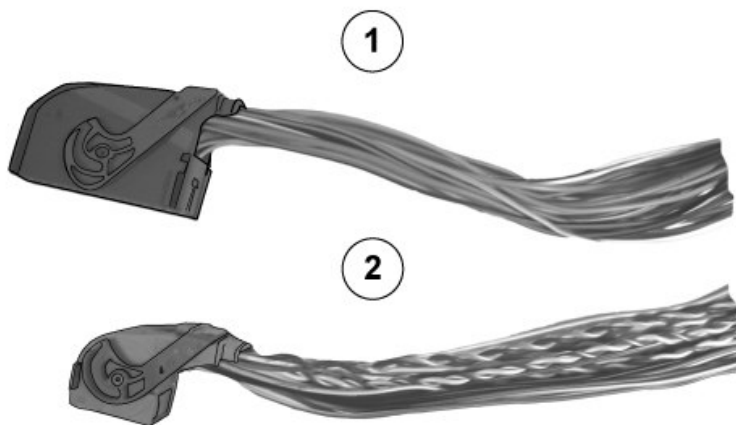
IMG-277370

To prevent having to replace the entire engine compartment cable harness in the event of water penetrating the central control module (CEM), 2 different types of extension cables have been introduced.

- (1) Extension cable, 32 pin
- (2) Extension cable, 36 pin

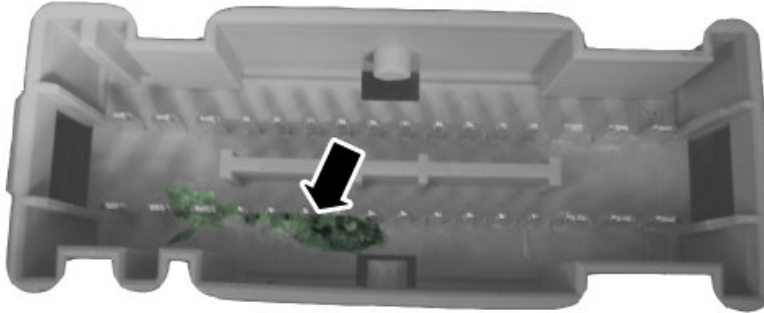
IMG-277367

Check that there is no oxidation in any of the upper connectors on the CEM. If there is oxidation, the CEM must be replaced at the same time as replacing any affected connectors.

To replace the connector, see Instruction T9159, Connector replacement.

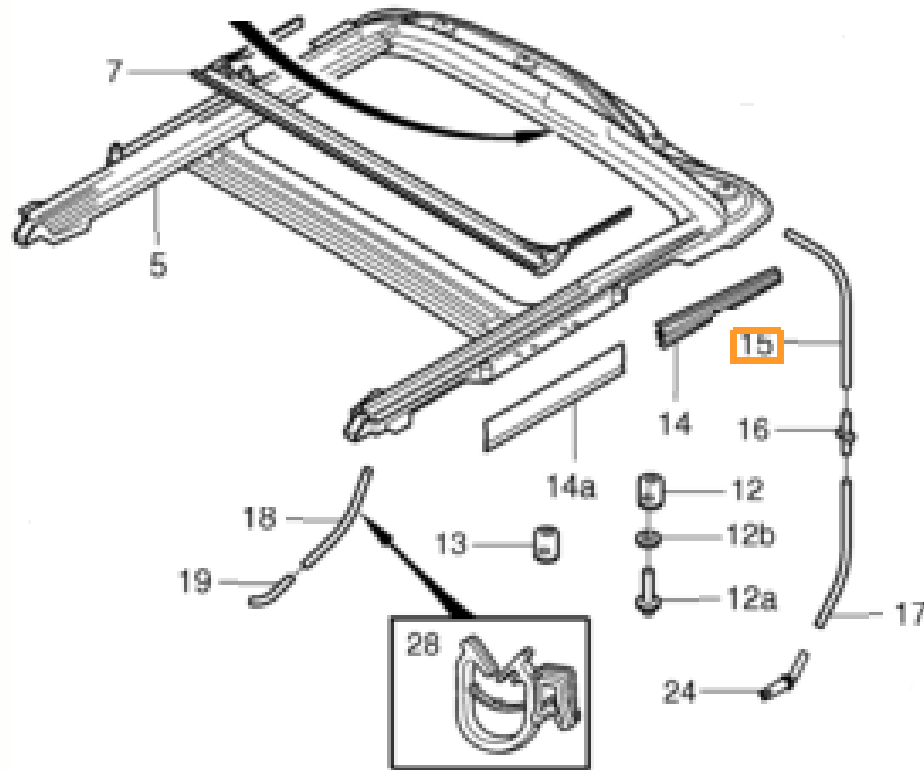
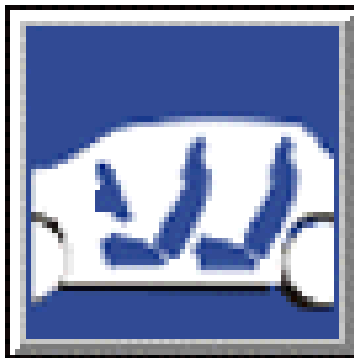
# All Models Sunroof, water leakage due to shrunk hoses.

Analyze of returned parts from California confirms the statements from the TRs.  
Hoses with new material will be introduced 09W15.

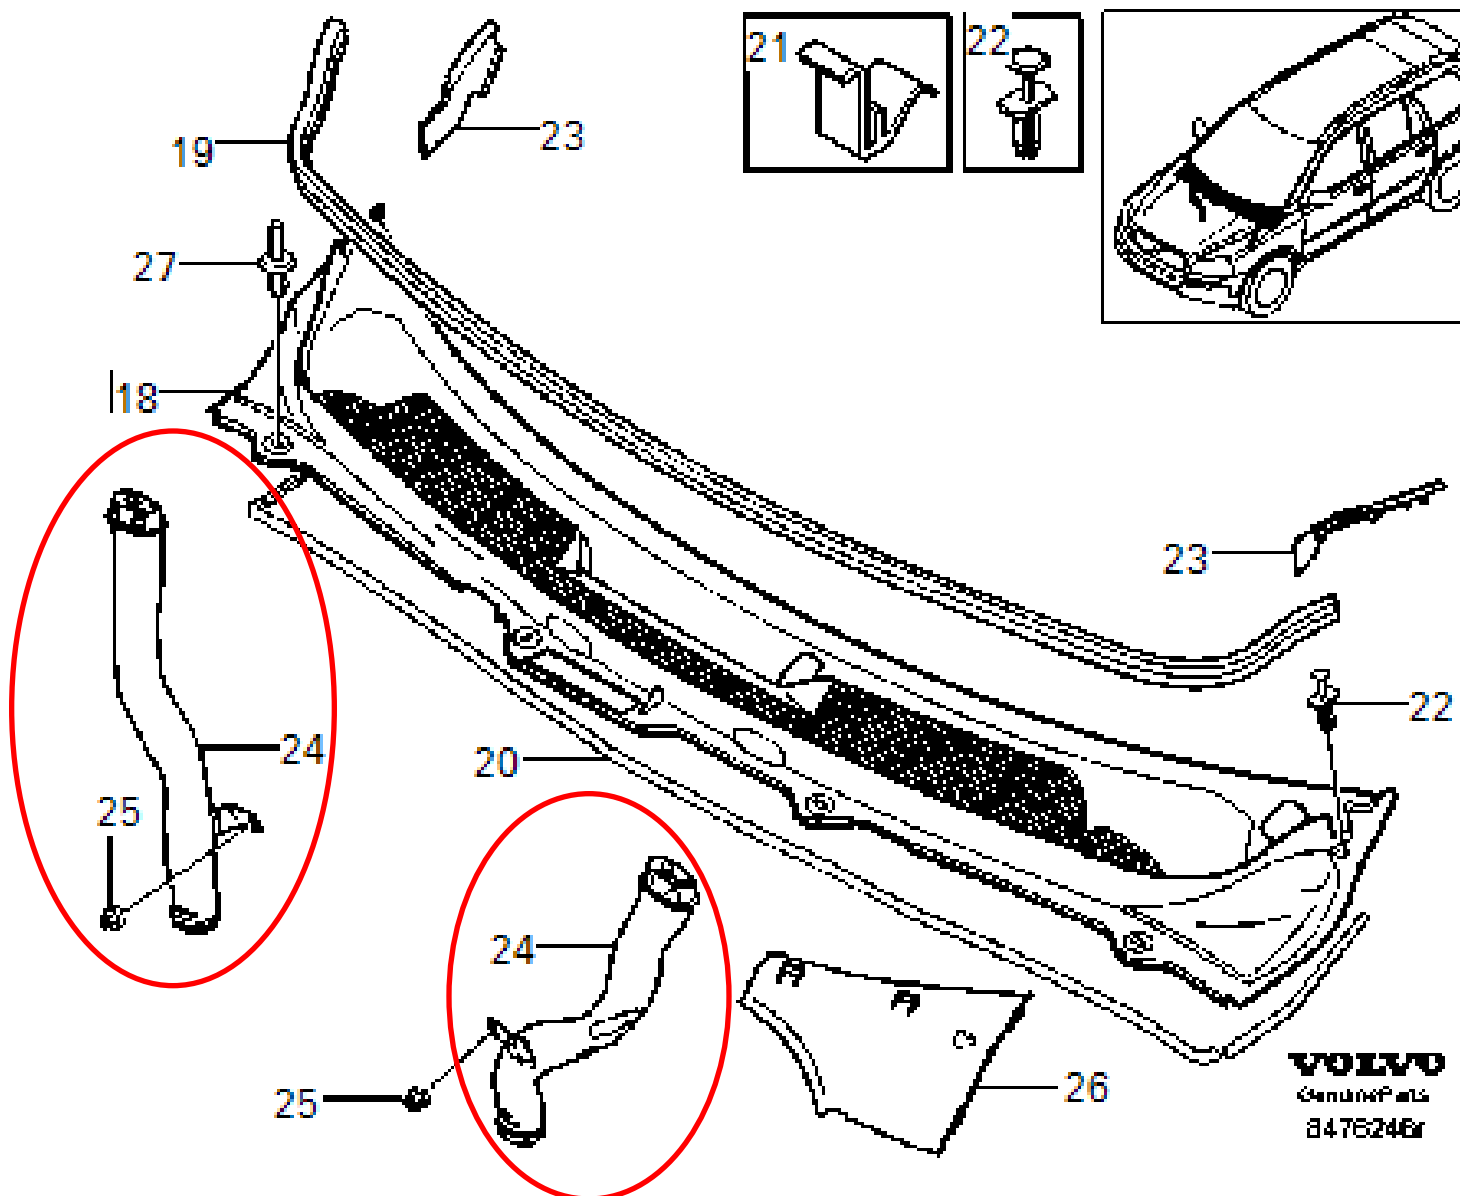
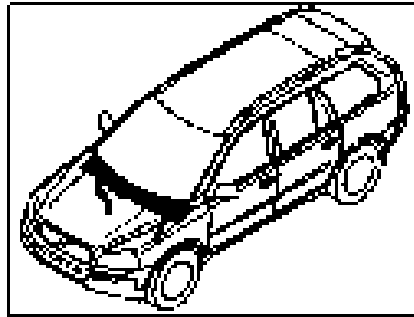
# P1/P2 Plenum water leakage

Under specific weather conditions (alternating above/below freezing) there is a risk for the plenum drains to freeze. As a result, water builds up in the plenum box.

- Water leakage into plenum box – possible CEM damage.
  - => Through rubber grommet (butyl introduced MY05)
  - => Through top lid
  - => Through “Octopus”
  - => Other
- Water leakage into car interior via air box.
  - => Simply goes over the edge of the collar

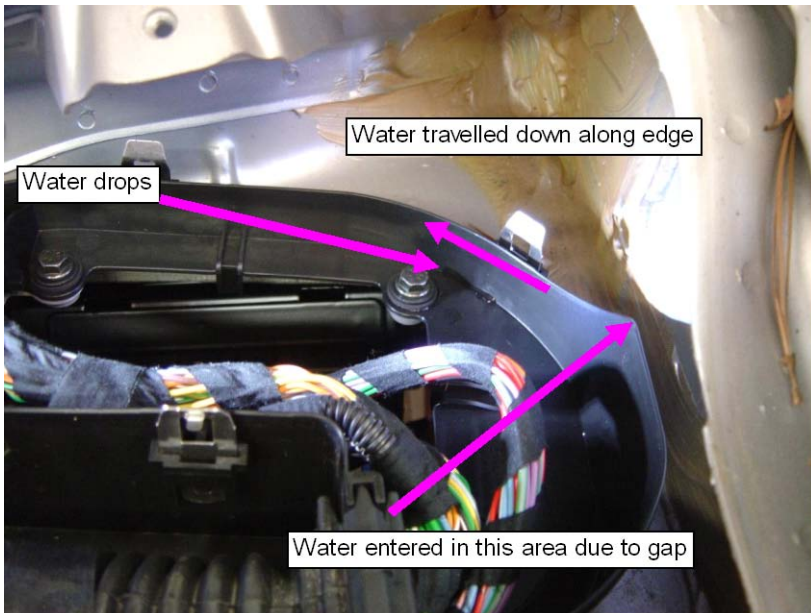
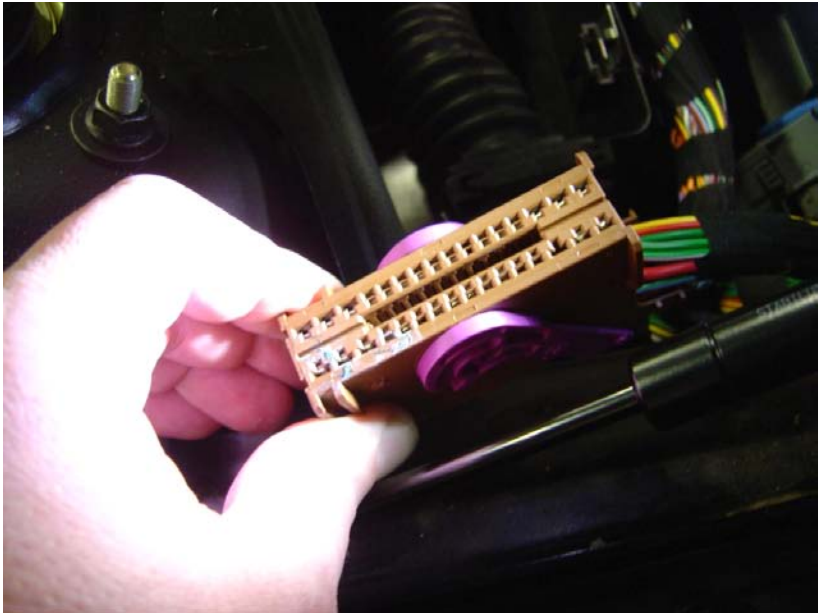
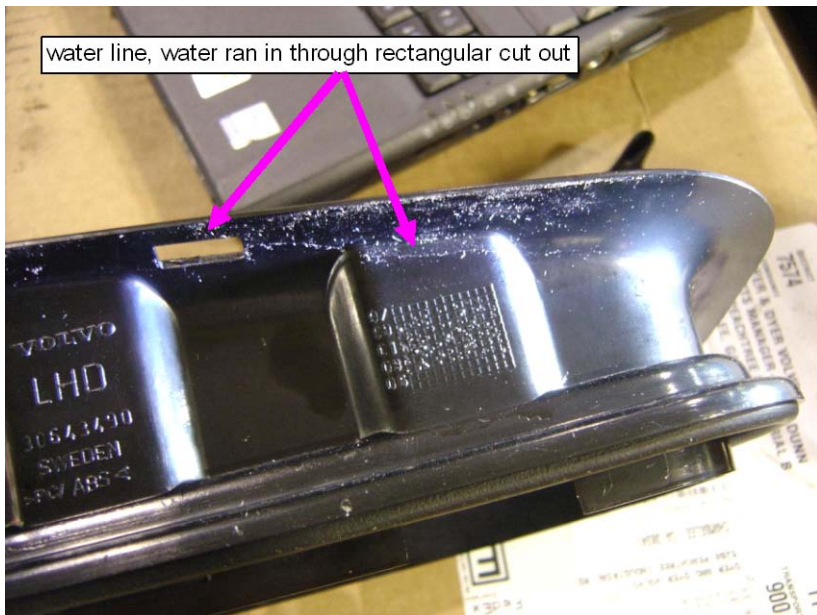
Water drop found in cable harness

No indentation in seal
