Recall Circular

Code: **26E5/R5**

Subject: **1999-2005 Passat & Passat Wagon (5th Generation)**

Install Underbody Heat Shield(s); Inspect/Replace

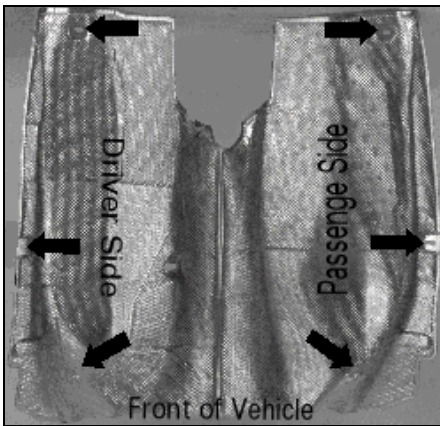
- ⇐ Remove nuts -arrows- securing heat shield on passenger side (all engines) and nuts -arrows- securing heat shield on driver side (2.8L & W8 only)

! Note: Picture shows heat shield for clarity
DO NOT REMOVE EXISTING HEAT SHIELD FROM VEHICLE

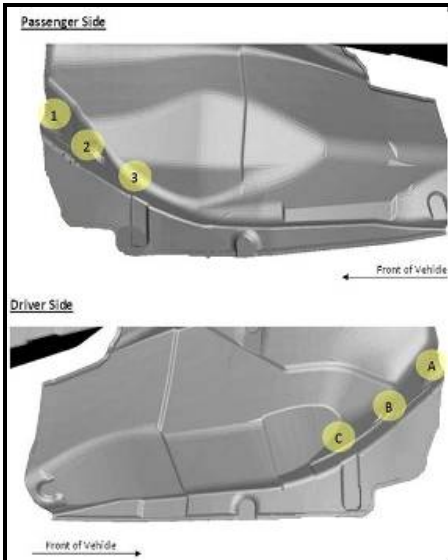
⇐ After the sub-frame and exhaust have been put back in place, ensure there is at least 20mm of clearance between new heat shield and exhaust pipe in locations 1,2,3 and A,B,C

Note: If clearance is not at least 20mm, use flat end of a pry bar to adjust the heat shield for proper clearance

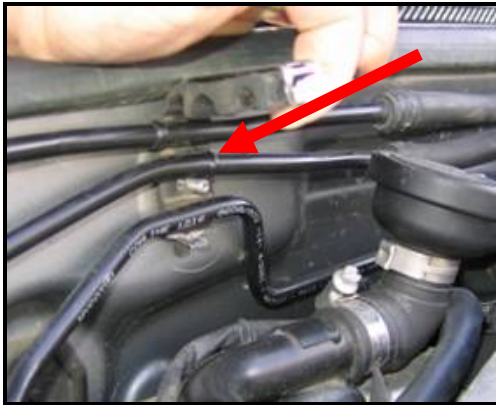
- ⇐ Check center fuel line -arrow- for signs of cracking or fuel leaks
 - If fuel line shows visible leaks or cracks, **proceed to Section D**
 - If no cracking or fuel leaks are found, close brackets and continue

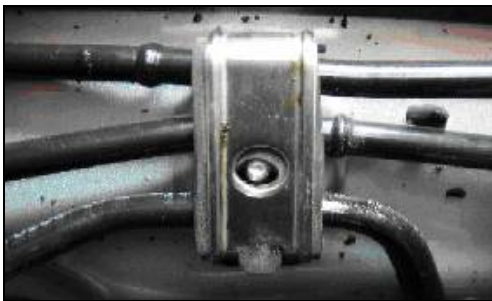
- ⇐ Inspect center fuel line to ensure flare joint is positioned to the right and outside of bracket
 - If flare joint is visible outside of bracket approximately 1mm to the right, **NEW** *reinstall small plastic fuel line retainer and plastic cover for air filter housing, work is complete*
 - If flare joint is not visible outside of bracket approximately 1mm to the right, **proceed to Section C**

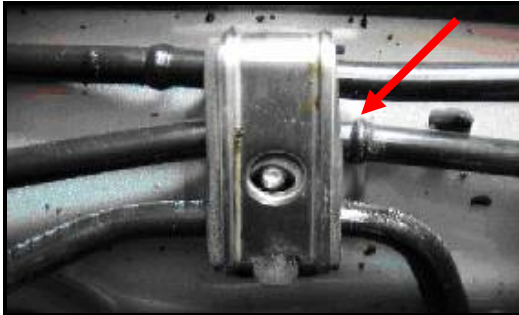
- Close connector at rear wall
- Check to see if flare joint is now visible outside bracket -arrow-
 - **If not visible** outside bracket, carefully pull fuel line to the right to move flare joint outside of bracket
- Close bracket near air filter

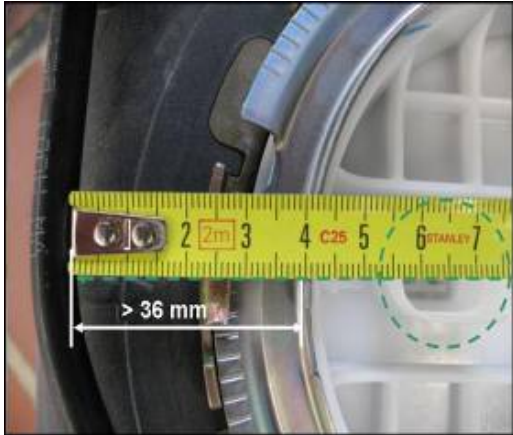
- ⇐ Using measuring tape centered over electrical connector -dotted circle-, measure distance between vent line and fuel sender retainer ring - arrow-, it should be at least 36mm
 - If the measurement is 36mm or greater, reinstall cover for fuel sending unit and rear seat bottom

- If the measurement is less than 36mm, **proceed to Section F** to perform visual inspection/vent line measurement check of surrounding surfaces for signs of fuel leak

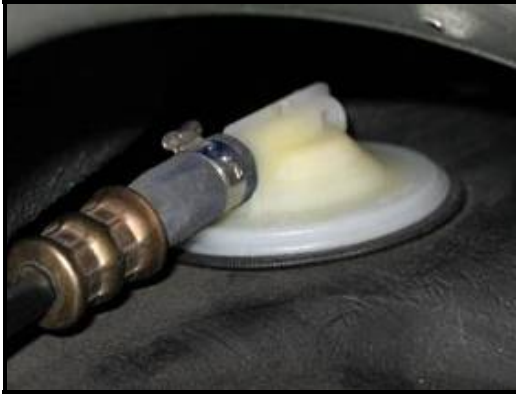
- Visually check fuel tank ventilation valve and surrounding area for fuel leak
 - If fuel leak is found go to **Section G**
 - If no fuel leak is found, continue with procedure

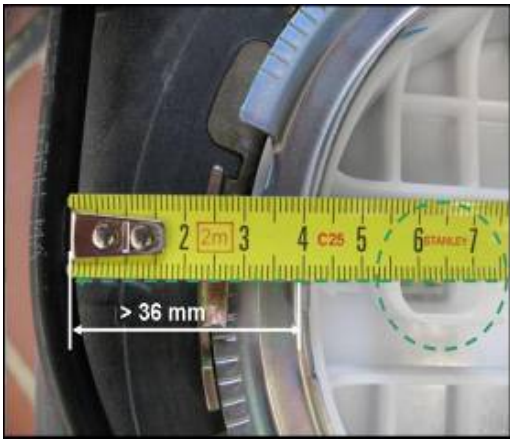
- ← Using measuring tape centered over electrical connector -dotted circle-, measure distance between vent line and fuel sender retainer ring -arrow-, it should be at least 36mm
- If measurements are within specification, reinstall fuel tank straps, exhaust hangers, bolts for heat shield, sending unit cover and seat bottom
 - 1.8T 4Motion with automatic transmission **go to Section K**
 - All other models **Work is complete**

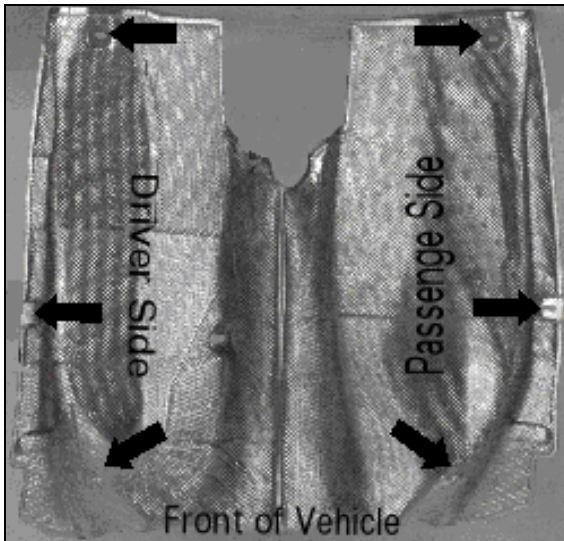
⇐ Remove nuts -arrows- securing heat shield on passenger side (all engines) and nuts -arrows- securing heat shield on driver side (2.8L & W8 only)

⚠ Note: Picture shows heat shield for clarity
DO NOT REMOVE EXISTING HEAT SHIELD FROM VEHICLE

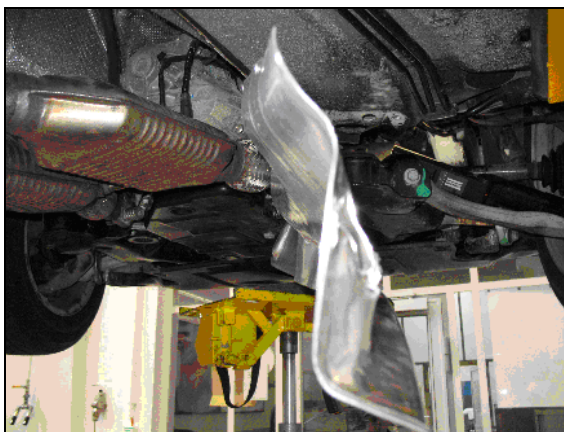
- (1.8T, 2.8L & W8)
- Carefully insert passenger side heat shield (3B0 825 676) between body and exhaust, then push front edge of heat shield between exhaust and body

- (2.8L & W8 Only)
- Repeat this step for driver side heat shield (3B0 825 675)

⚠ Note: Be careful not to distort or damage heat shield

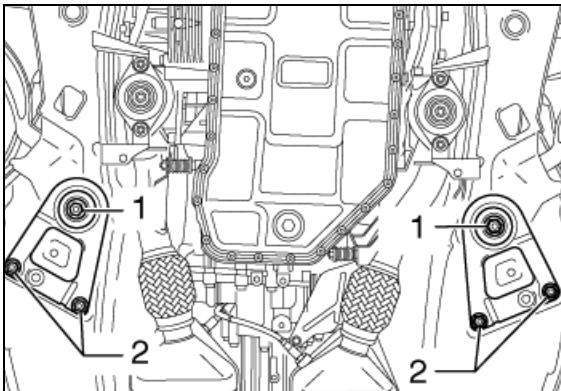
- Install new sub-frame bolts (N 908 235 01) -1- and torque to 110 Nm + ¼ turn

⇐ Reinstall bolts -2- and torque to 30 Nm

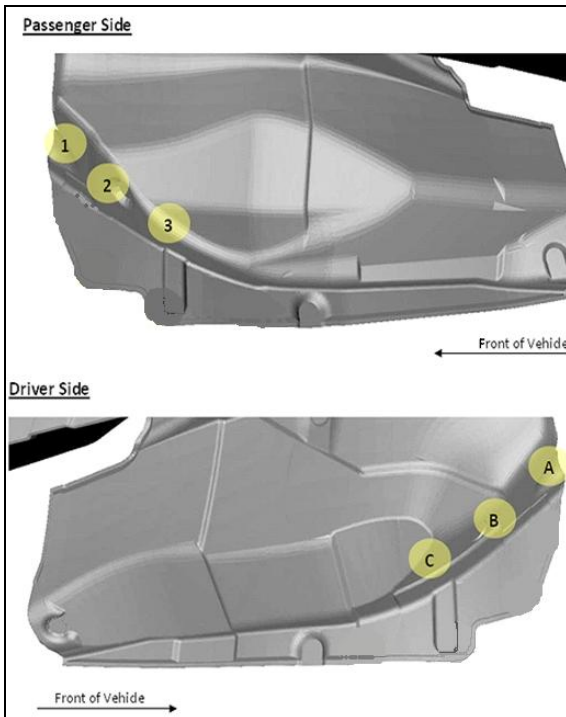
- ⇐ After the sub-frame and exhaust have been put back in place, ensure there is at least 20mm of clearance between new heat shield and exhaust pipe in locations 1,2,3 and A,B,C

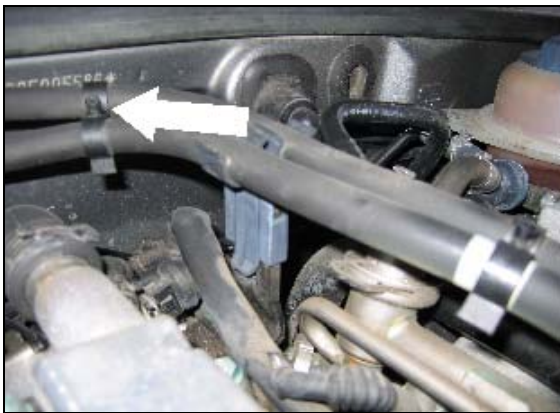
- ⇐ Remove plastic fuel line retainer -arrow- to relieve fuel line tension

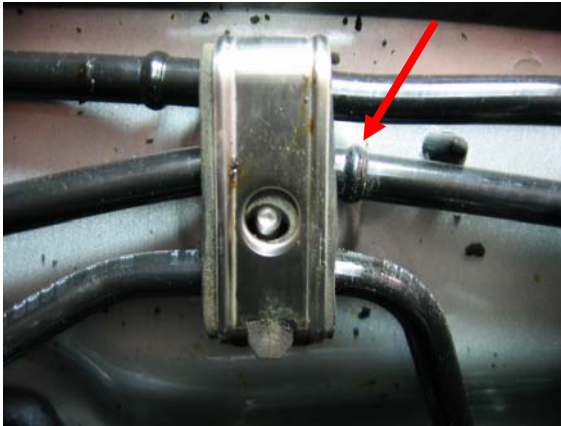
- Close connector at rear wall
- Check to see if flare joint is now visible outside bracket
 - **If not visible** outside bracket, carefully pull fuel line to the right to move flare joint outside of bracket
- Close bracket near air filter

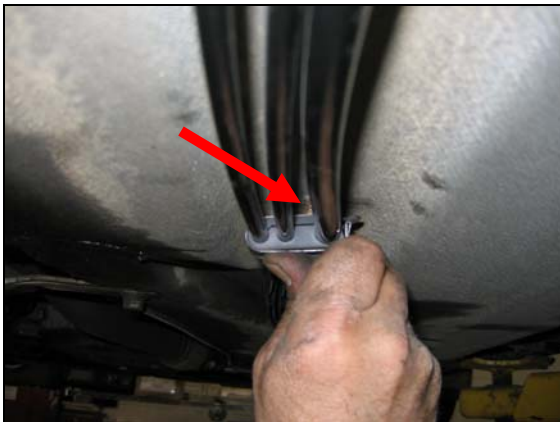
⚠ Note: Ensure that fuel lines are not touching together and are positioned free and clear of vehicle body

⇐ Secure new fuel line clips in place by pushing clip onto existing stud -arrow-

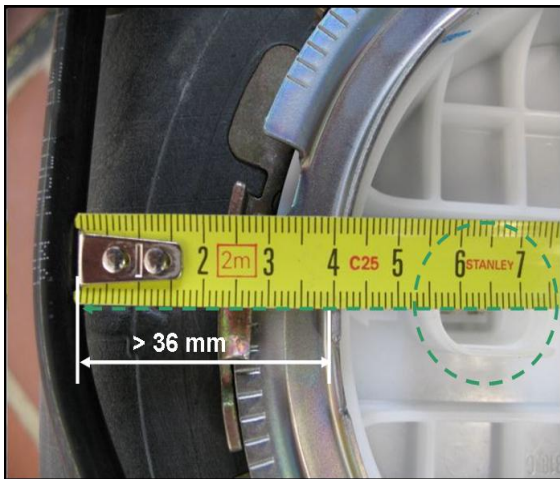
- ⇐ Using measuring tape centered over electrical connector -dotted circle-, measure distance between vent line and fuel sender retainer ring -arrow-, it should be at least 36mm
 - If the measurement is 36mm or greater, reinstall cover for fuel sending unit and rear seat bottom

- If the measurement is less than 36mm, proceed to **Section F** to perform visual inspection/vent line measurement check of surrounding surfaces for signs of fuel leak

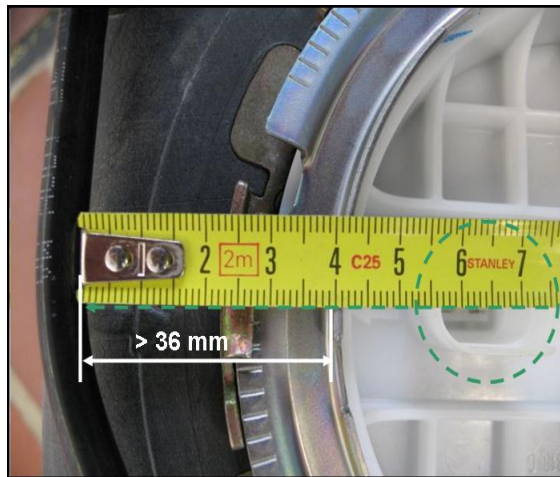
⇐ Using measuring tape centered over electrical connector -dotted circle-, measure distance between vent line and fuel sender retainer ring -arrow-, it should be at least 36mm

- If measurements are within specification, reinstall fuel tank straps, exhaust hangers, bolts for heat shield, sending unit cover and seat bottom
 - 1.8T 4Motion with automatic transmission **go to Section K**
 - All other models **Work is complete**

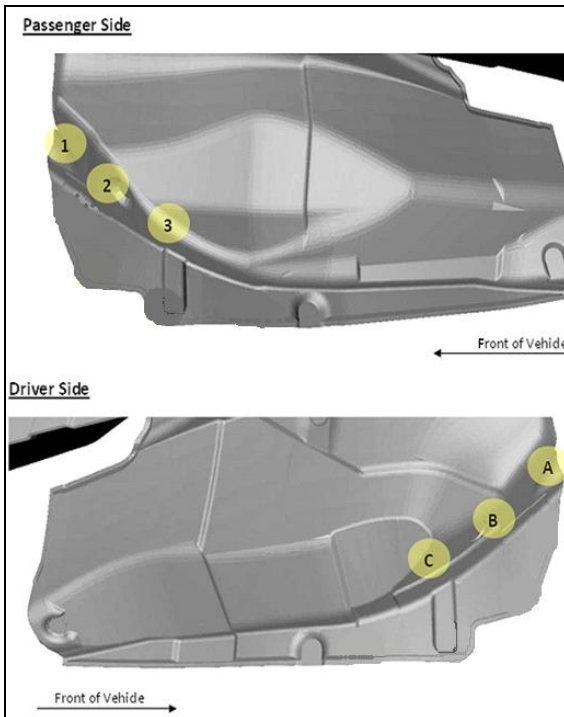
- ⇐ After the sub-frame and exhaust have been put back in place, ensure there is at least 20mm of clearance between new heat shield and exhaust pipe in locations 1,2,3 and A,B,C

⚠ Note: If clearance is not at least 20mm, use flat end of a pry bar to adjust the heat shield for proper clearance

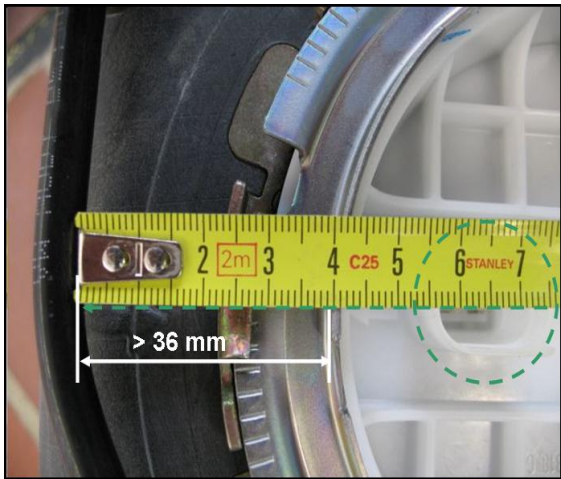
- ⇐ Using measuring tape centered over electrical connector -dotted circle-, measure distance between vent line and fuel sender retainer ring -arrow-, it should be at least 36mm
 - If the measurement is 36mm or greater, reinstall cover for fuel sending unit and rear seat bottom

- If the measurement is less than 36mm, proceed to Section F to perform visual inspection/vent line measurement check of surrounding surfaces for signs of fuel leak

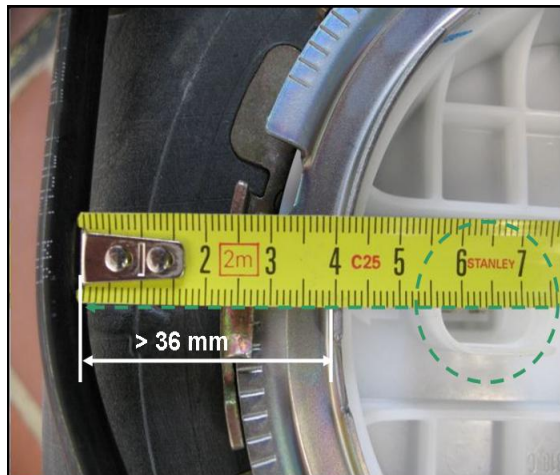
⇐ Using measuring tape centered over electrical connector -dotted circle-, measure distance between vent line and fuel sender retainer ring -arrow-, it should be at least 36mm

- If measurements are within specification, reinstall fuel tank straps, exhaust hangers, bolts for heat shield, sending unit cover and seat bottom
 - 1.8T 4Motion with automatic transmission **go to Section K**
 - All other models **Work is complete**

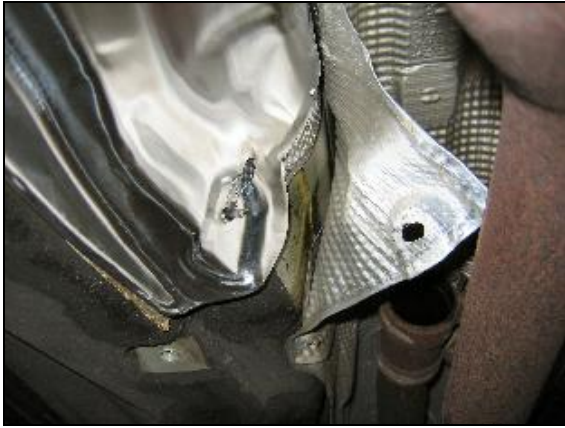
When installing heat shield, do not overly deform or damage new heat shield, including cuts, holes, or tears
Damage to new heat shield could potentially cause a fire. If during installation a heat shield is damaged, install a new and undamaged heat shield
Damage to these parts will not be covered under this action!

- Bend center shield over to allow new shield to lay under it, bend center shield back into place

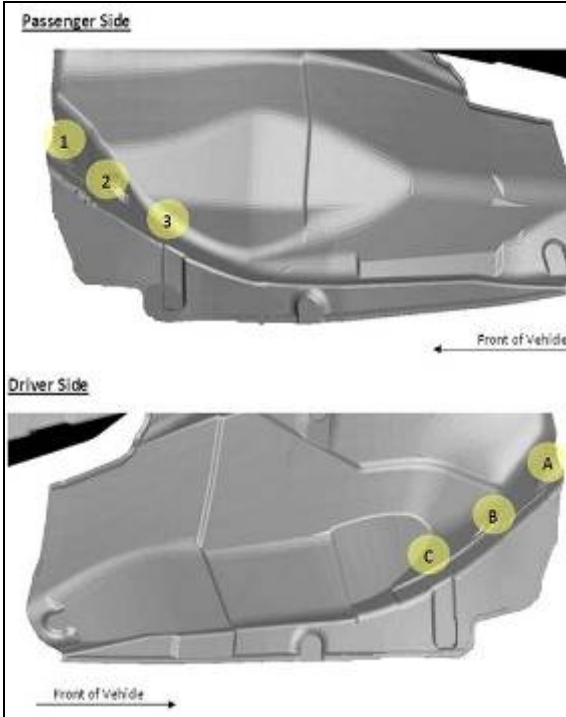
- ⇐ After the sub-frame and exhaust have been put back in place, ensure there is at least 20mm of clearance between new heat shield and exhaust pipe in locations 1,2,3 and A,B,C

⚠ Note: If clearance is not at least 20mm, use flat end of a pry bar to adjust the heat shield for proper clearance

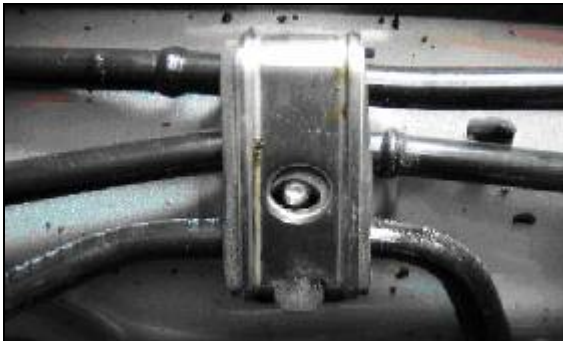
- ⇐ Inspect center fuel line to ensure flare joint is positioned to the right and outside of bracket
 - If flare joint is visible outside of bracket approximately 1mm to the right, **work is complete**
 - If flare joint is not visible outside of bracket approximately 1mm to the right, **proceed to Section C**

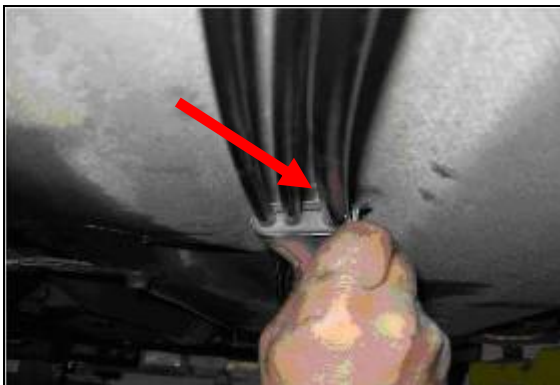
⚠ Note: Ensure that fuel lines are not touching together and are positioned free and clear of vehicle body

⇐ Secure new fuel line clips in place by pushing clip onto existing stud -arrow-

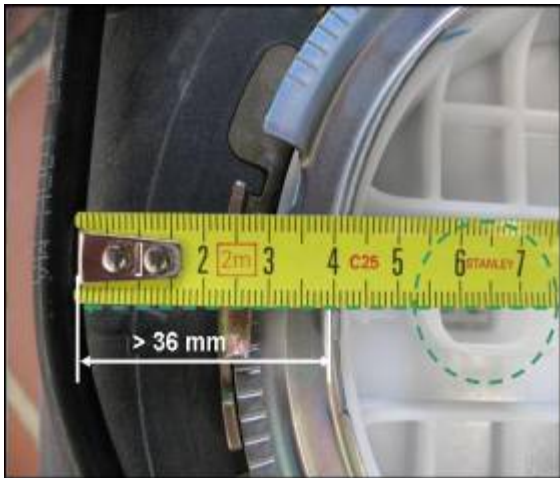
- ⇐ Using measuring tape centered over electrical connector -dotted circle-, measure distance between vent line and fuel sender retainer ring -arrow-, it should be at least 36mm

- If the measurement is 36mm or greater, reinstall cover for fuel sending unit and rear seat bottom

- If the measurement is less than 36mm, **proceed to Section F** to perform visual inspection/vent line measurement check of surrounding surfaces for signs of fuel leak

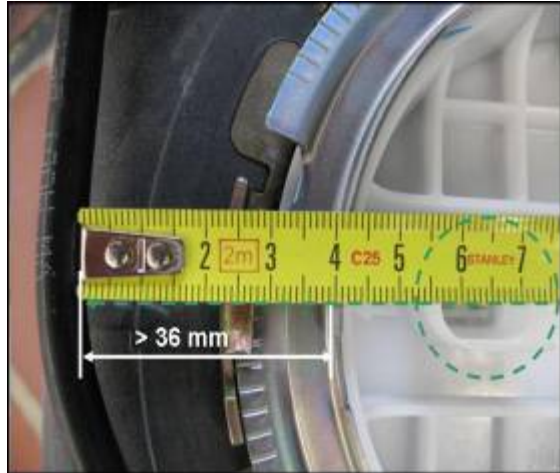
⇐ Using measuring tape centered over electrical connector -dotted circle-, measure distance between vent line and fuel sender retainer ring -arrow-, it should be at least 36mm

- If measurements are within specification, reinstall fuel tank straps, exhaust hangers, bolts for heat shield, sending unit cover and seat bottom
 - 1.8T 4Motion with automatic transmission **go to Section K**
 - All other models **Work is complete**

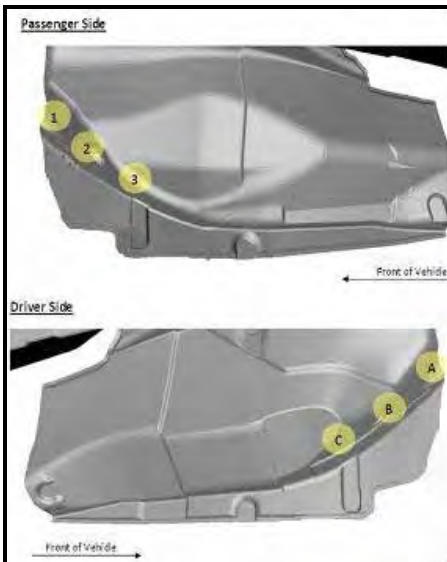
⇐ After the sub-frame and exhaust have been put back in place, ensure there is at least 20mm of clearance between new heat shield and exhaust pipe in locations 1,2,3 and A,B,C

Note: If clearance is not at least 20mm, use flat end of a pry bar to adjust the heat shield for proper clearance

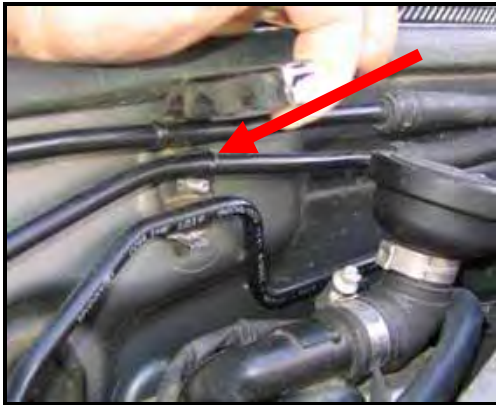
- ⇐ Check center fuel line -arrow- for signs of cracking or fuel leaks
 - If fuel line shows visible leaks or cracks, **proceed to Section D**
 - If no cracking or fuel leaks are found, close brackets and continue

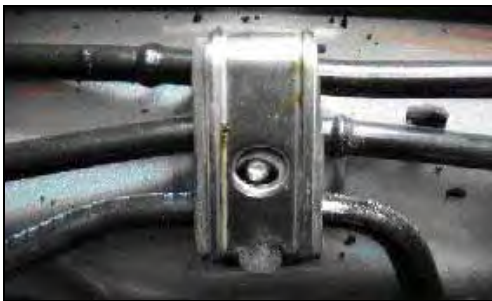
- ⇐ Inspect center fuel line to ensure flare joint is positioned to the right and outside of bracket
 - If flare joint is visible outside of bracket approximately 1mm to the right, reinstall small plastic fuel line retainer and plastic cover for air filter housing, **work is complete**
 - If flare joint is not visible outside of bracket approximately 1mm to the right, **proceed to Section C**

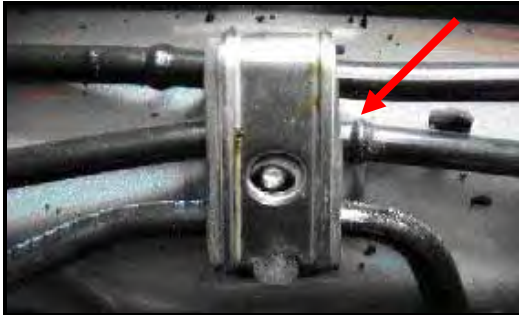
- Close connector at rear wall
- Check to see if flare joint is now visible outside bracket -arrow-
 - **If not visible** outside bracket, carefully pull fuel line to the right to move flare joint outside of bracket
- Close bracket near air filter

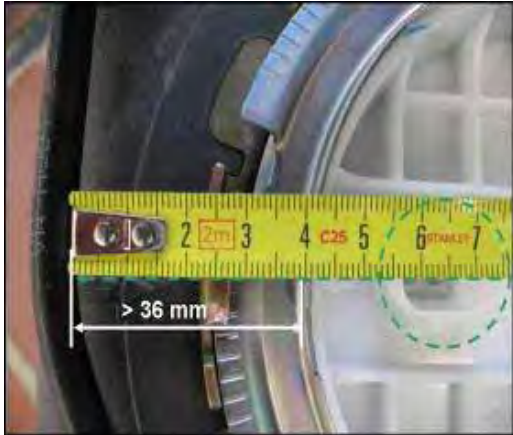
- ⇐ Using measuring tape centered over electrical connector -dotted circle-, measure distance between vent line and fuel sender retainer ring - arrow-, it should be at least 36mm
 - If the measurement is 36mm or greater, reinstall cover for fuel sending unit and rear seat bottom

- If the measurement is less than 36mm, **proceed to Section F** to perform visual inspection/vent line measurement check of surrounding surfaces for signs of fuel leak

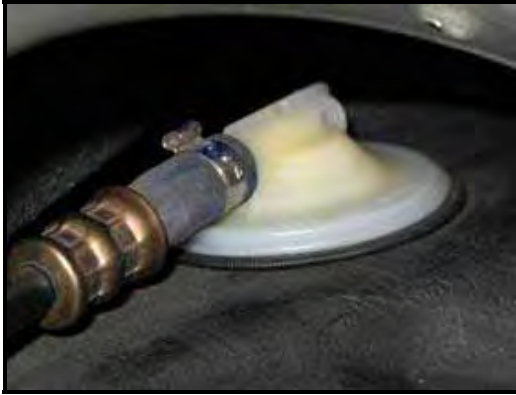
- Visually check fuel tank ventilation valve and surrounding area for fuel leak
 - If fuel leak is found go to **Section G**
 - If no fuel leak is found, continue with procedure

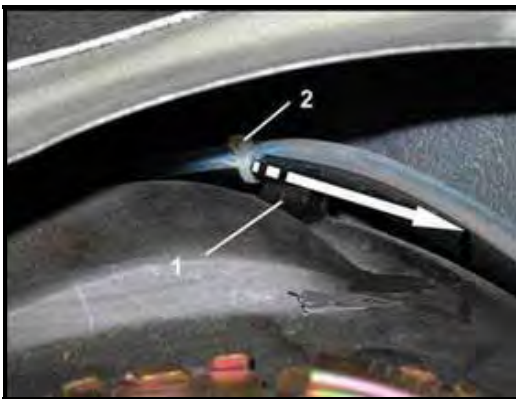
- ⇐ Secure electrical wiring to vent hose -1- with a new zip tie -2- and move zip tie as shown in image to ensure tension is no longer present

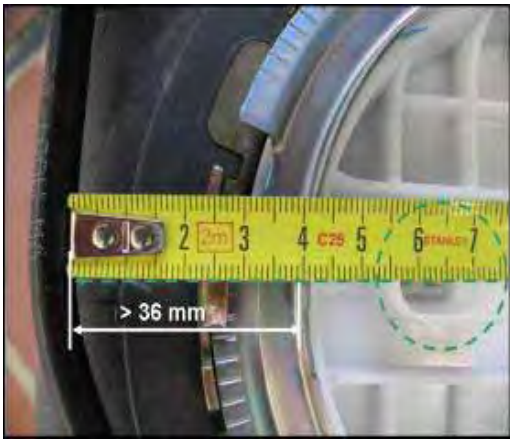
- ← Using measuring tape centered over electrical connector -dotted circle-, measure distance between vent line and fuel sender retainer ring -arrow-, it should be at least 36mm
- If measurements are within specification, reinstall fuel tank straps, exhaust hangers, bolts for heat shield, sending unit cover and seat bottom
 - 1.8T 4Motion with automatic transmission **go to Section K**
 - All other models **Work is complete**

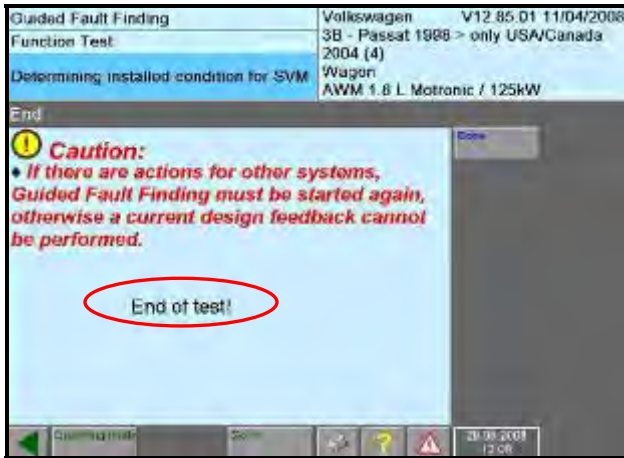
Any interruption of Software Version Management (SVM) process will result in damage to ECM

ECM replacement is not covered by this action

← Follow on-screen instructions to completion. User Test Plan complete when “End of test!” -circle- appears on screen
