PE10-027

VW

EXHIBIT TO
REQUEST 8, DATA

9752 – Engine Wiring Loom - PASSAT/Audi A4 - MJ01-03 VWOA / AOA

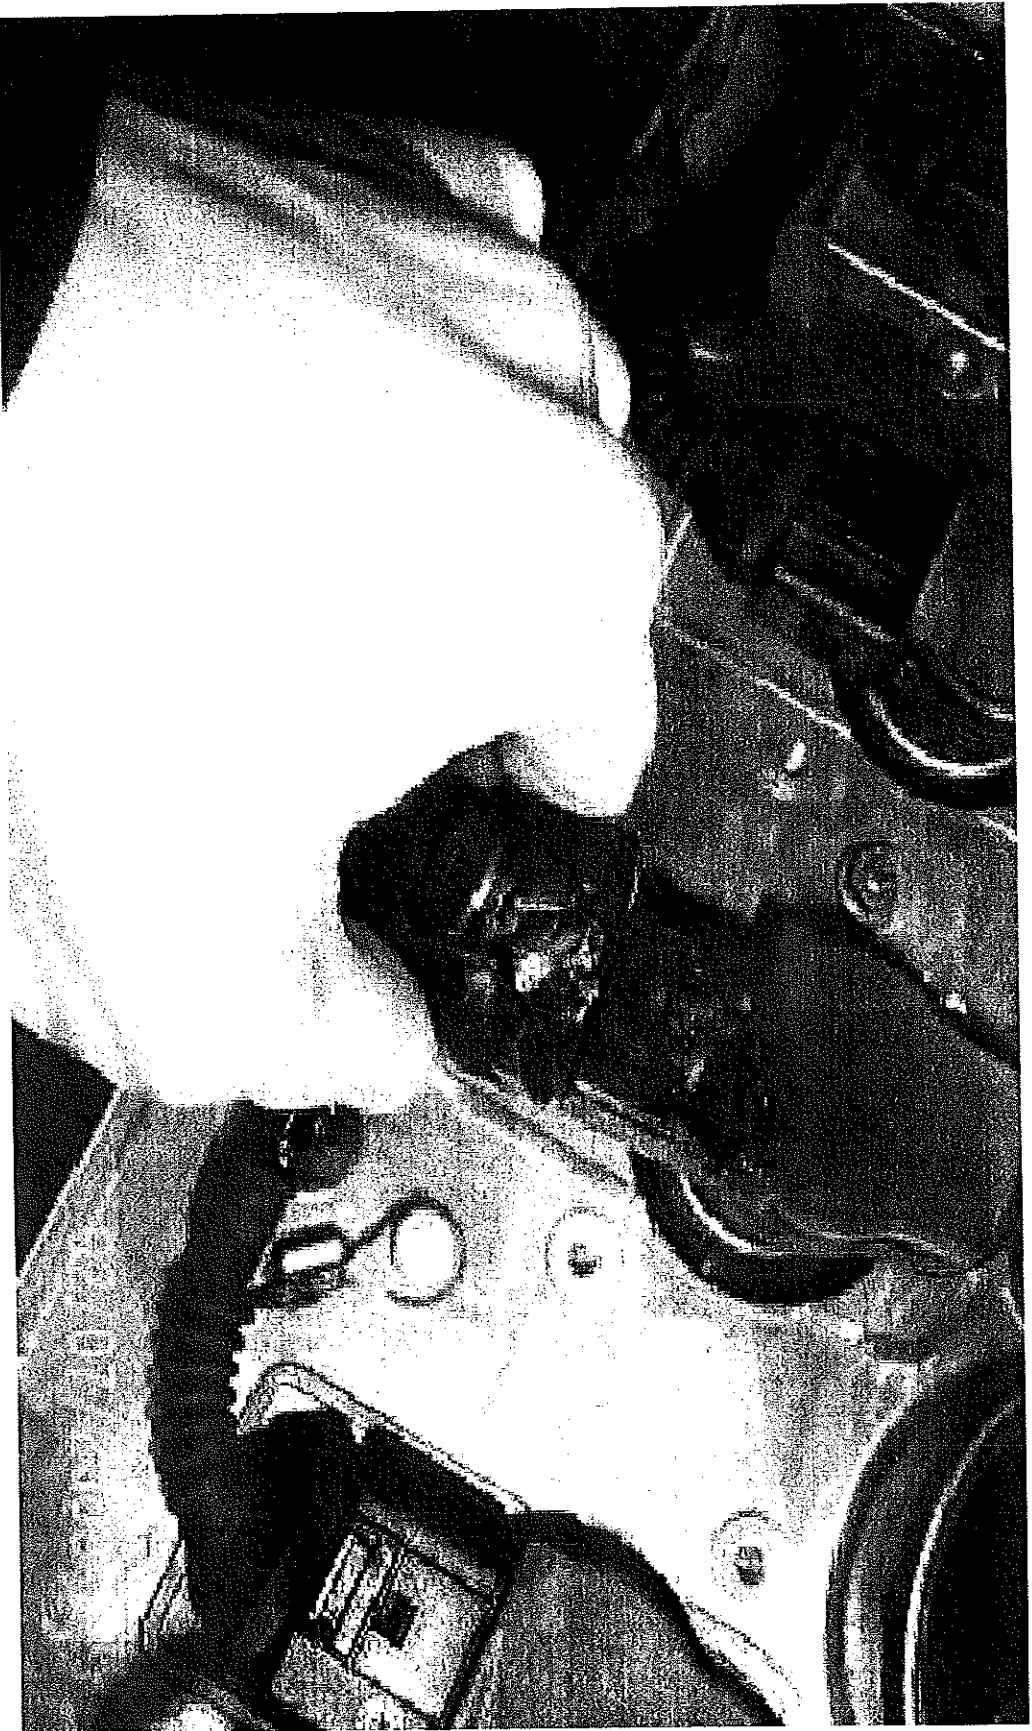
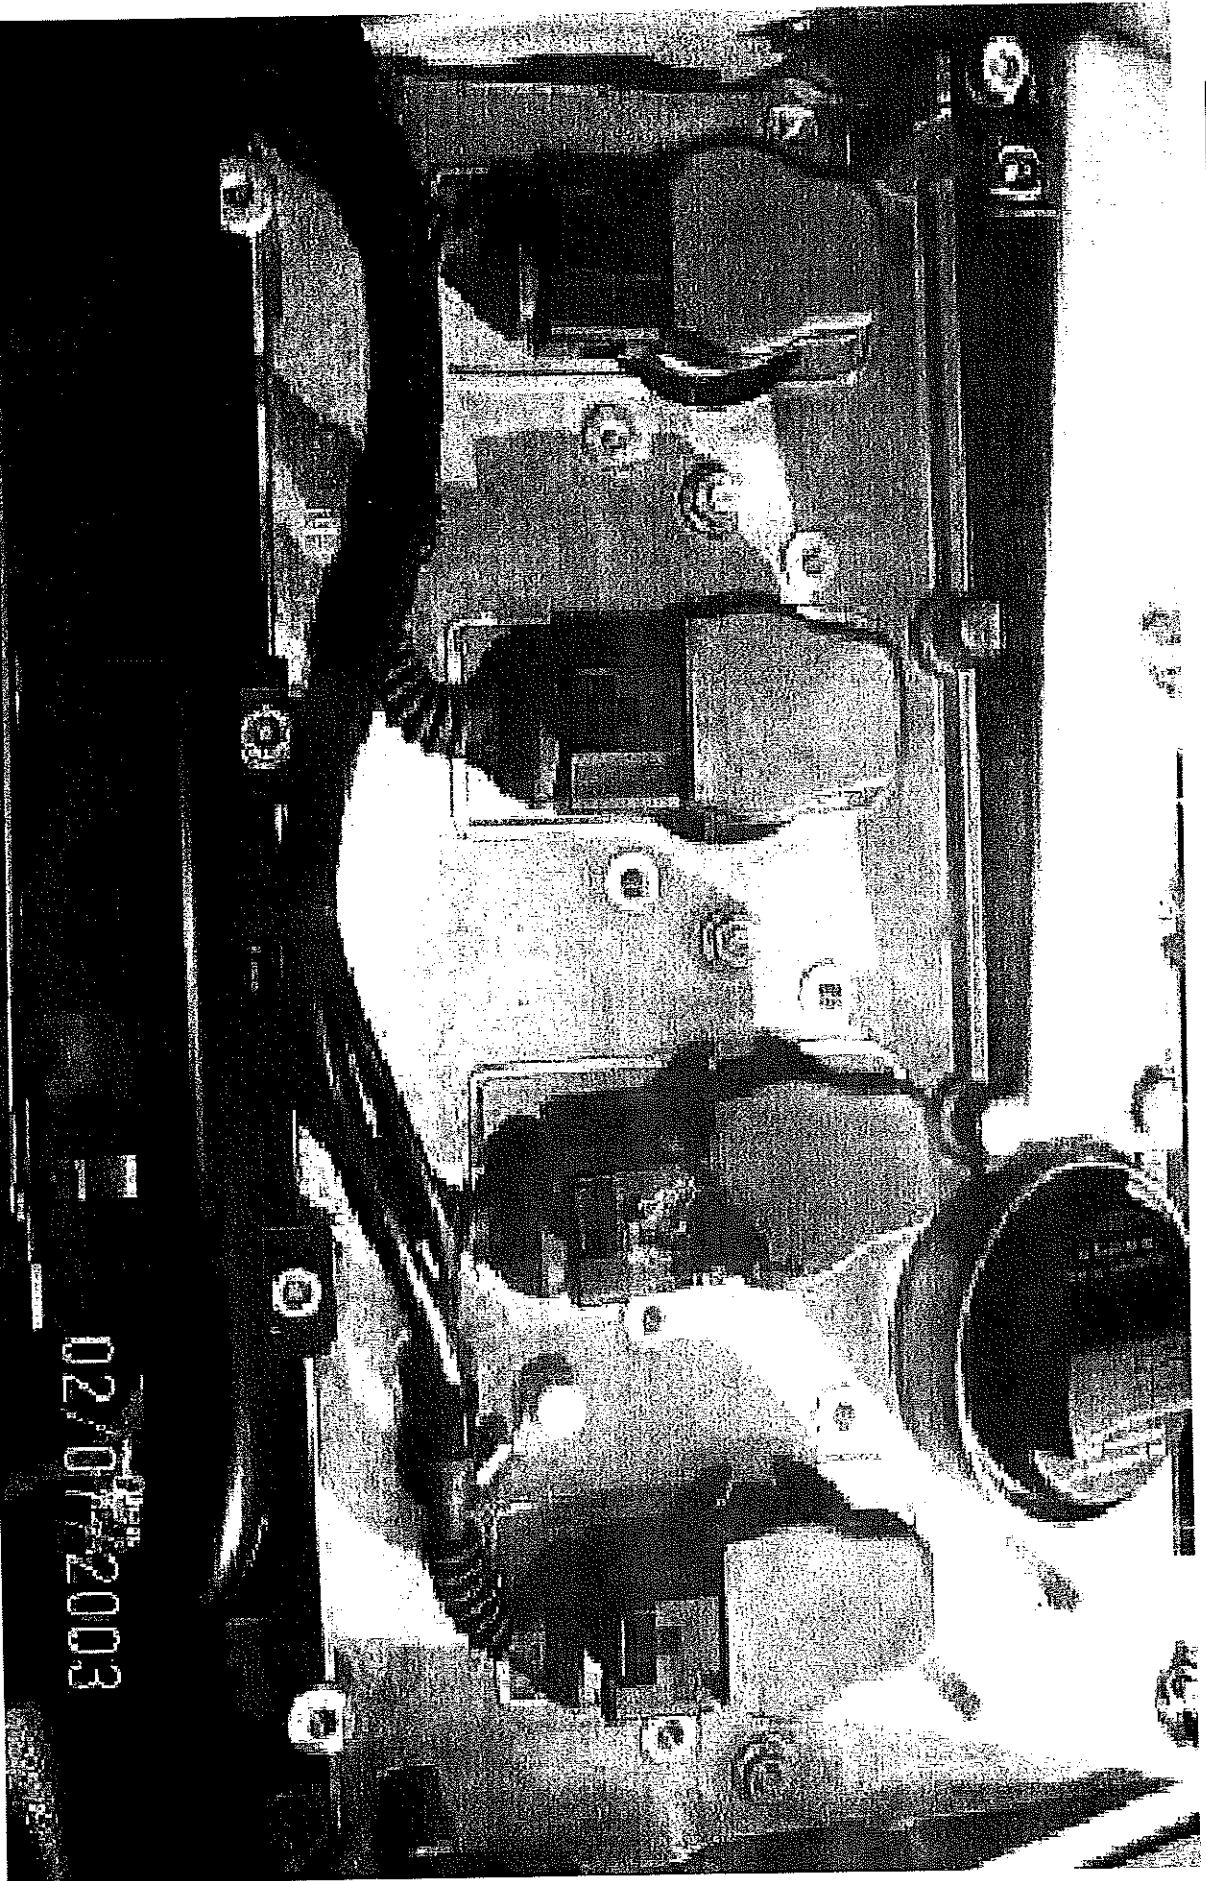
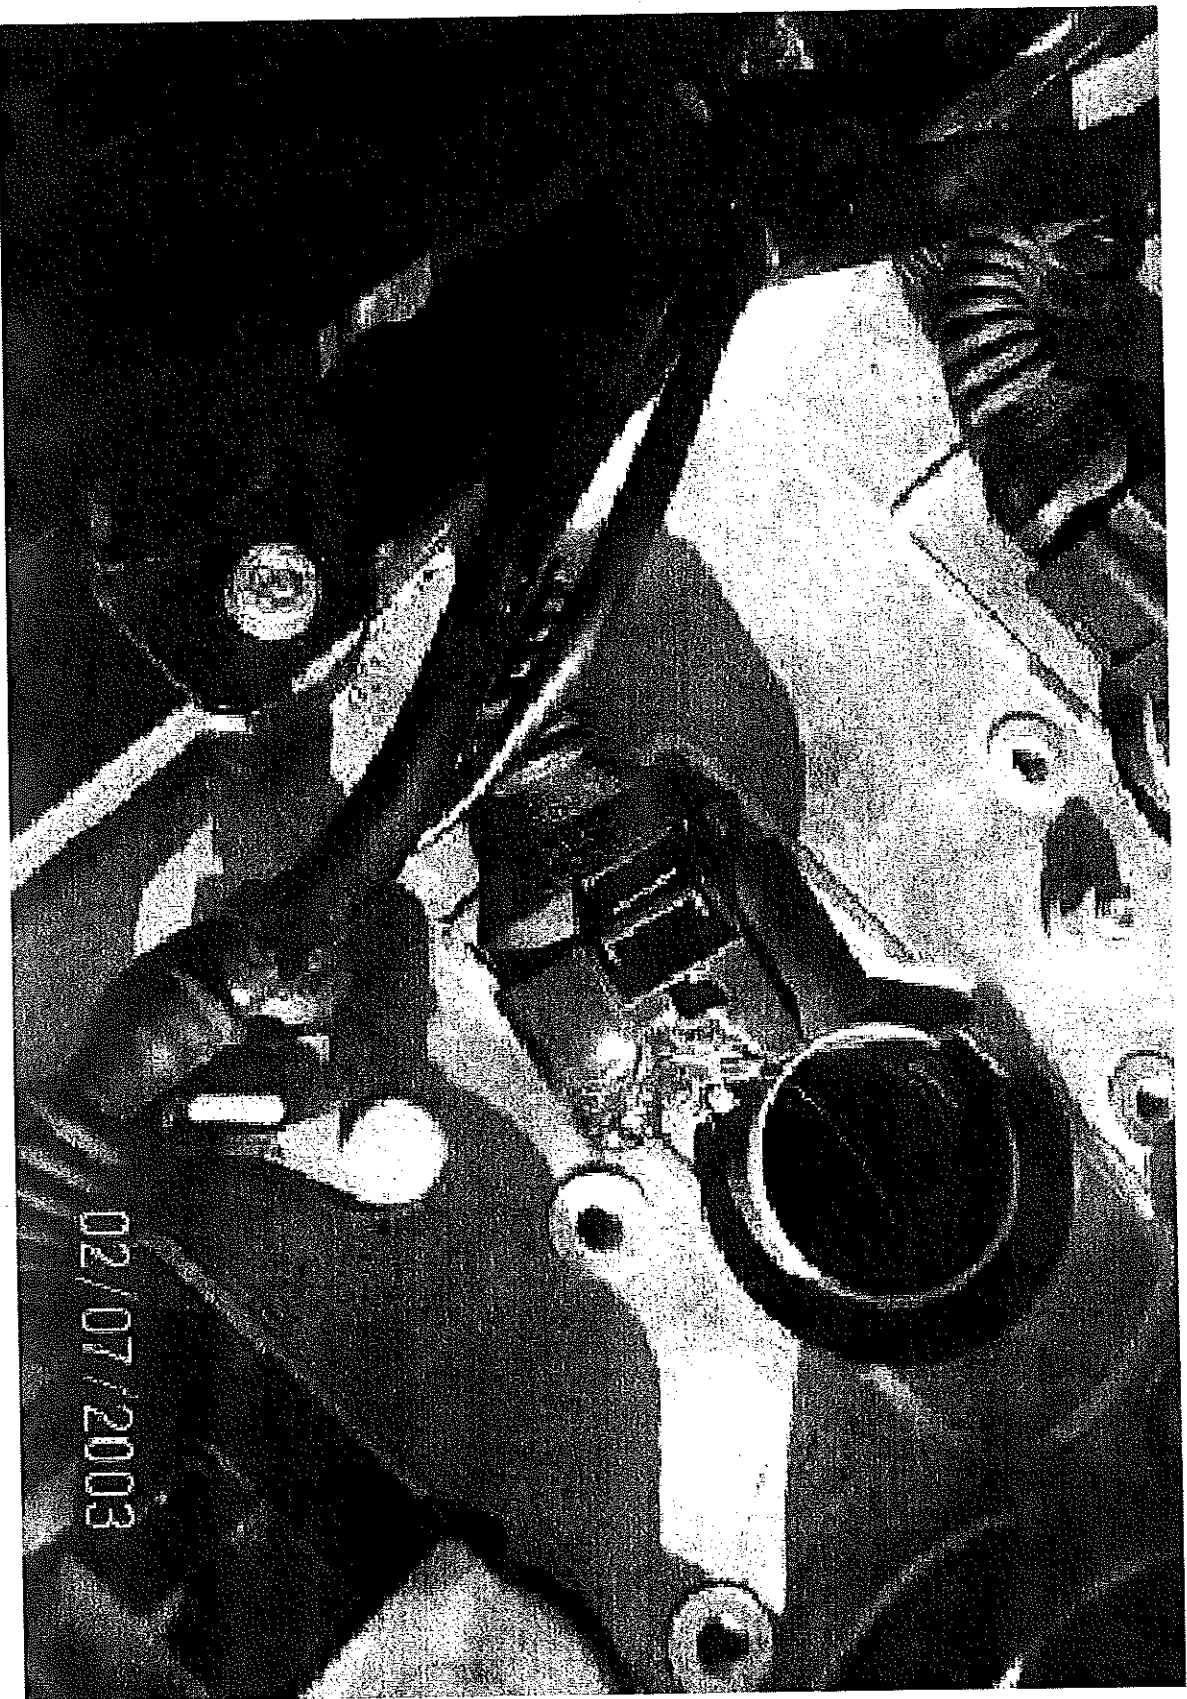
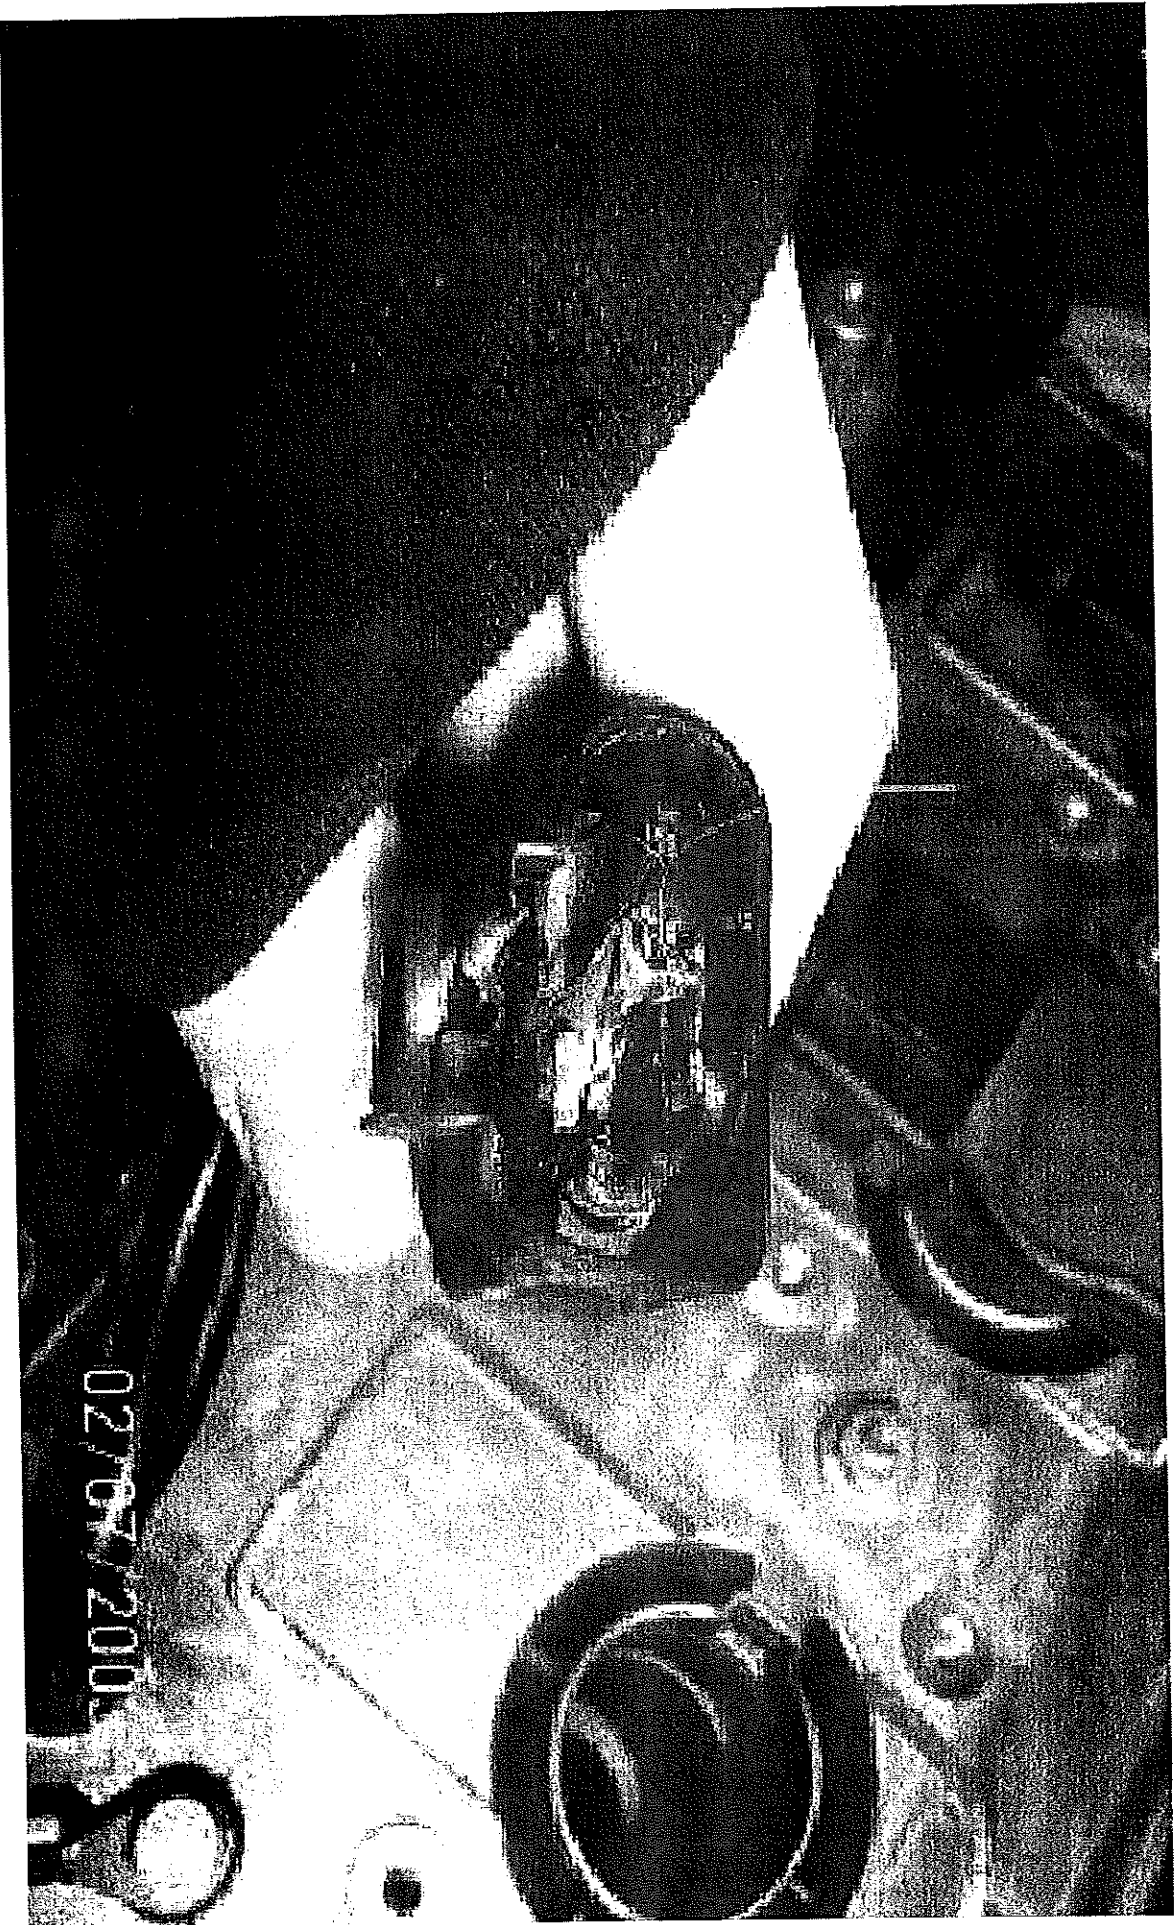
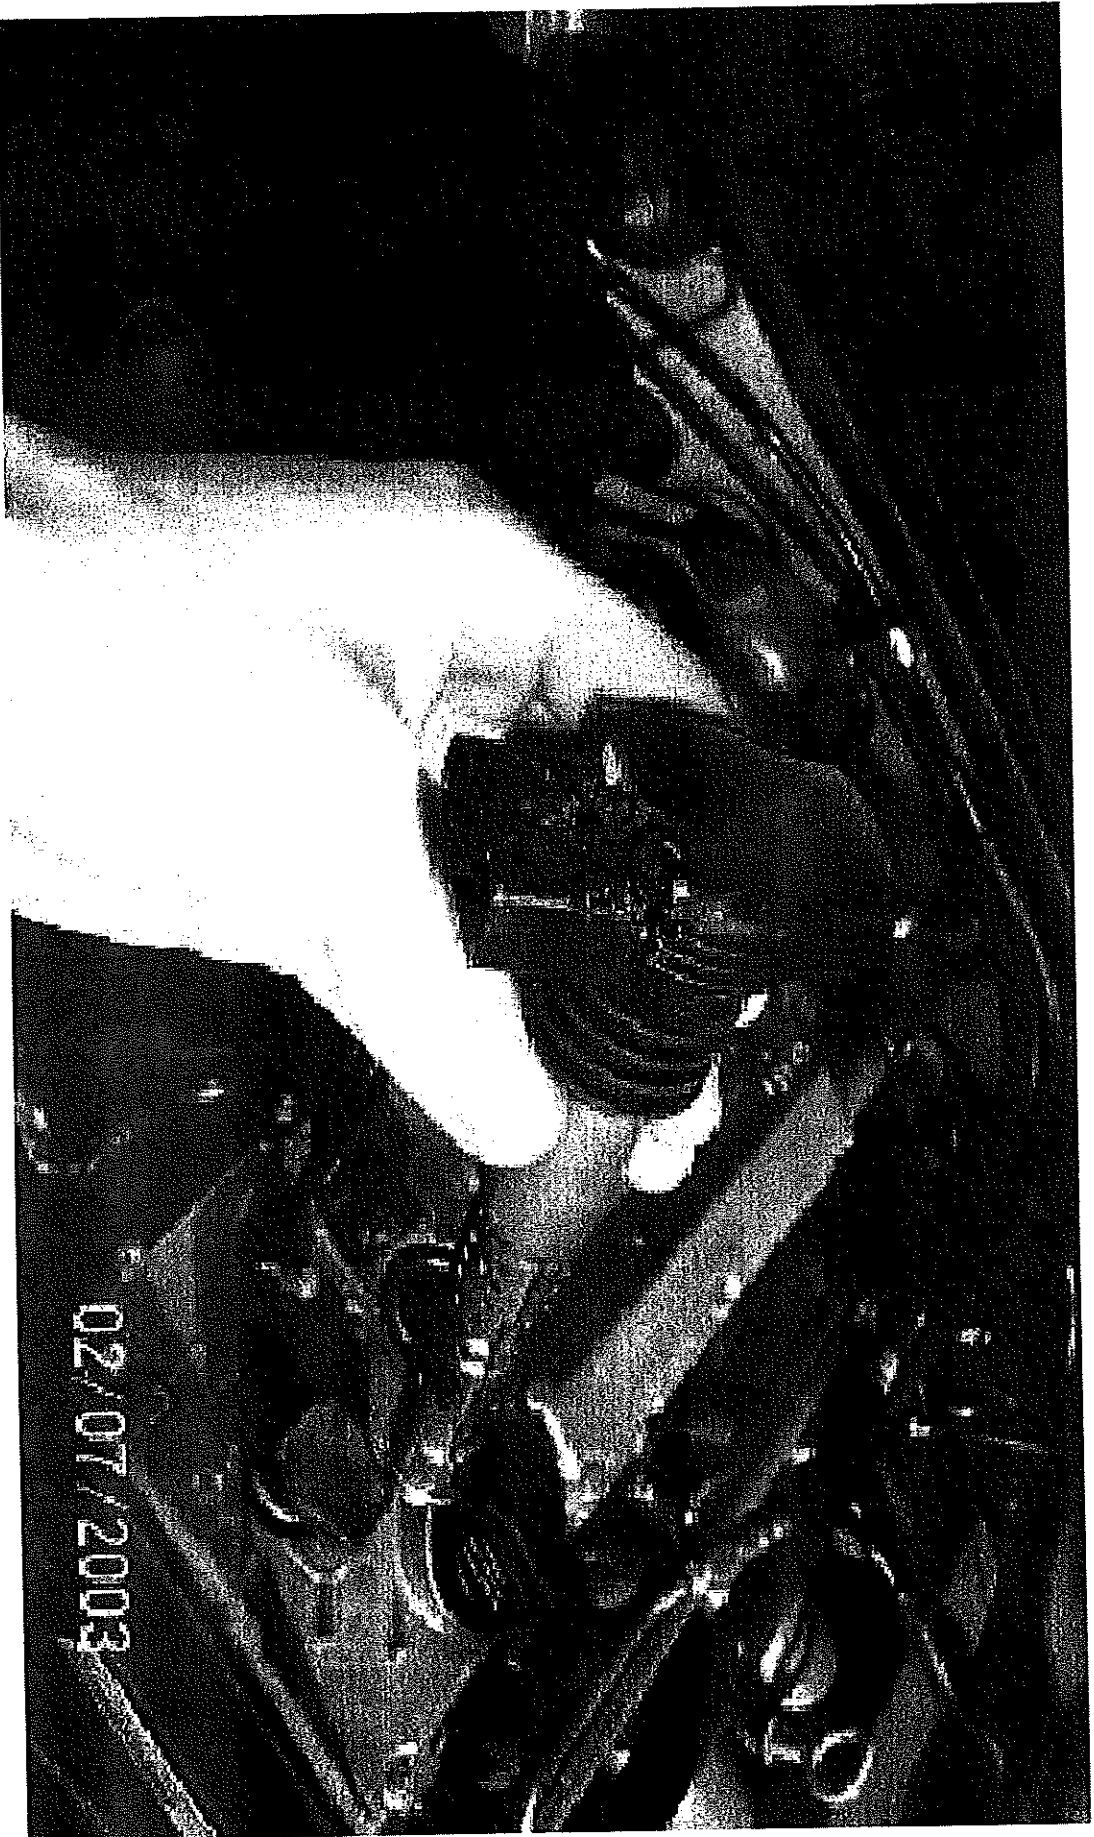
Inspection reveals that the #2 coil pack connector shorted internally while in operation. The internal pin short resulted in smoke and fire which the customer extinguished. The following pictures verify the condition as a harness pin short not a coil failure due to the location of the burn. Coil fires usually result in a burn through above the chip near the back of the coil head not at the pin connector.

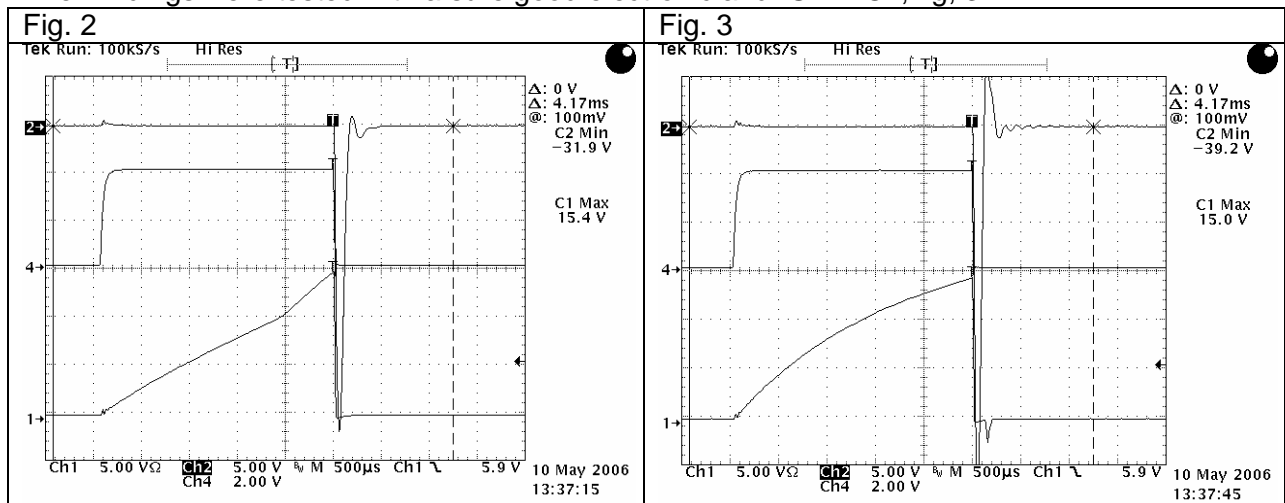
The IGBT was checked with a sure good electronic and windings: Ok, fig. 2.

The windings were tested with a sure good electronic and IGBT: Ok, fig. 3.

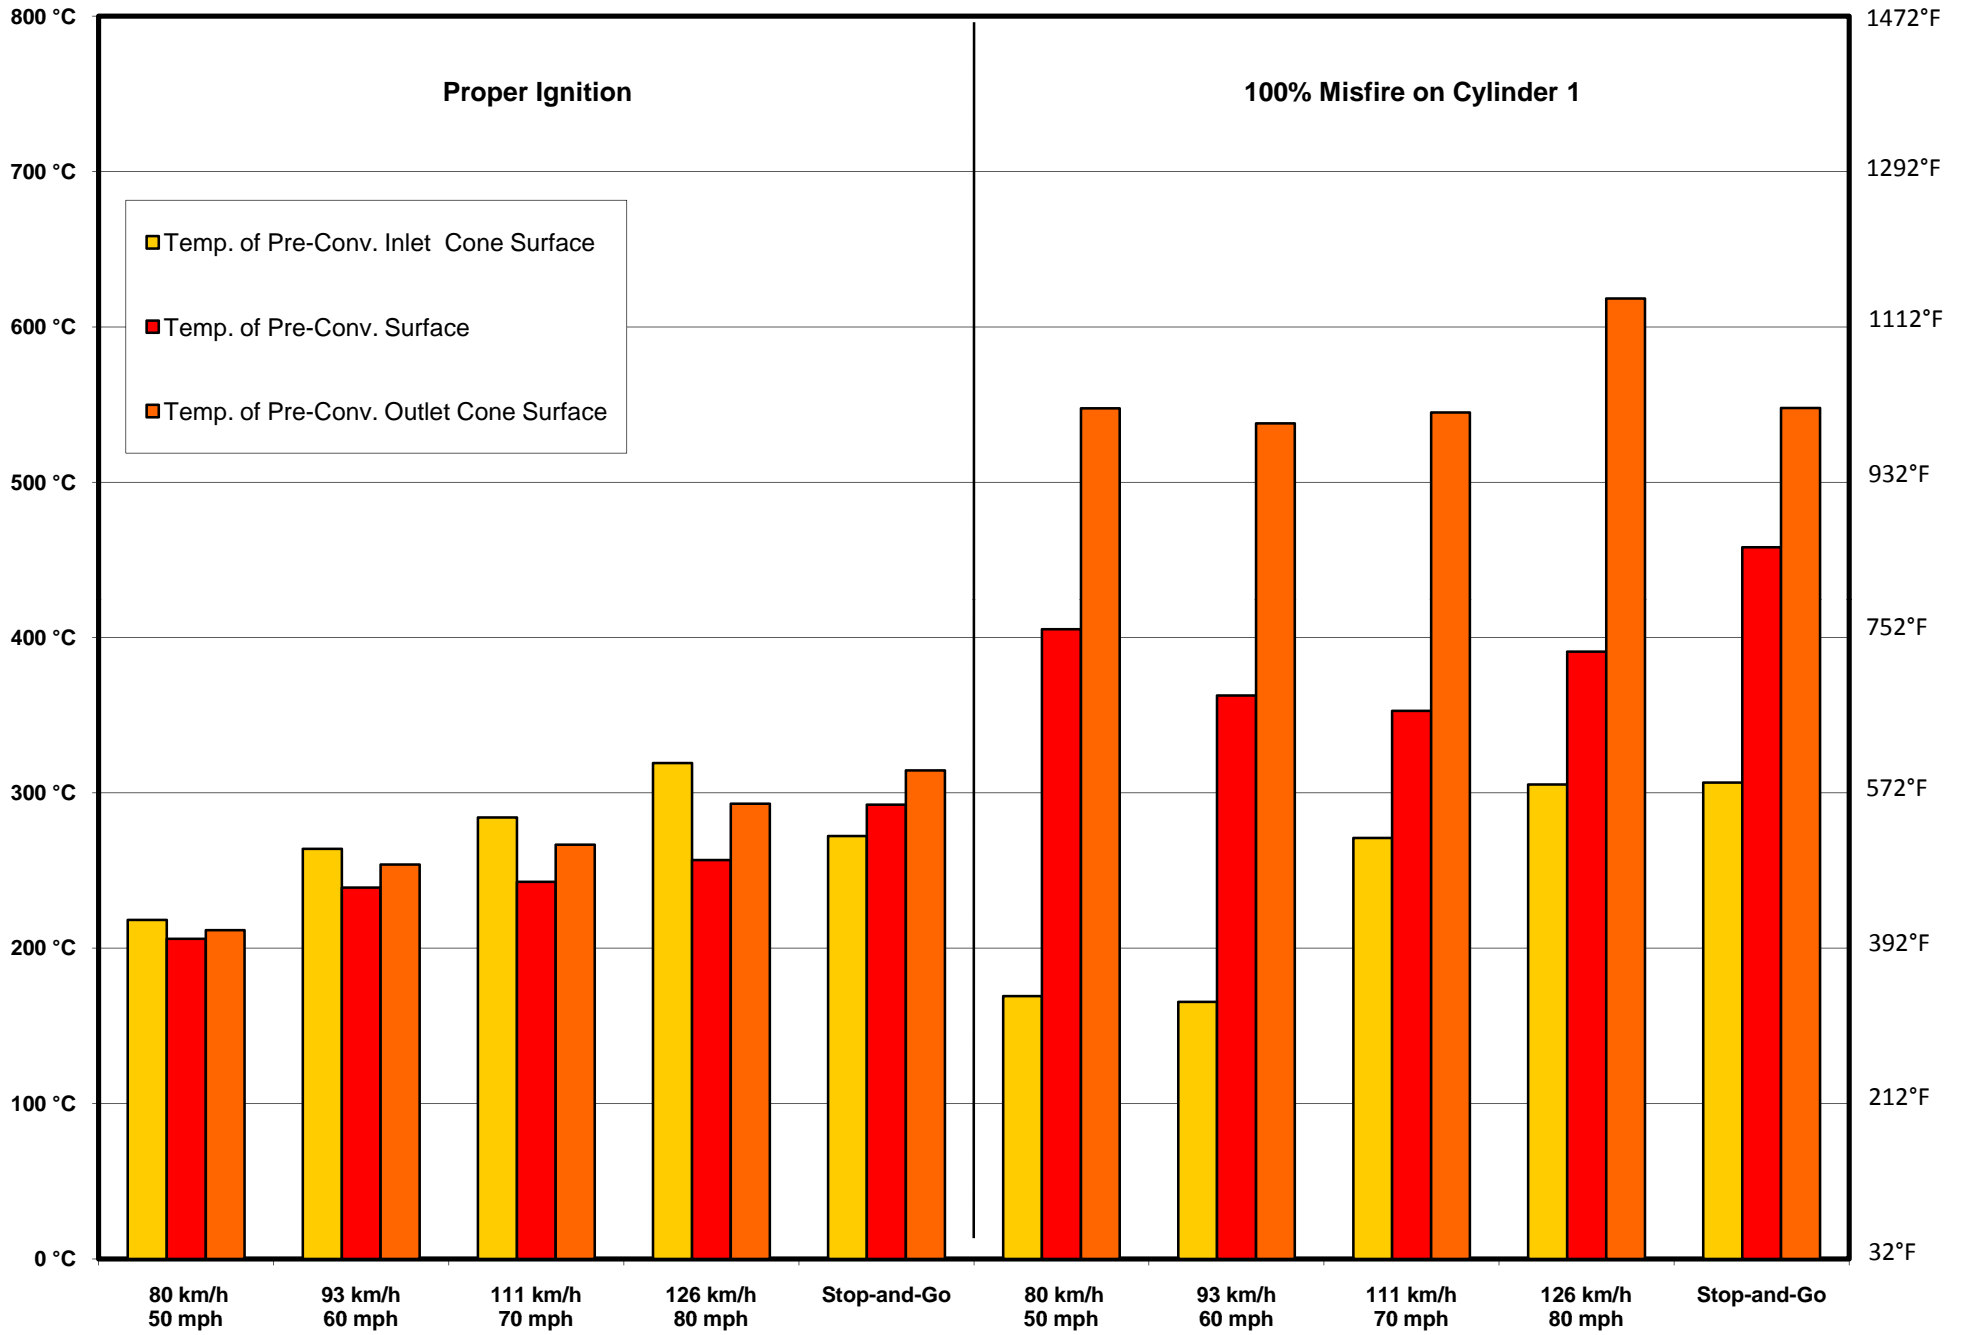
Temperatures measured on roller test bench after approx. 5 minutes driving (steady conditions)

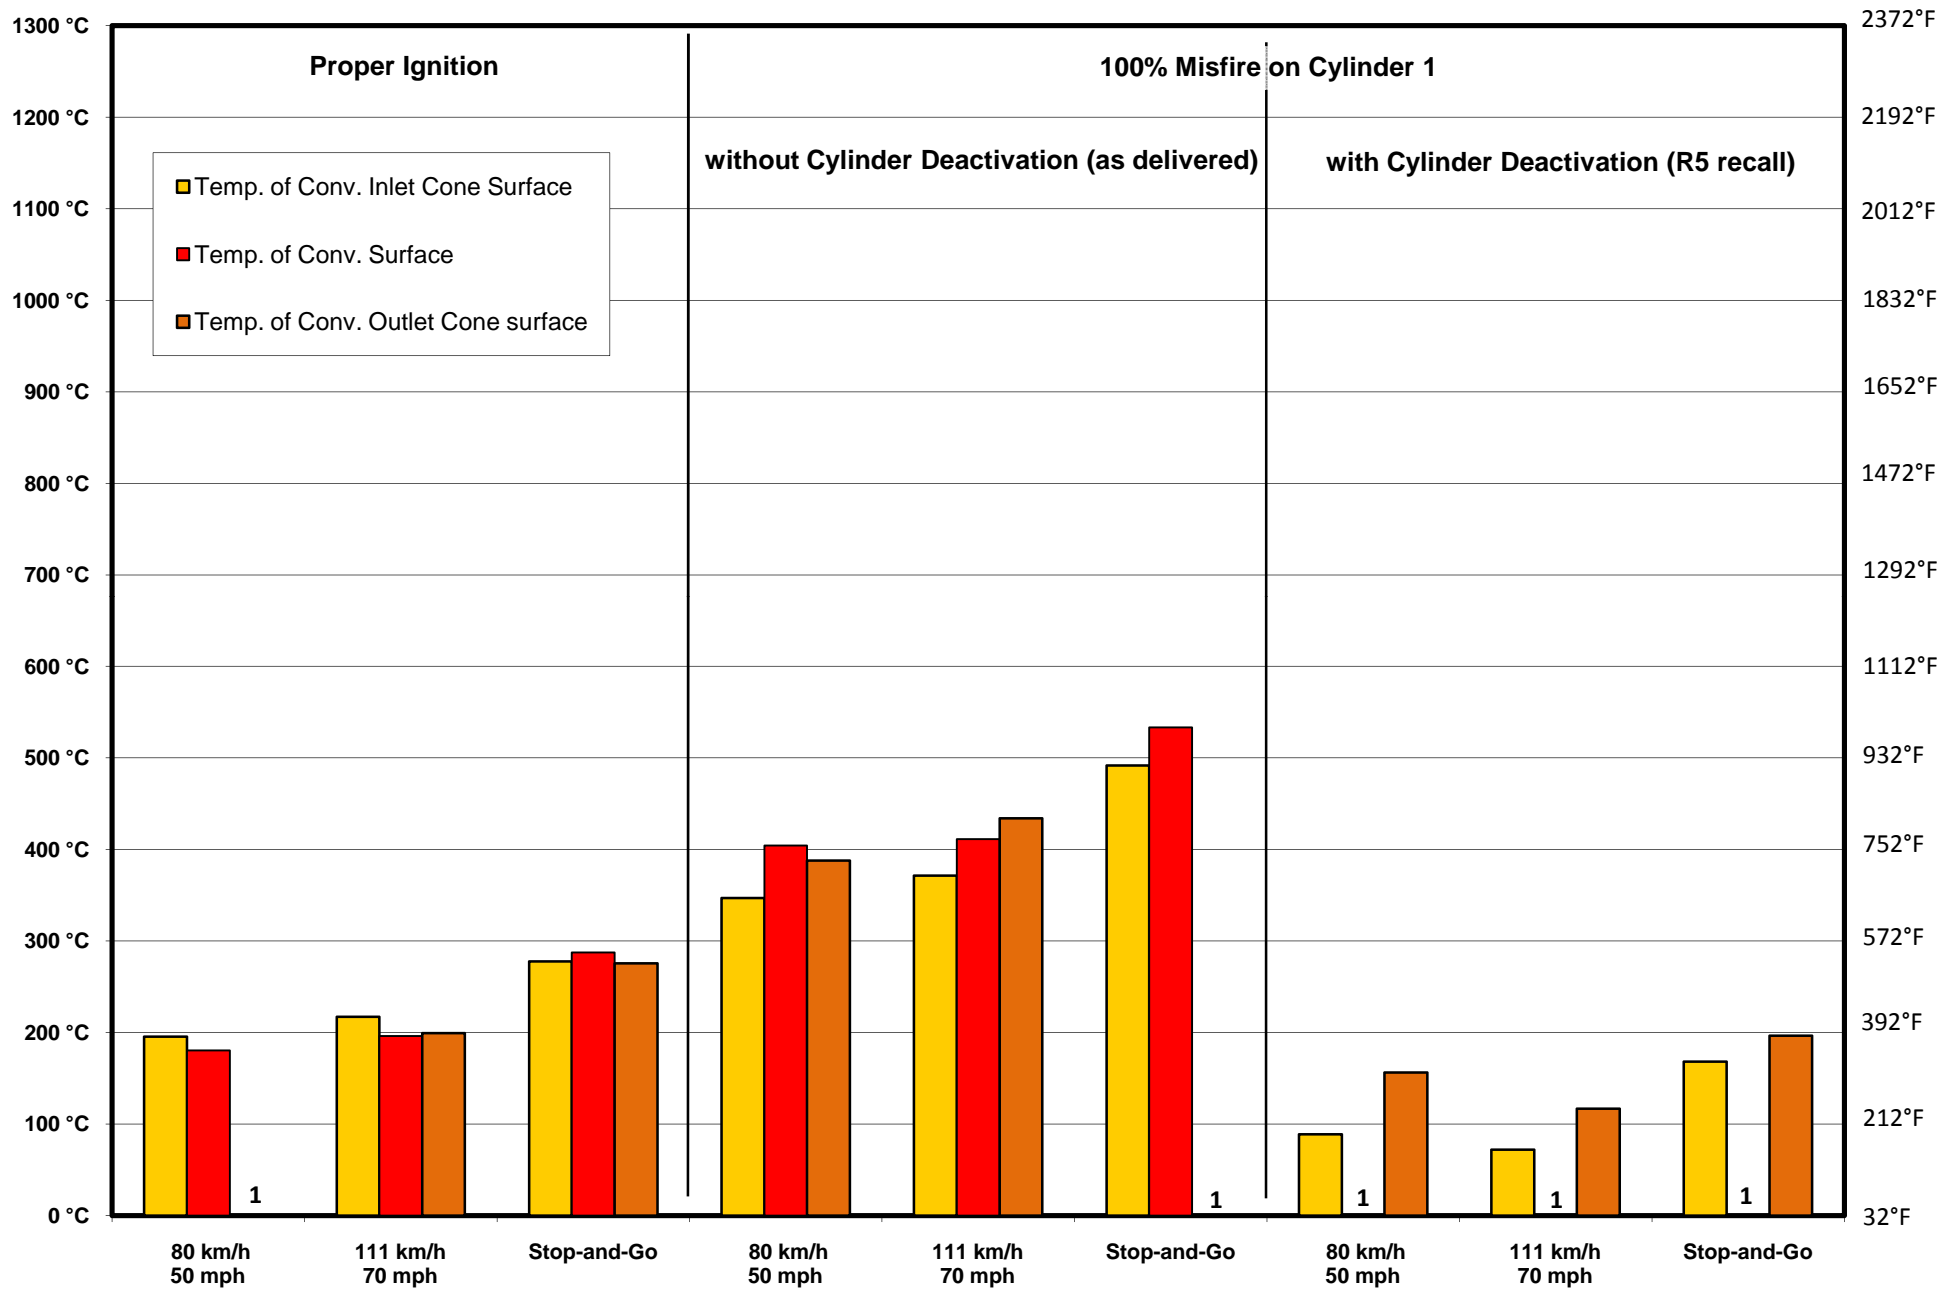
Temperatures measured on roller testbech after approx. 5 min driving (steady conditions), with deactivation measured on Wolfsburg proving ground

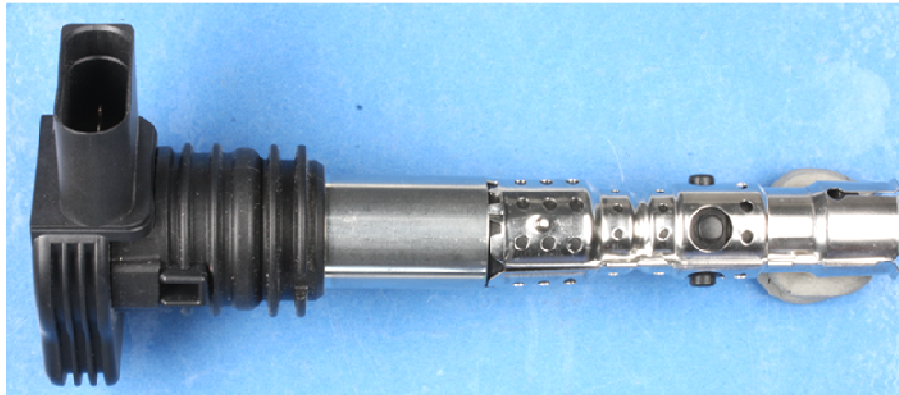
OEM Part
06B 905 115 R

Arrow points to incorrectly mounted shell
