Action	Document	Start Date:	End Date:	Subject/Objective:	Responsible:	Summary:
Action 09-01	09-01_PQA2004470102.pdf	11/19/2004	11/19/2004	Failure analysis of overheated pencil coils	Sub-Supplier Fairchild (Pulse's supplier for IGBT)	IGBT overheated due to current related overstress
Action 09-02	09-02_MPV05-009.pdf (German Original) 09-02_MPV05-009_EN.pdf (English Translation)	9/1/2004	3/4/2005	Failure analysis of 8 failed pencil coils	Supplier Pulse	Coils were damaged by external influences; electrical overstress resulting from missing ground connection caused IGBT to overheat
Action 09-03	09-03_0001924068.pdf (German Original) 09-03_0001924068_EN.pdf (English Translation)	11/25/2004	3/23/2005	Component analysis of ignition coil	Audi AG	Exact analysis not possible because of damage degree
Action 09-04	09-04_11-Z-05-2207.pdf (German Original) 09-04_11-Z-05-2207_EN.pdf (English Translation)	4/14/2005	4/15/2005	Failure analysis of overheated pencil coils	Volkswagen Laboratory	IGBT latch-up, impaired capacitor soldering

Action 09-05	09-05_MPV05-018.pdf (German Original) 09-05_MPV05-018_EN.pdf (English Translation)	9/1/2004	4/25/2005	Failure analysis of overheated pencil coils	Supplier

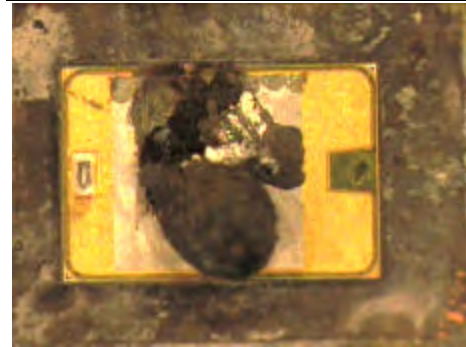
Process name: Root Cause Analysis
 Person responsible: Copertino, Dan
 Step initiated date: 19 Nov 2004
 Step completion date: 19 Nov 2004
 Results Comments: The severe burned and cracked condition of the epoxy resin upon receipt indicates the devices suffered from prolonged current flow and subsequent heating after the device shorted. The reflowed metallization observed on the die surface and localized heating around the emitter bond wires indicates the devices failed as a result of electrical overstress (EOS). The location and nature of the electrical damage, surrounding the emitter bond wires, is indicative of a current related overstress.

Figure 2: #6476
Electrical damage centered near the emitter bond wire area.

These EOS failures have been referred to our Test and Fabrication Engineering groups for their tracking and continued review. At the same time, we request the customer investigate their application for possible sources of an EOS event. If necessary, the Fairchild Field Application/Service Engineer may be requested via the local Fairchild Sales Office to assist in the investigation.

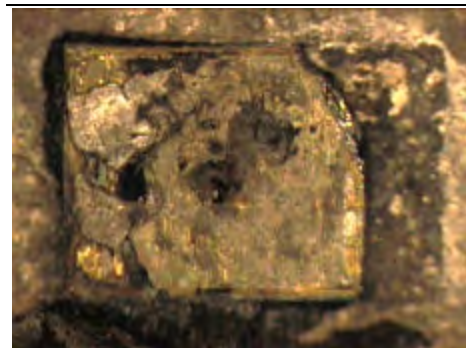
Figure 4: #6423
Electrical damage noted covering the entire die surface.

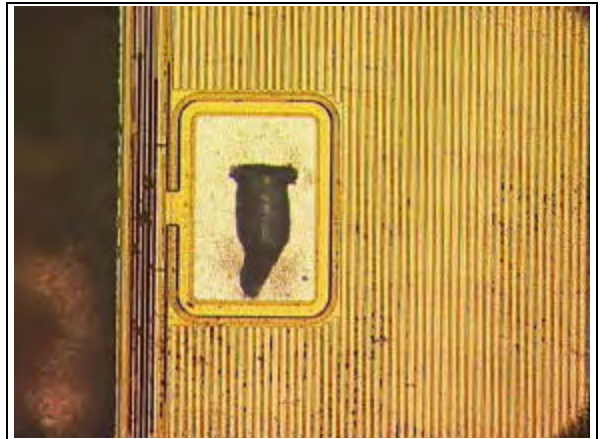
Ref VW – 26-2005-04-12-p-001
Electrical damage noted in the ring structure. Upper left corner of the die. Entire ring area appeared to get hot for extended period as evident by carbonized epoxy left in the ring area after decap

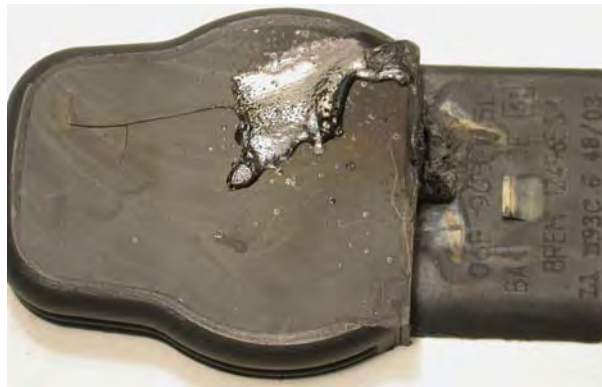
- Part number: 06B 905 115 L L1 N93C 6 48/03 Bremi
- Vehicle no.: WVWPD63B24E239903
- The sealing compound above the control board is cracked and is very dirty in the area of the Pin 1 plug (image 11).
- The IGBT is faulty.

Image 12: coil control view

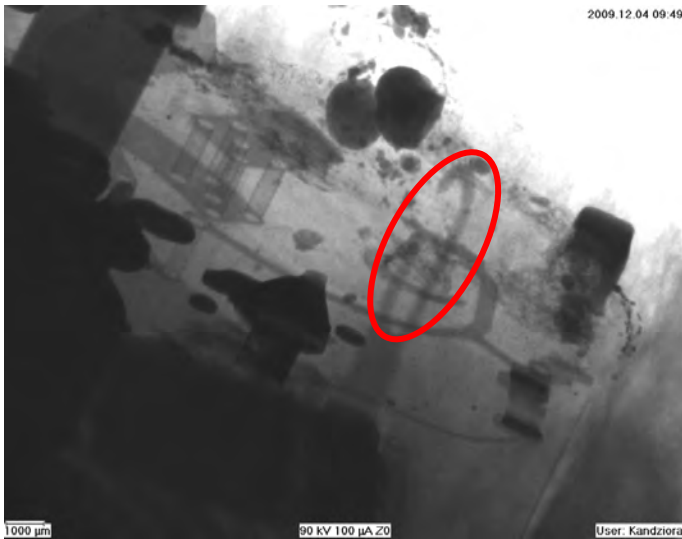
Abbildung 6: Platine, RC-Glied Bereich mit Massefeder: Teilerstörung der Massefeder in der Leiterplatten-Bohrung.

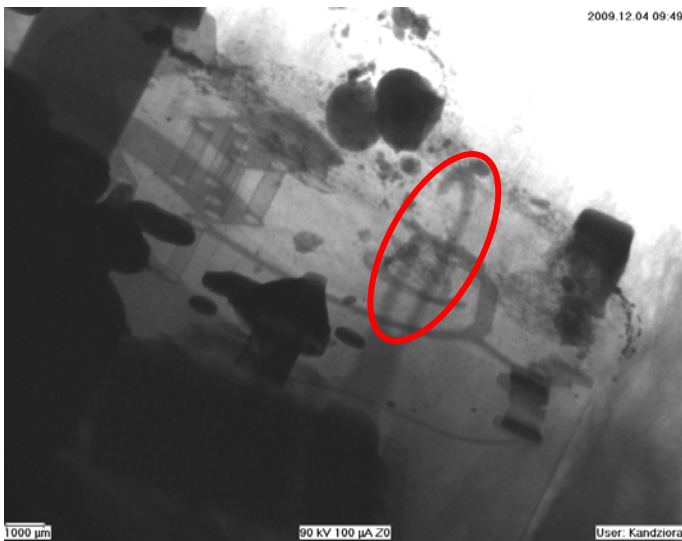
A fault on the RC link lead to the overheating of the conducting contacts (Pin1) and lead to the damage of the coil head. The production date of the coil can no longer be read, it is a coil from the R2 coil generation.

Image 6: printed circuit, RC link area with earth spring: partial destruction of the earth spring in the printed circuit hole.
