PE10-037

Q6 Labor Op and Problem  
Codes

| Theme | Low beam doesn't work<QAH2946><br>(Lighting SW) |

# Analysis results (Comparison of US FIT and Japanese FIT)

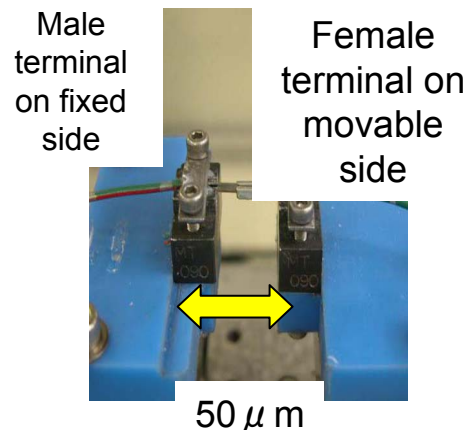
### <Tester appearance>

## Recreation test: Minute sliding and wear test

Sliding cycle: Repeat sliding 10,000 times $\Rightarrow$ 24hrs stopped.

- ◆ No abnormalities confirmed when contact pressure is within mass production control value (8N or more).
- ◆ GND (Ag-Sn) spec. has advantage so Ag plating is a factor to improve toughness of GND terminal. (Cu-Sn, Sn-Sn: 6N, Ag-Sn: 4N)
- ◆ Increased resistance is caused by exposed base material, copper.
- ◆ If contact load is high, resistance is stabilized from "oxide film is torn" that is a known effect and from "terminal sliding is reduced and plating wear is unlikely to be advanced" from the results of this time.  **$\Rightarrow$ It revealed that reduced contact load causes plating to wear, leading to heating and melt.**

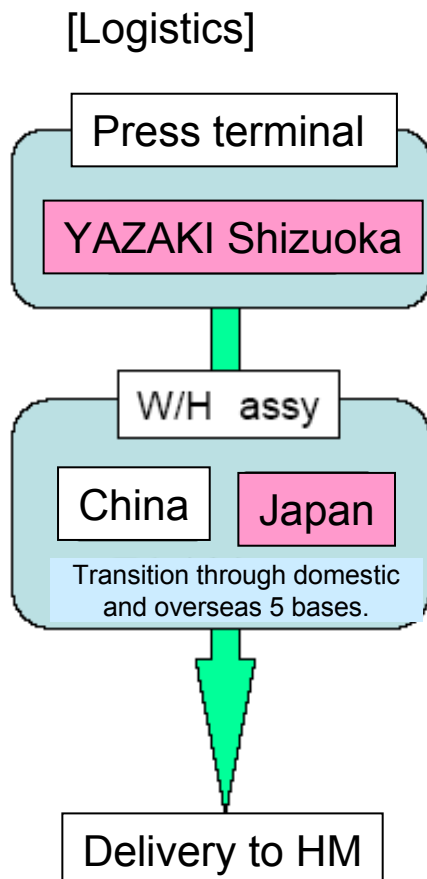
# Analysis results (Investigation into factor contact pressure to lower)

◇ Verified two bases mass production is going on in Japan for FIT

<Results> Implemented an improvement in W/H assy process.

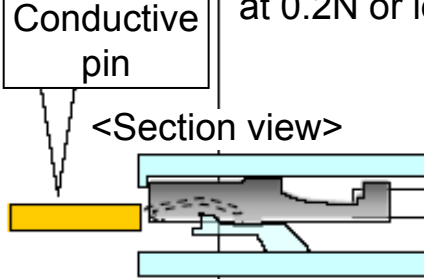
| Verified factory | Concern items | Results |
|---|---|---|
| Area contacted by<br>conductive pin | Contact by<br>conduction checker | -Pressing load is controlled<br>at 0.2N or less. |

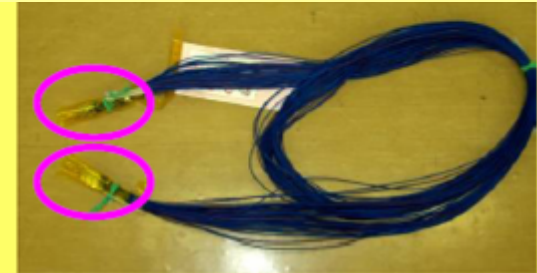
◆ Corded condition of work in process has a factor causing terminal deformation and improvement was instructed.

<Improvement instruction>

Terminals should be corded separately without fail.

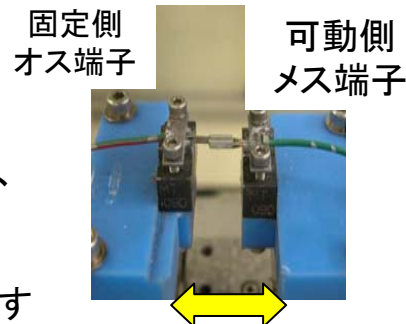
### <試験機概観>

- ①接触荷重：1N ～ 8N(量産管理値下限)～10N
- ②めっき種類と電流の方向：Sn⇒Cu、Sn⇒Sn、Ag⇒Sn、
- ③通電電流量：10A
- ④酸化促進：試験前 未嵌合で100°C×120h放置  
摺動サイクル 摺動1万回⇒24h停止を繰り返す

- ◆ 接触圧 量産管理値内(8N以上)では異常が認められない。
- ◆ GND(Ag-Sn)の仕様に優位性が見られることから、AgメッキがGND端子のタフネスアップの一つの要因である。(Cu-Sn、Sn-Sn:6N、Ag-Sn:4N)
- ◆ 抵抗値上昇の原因は、母材である銅の露出である。
- ◆ 接触荷重が高いと  
従来より確認されていた効果「酸化膜を破る」ことと  
今回の結果より「端子の摺動が抑えられ、メッキの磨耗が進みにくい」ことで、抵抗値は安定する。

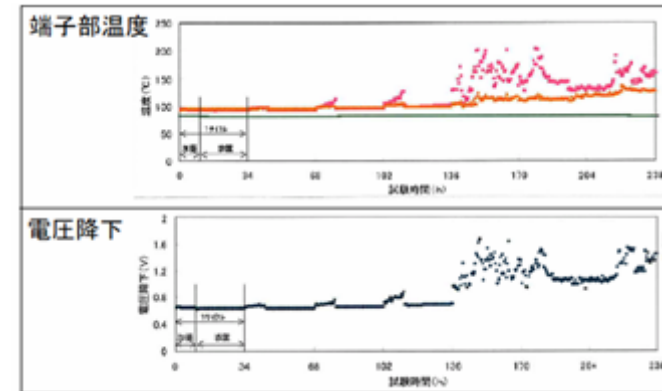
- ・ハーネス

端子接圧NG品(1.5N)をLo端子とGND端子に入れたもの

- ◆接触圧、量産管理値内では異常が認められない。
- ◆接触圧1.5Nまで落とし、酸化を促進させるモードを加速要因として入れると、実車振動相当で事象再現した。
- ◆GND端子のみ接圧NG品を組み込み評価したが、若干の電圧降下が確認出来たのみで、溶損には至らなかった。(通常の倍のサイクル数実施)
- ◆メッキ材質を入れ替えたサンプルで評価したが、AgメッキのLo端子で溶損が再現。

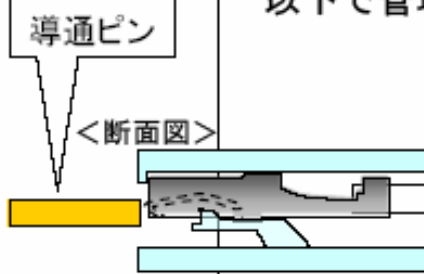
| 検証工場名 | 懸案項目 | 結果 |
|---|---|---|
| | 導通チェッカーの接触 | <p>・押し当てる荷重は、0.2N以下で管理されている。</p> <p>OK</p> |

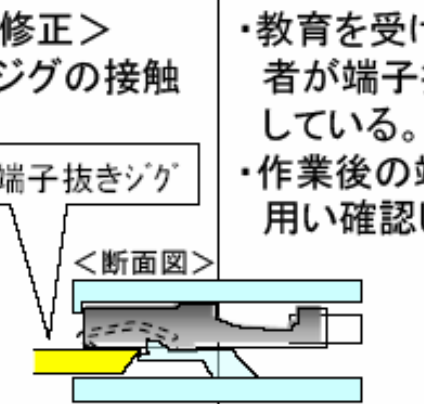
| 検証工場名 | 懸案項目 | 結果 |
|---|---|---|
| | <p>&lt;後配列修正&gt;<br/>端子抜きジグの接触</p> <p>端子抜きジグ<br/>挿入口</p> <p>端子抜きジグ</p> <p>&lt;断面図&gt;</p> | <p>・教育を受けた専任の作業<br/>者が端子抜き作業を実施<br/>している。</p> <p>・作業後の端子変形をジグを<br/>用い確認している。</p> <p>OK</p> |

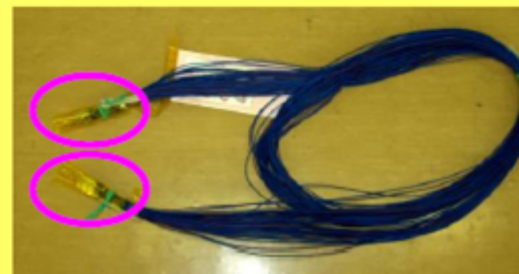
## ◆ 切圧品の結束状態に端子変形を起こす要因があり、改善を指示

<改善指示>

端子は、必ず別々に束ねること
