PE10-045

DUCATI

# Leakage

## PE 10-045 - IR on Monster Old

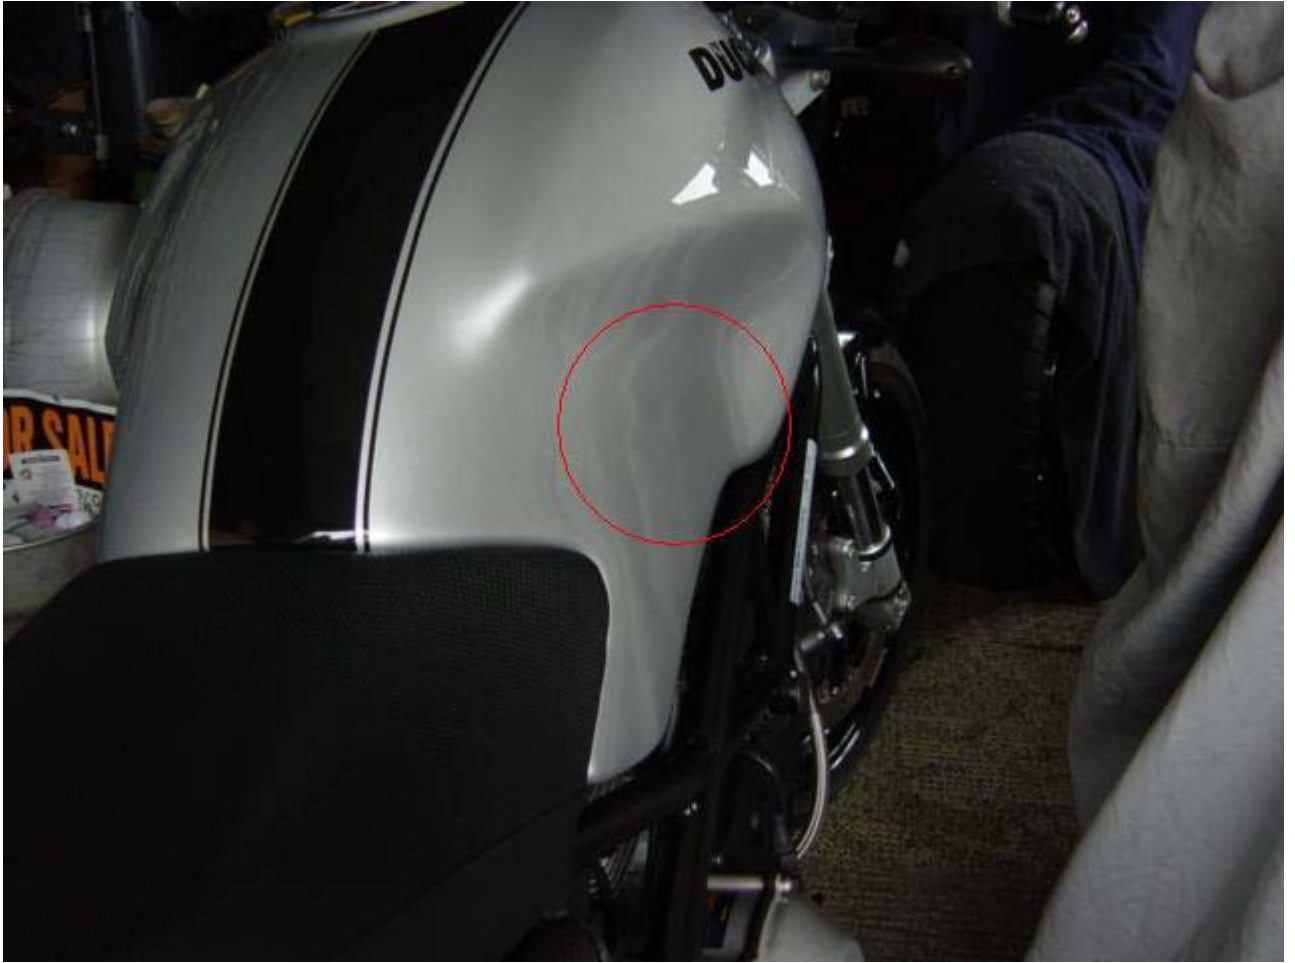
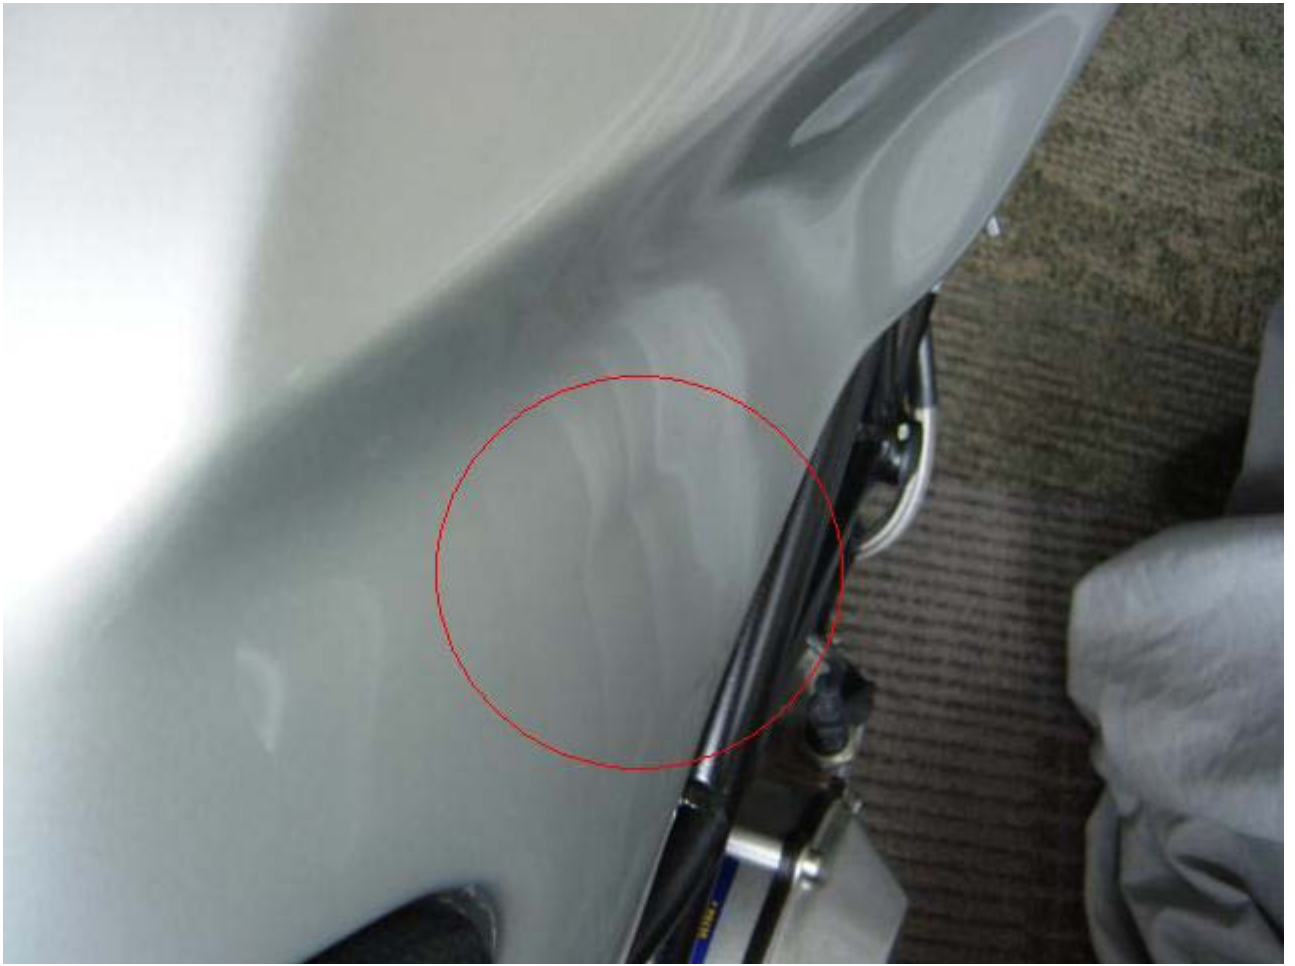
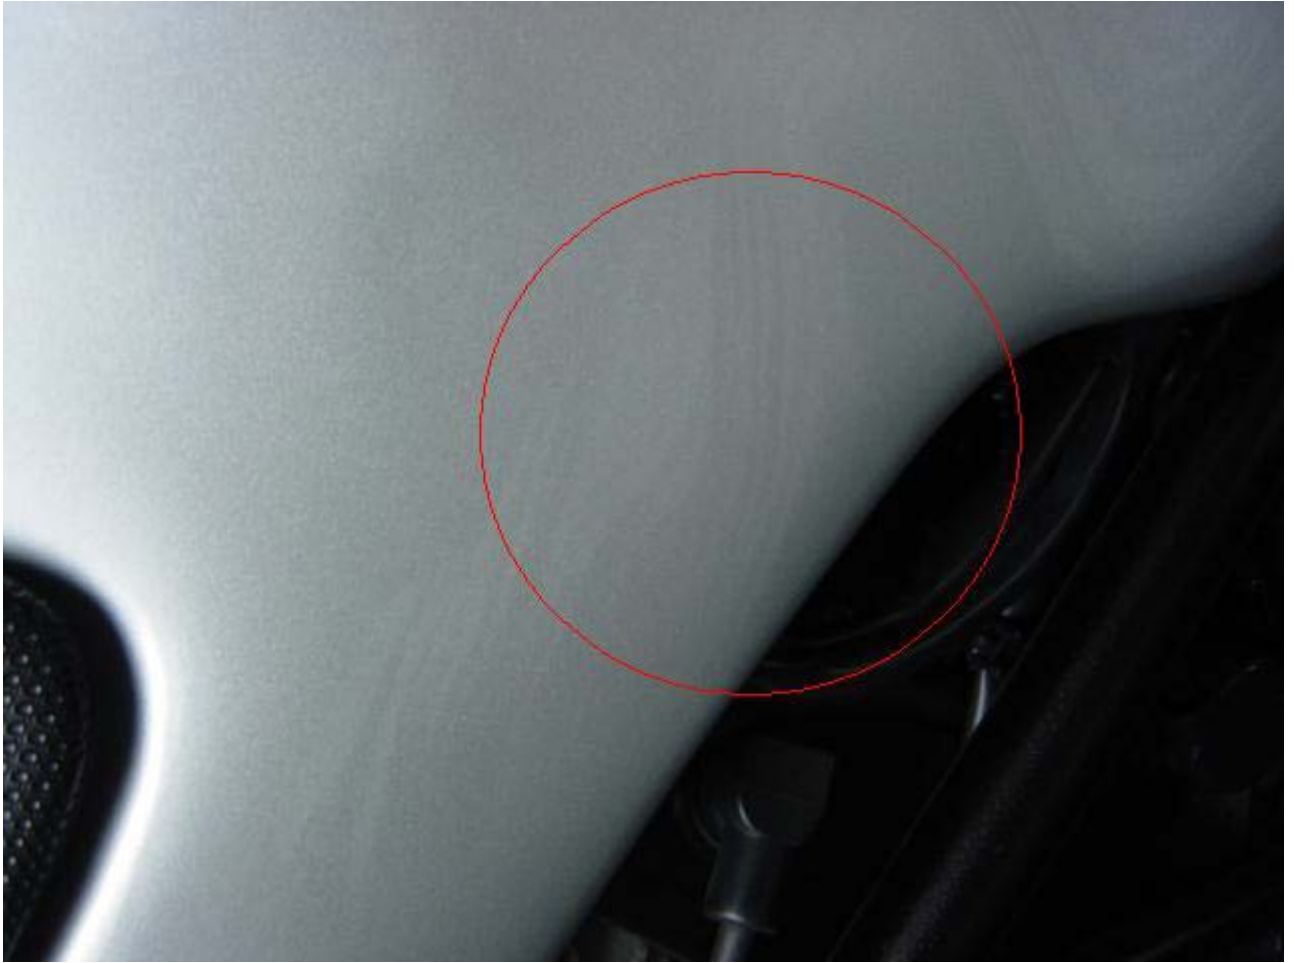
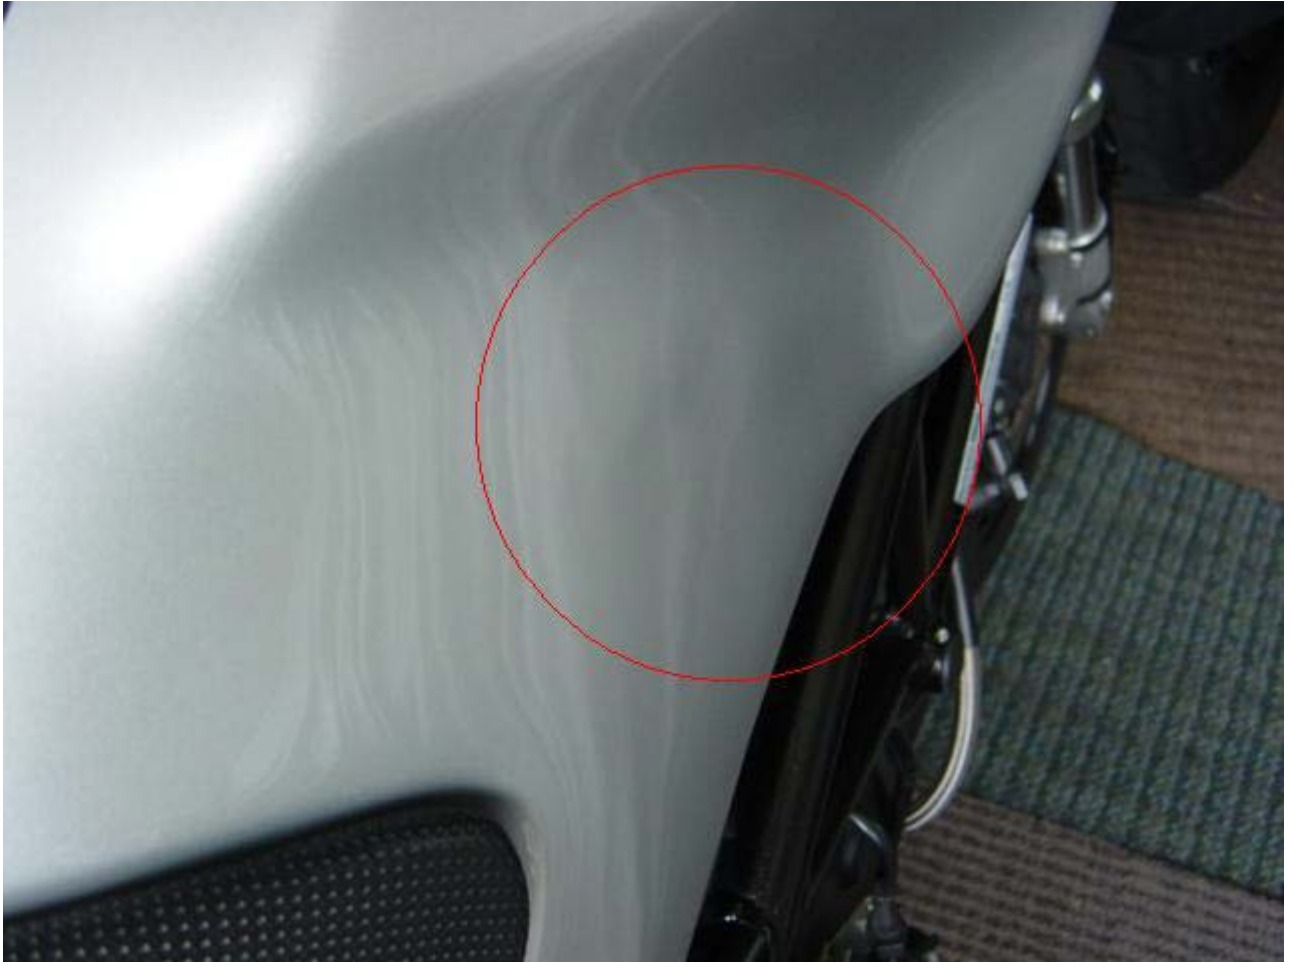
Leaking from fuel pump flange onto top of engine and exhaust system. Material of tank very thin around pump flange which is distorted. Tried relieving bolt holes in pump flange to suit mounting bolts to no avail. Leak is due to tank distortion from lack of strength (possibly engine heat also) Stained crankcase and alternator cover from fuel.

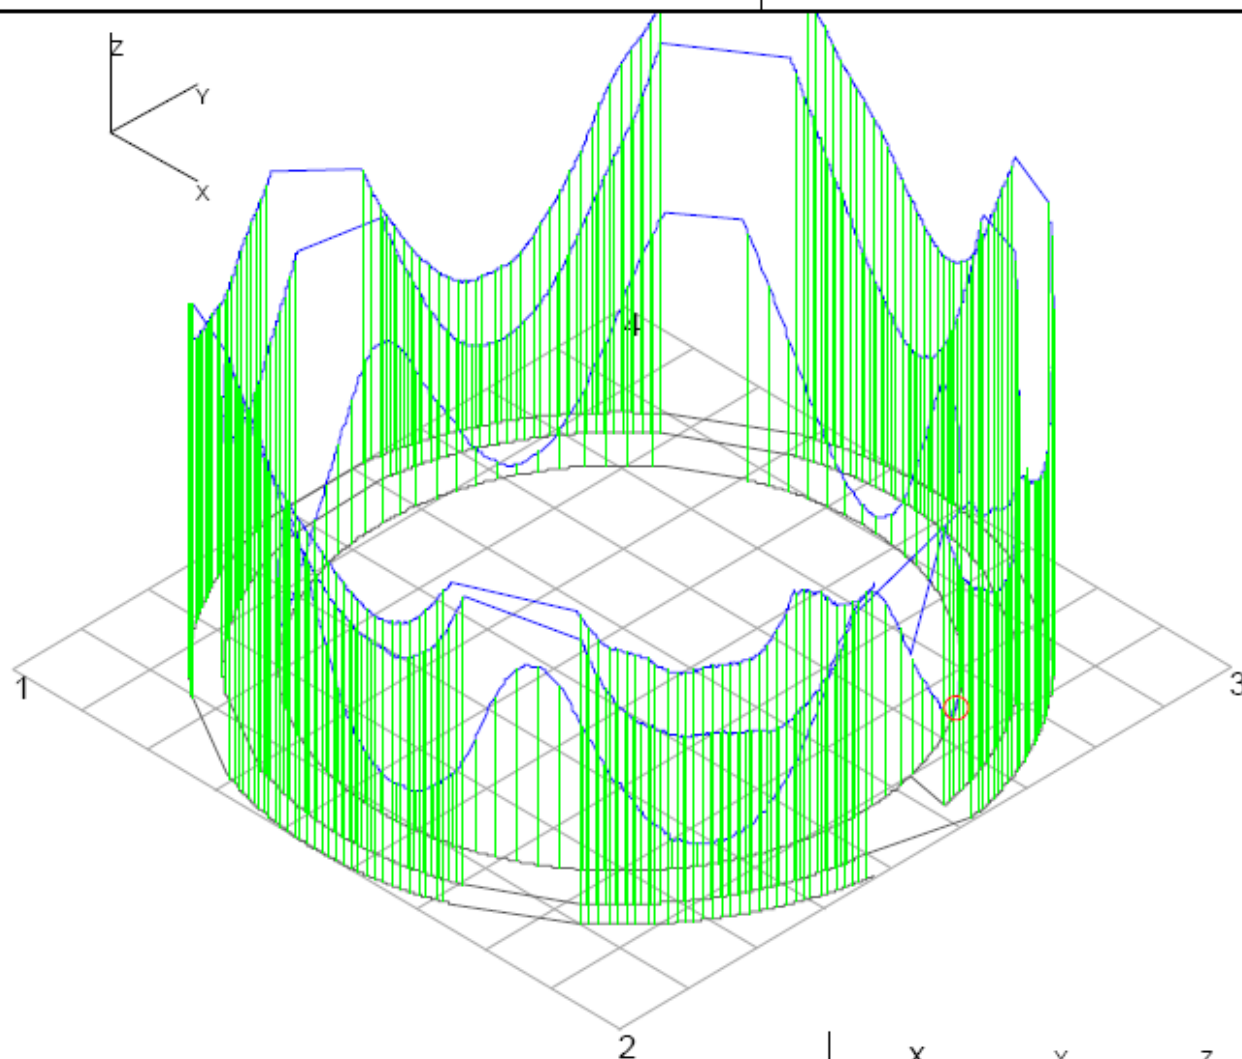
Planarità\_totale

| N. | Identificazione | Valore attuale | Toll. | Punti | Vel. | RagTast | TipoFilt | L-C | UPR |
|---|---|---|---|---|---|---|---|---|---|
| 1 | Planarità_totale | 1,3199 | 0,0000 | 4810 | | 1,5285 | | | |

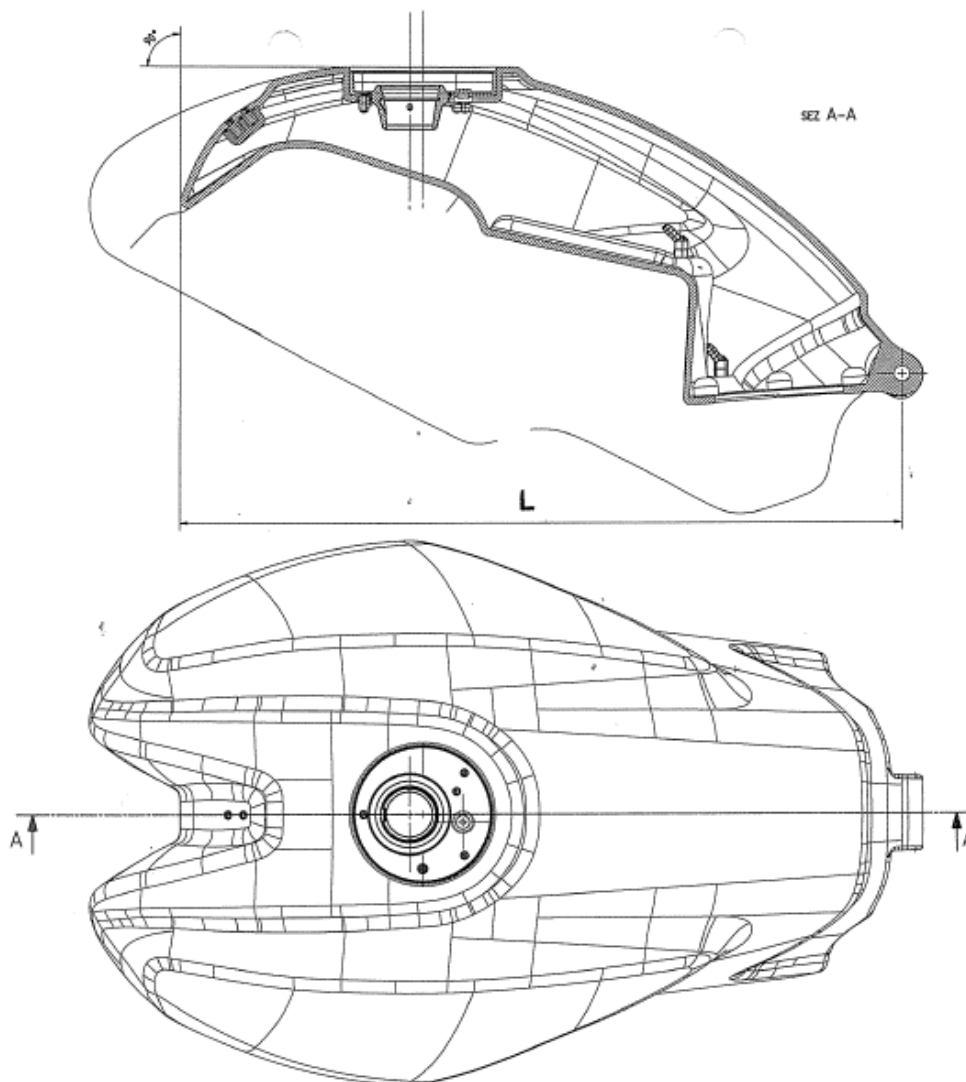
In order to assess the amount of the alleged deformation, the dimension "L" shown in the sketch here below was measured on the replaced tank and on the original tank of the reference bike (i.e. the "reference fuel tank").
