Quality Assurance - Early Warning Report

TQCN DOC#: EVRG101821C	RTS#: 13412-1	RTS Disposition: Forward	TMS QA Dept: QA-Powertrain	Assigned PE: STEGERT	Distribution Date: 1/24/02
Report Source: FPE	Primary Model: ES 300	Model Year: 2002	Production Date: 10-2001	Miles: 1105	VIN: (CONFIRM 17 DIGITS) JTHBF30G420 [REDACTED]
Condition Title: SURGE ON ACCELERATION - A/F SENSOR FAILURE				Author: MATT HENNESSEY	Dealer Code: 64204

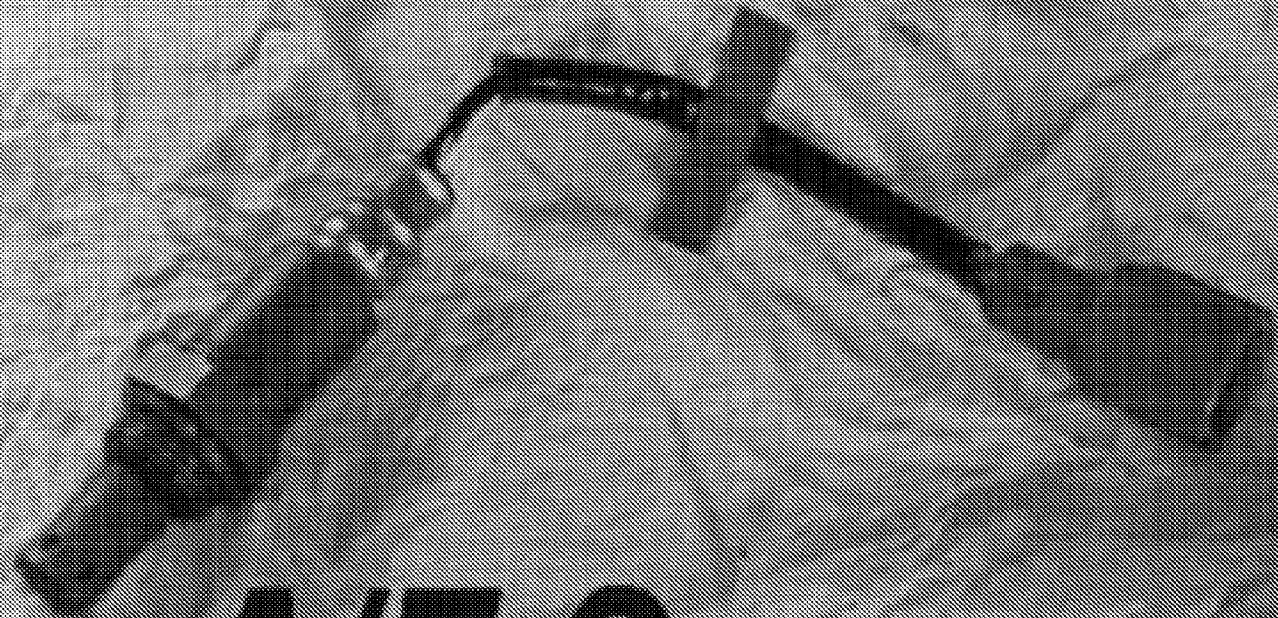
Short Term Fuel Trim, AF B1 S1, ranged from -16% to +16%; rapidly fluctuating. A/F sensor defective.

Picture of defective A/F sensor

A/F Sensor

Technician replaced A/F sensor B1 S1 to correct condition.

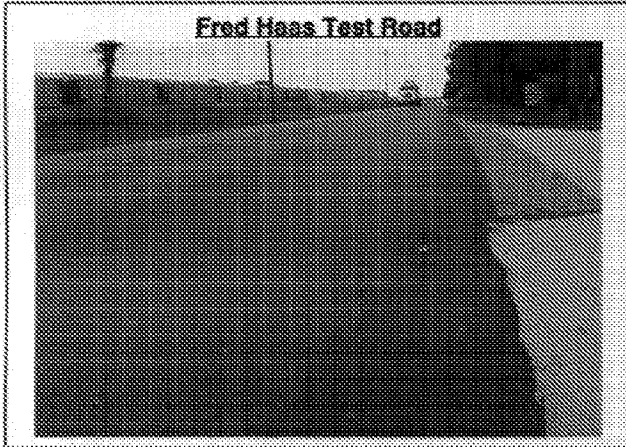
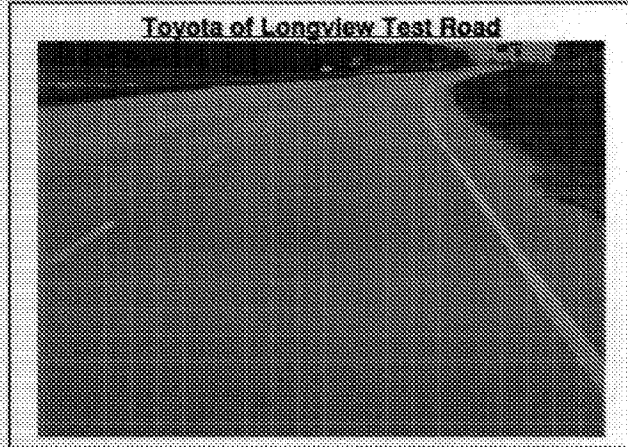
All vehicles tested were driven by TMS / TTC engineers and the GST Regional FTS and FPE to provide the best objective evaluation of the "surging" condition. All vehicles were tested and evaluated on flat to slight uphill road profiles (2 ~ 3% grade) with smooth surfaces. Illustrations of the actual test roads are provided below:

All vehicles tested, both customer complaint and new dealer in-stock units, exhibited the "surging" condition between 38 ~ 42 mi/h, transmission in 4th gear, L/U "ON" (Lock-Up). Throttle input was 13 ~ 15% with the vehicle maintaining a steady cruise. It was agreed by both TTC and TMS engineers that the "surging" condition experienced on the customer and dealer vehicles was equal to the TMS Internal Fleet Vehicle previously evaluated by TTC, TMS and TMC. Using Vehicle No. 2 described in Chart 1, TTC and TMS engineers installed a Panel A-2 diagnostic tool including the installation of a "G" sensor on the front passenger seat mounting rail. This allowed for the precise measurement of the longitudinal forces that were experienced during the "surging" condition. Measurements were taken during the "surging" condition with L/U coming on at 38 mi/h. The measured frequency was 8hz with the "G" sensor reading a 0.1G force during the "surging" condition. The Panel A-2 screen is shown below with the RED line indicating the "G" sensor signal and the GREEN line indicating L/U operation. (L/U "ON" is at this point)

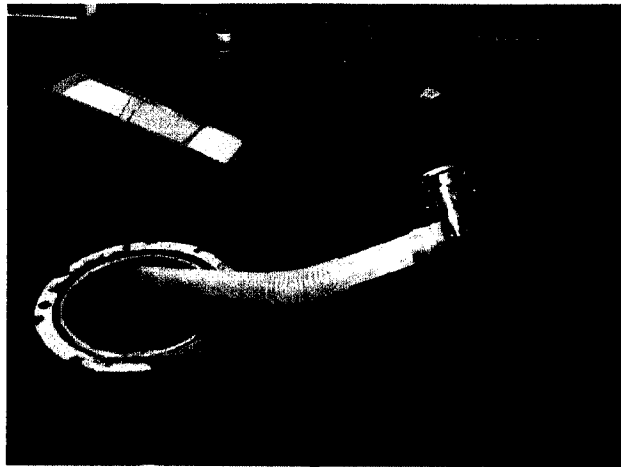
Photo A

Vapor Hose pulled from inside Fuel Tank

- Fuel Tank Replaced. P/N (77001 – 06080)
- EVAP Canister replaced. P/N (77740 – 06141)
- Fresh Air Filter replaced. P/N (17700 – 0A080)
- Part Numbers are currently not loaded into parts system.

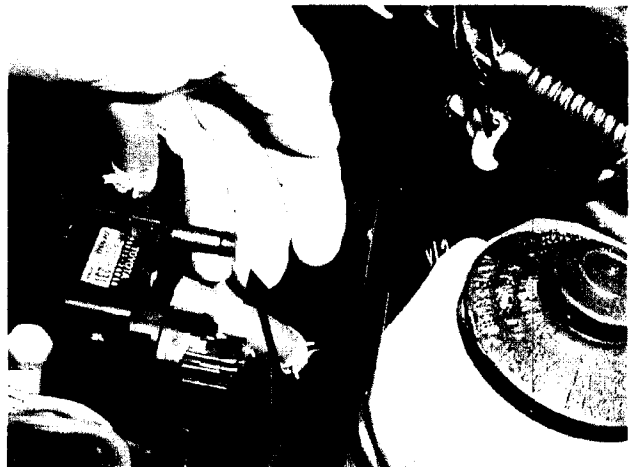
Photo B

Liquid Fuel at EVAP VSV

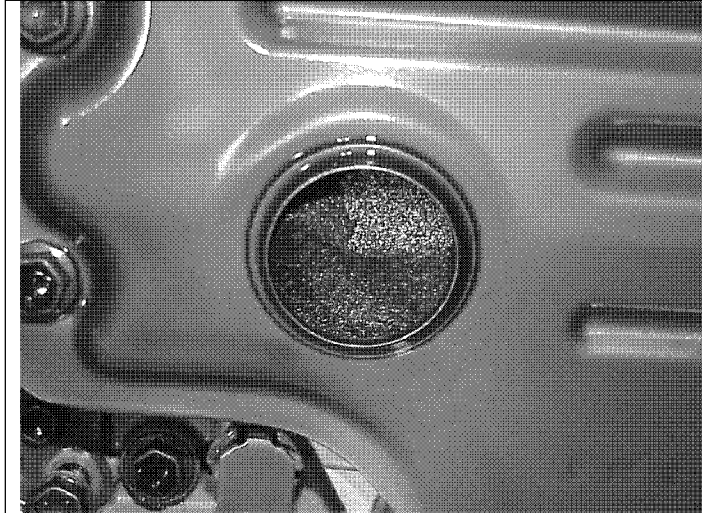
Close-up view of ATF Intake Filter Screen showing heavy deposits of debris almost completely restricting visible portion of Screen.

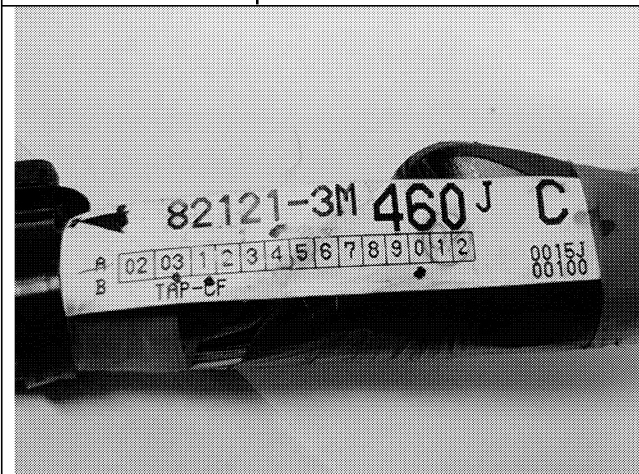
Part # for wire loom.

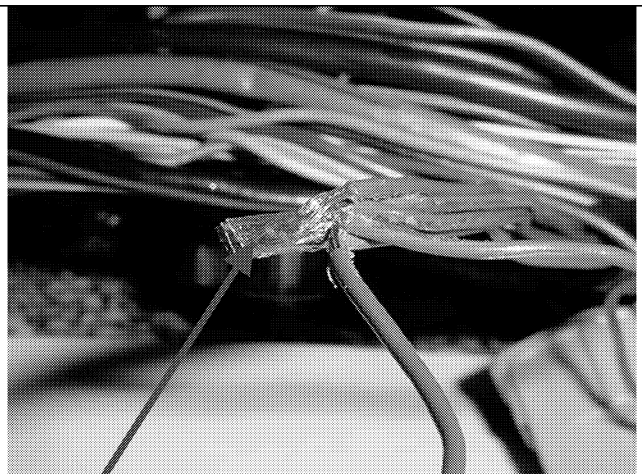
Splice point E8.

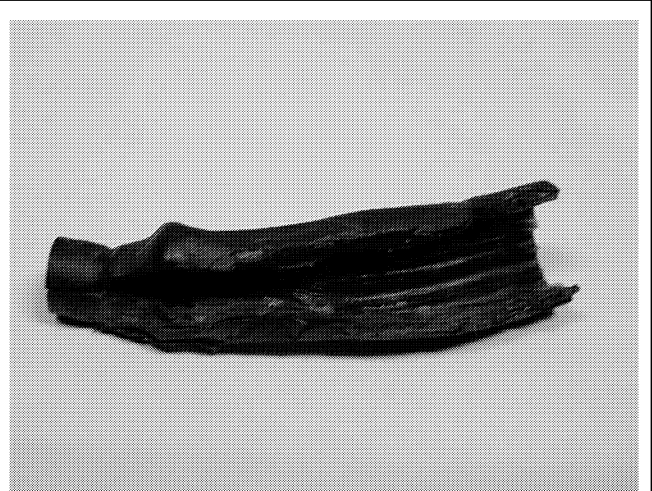
Splice point cover.

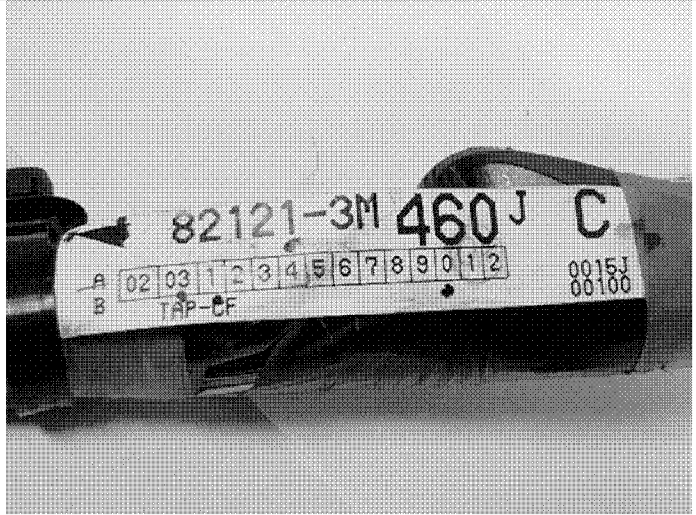
Part # for wire loom.

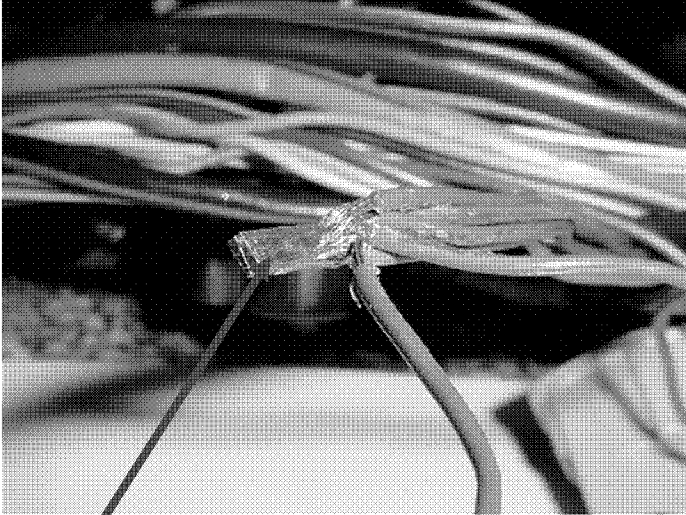
Splice point E8.

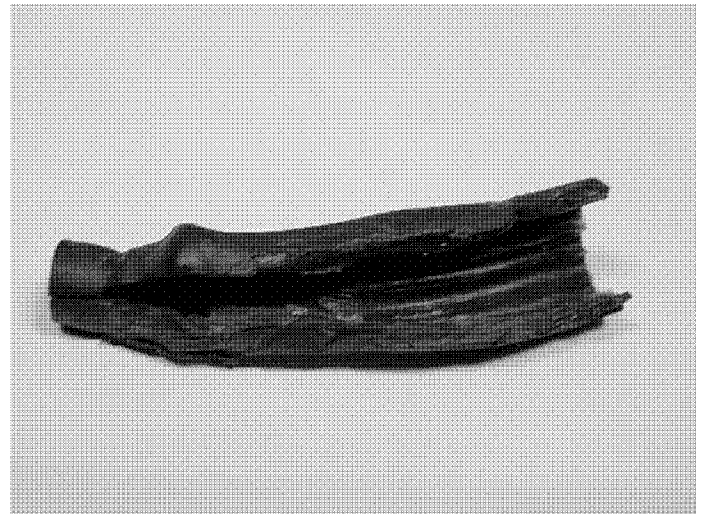
Splice point cover.

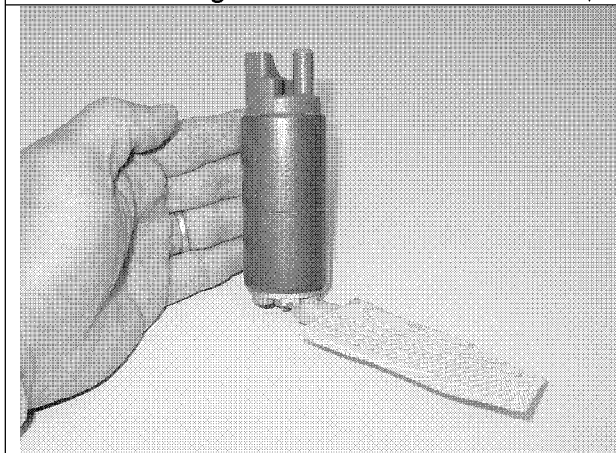
Overall view of malfunctioning LS 430 Fuel Pump that had caused intermittent lack of Engine power, surging and stalling due to low fuel pressure.

- Fuel Pump was manufactured by Aisan.
- A yellow-colored paint mark was located on rear of the brown plastic housing.
- No other markings were identified on Fuel Pump assembly.

Note: Fuel pump Connector Receptacle sustained damage when it was accidentally dropped after removal from Vehicle.

Fuel Pump assembly ("Pump Assy, Fuel" PN 23220-50110) was replaced, correcting condition. Malfunctioning OEM unit was recovered, and will be forwarded to TMS QAP with this Report.

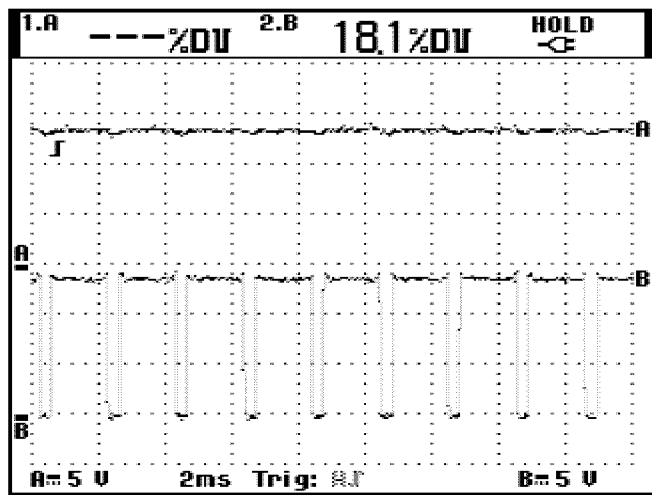
KGU - NOT idle
Ch A = M+ Ch B = M-

Picture 1:
Known good unit at normal operating temperature idle. M+ is a steady +B power supply and M- is duty cycled to control idle speed.

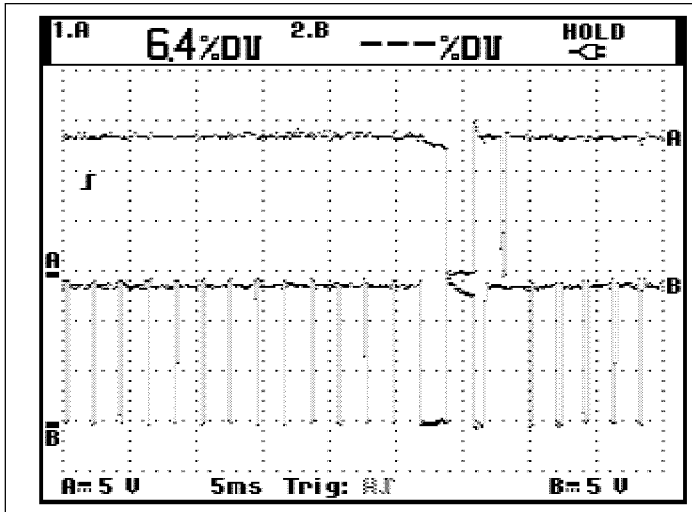
JTJHA31U940046786 - NOT idle
Ch A = M+ Ch B = M-

Picture 2:
This is the problem car at normal operating temperature idle.

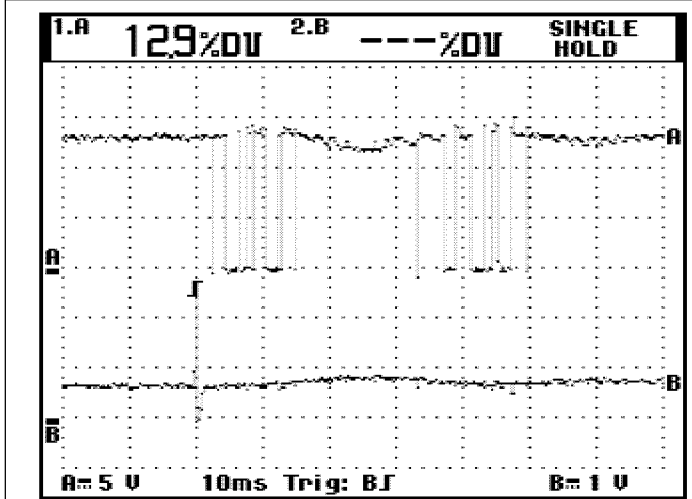
JTJHA31U940046786 - NOT idle
Ch A = M+ Ch B = VTA

Picture 3:
This is the problem car showing M+ and VTA. Note the spike in VTA and shortly afterward the pattern on M+.

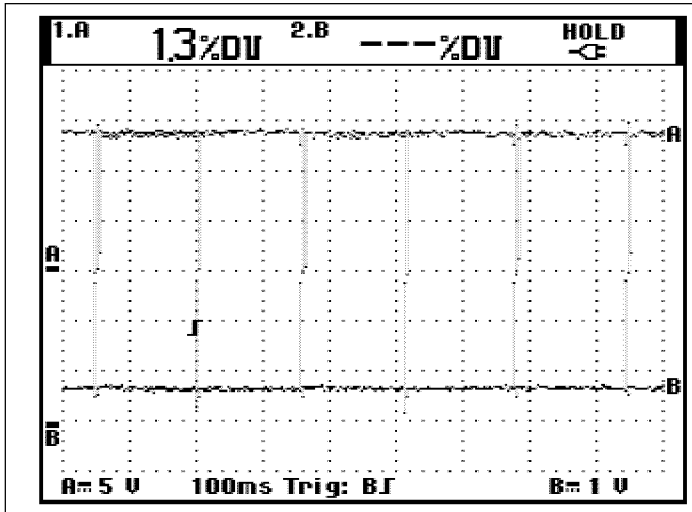
JTJHA31U940046786 - NOT idle
Ch A = M+ Ch B = VTA

Picture 4:
This is the problem car at 100 ms per division.

Once the relationship between the spikes on VTA and the M+ was found, bypassed VTA and VTA2 wires with external jumper wires. Condition still present. Swapped wiring harness from known good unit and condition was corrected.

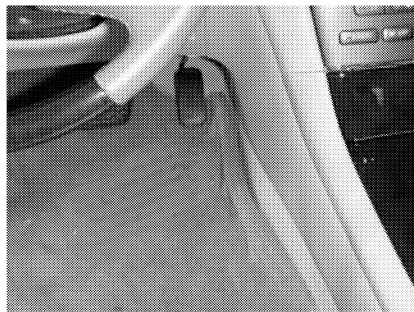
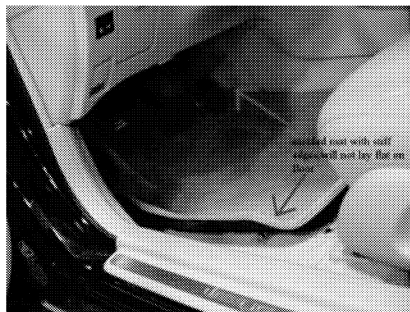
Spoke again with customer to see exactly when it occurred and customer stated that it happened on hard acceleration to pass someone. Also said engine shifted and sounded different, (transmission downshifted). By hand moved floor mat up to see just how it would interfere and it will interfere with accelerator pedal. Explained this to customer showing them the possibility and told them not to drive vehicle with that floor mat.

As shown in the picture the factory mat is still installed below aftermarket floor mat.

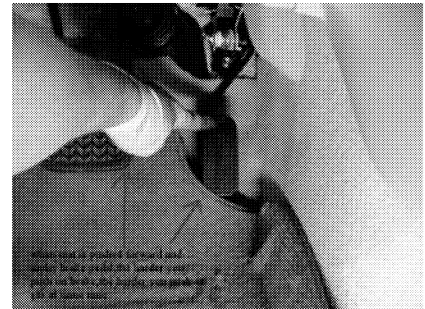
Aftermarket floor mat would slide forward and contact accelerator pedal. Pushing on brake pedal hard would cause floor mat to slide forward more.

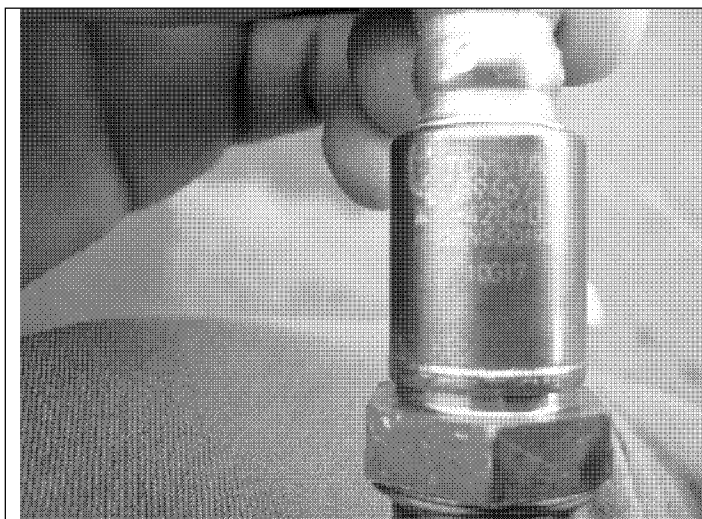
Code on AF Sensor is '10G17'

The technician replaced the AF sensor PN 89467-42040 to remedy the condition
Part was shipped UPS for quality evaluation purposes to TMS UPS tracking #
1Z 4X4 15X 06 2165 517 9

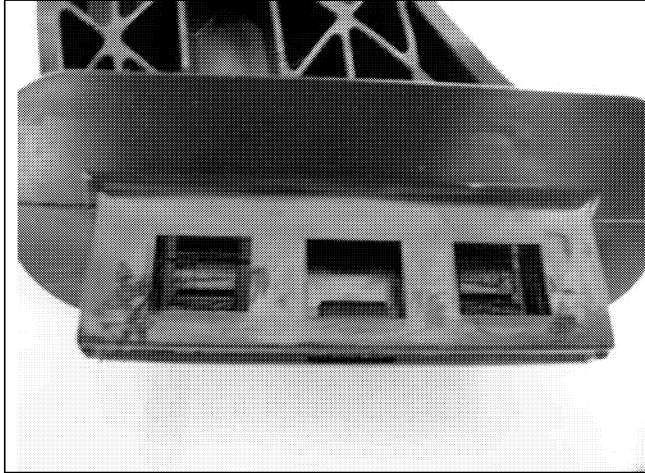
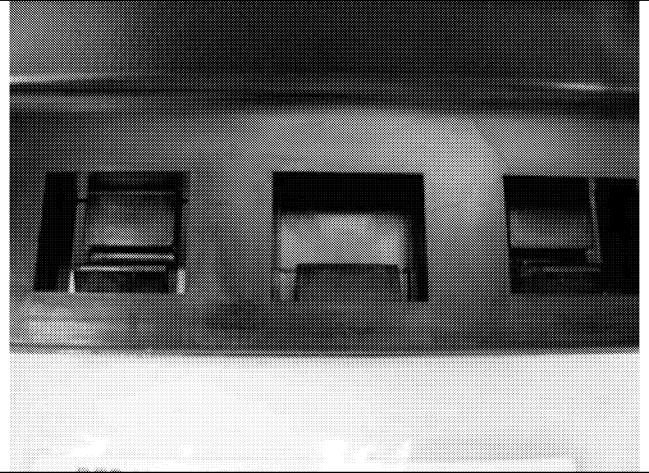
Attachment tabs - pedal from
JTHBN96S265 [REDACTED]

Attachment tabs – new service part

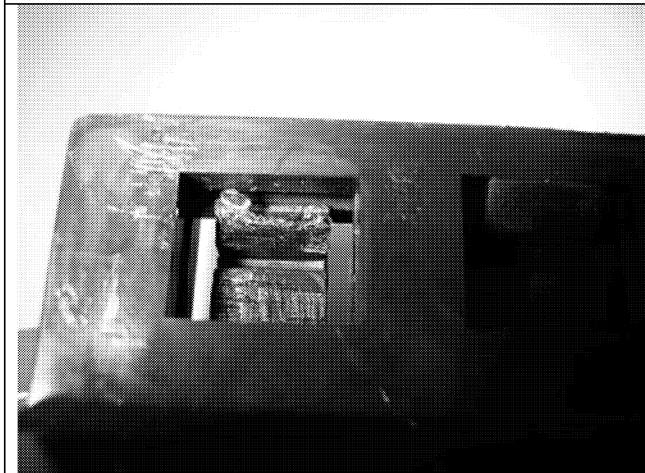
Detail of attachment tab - pedal from
JTHBN96S265 [REDACTED]

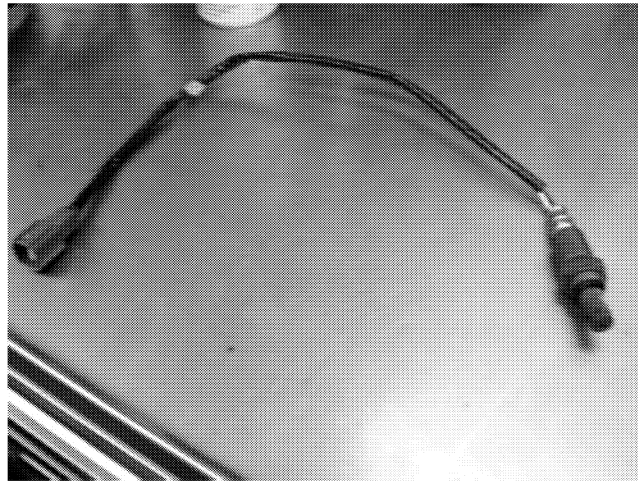
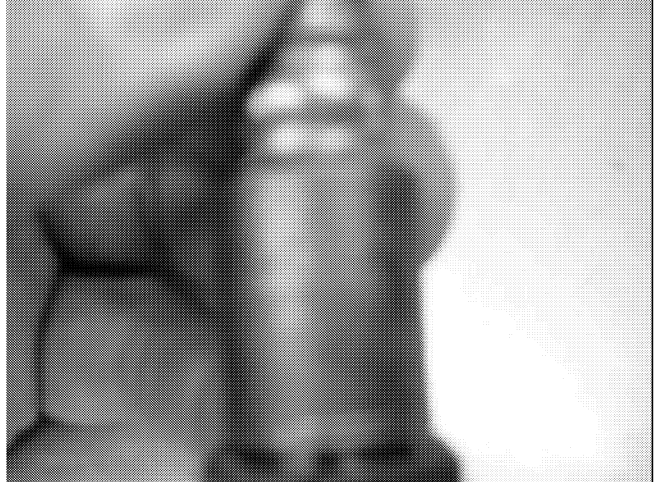
A/F Sensor P/N 89467-06030

Picture attempts to show the following data:
Toyota 89467-06030
Denso 0350 09G19

- Technician replaced A/F sensor and test drove concern was resolved.

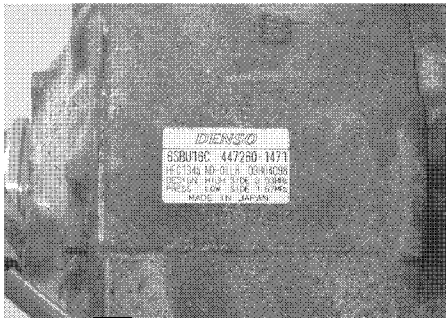
Replaced A/C compressor and clutch

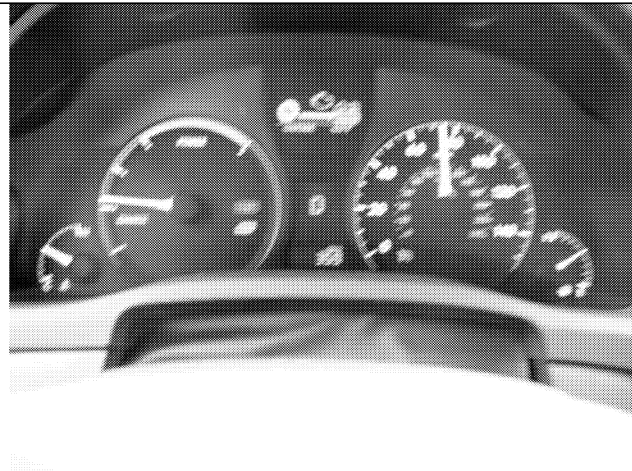
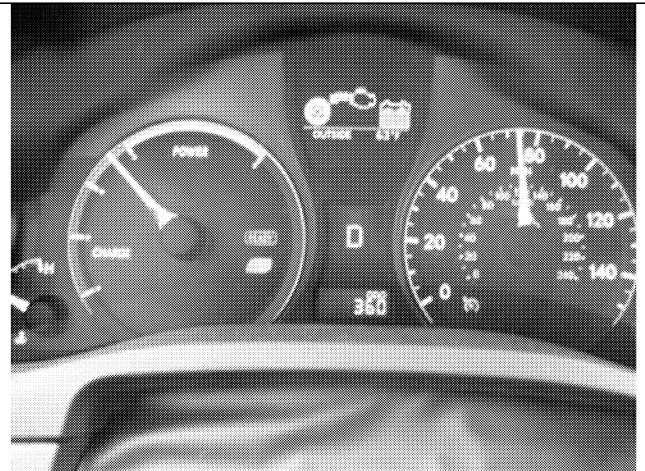
FTS noted the vehicle exhibits a non rhythmic surge under the following conditions:

- Driving vehicle at 65 to 75 mph on a smooth and flat road.
- Maintaining a constant speed as needed with steady throttle in put.
- The sensation is in frequency with the energy monitor as it changes from “engine drive” to “battery drive” to “battery charge”.
- The sensation is like a slow speed up and slow speed down as the computer changes between “engine, battery, and charge control”.
- The sensation is not present with cruise control set.
- Another description of the condition is like a slow rocking motion.

No repairs performed.

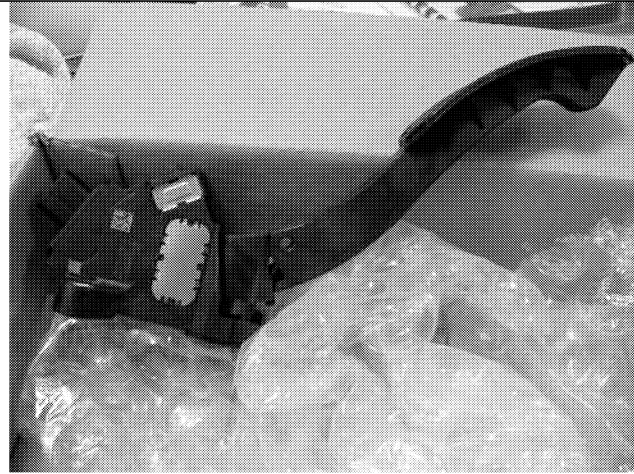
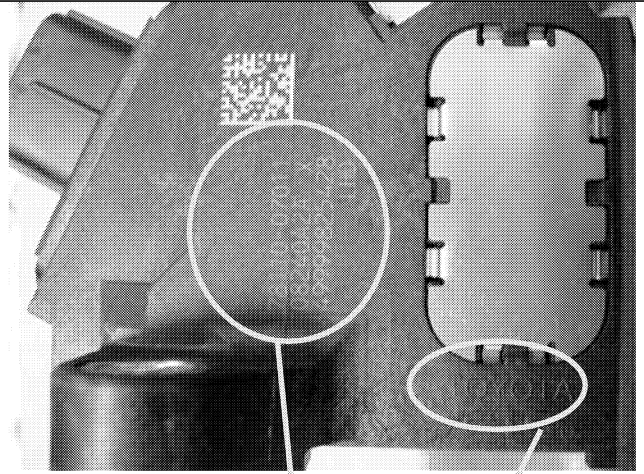
Sensor Assembly, Accel Pedal
PN 78110-07011

78110-07011
08240A2A X
49999825428
LHD

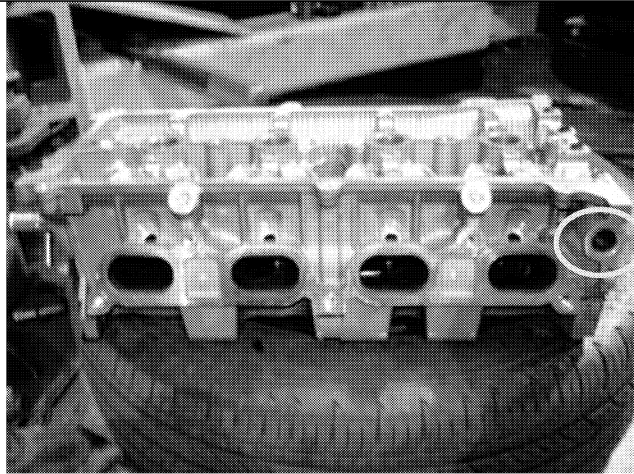
2AZ cylinder head
OCV port

TQCN DOC# TQCN_FTR-093100014		Condition Title Engine surge at 1200 RPM (2AZ-FE)			Date 11/09/2009
Primary Model Camry	Model Year 2009	Production Date 2008-09-29	Odometer 11024	VIN (confirm 17 characters): 4T1BE46K49U [REDACTED]
