NVS-213dsy
PE04-021

This letter is to inform you that the Office of Defects Investigation (ODI) of the National Highway Traffic Safety Administration (NHTSA) has opened a Preliminary Evaluation (PE04-021) to investigate allegations that the electronic throttle control system fails to properly control engine speed in model year (MY) 2002 and 2003 Toyota Camry, Camry Solara and Lexus ES300 model vehicles manufactured by Toyota Motor Corporation, and to request certain information.

Subject: AMENDMENT TO PETITION FOR DEFECT INVESTIGATION OF ALL 2002-2005 TOYOTA AND LEXUS VEHICLES CONCERNING VEHICLE SPEED CONTROL (VSC), ELECTRONIC THROTTLE, AND UNCONTROLLABLE ACCELERATION PROBLEMS, ATTACHMENTS NOT IMAGED FWD TO NVS-200

Denial of Motor Vehicle Defect Petition

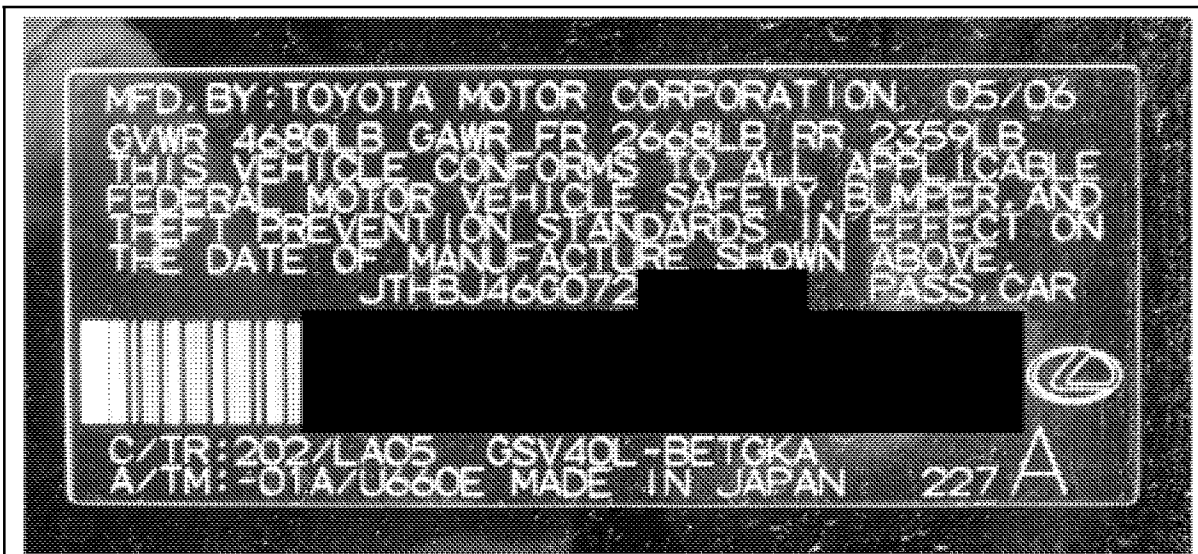
Photo 1: Certification label, driver side door jam (redacted)

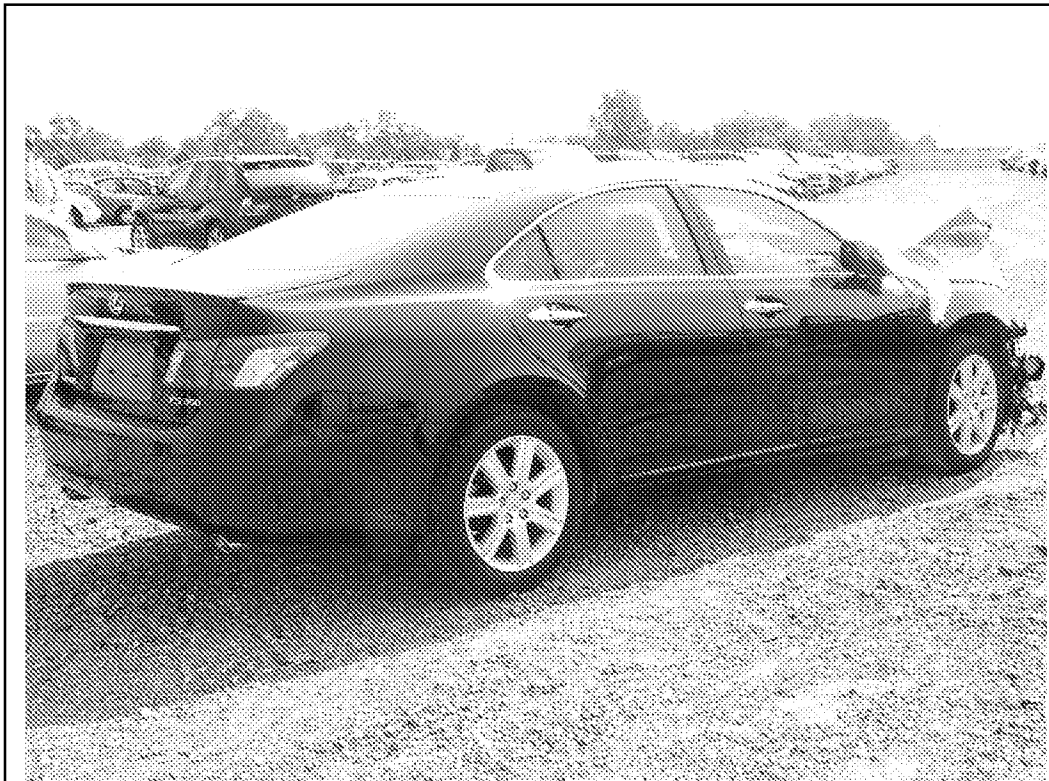
engine compartment combustibles and damaged the windshield, driver glass, and other interior and exterior components. See photos 2 to 5.

Photo 3: Rear oblique view of vehicle.

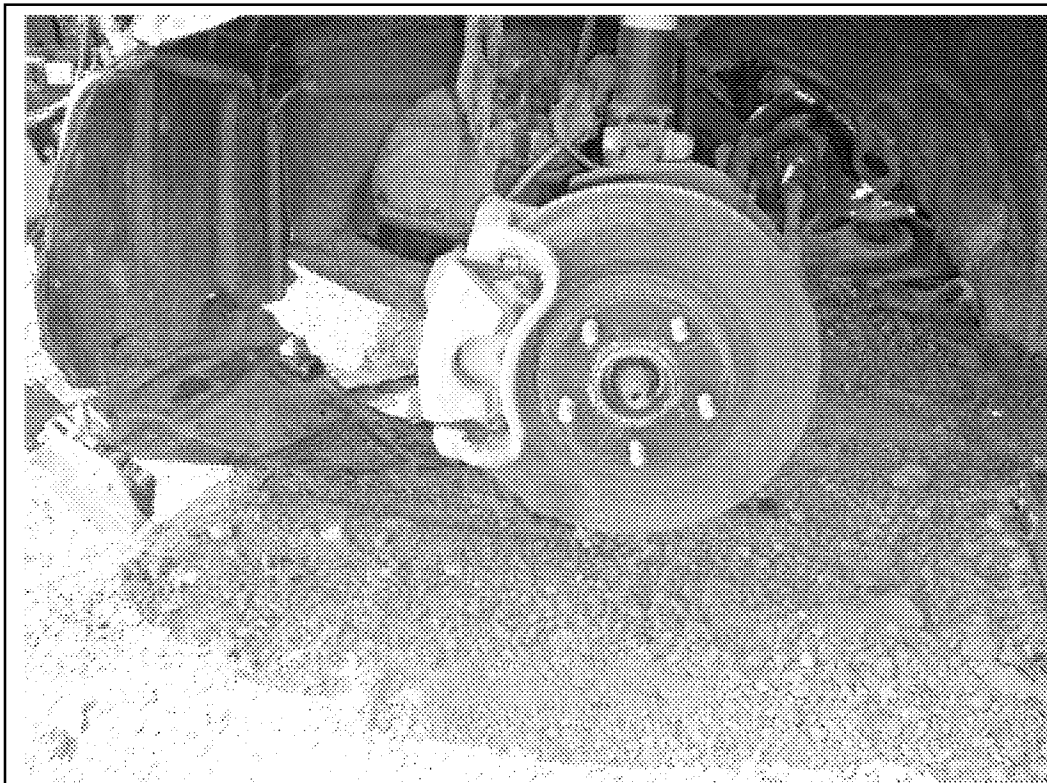
Discoloration, rust and surface damage to the brake rotors is visible through all four wheel apertures. The LHF and LHR brake calipers were removed and the brake components inspected. The components displayed significant damage due to overheating. The damage is consistent with the driver's statement that she was attempting to stop the vehicle while it was moving at high speed for a significant distance. See photos 6 to 10.

Photo 7: LHF brake assembly, wheel removed

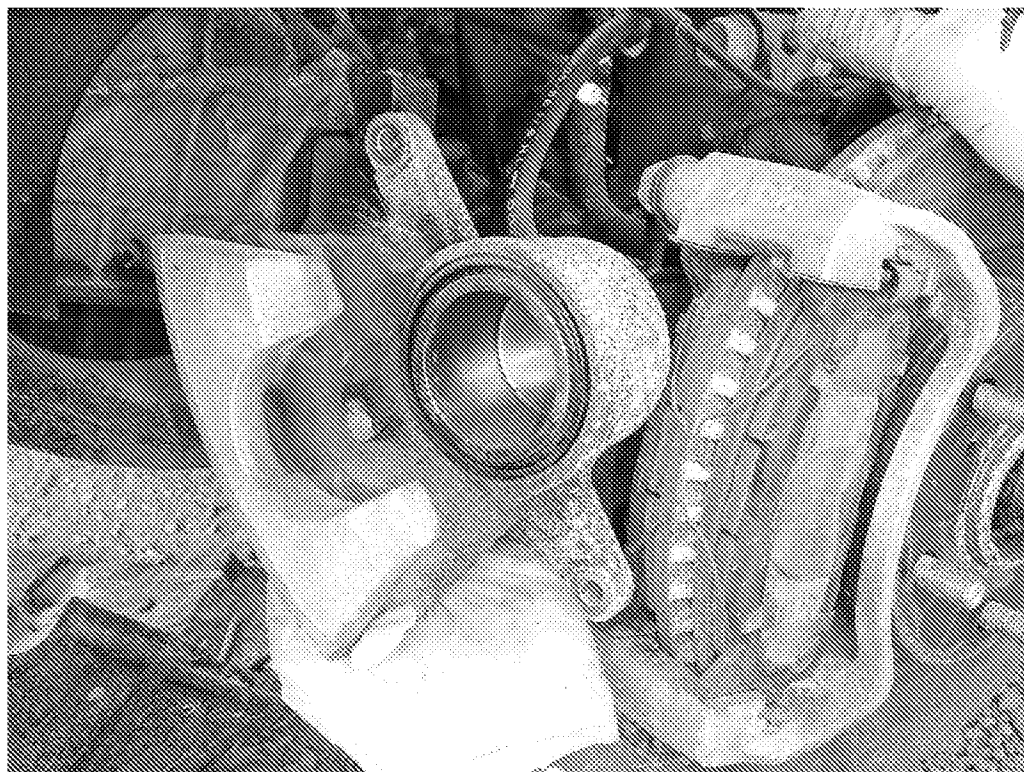
Photo 8: LHF brake hardware, caliper removed

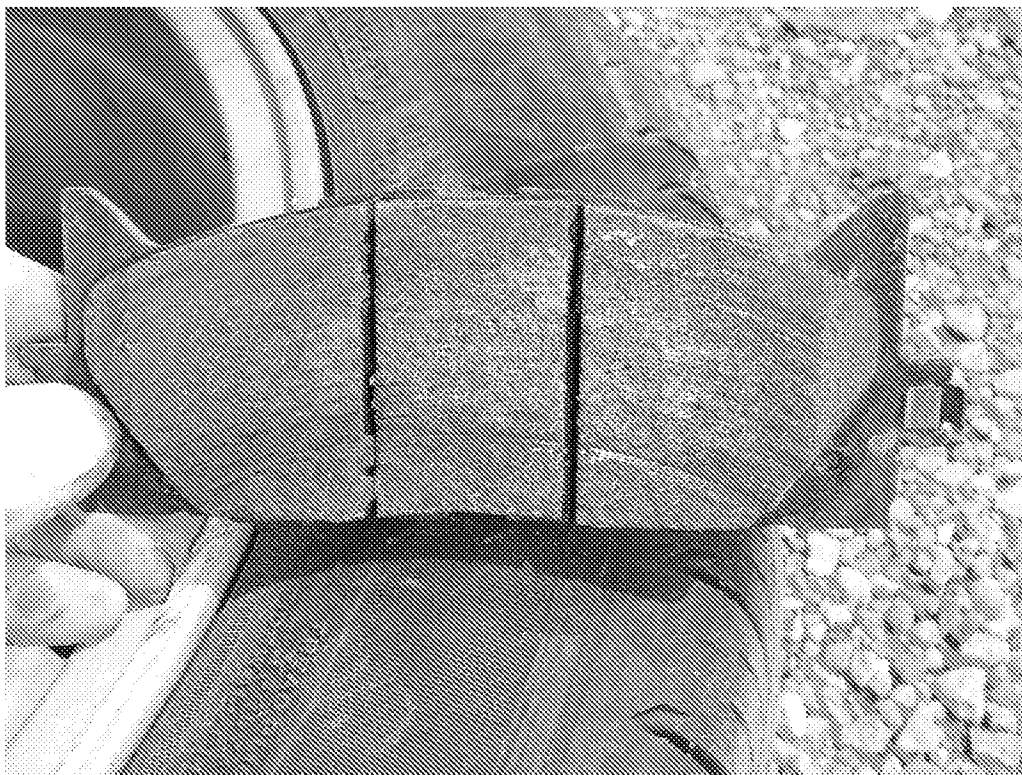
Photo 9: LHF disc brake pad, friction surface/rotor side

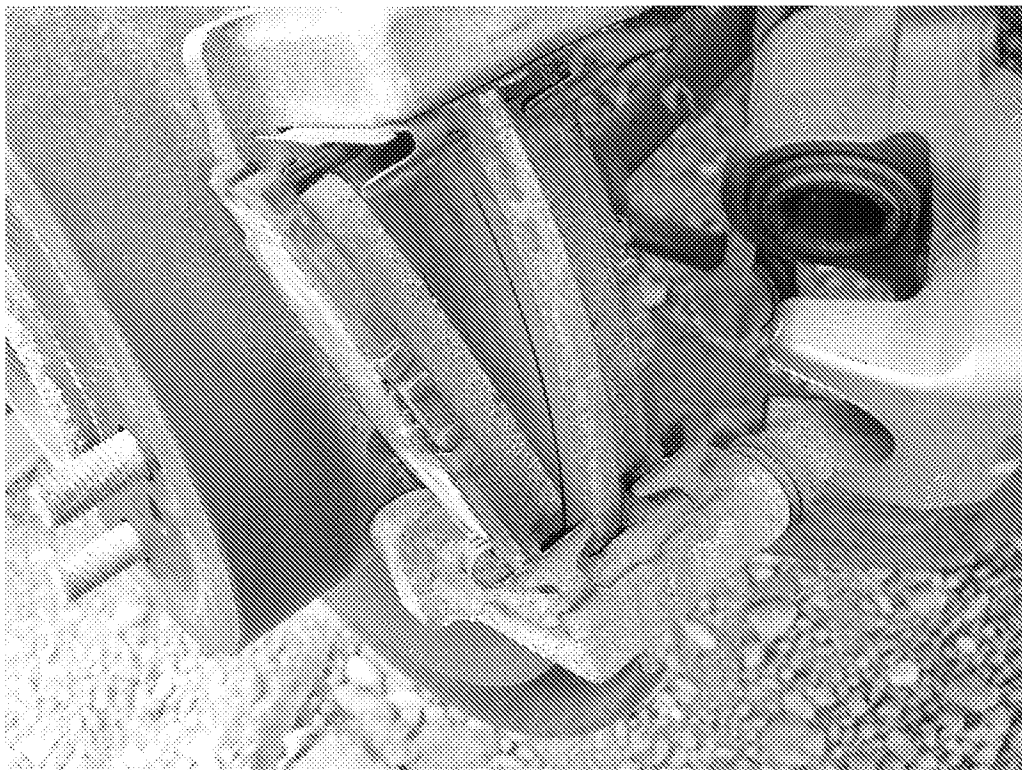
Photo 10: LHR disc brake hardware, caliper removed

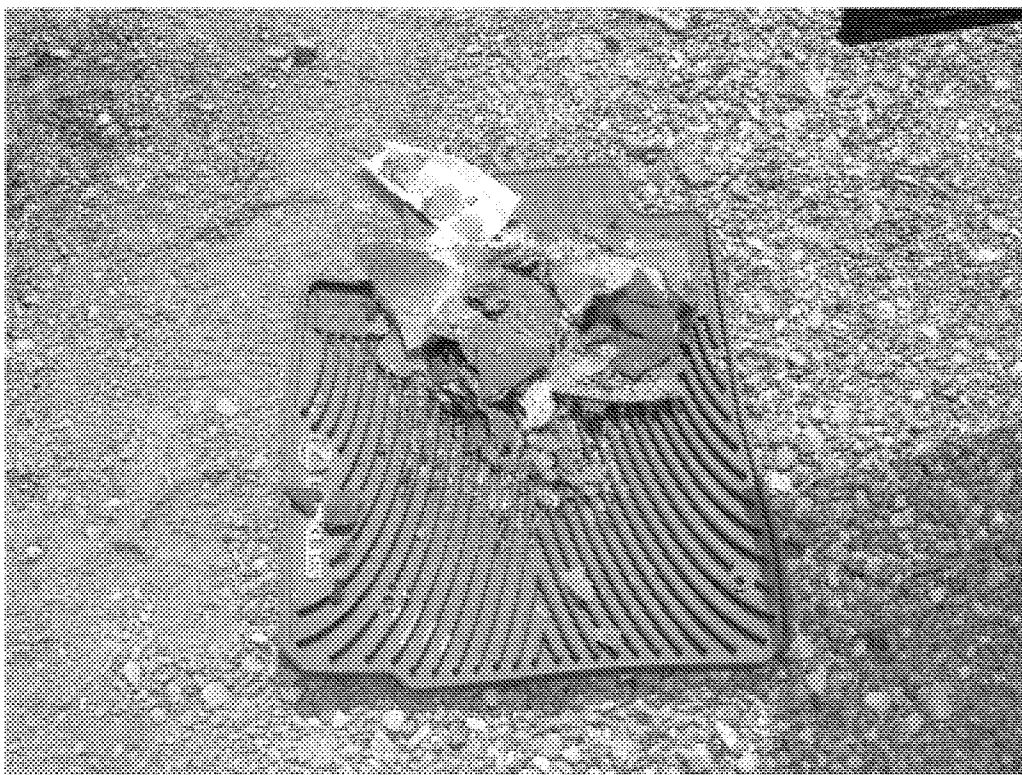
The vehicle interior condition is consistent with the estimated vehicle mileage. All weather mats are installed at all four seating positions. The driver side all weather mat was found to be installed by itself; it was not on top of another floor mat. The installed mat was found to be unsecured by the retention hooks; the mat did not interfere with the accelerator pedal in the position it was originally inspected. The mat was removed from the vehicle. The two retention hooks were found engaged in the flooring material after the mat was removed⁵. The hooks were intact and did not appear to be damaged from the collision. See photos 11 to 16.

Photo 15: Driver all weather mat removed from vehicle

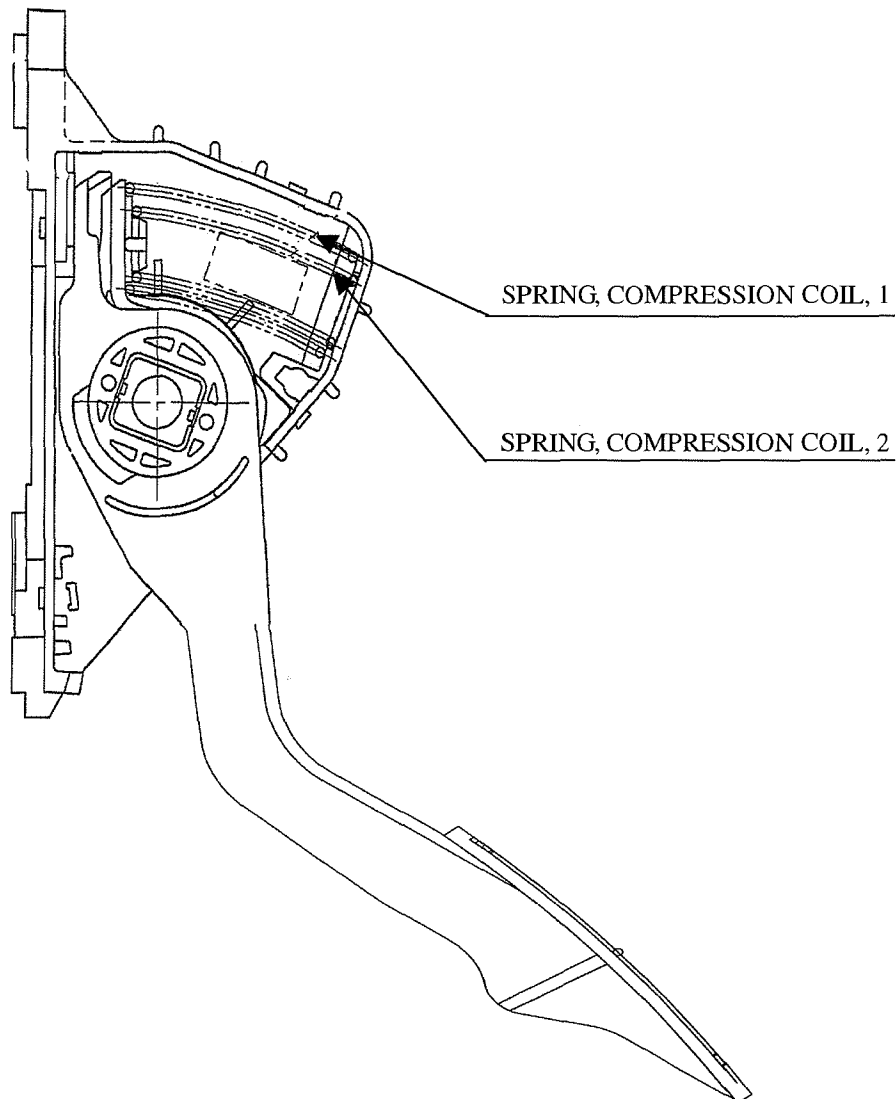
The Accelerator pedal assembly has 2 sources of energy capable of returning the throttle to the idle position (i.e.; 2 compression coil springs). The details are shown in the figure below.

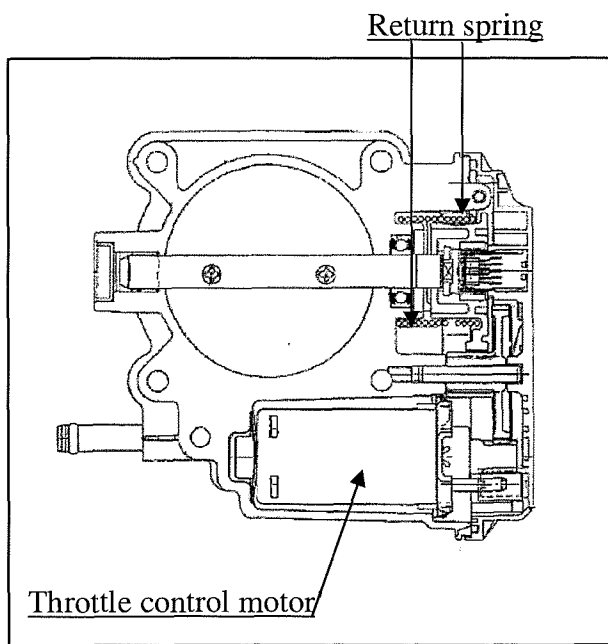
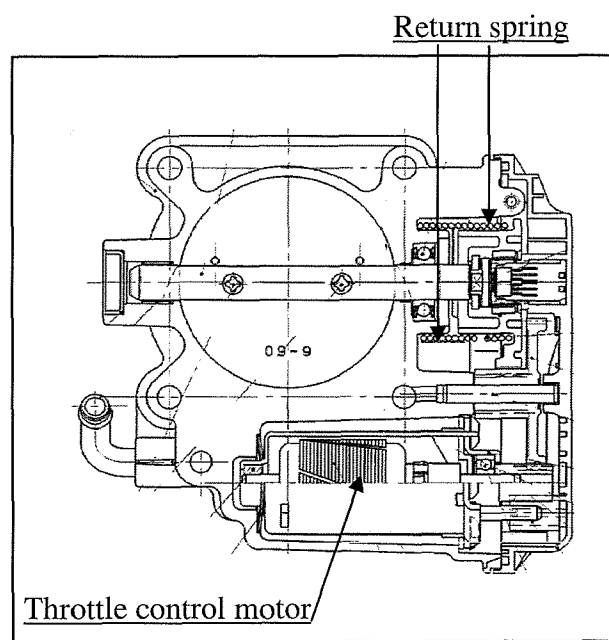
The throttle body assembly has 2 sources of energy capable of returning the throttle to the idle position (i.e. The throttle return spring and the throttle control motor). The details are shown in the figure below.

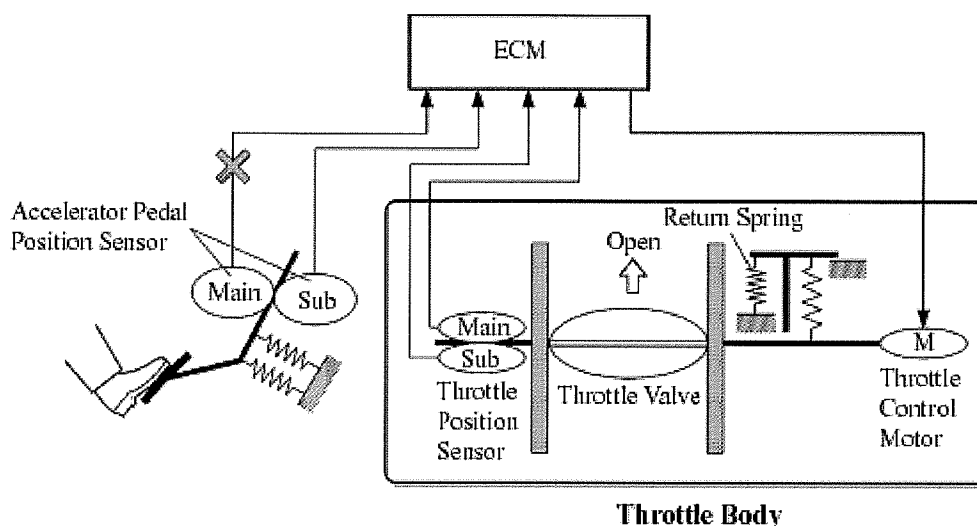
D13N08

- If a malfunction occurs in either one of the sensor circuits, the ECM detects the abnormal signal voltage difference between these two sensor circuits and switches to the limp mode. In the limp mode, the remaining circuit is used to calculate the accelerator pedal opening, in order to operate the vehicle under limp mode control.

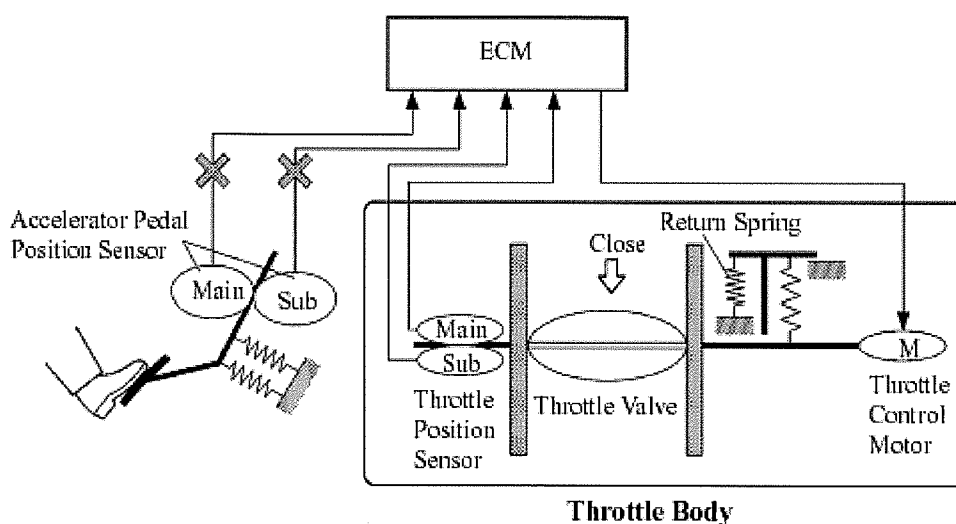
D13N09

- If both circuits malfunction, the ECM detects the abnormal signal voltage from these two sensor circuits and discontinues the throttle control. At this time, the vehicle can be driven within its idling range.

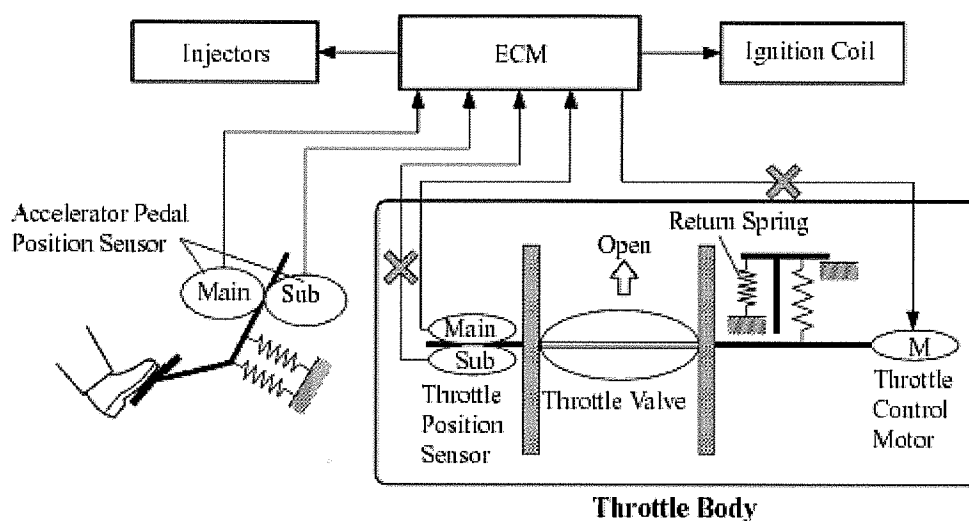
D13N18

- If a malfunction occurs in either one of the sensor circuits, the ECM detects the abnormal signal voltage difference between these two sensor circuits, cuts off the current to the throttle control motor, and switches into the limp mode.
- Then, the force of the return spring causes the throttle valve to return and stay at the prescribed opening. At this time, the vehicle can be driven in limp mode while the engine output is regulated through the control of the fuel injection and ignition timing in accordance with the accelerator opening.
- The same control as above is effected if the ECM detects a malfunction in the throttle control motor system.

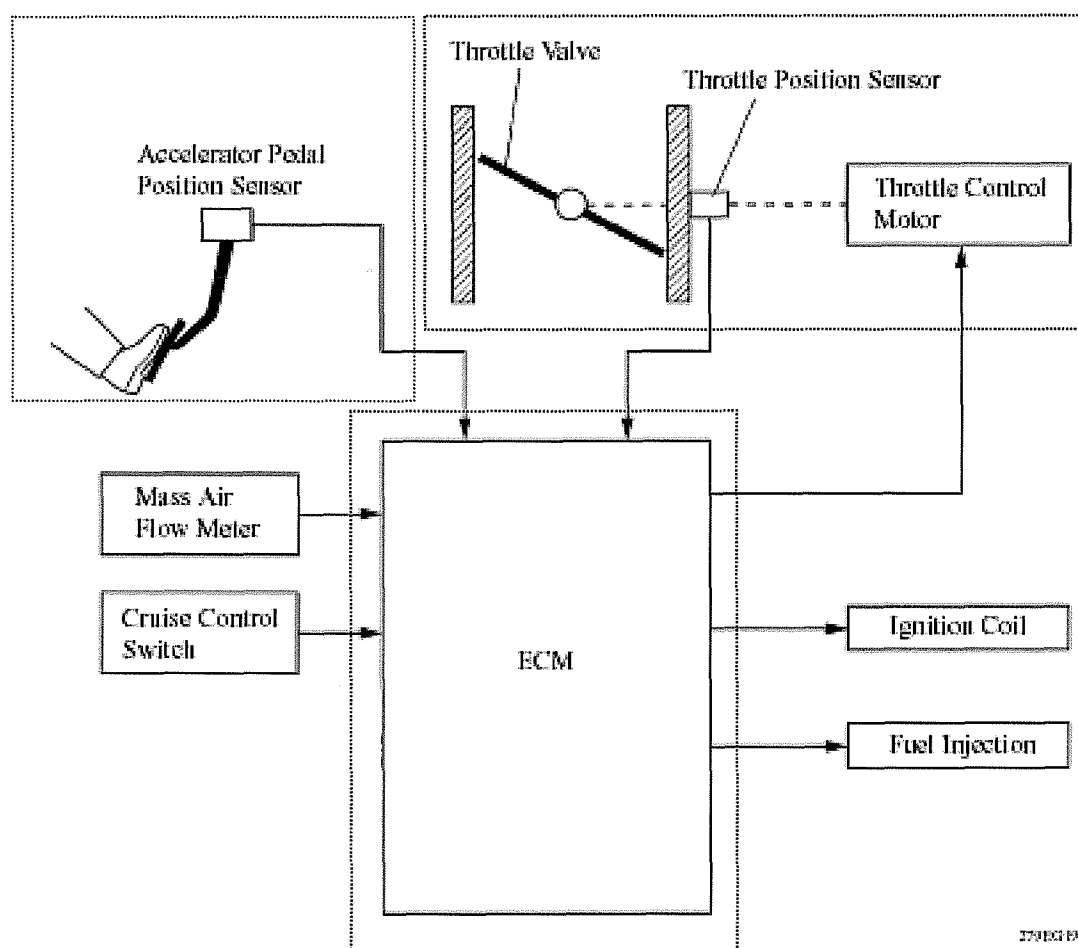
Figure 1: Electronic Throttle Control System

In the case of the Toyota Tacoma, no cable is connected between the accelerator pedal and the throttle valve because the throttle valve of the engine is controlled electrically by the electric throttle control system. Therefore, Toyota assures that the Tacoma vehicles conform to FMVSS124 by conducting compliance confirmation tests (refer to Table 1), which are necessary for each component shown in Figure 1.

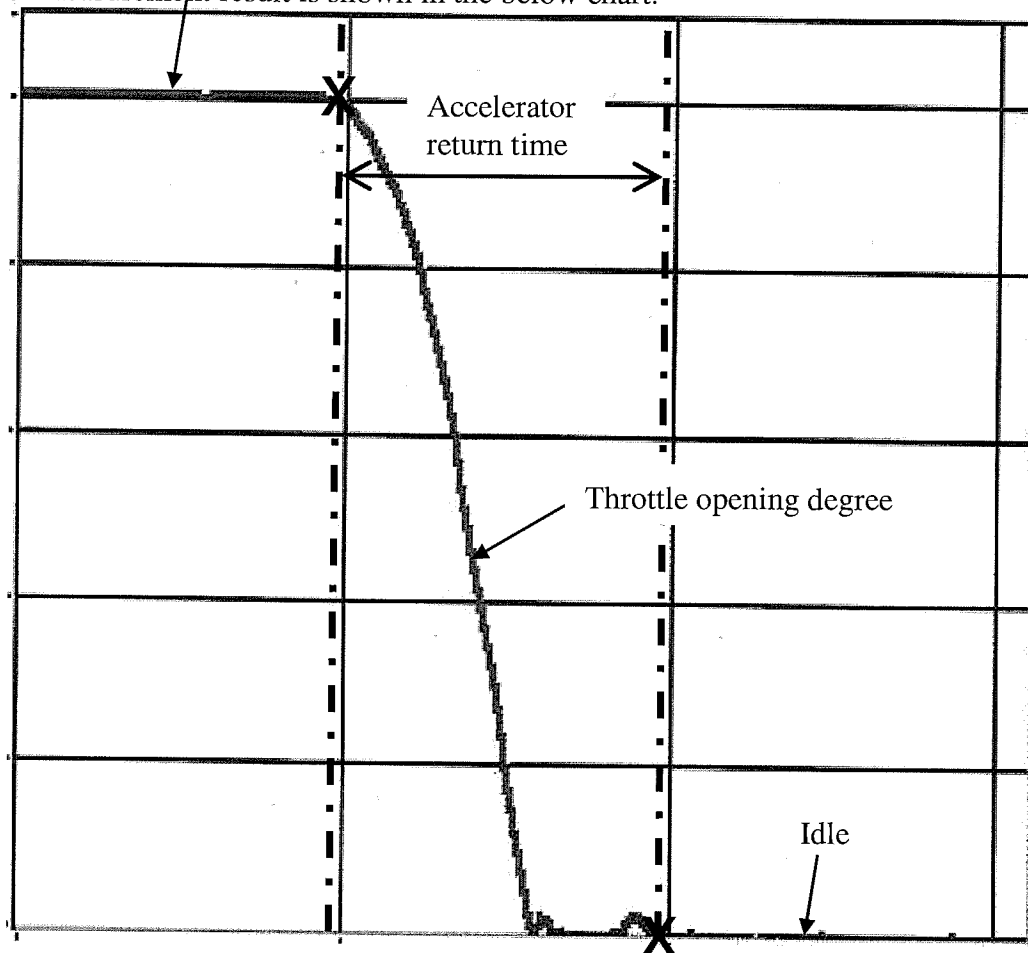
The return time is the time that the throttle valve closes from the wide open throttle to the idle position. The throttle opening degree is measured by detecting output-signal from Throttle Position Sensor. Example of measurement result is shown in the below chart.

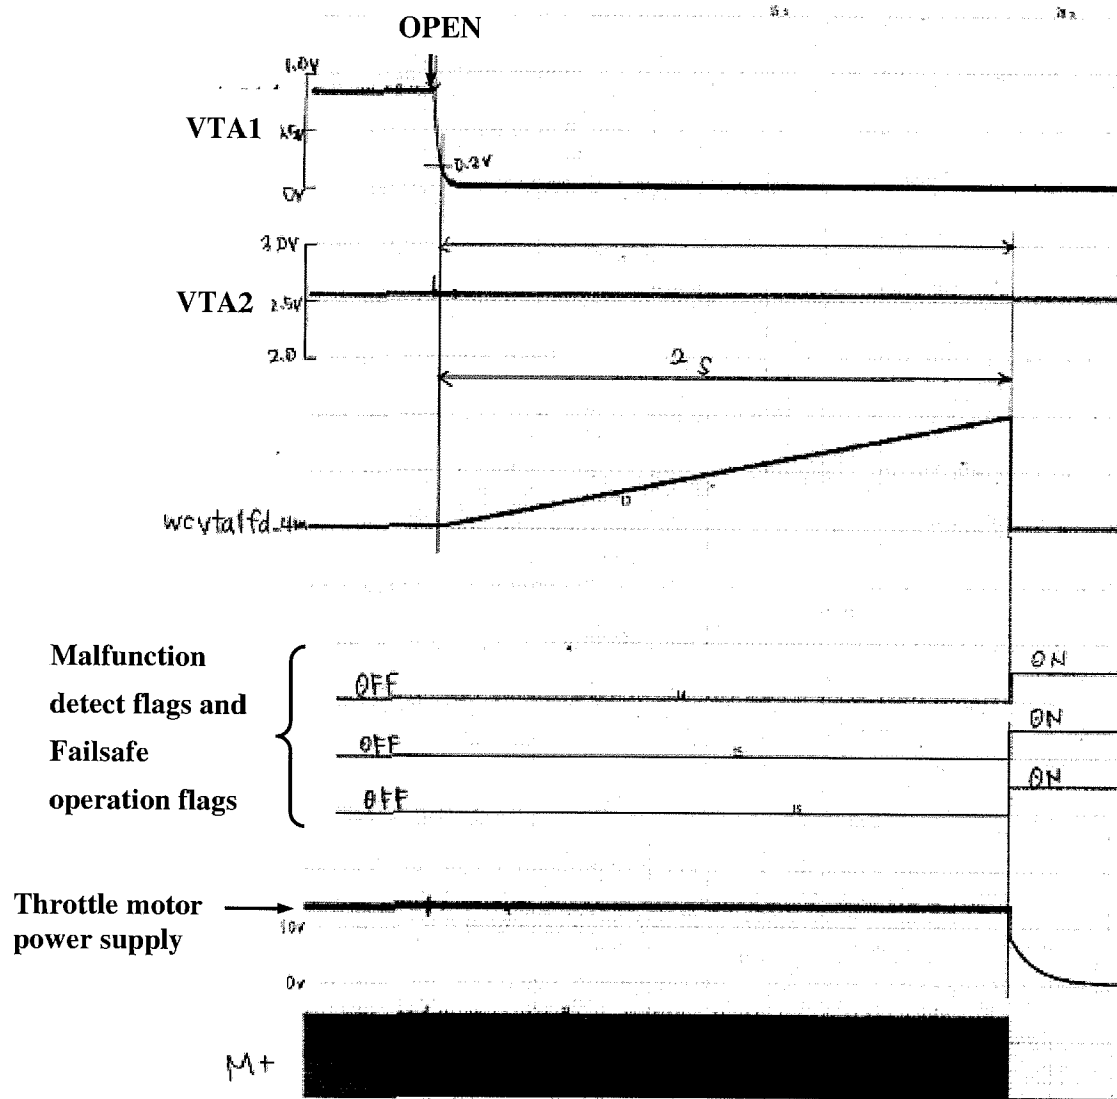
VTA1 Throttle Position Sensor Circuit Open

Failure Mode	Fail-safe Condition	Pass or Fail
Throttle position sensor circuit open	Shut down the power supply of throttle control motor	Pass
ECM internal circuit open	Shut down the output of Throttle control motor	Pass

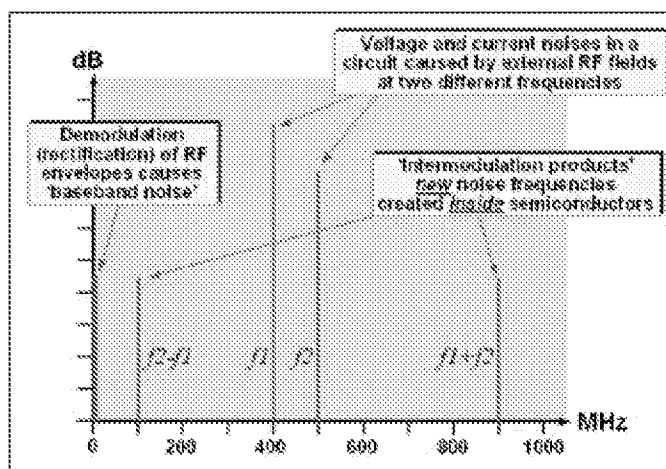
Figure 2: Example of demodulation and intermodulation

Simultaneous disturbances that have different frequencies can cause EMI through intermodulation (IM), which (like demodulation) occurs naturally in non-linear devices like semiconductors. Figure 2 shows a simple example of two RF fields at different frequencies, which can cause EMI by:

Vehicles have many independent sources of EM disturbances that can occur at the same time. A simple analysis, based on reasonable assumptions for a 6-cylinder engine at 2000 rpm with spark-ignition transients lasting 50ns, shows that, if there was an average of one unrelated 100ns transient per minute (e.g. due to the actuation of an electric motor or solenoid), there would be a 0.001% likelihood that the 100ns transient would overlap with a 50ns spark-ignition transient.

If this vehicle were driven for 1 hour/day, 5 days/week, 40 weeks/year, the likelihood of it experiencing an overlapping pulse event would be 12% per year. And, if the overlapping pulses caused an ESA to malfunction and caused a 1% chance of death (the official rate of death due to runaway vehicles in the United States over recent decades), the driver would have a risk of death of 0.12% per year. This might not sound much, but it is comparable with the risk of death knowingly accepted

by people working in the most hazardous occupations (e.g., oil industry divers). If there were 100,000 such vehicles on the roads for similar periods, we could expect 120 deaths from these overlapping transients every year.

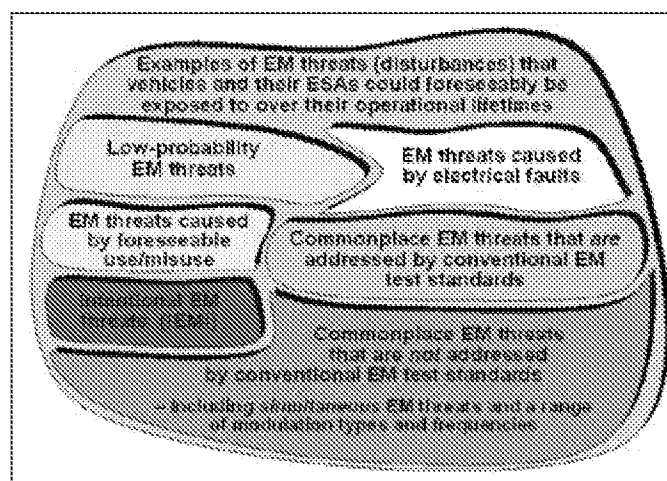
Figure 3: Examples of foreseeable EM disturbances

It is usually only possible to establish the types of EM phenomena (see Figure 3), their modulations and worst-case levels, with any confidence.

Appropriate QC activities are required for maintenance, repair, refurbishment, modification and firmware upgrades to ensure that the required EM and physical characteristics are not compromised over the vehicle lifecycle.

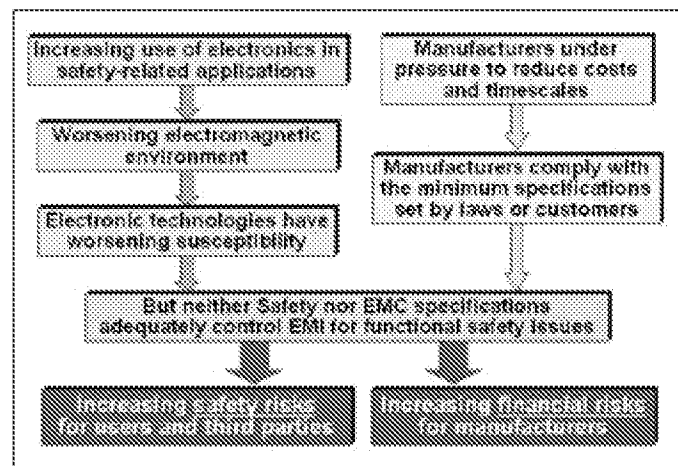
Figure 1: Increasing safety risks due to EMI

Figure 1 outlines the general situation at the time this article is being written.

Traditional radiated field immunity tests specify anechoic test chambers, which are unlike all real-life EM environments experienced by road-going vehicles, so their results can differ markedly from real-life. Vehicle manufacturers overttest to address this and other shortcomings in their test methods, but over-testing cannot compensate for the deficiencies associated with anechoic chambers.

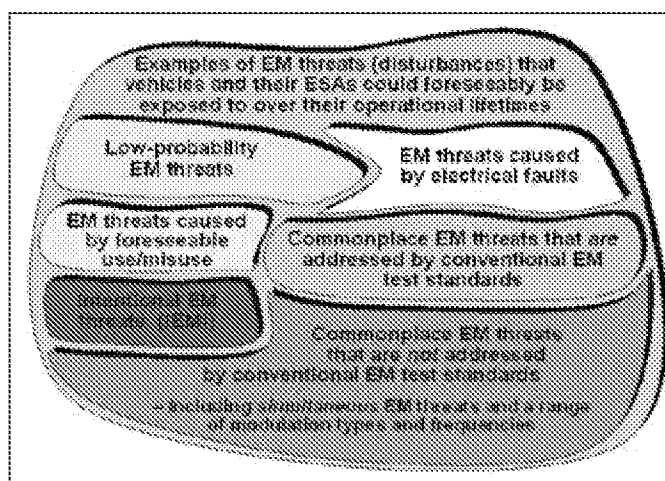
Figure 3: Examples of foreseeable EM disturbances

It is usually only possible to establish the types of EM phenomena (see Figure 3), their modulations and worst-case levels, with any confidence.

Assumptions originally made about real-life EM and physical environments should be verified during the lifecycle of a model of vehicle and, if they are in error, what appropriate actions were taken.

Appropriate QC activities are required for maintenance, repair, refurbishment, modification and firmware upgrades to ensure that the required EM and physical characteristics are not compromised over the vehicle lifecycle.
