RE: NVS-213kmb, PE10-035

161,946 MY 2011 Hyundai Sonata vehicles have been manufactured through October 8, 2010.

If the connection between the steering wheel and steering gear separates, the driver would lose the ability to steer the front wheels, which may increase the risk of a vehicle crash. Hyundai submitted a Part 573 defect information report to NHTSA on September 21, 2010 stating its decision to conduct a recall to inspect the subject vehicles for the alleged defect and to make repairs when necessary and is presently conducting recall 10V-426.

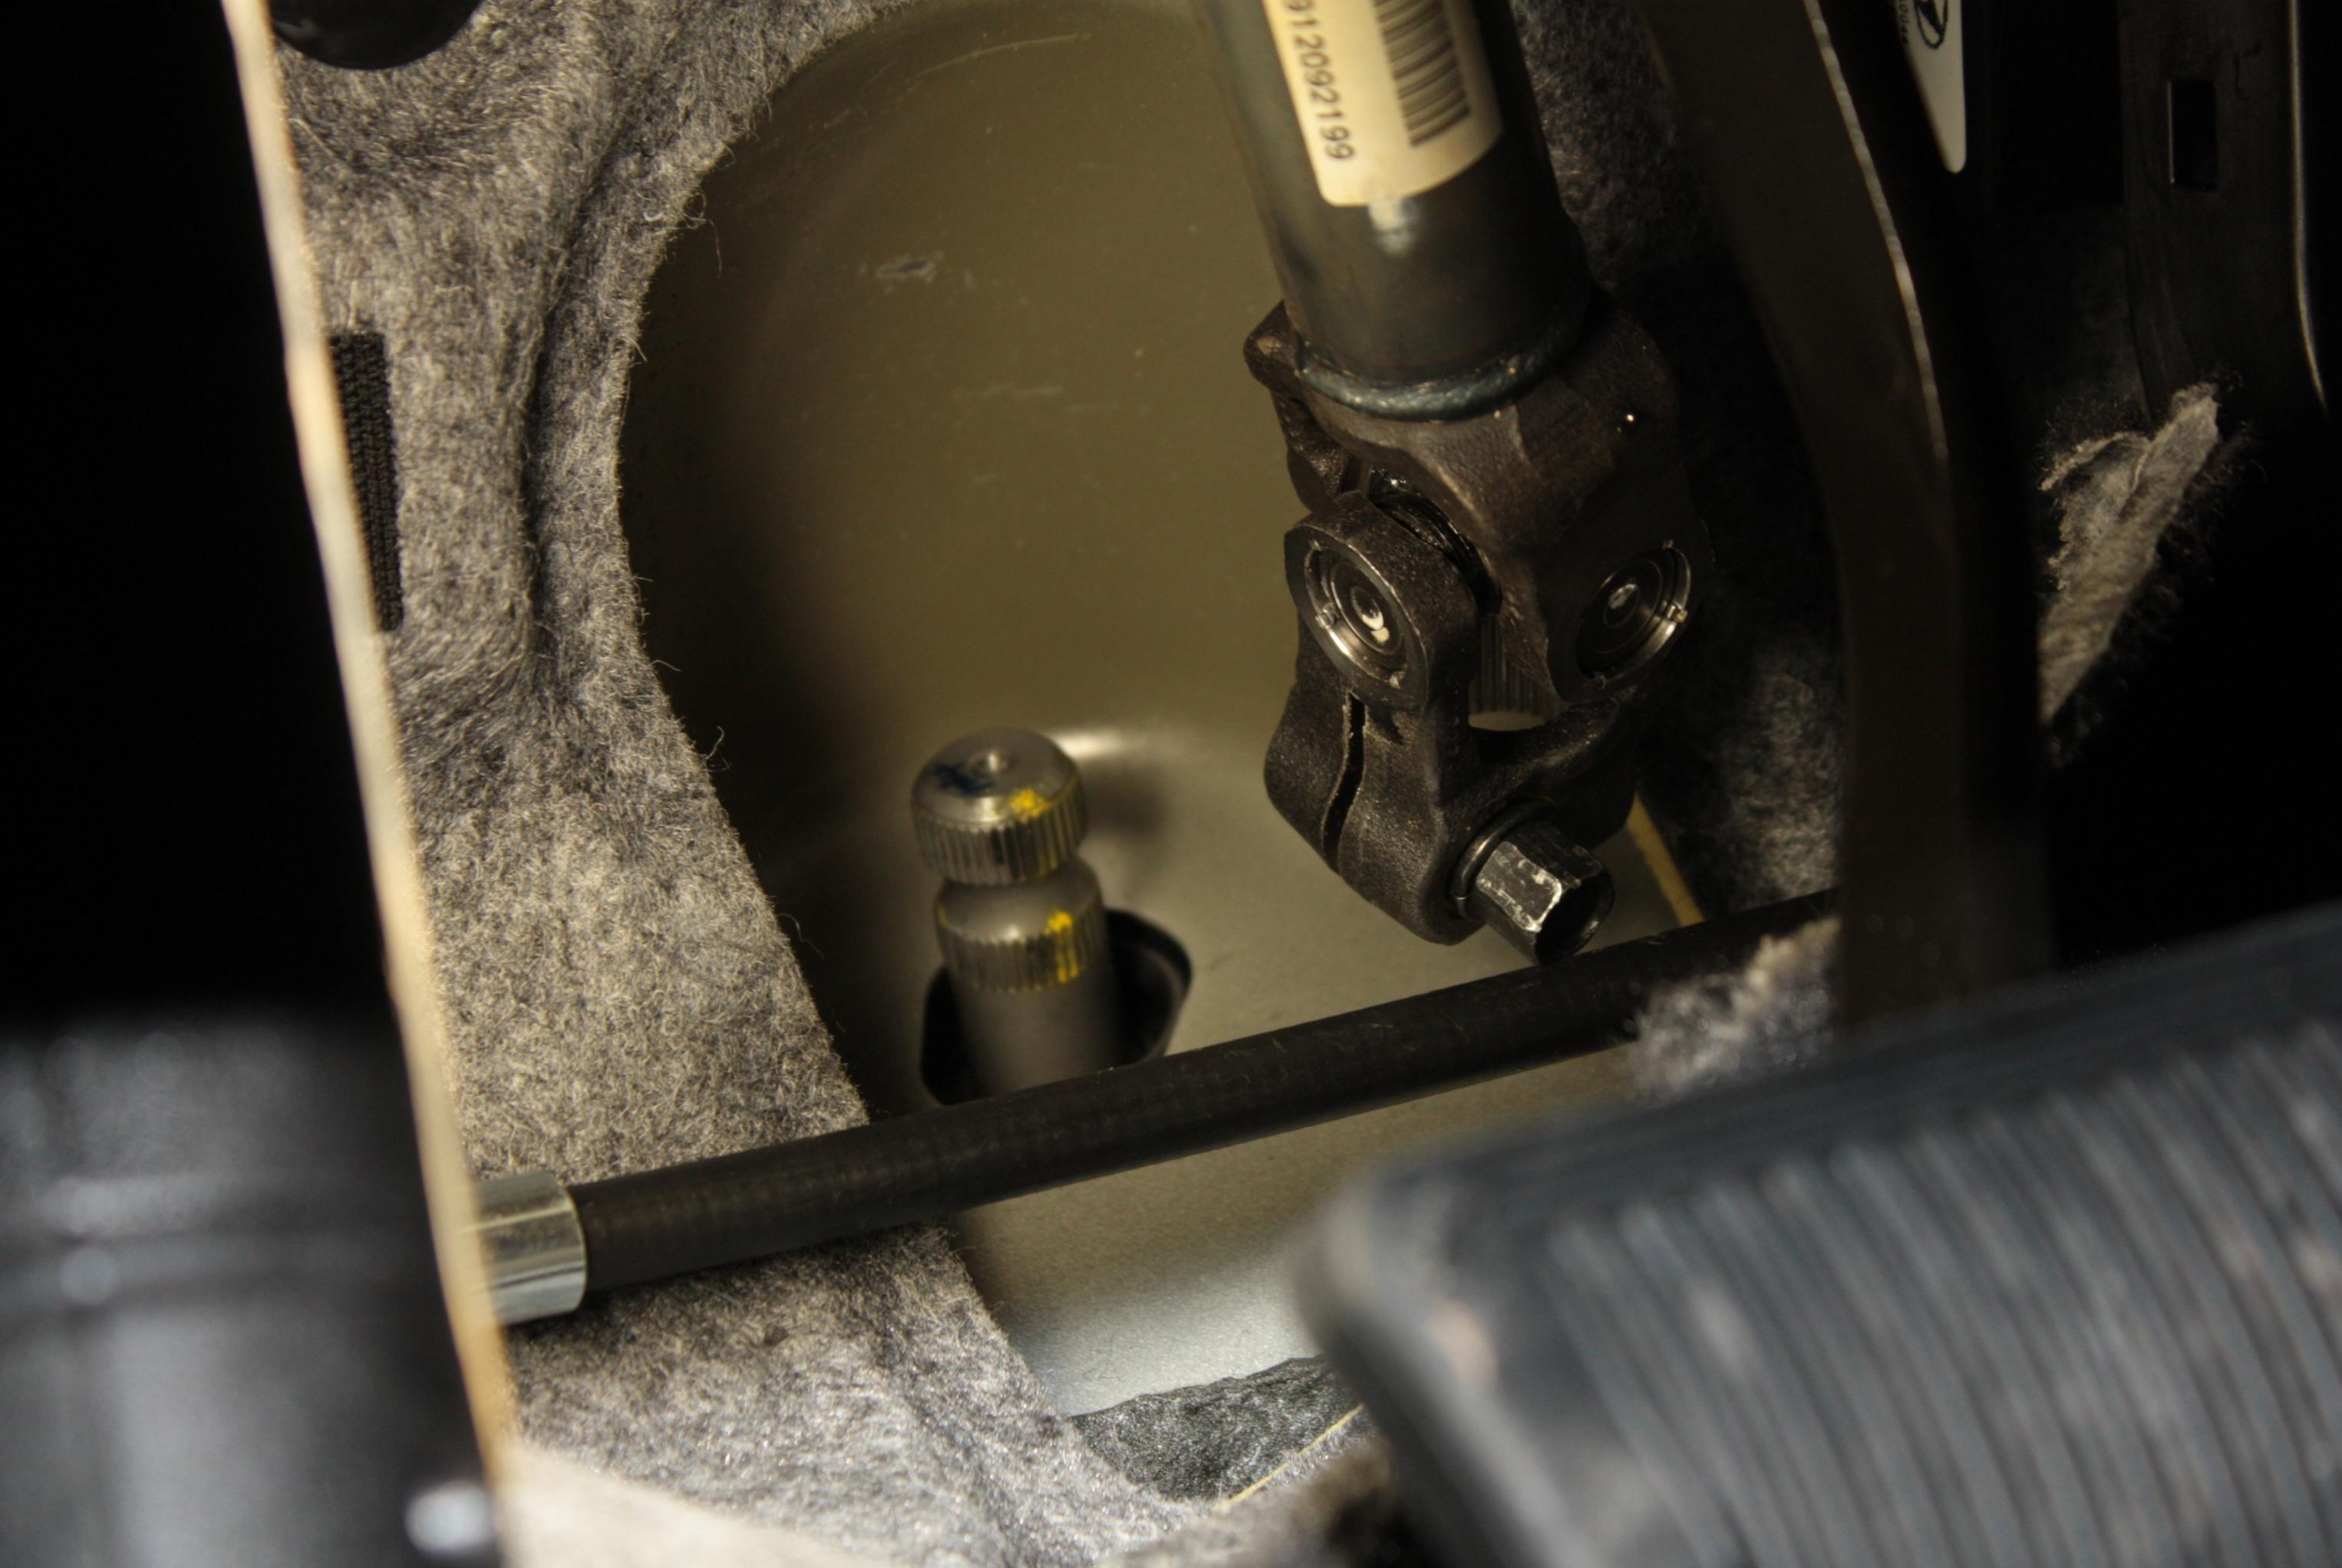
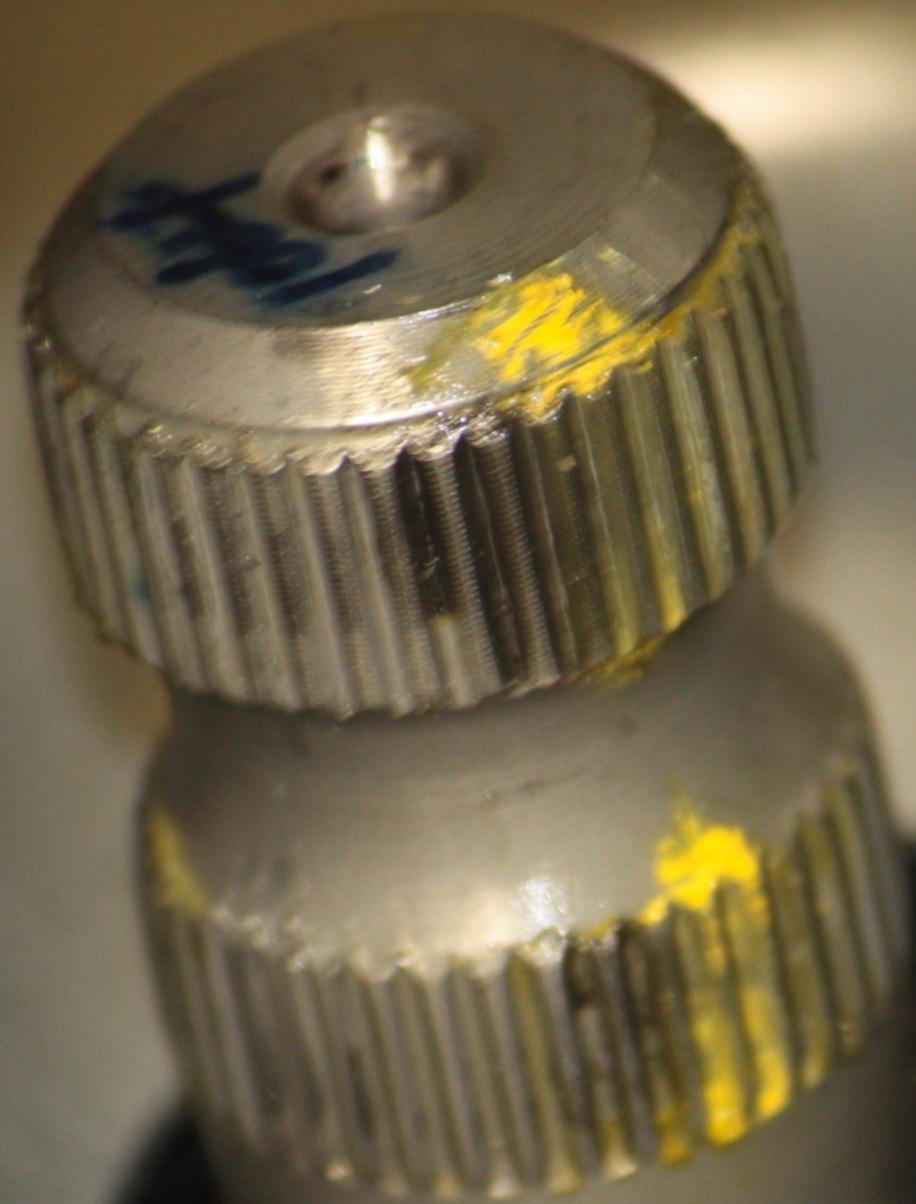
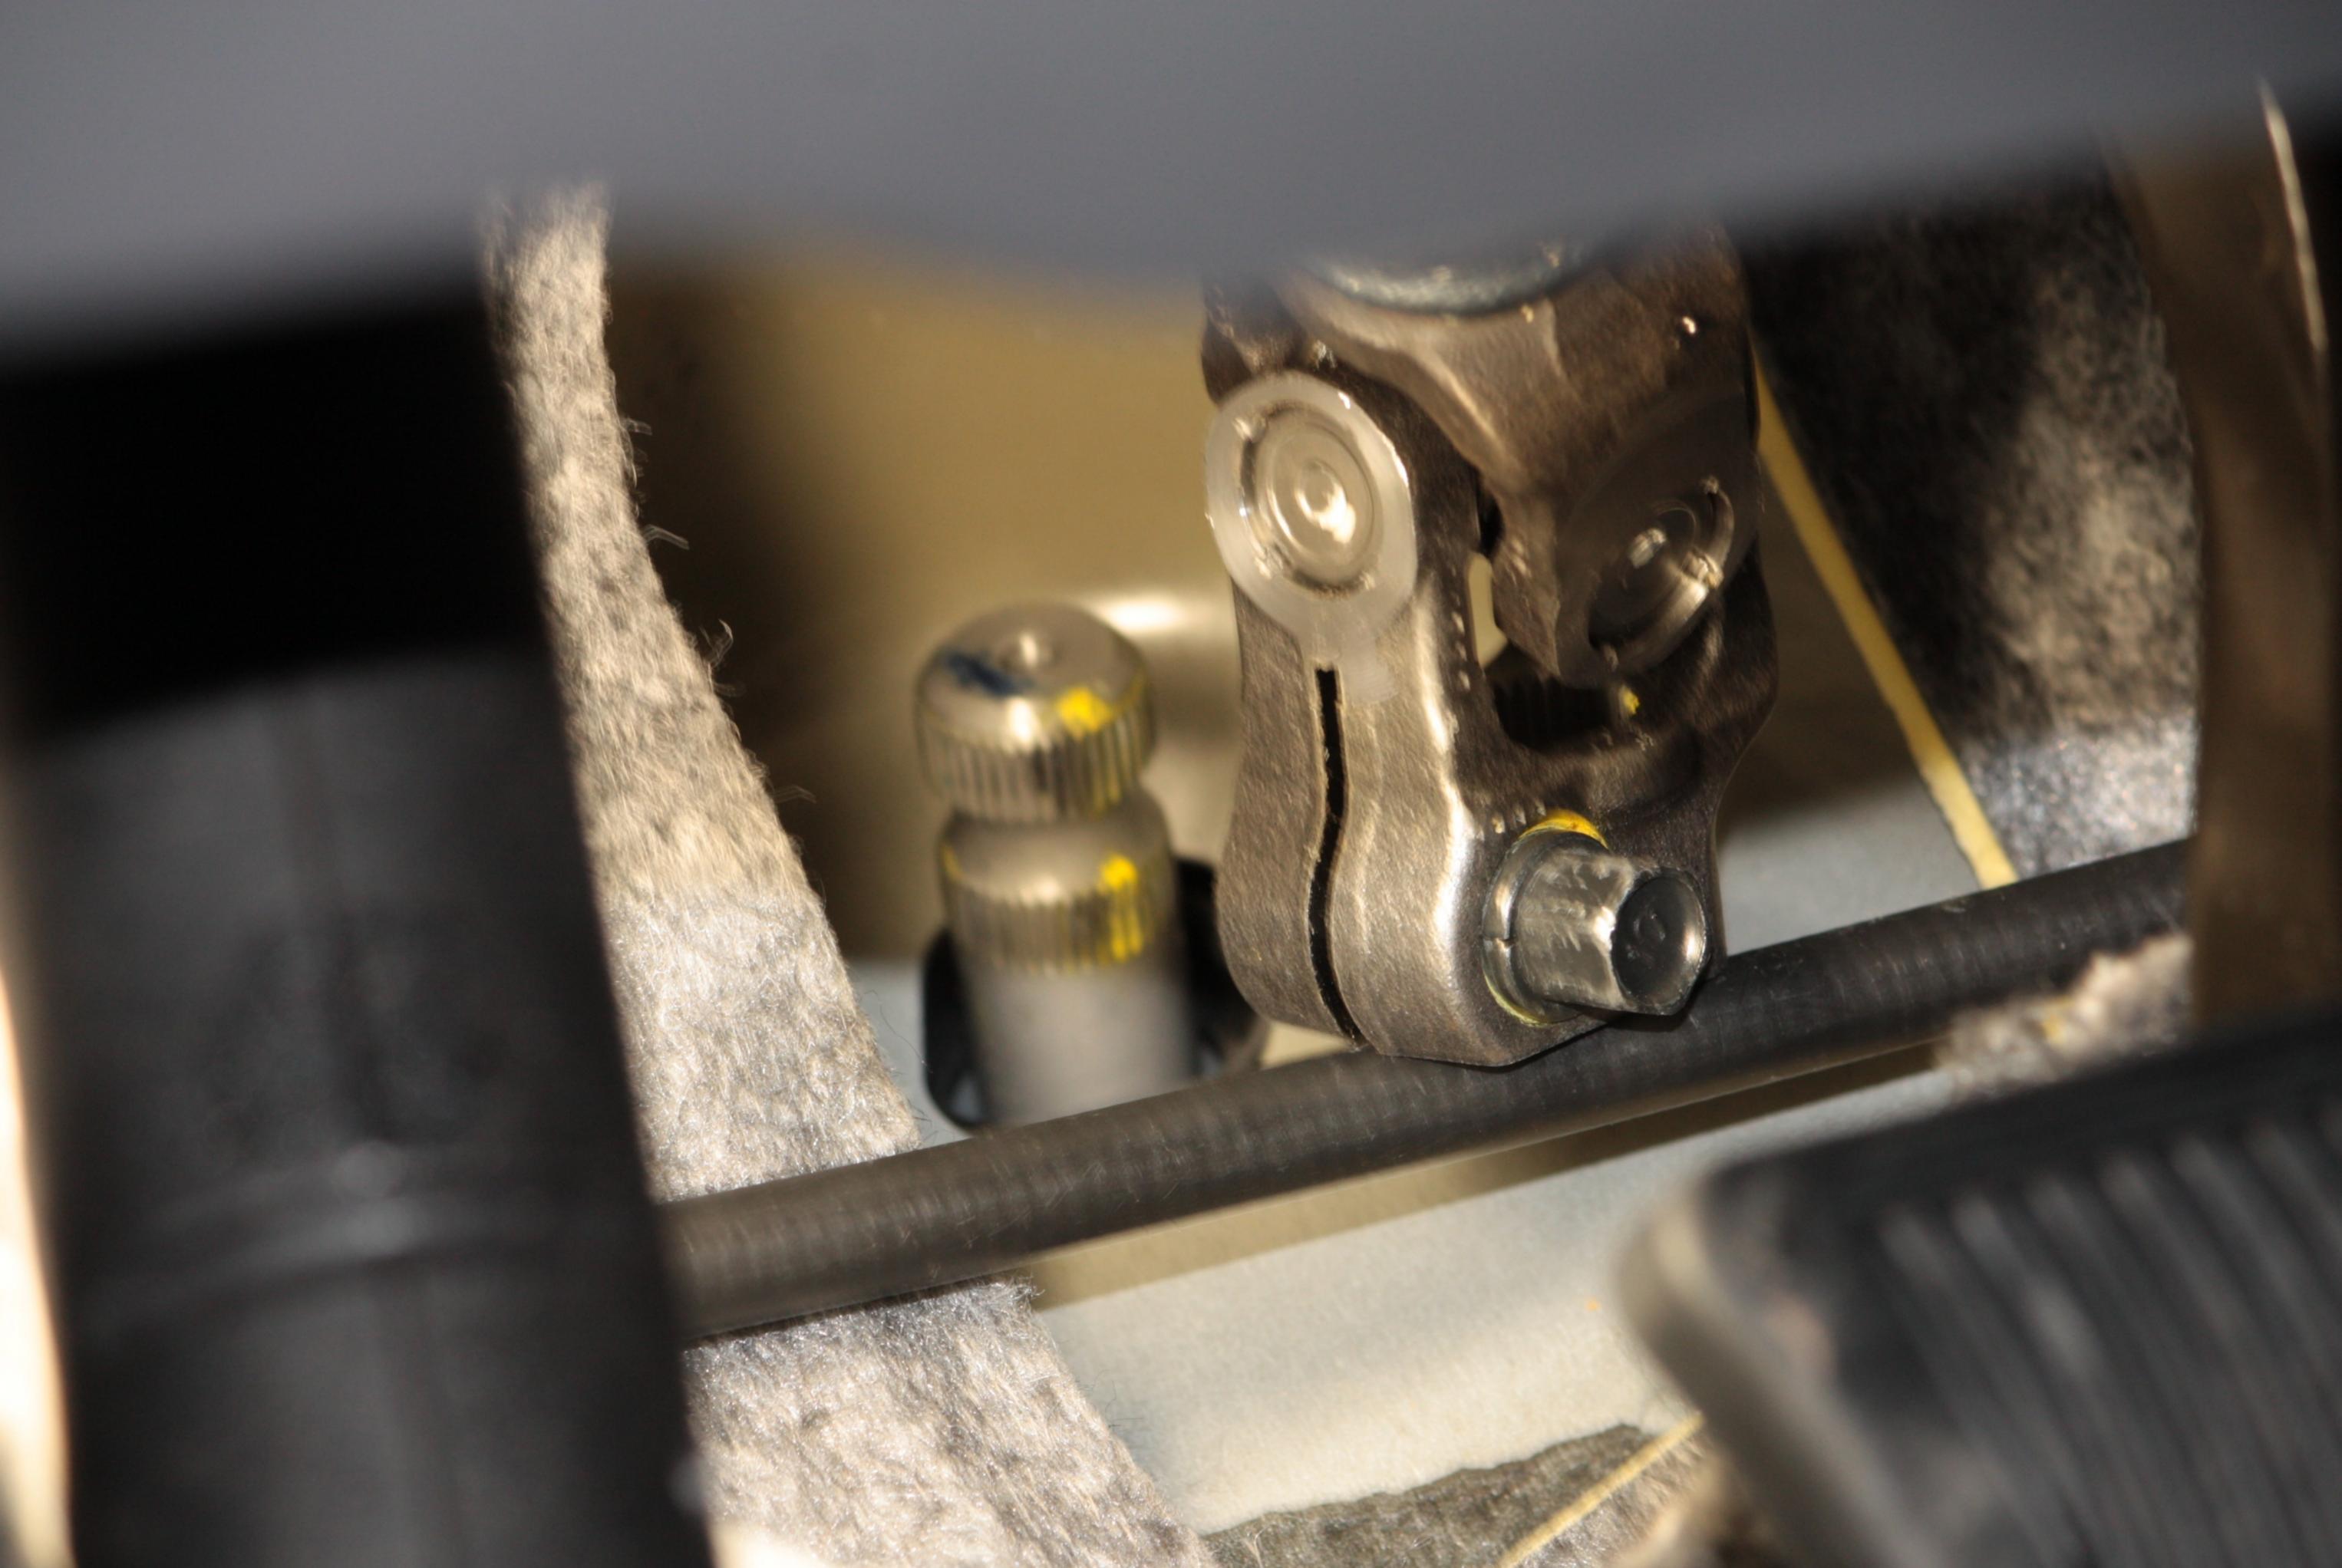
IMG_8471.JPG

- When vehicle arrived at dealer the technician found the intermediate shaft detached from the steering rack shaft as shown here

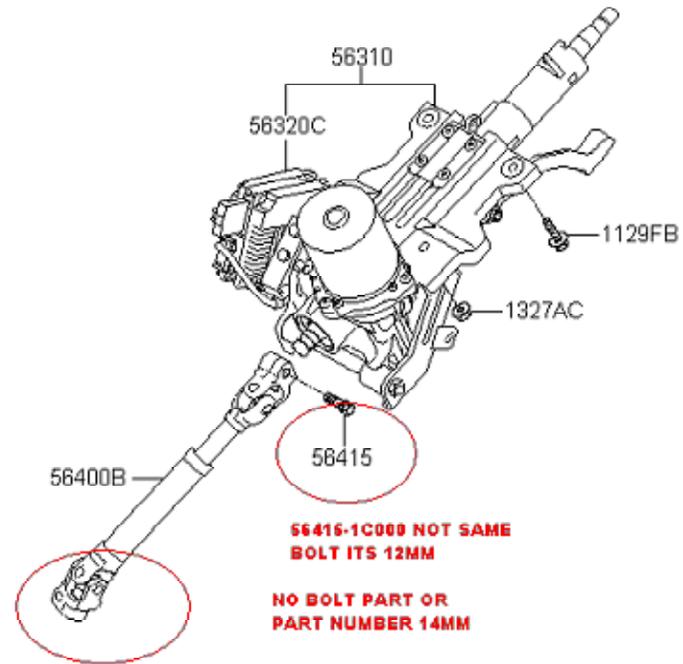
YF INTER STEER SHAFT AND BOLT.bmp

2011 YF--STEERING RATTLES, INTERMEDIATE SHAFT BOLT LOOSE FRFT

Customer states when moving steering wheel, a rattle noise is coming from under the dash. Tech found upper intermediate shaft U-Joint bolt stripped, not tight

dealer will replace intermediate steering shaft and pinch bolt (part taken from like vehicle at central region

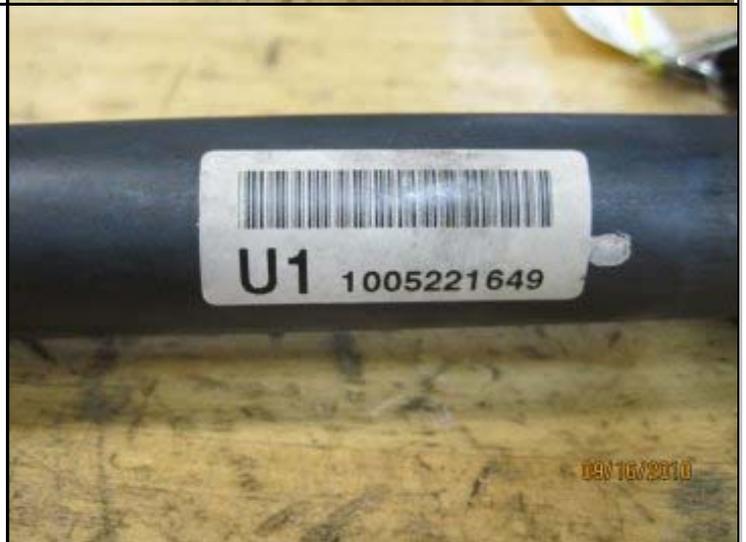
Img_1530.jpg Img_1531.jpg Img_1529.jpg

One of the steering shaft joint caps was missing.

- Picture shows decal on steering shaft.

Replace steering shaft.

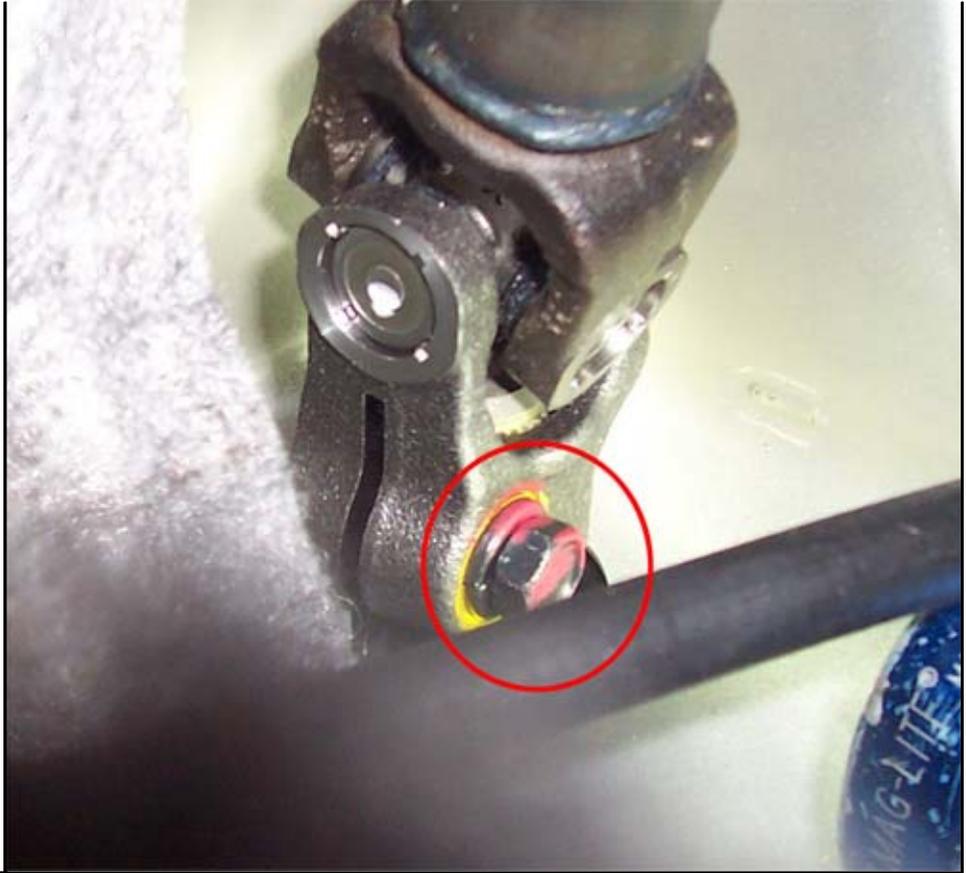
- Intermediate shaft pinch bolt was not tight from factory
- Tech stated that the bolt took approx 7 full turns to tighten to

spec

tighten intermediate shaft pinch bolt
