Re: **PE10-042**  
**NVS- 214phk**

On behalf of Mack Trucks, Inc., I am responding to the questions raised in your letter dated January 19, 2011.

DSR...Fifth Wheel Angle Hardware Issue

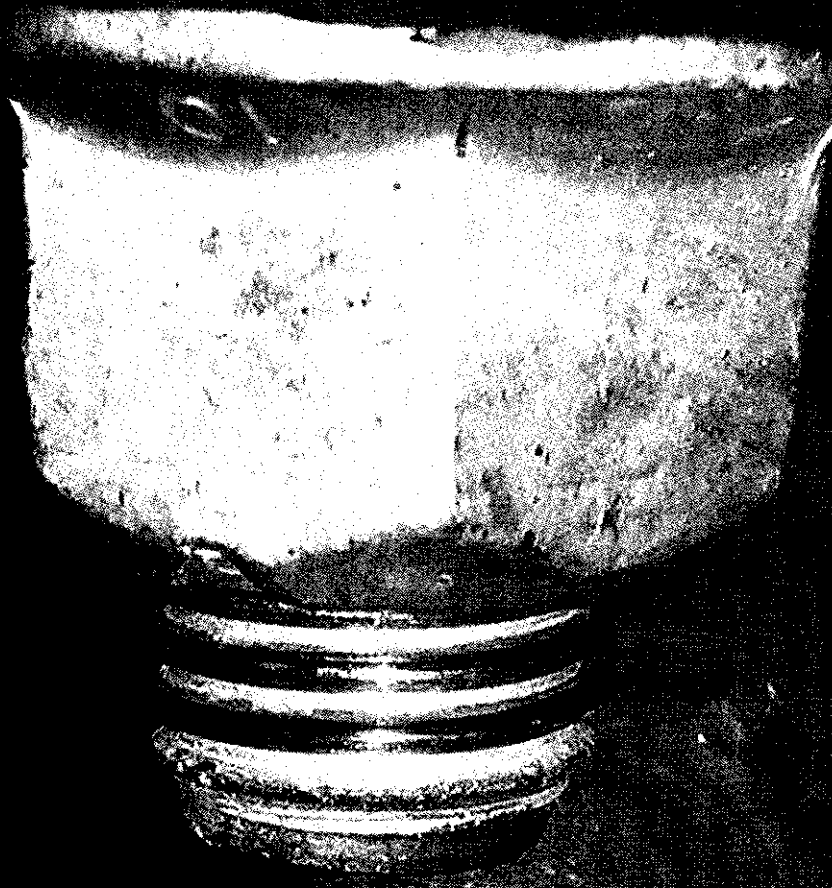
Found all 5th wheel mounting bolts loose. Also looks like fifth wheel flange to frame huck bolts at the front of the fifth wheel are loose. See attached pictures. Technician started replacing loose fifth wheel bolts with bolts per VIN, [REDACTED]. Technician noticed that the mounting bolt when ran all of the way down bottomed out on top of a huck bolt. Checked and looked at another similar spec'd unit on the yard for service and found it too also had the mounting bolts sitting on top of the huck bolts. (CXU613,010948.)  
Went to customers local terminal and found one unit there with loose mounting bolts also. (CXU613,012155.)

| Created | Created By | Activity Type | Description |
|---|---|---|---|
| 2010-09-24 11:18:35 | RONALD DUNCAN | Web Response | Thanks for the report. Please replace fifth wheel hardware with part # 25189745 flange screw(12ea) and 25093559 nut(12ea) on all units that you currently have at your location. |
