**National Highway
Traffic Safety
Administration**

Subject: FINAL REPORT: PE10-038 "BMW Mini Cooper Electric
Power Steering"

Date: 4/11/2011

**Memorandum Report
PE10-038
BMW Mini Cooper Electric Power Steering**

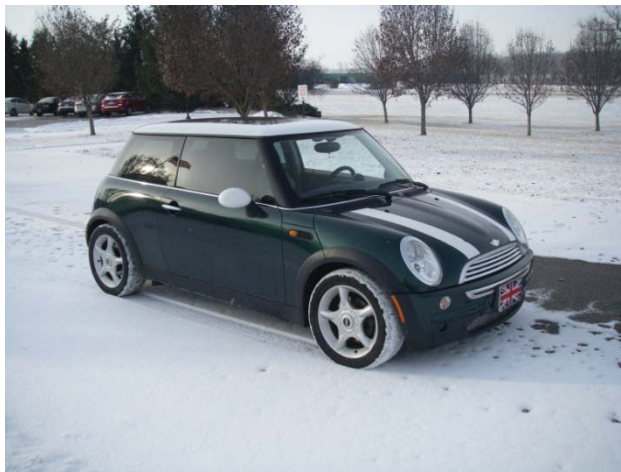
Figure 2
Subject Test Vehicle

A 2004 BMW Mini Cooper (VIN: WWMRC33424 [REDACTED]) was leased from a complainant for testing. The odometer registered 55,594 miles when delivered and the EHPS was inoperative. The receiving inspection at VRTC showed that the vehicle was equipped with Bridgestone Potenza G009 tires, size 205/50R16, set to 25 psi. The vehicle manufacturer's recommended tire pressure is 35 psi. The tire manufacturer's maximum allowable inflation pressure is 44 psi. After allowing the tires to cool overnight, the inflation pressure in all four tires was adjusted to the recommended 35 psi. Various vehicle parameters were measured or calculated at this time. Figure 2 shows the test vehicle used for this program.
