## ENGINEERING ANALYSIS CLOSING REPORT

**SUBJECT:** High-pressure fuel pump (HPFP) failure resulting in engine stall while driving.

**EA No.:** EA11-003

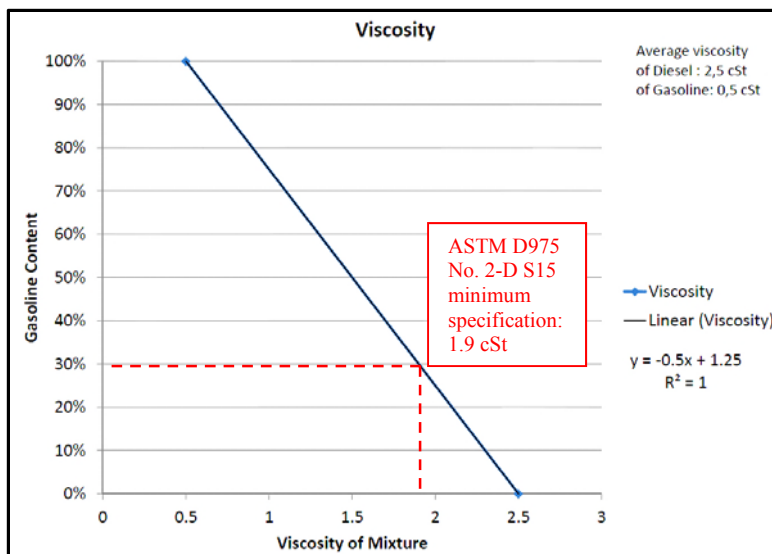
Figure 9. Volkswagen Viscosity Exhibit.

**“Workshop Program” fuel testing.** As of October 2013, Volkswagen had submitted data to ODI from fuel sample testing of 305 filling stations, 318 randomly selected vehicles, and 1,339 incident vehicles. As previously noted, Volkswagen has identified misfueling with gasoline as the primary cause of HPFP drivetrain failures in the subject vehicles. Volkswagen indicated that viscosity was the best indicator of gross misfueling (Figure 9) and also a critical fuel property for maintaining HPFP drivetrain integrity.
