Meeting with NHTSA

December 12, 2012

EA11-003 TDI High Pressure Fuel Pump

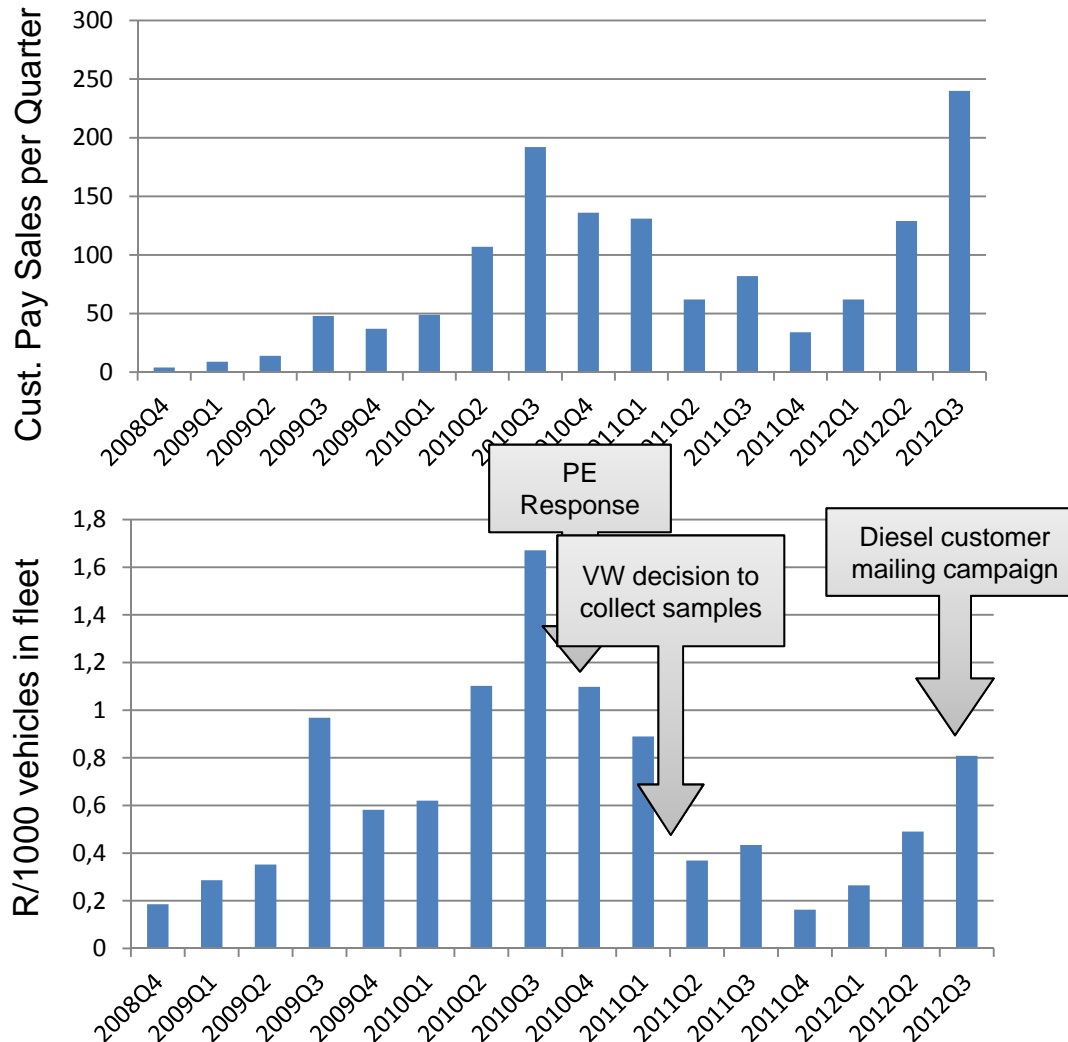
Part Sales – Customer Pay

- 1385 HPFPs have been paid by customers, although **all** vehicles/HPFPs were still covered under warranty --- Why?
- Over 1000 of these replacements contain misfuel information in VWs data
- Customer Pay went to minimum when VW started to retrieved field samples
- Customer Pay would have been even higher w/o this approach
- Customer Pay to rise with VW mailing campaign

Customer Pay while vehicle HPFP is still under warranty results from misfuel incident (customer's responsibility)

Records do not disclose all misfuel incidents, depending on the actual wording used by the dealership technician etc.

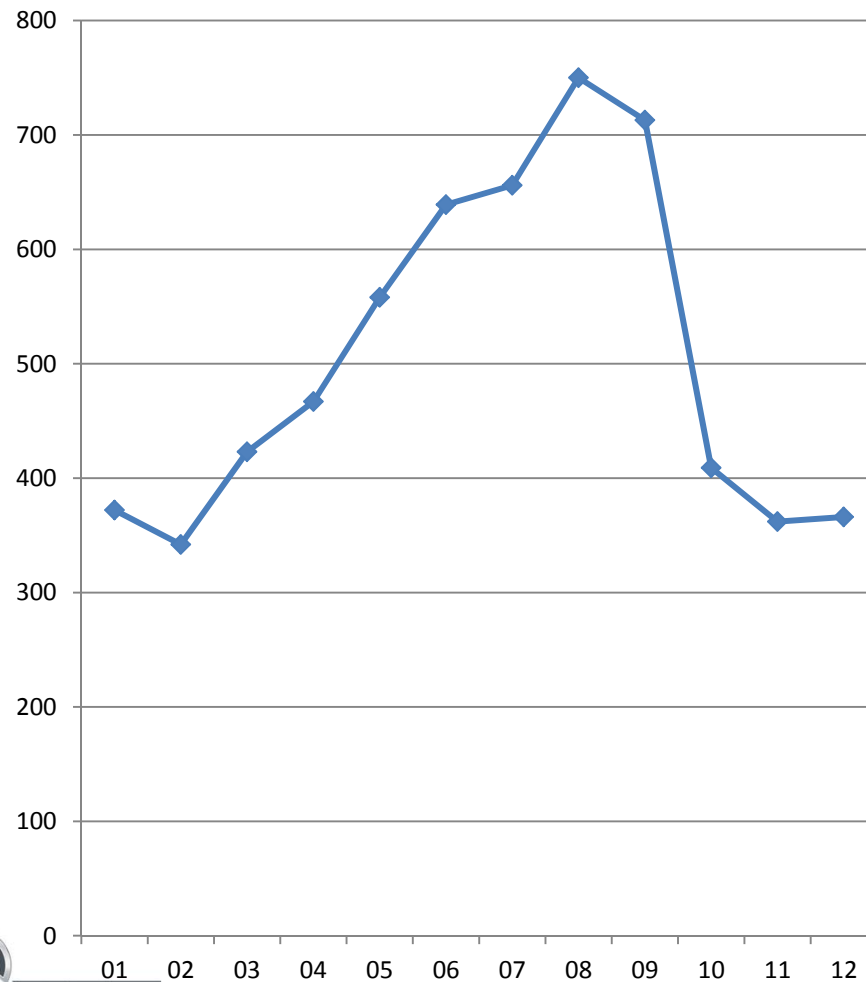
Pump Sales by Month

- When analyzed by season, pump sales reveal a maximum in the warm months
- This is another indication for misfuel related failures:
- Normally higher failures would be expected in winter: Winterized diesel fuel or gasoline added to diesel by customers to winterize the fuel, but actual pattern is different
- In summer actual viscosity is lower, simply depending on higher ambient temperatures.
- As viscosity is significantly reduced when gasoline is mixed into diesel fuel, warm temperatures contribute to even lower viscosity – increasing the possibility of an interrupted lubrication – leading to higher part sales in summer.

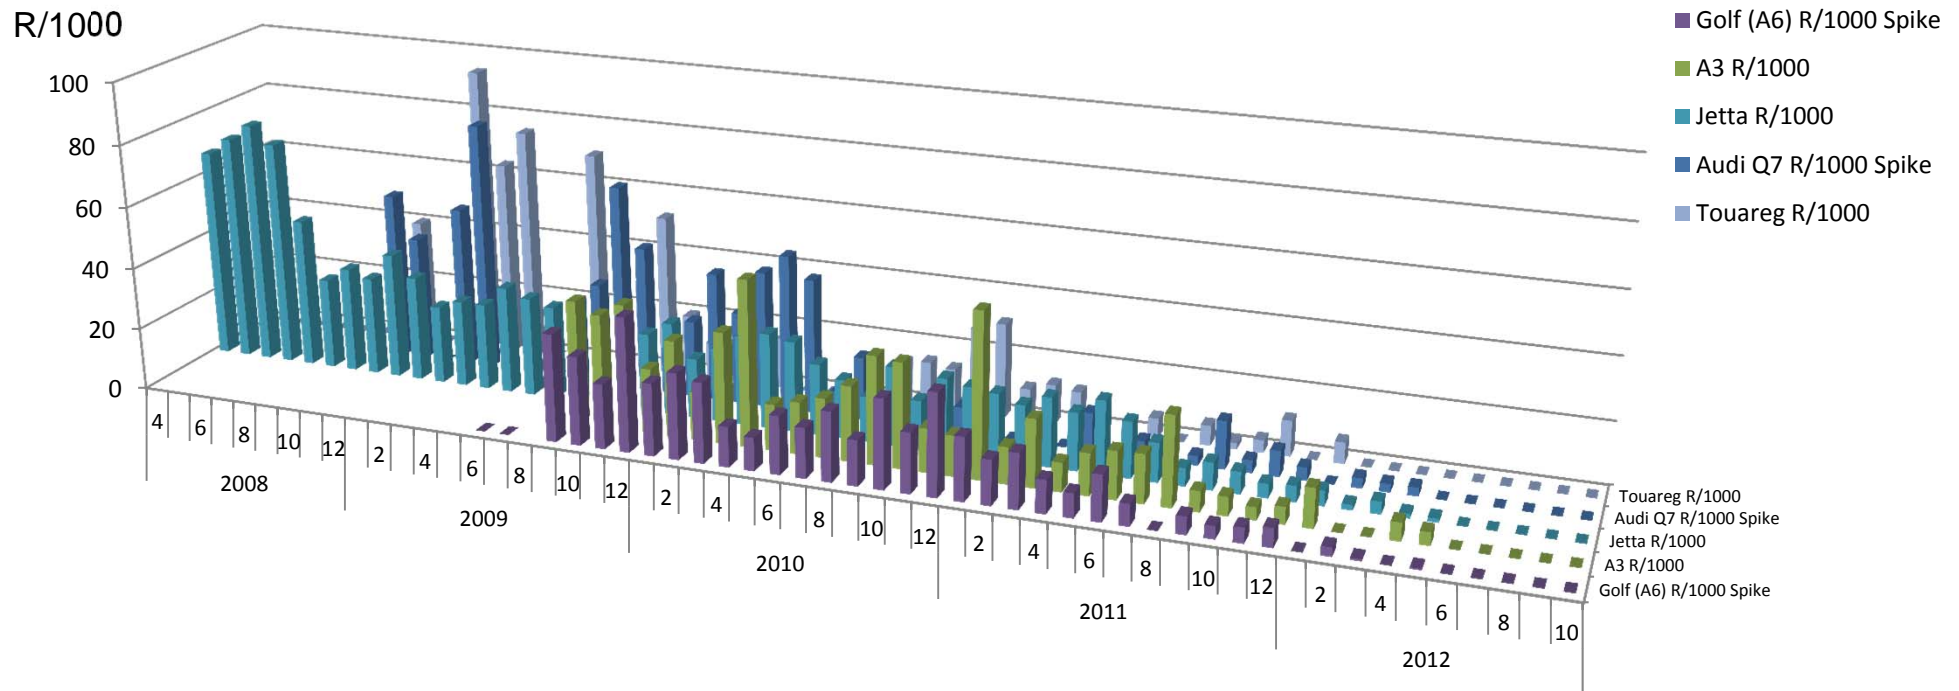
Warranty Claim Plots by month of production

- Two months with very limited production (19 & 9 vehicles) created spikes due to single replacements
- These spikes have been removed for better interpretation

→ All model lines show consistent patterns; deviations are within normal statistical spread („not significant“)

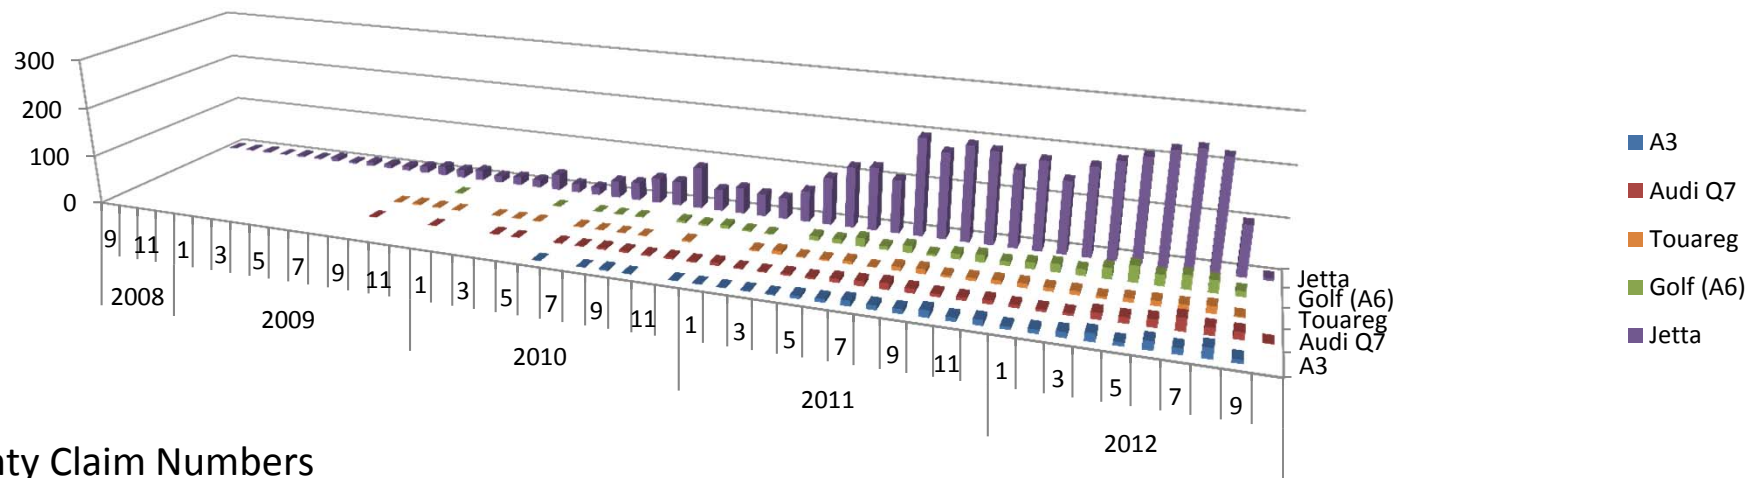
Warranty Claim Plots by Repair Date

- Many HPFPs are replaced as in abundance of caution (per repair guidelines), not b/c the HPFP has actually failed
 - Volkswagen trying to receive additional HPFP samples → causes exaggerated numbers
 - Increase of claims when starting to extensively collect parts, claims previously rejected are now being paid
- Warranty data cannot be used to calculate actual failure rates (also: NTF rates)

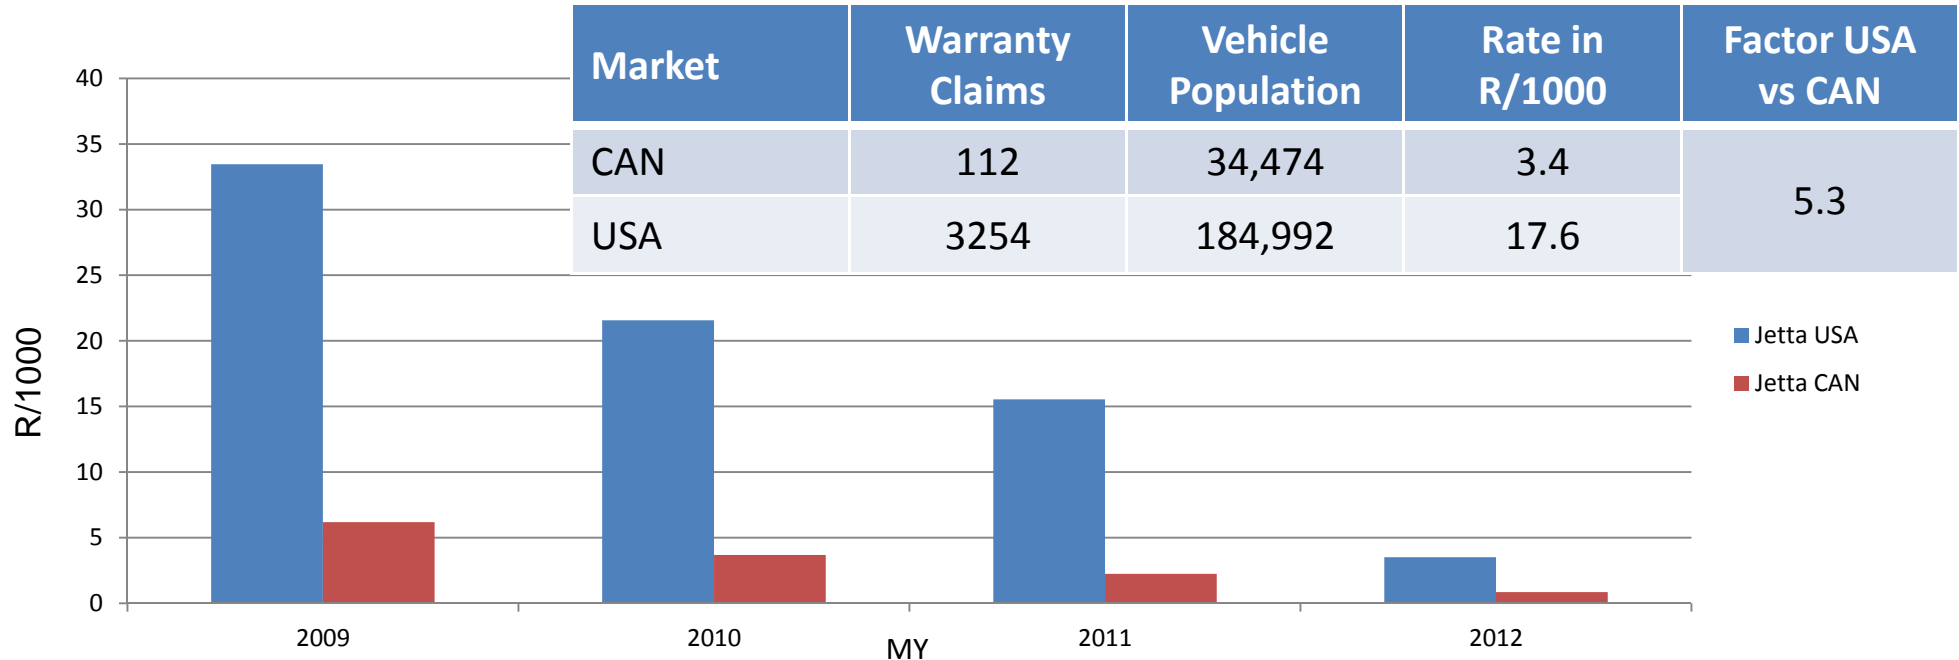
Market Comparison USA vs. Canada (Jetta only)

- Same fuel standard, same fuel supply
- Same vehicles (model, engine, injection system, emission standard)
- Warranty Rate in USA over 5 times higher than in Canada

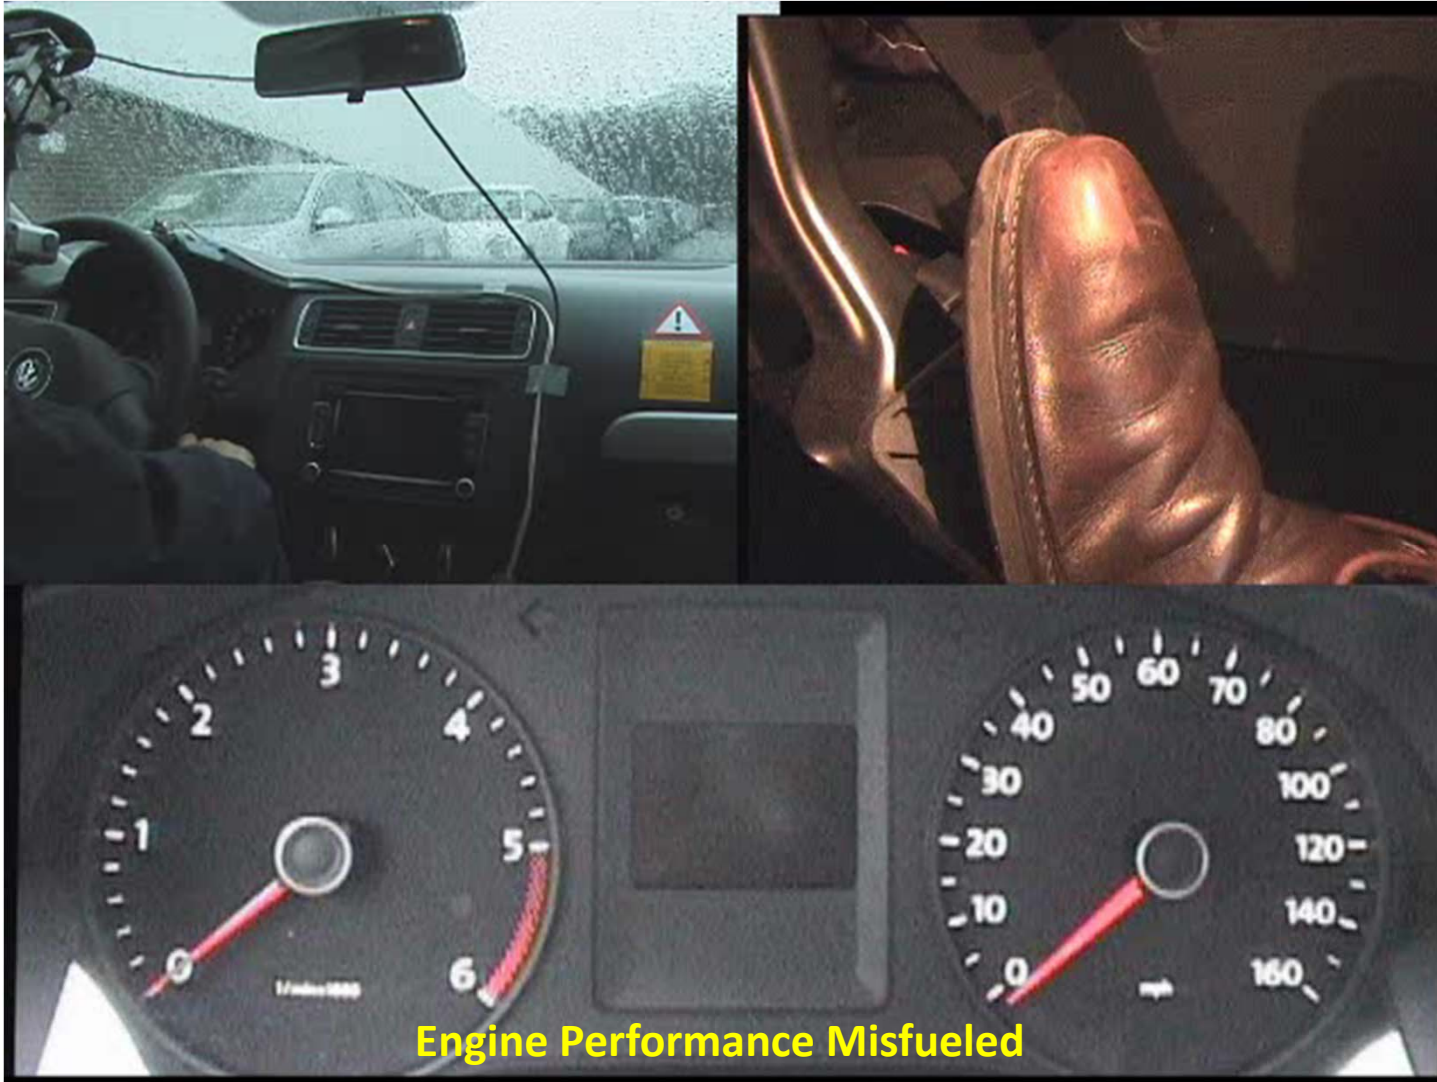
Misfueling Test #2 Misfuel Rate 80%

- No damage in high pressure fuel pump
- Occurrence of initial change in engine performance at about 0.25 km (0.16 miles)
 - Knocking sound from engine
 - No spontaneous engine response
- Engine response with significant hesitation at about 1.2 km (0.75 miles)
- Occurrence of limp home mode at about 1.4 km (0.87 miles)
- End of test at about 2.1 km (1.3 mile)

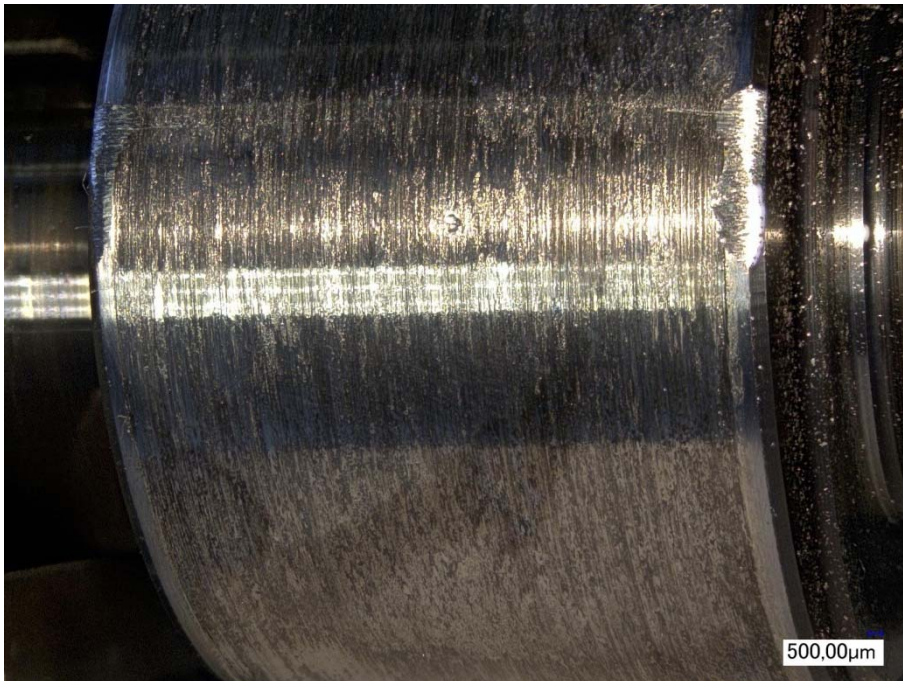
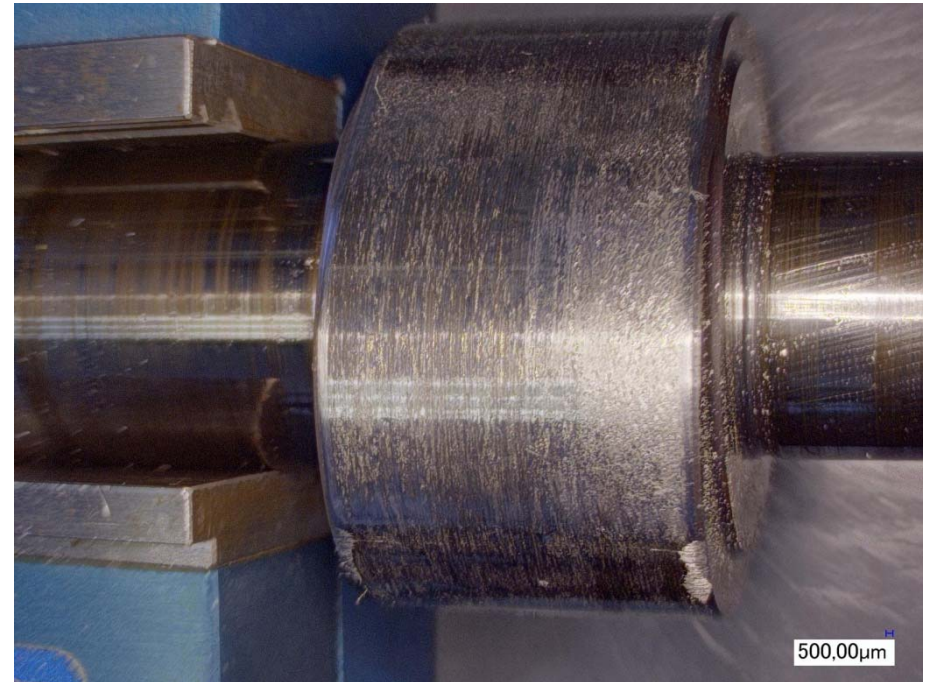
Misfueling Test #4 Misfuel Rate 60%

- About 23 min engine warm up
- Warning Light (Glow Plug) coming up within initial acceleration up to 78 ^{km}/_h (about 50 mph)
➡ Trigger for Limp Home Mode
- About 43 min driving cycle with flashing glow-plug indicator light and reduced performance
- Significant loss of pressure supply from HPFP in the final 5 minutes of the test
- End of test after 66 minutes at 58.4 km (36,3 miles)
- Metal flakes found in HPFP did not cause engine shutdown, plunger displacement was reduced and impaired fuel supply (see pictures)

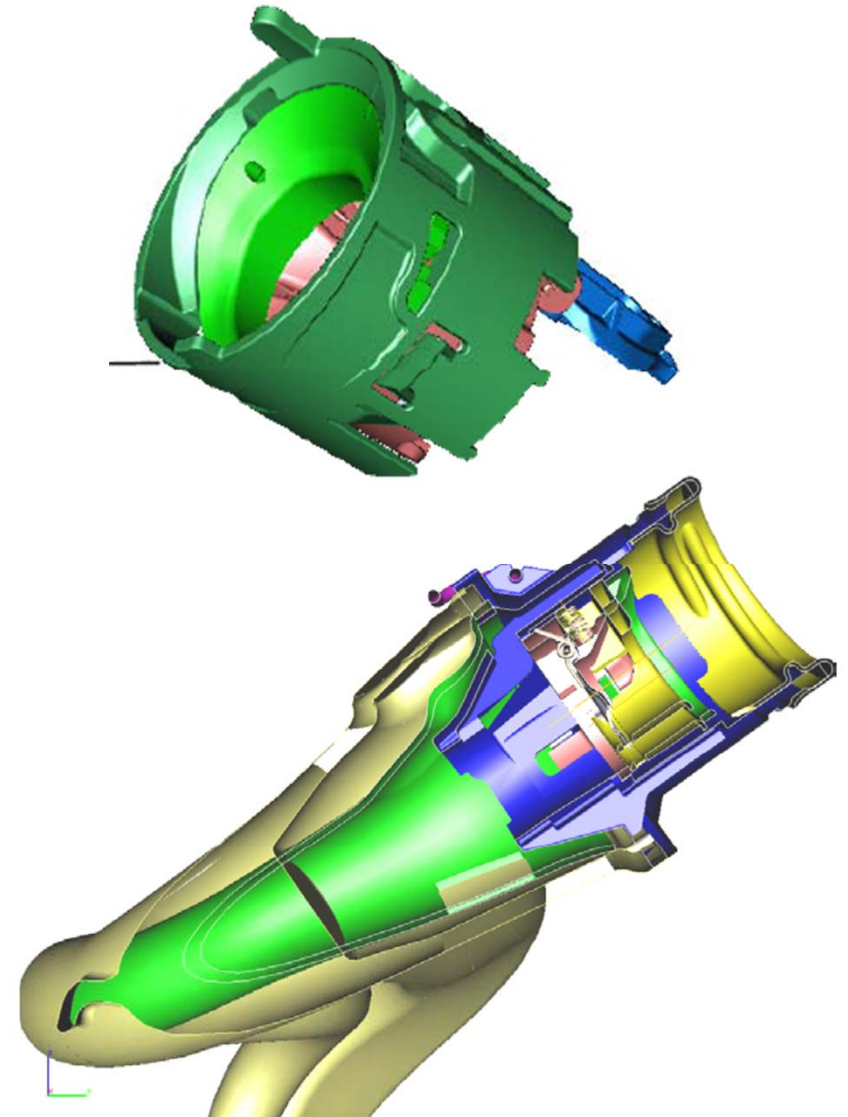
Series Misfuel Protection

- Implemented as of MY13 (Q7 since SOP2009)
Starting May/June 2012 depending on individual model
- Device detects outer diameter of fuel nozzle and opens only when 24.6 mm diesel nozzle is detected (plus tolerance)
- 21mm gasoline nozzles will not open restrictor and nozzle cannot be inserted into vehicle's filler neck
- “emergency fueling” option allows bypass of approx. 6L/min w/o release of the restrictor, for example when filling with a fuel canister (commonly equipped with a small nozzle)

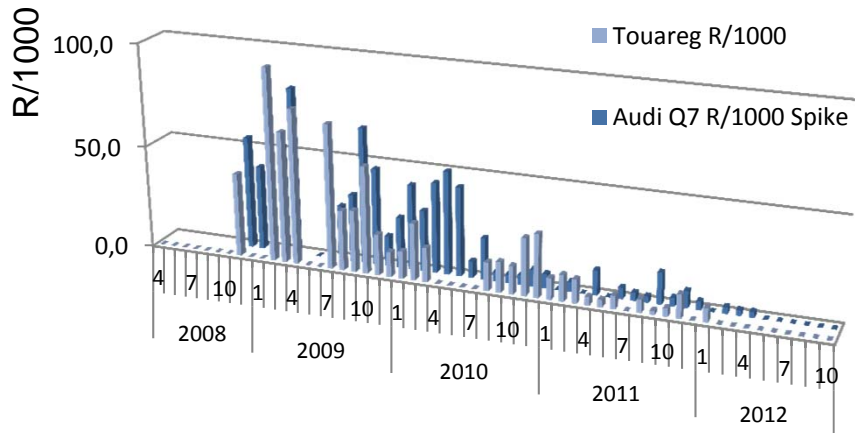
Q7 vs. Touareg

Volkswagen considers several reasons as the cause for Q7 being „over represented“

- AdBlue filler neck close to fuel filler neck (this was the reason to implement the misfuel restrictor in the Q7) ; AdBlue commonly being refilled with bottles (misfuel restrictor allows 6L/min „emergency fueling“) → several Q7 AdBlue incidents found (Touareg has AdBlue filler neck in the trunk...)
- Small population: Few HPFP replacements have huge effect on rates, statistical evaluation is rather weak
- Expensive premium vehicle: Dealers may be more willing to replace HPFPs to keep customers happy, although it would not be necessary
- Use of adapters to override misfuel inhibitor (sold by dealers and at every fuel station) → some misfuels detected in data / fuel samples
- Misfuel by roadside assistance occurred when refueling with spare can
