EA11-007 – Index of Laboratory Reports

QA Lab Report No. 4398

SUBJECT: Paint Thickness

OBJECT: Determine the mode and possible cause of breakage.

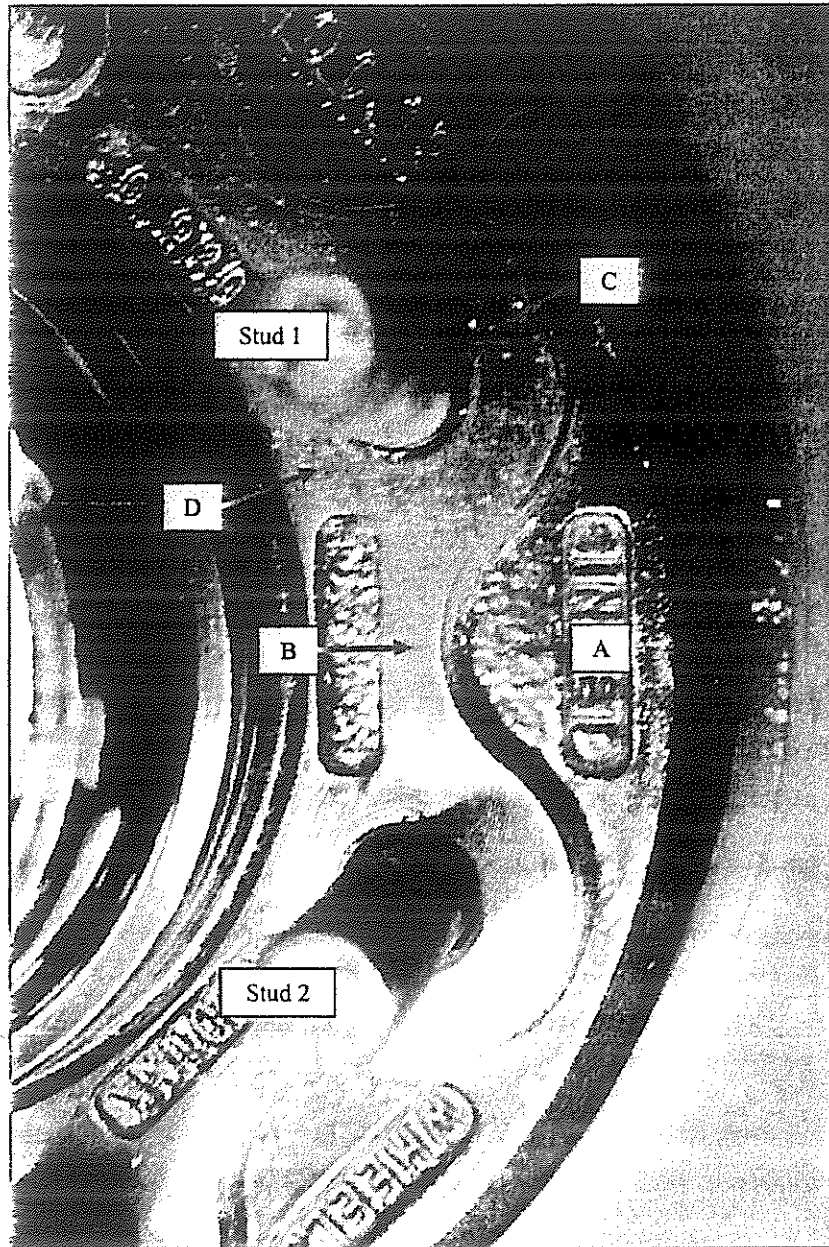
Figure 5. Showing the four locations of paint film thickness measurement relative -- measurements were made in a clockwise direction from stud 1 to stud 8

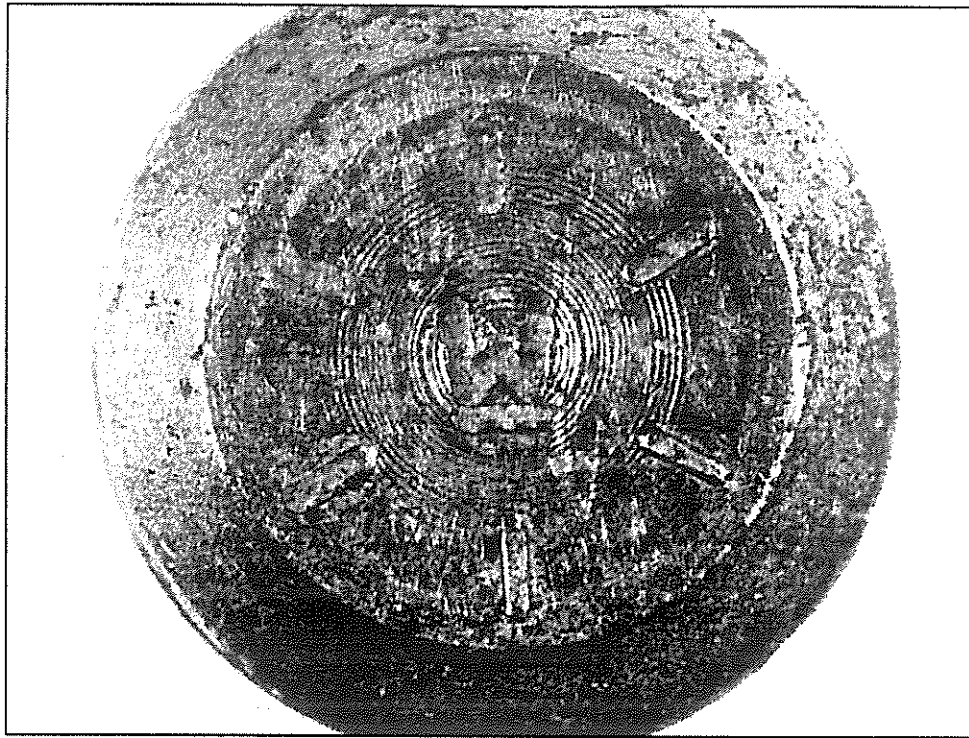
Head markings on all five bolt ends in the rotor assembly as well as the loose bolt were identical (Figure 7). They exhibited the six radial lines indicative of Grade 8. They also exhibited the manufacturer's identification marking, W.

Figure 7. Head markings on the five bolts remaining in the rotor assembly and the loose bolt were identical – 6 radial lines for Grade 8 and the manufacturers identification, W

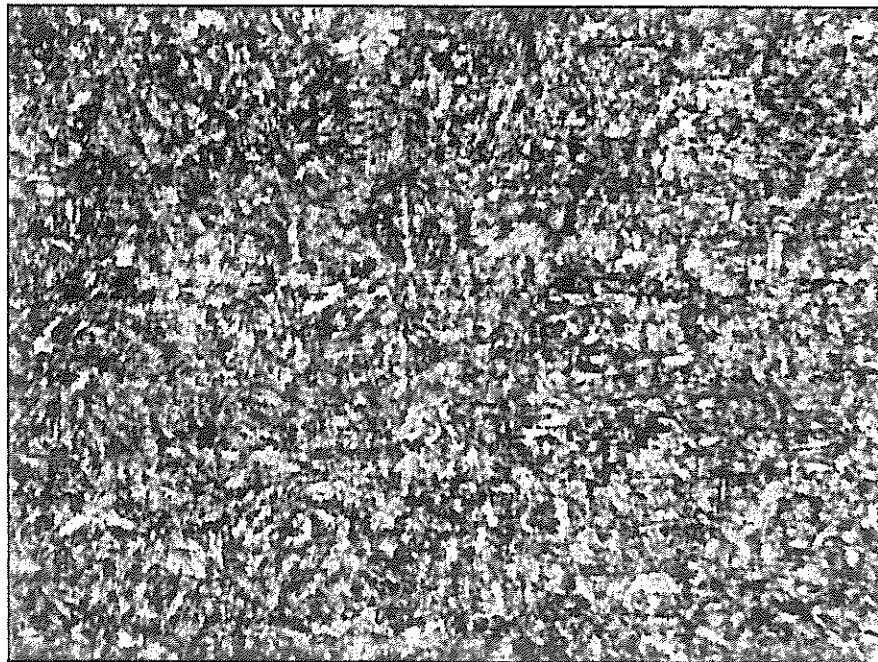
Bolts 2, 6 and the loose piece were examined. General microstructures of the three samples consisted of fine-grained, tempered, medium-carbon martensite (Figure 14). This microstructure complies with the requirement for 90 percent minimum martensite in the core of a Grade 8 product. No decarburization or carburization was observed in the spline. Overall results comply with the requirements for Grade 8.

Figure 14. Bolt 2, Core Microstructure – the microstructure consisted of fine-grained, tempered, medium carbon martensite – Nital Etchant, 500X

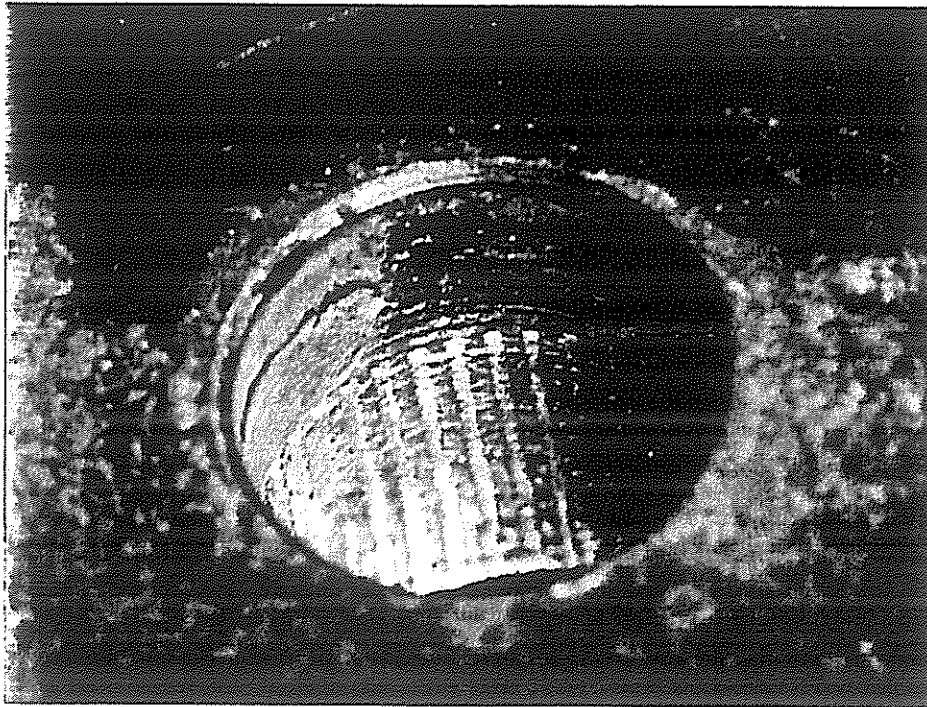
Hole surfaces in locations 2, 7 and 8 exhibited typical serration engagement features (Figures 2 to 4). Serration markings extended part way through the hole,

Figure 2. Location 2 – serration marks from the bolt extended from the inside toward the outside for an appropriate length – paint remained between the serration grooves

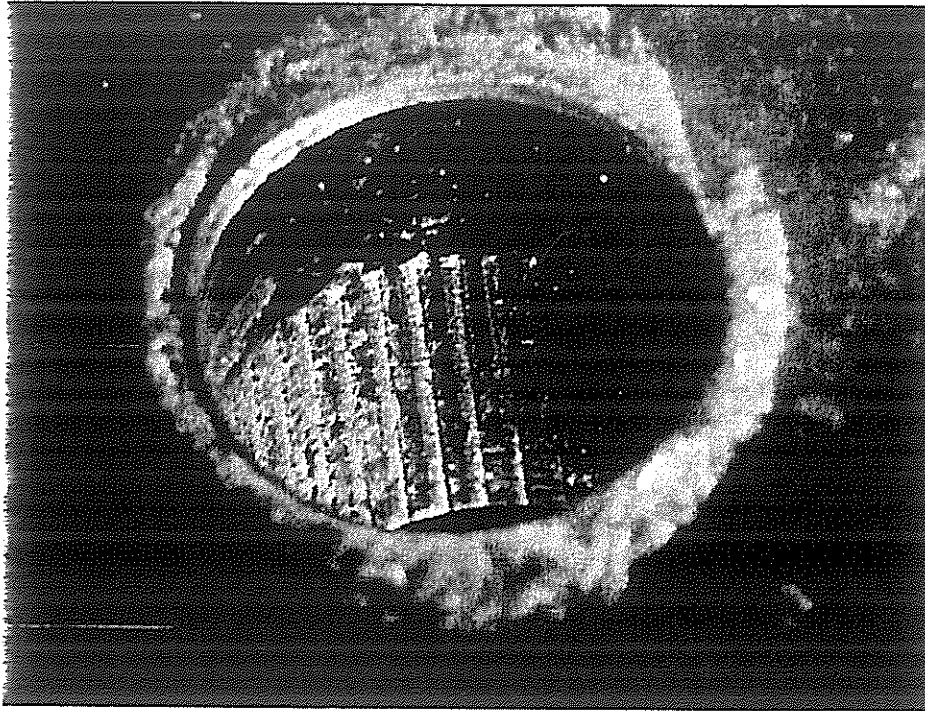
Figure 3. Location 7 – serration marks from the bolt extended from the inside toward the outside for an appropriate length – paint remained between the serration grooves

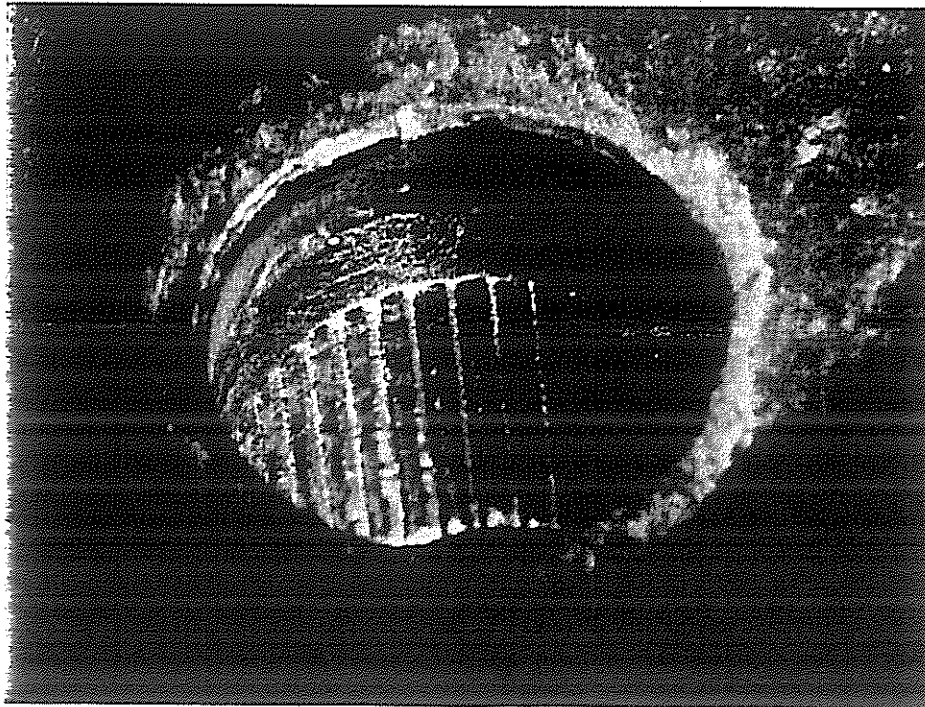
Figure 4. Location 8 – serration marks from the bolt extended from the inside toward the outside for an appropriate length – paint remained between the serration grooves
